**Condition Assessment Report
for 13 Buildings in the
Martin Luther King, Jr. Historic District,
a National Historic Landmark**

**Martin Luther King, Jr. National Historic Site
Atlanta, Georgia**

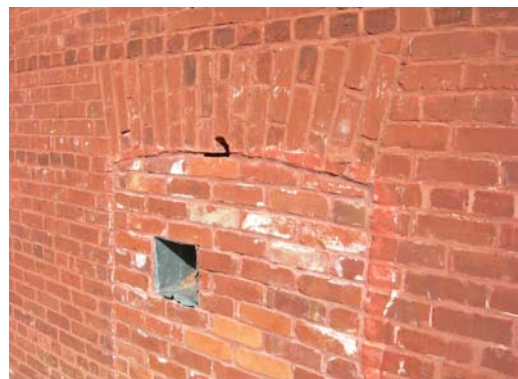
Right: In-filled window on south side with HVAC duct missing a grille

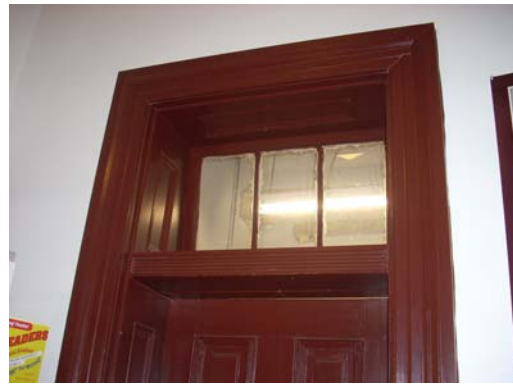
Original door, transom, and trim

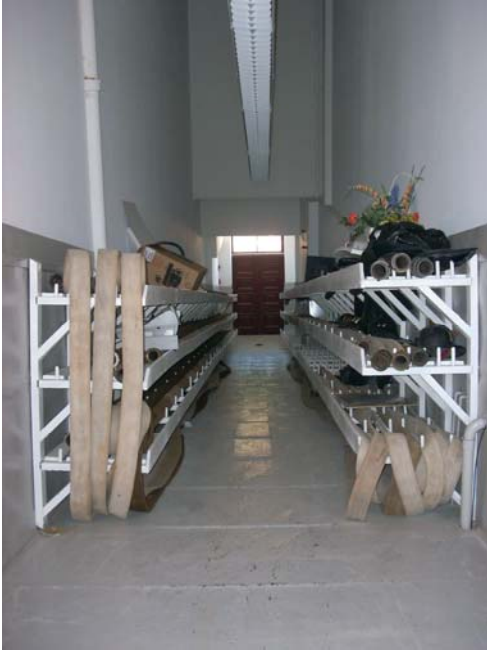
Fire hose chase, looking west from second floor to first floor door

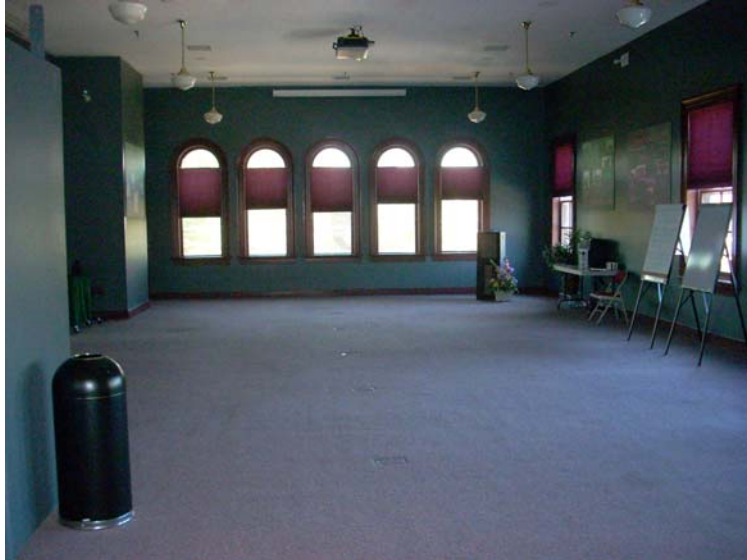
Main floor, second level

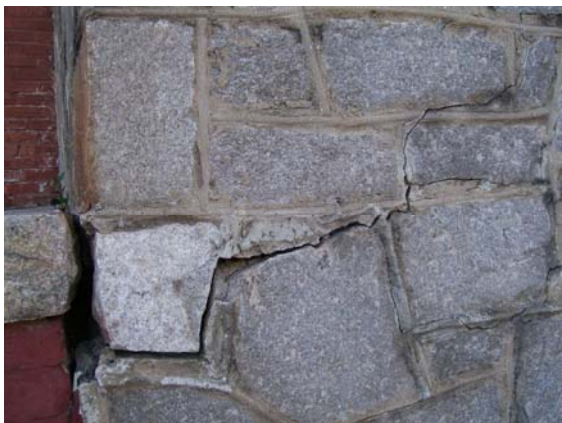
Stress cracks in retaining wall at southwest corner of building

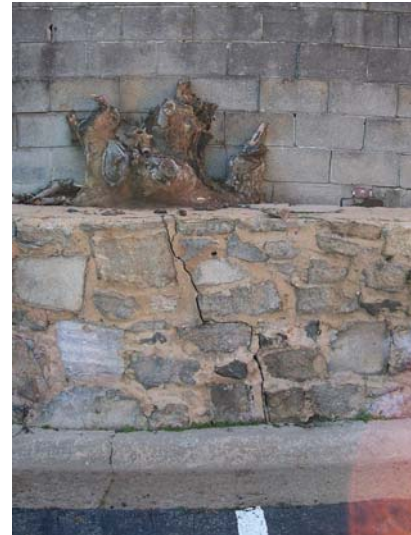
Tree stump growing out of retaining wall on south side property line, with stress cracks in lower wall

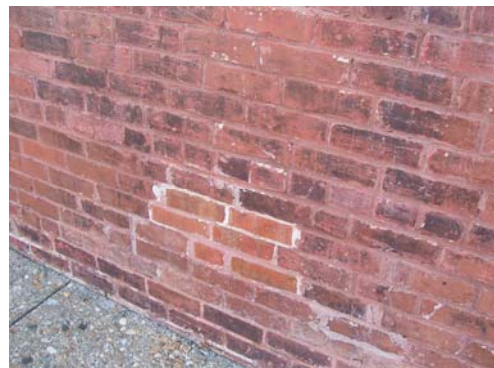
Inappropriate brick and mortar replacement

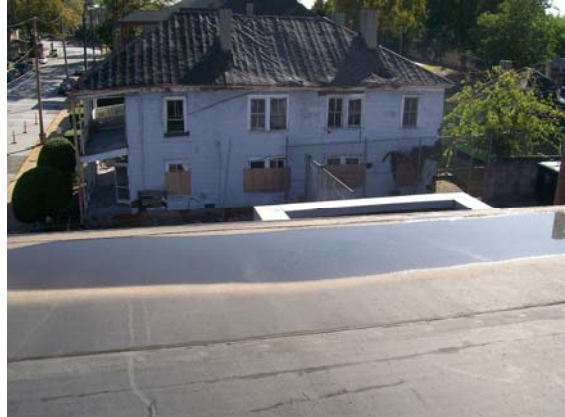
Ponding at east end of roof

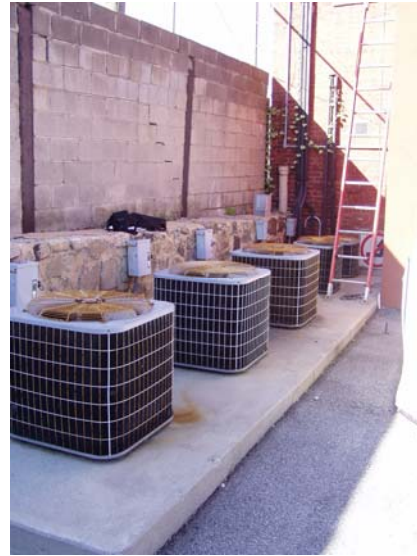
Fire Station condenser units

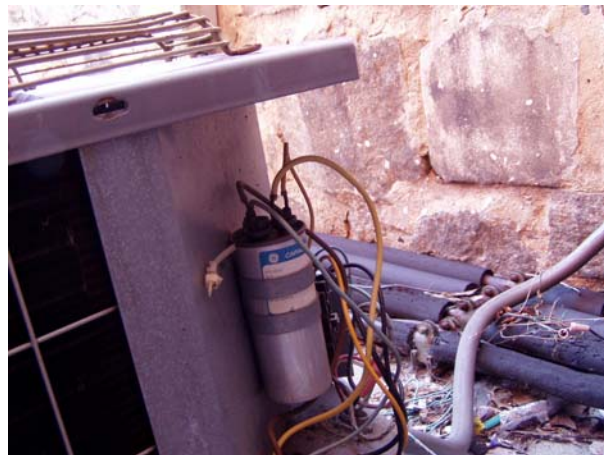
Condenser unit controls and damaged insulation

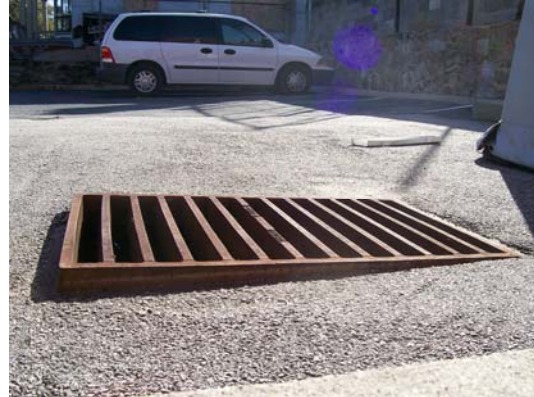
Drainage grate in east parking lot is improperly set

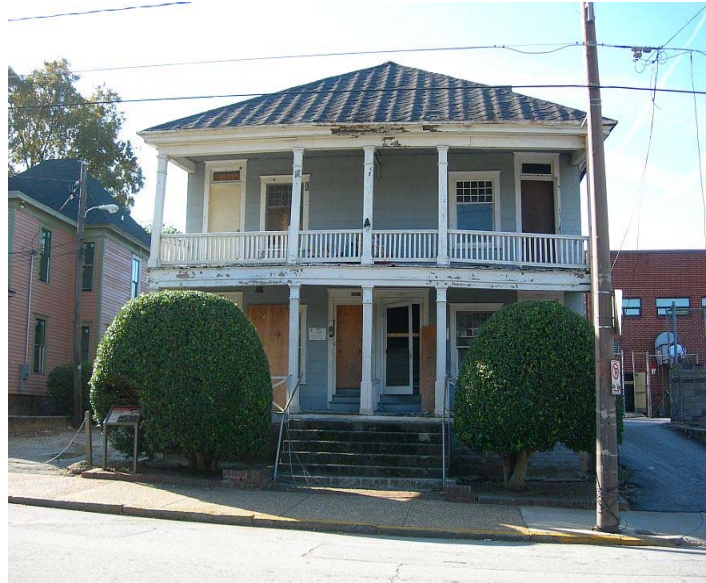
491-493 AUBURN AVENUE / APARTMENTS

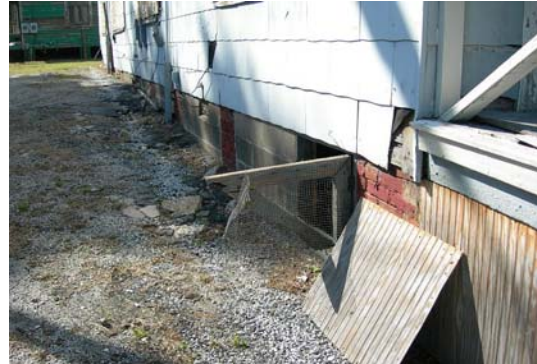
Detail of east foundation, crawlspace entrance, and composition shingle siding

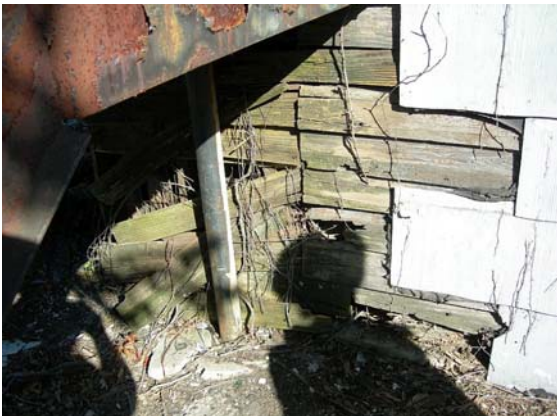
Metal stairway support and deteriorated composition siding over wood siding beneath back stairway

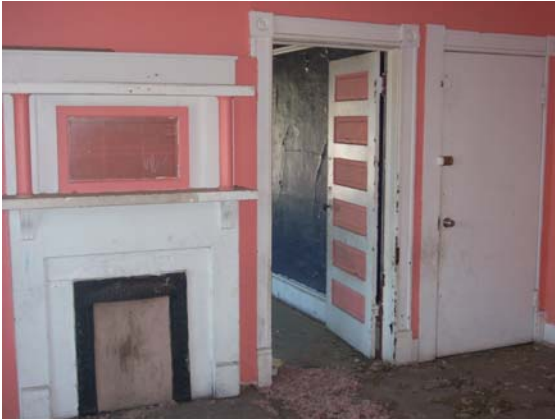
Fireplace surround and mantel, original and replacement doors, original wood trim in Unit 491-1/2

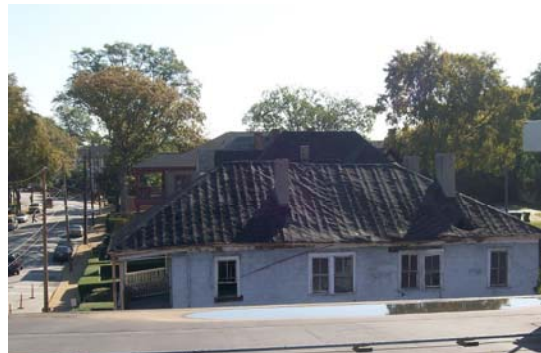
Roof, west elevation

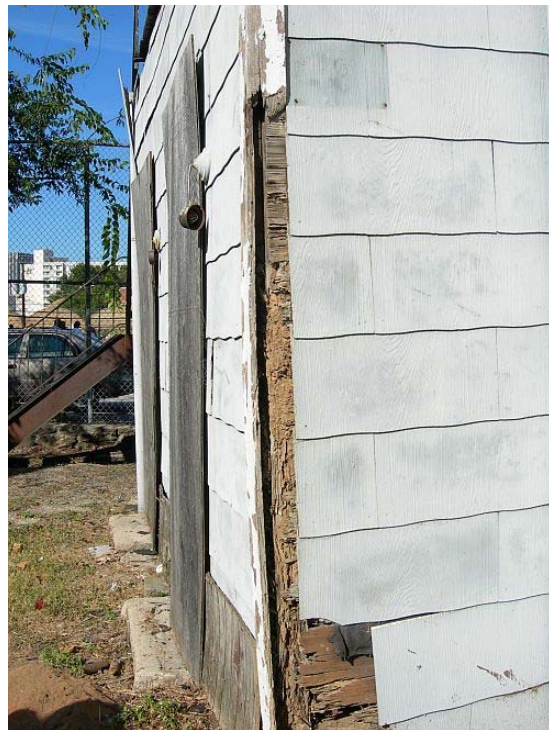
Missing cornerboard and damaged siding on south side of building

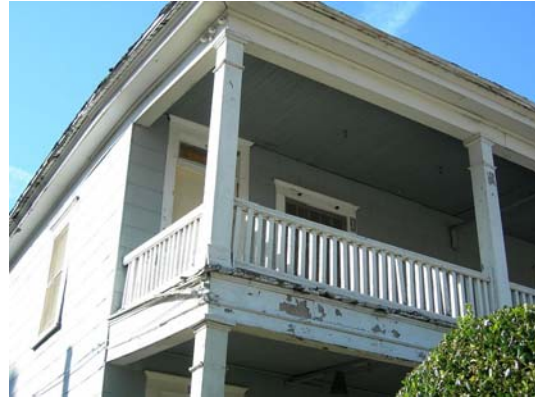
Second floor front porch railing

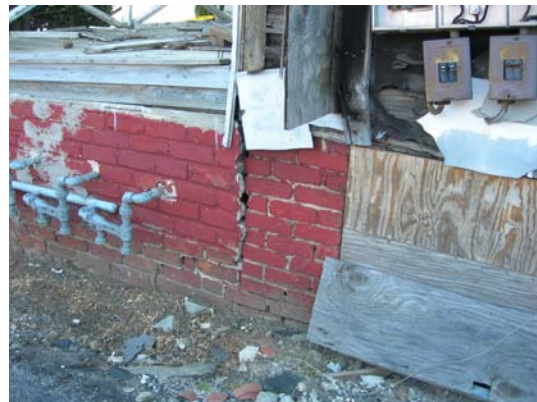
Failing porch foundation, west elevation

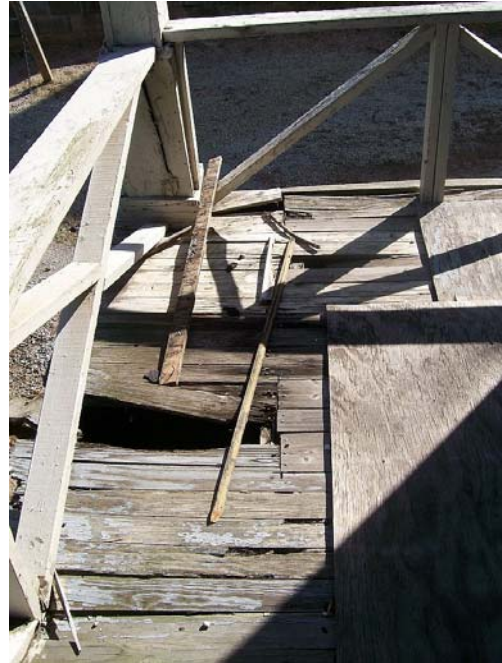
Pieced decking of front porch

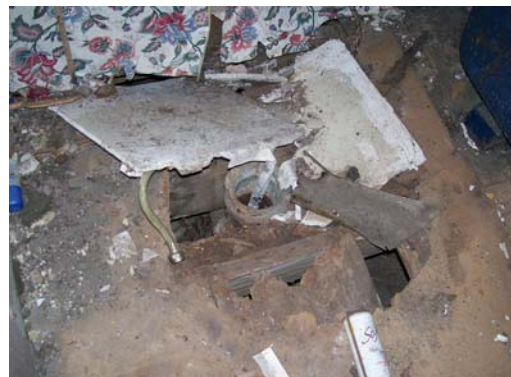
Damaged flooring at sanitary pipe

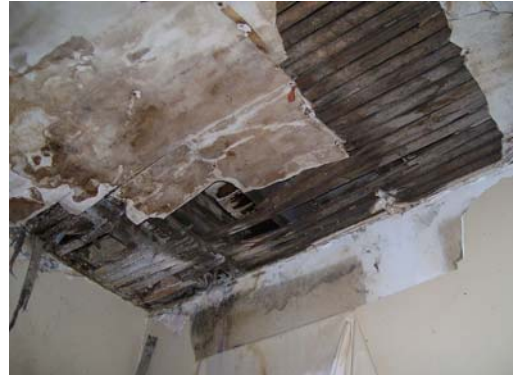
Damaged lath-and-plaster ceiling of first floor apartment unit.

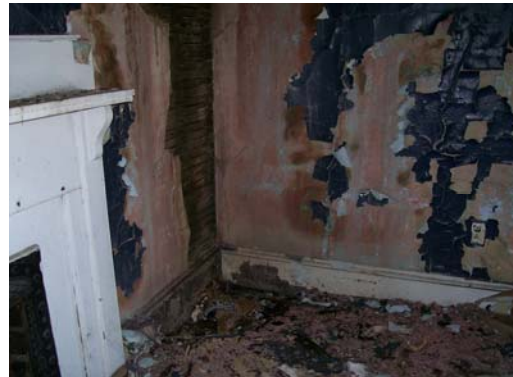
Moisture damage to plaster walls on second floor

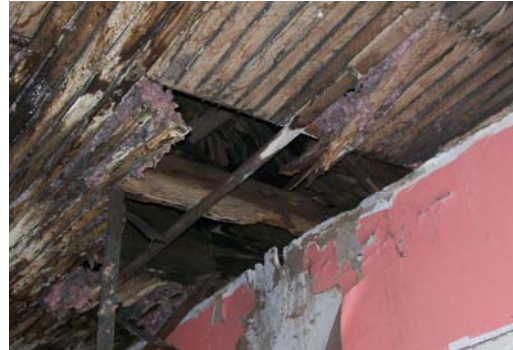
Failed lath and plaster ceiling

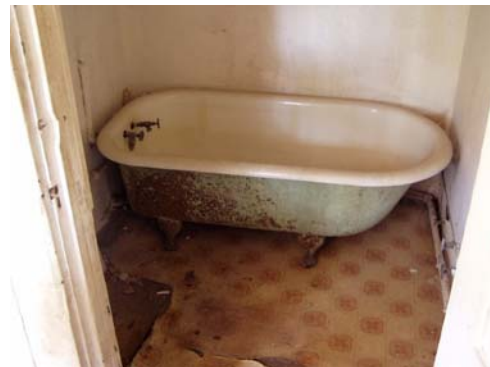
Footed tub in apartment bathroom

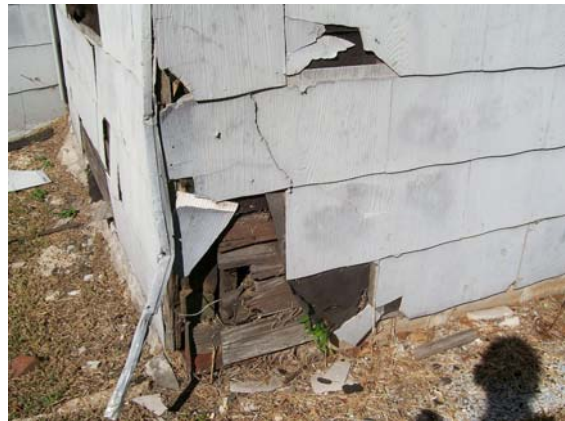
Damaged siding, underlying sheathing, and corner boards

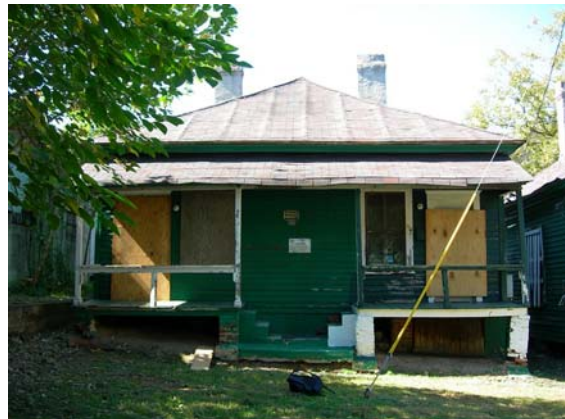
Alley House C Exterior, October, 2008, original site investigation

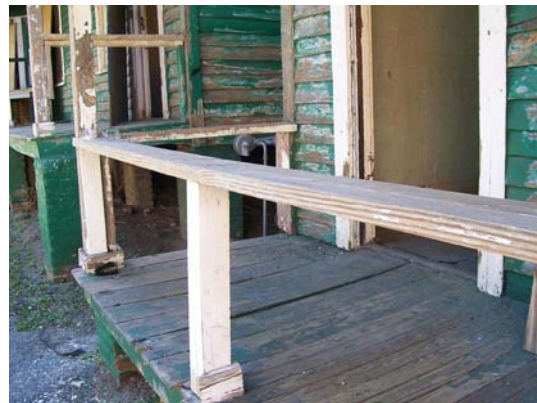
Typical front porch railing and flooring

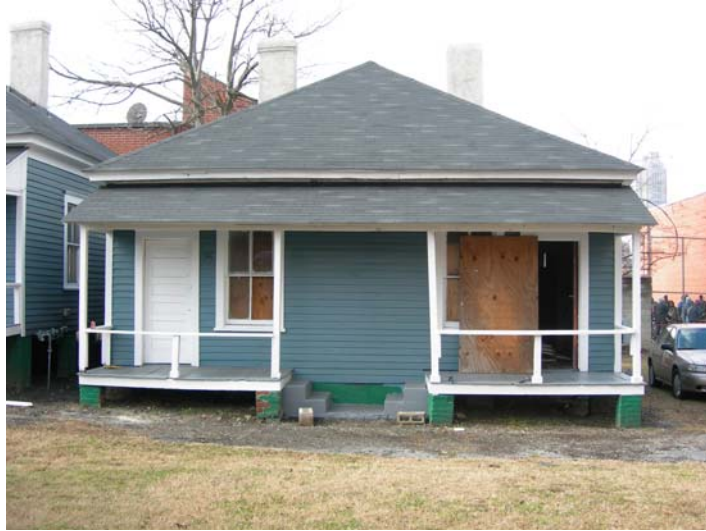
Additional Property Description

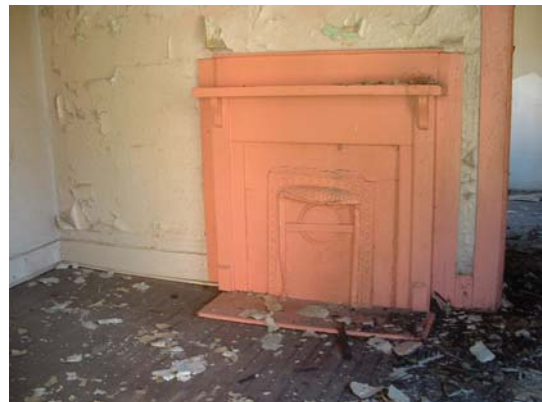
Gas and electrical utilities on north side of building

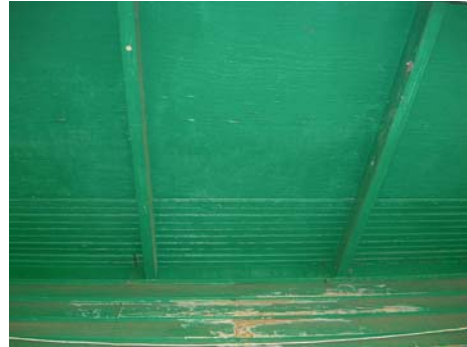
Typical porch roof decking

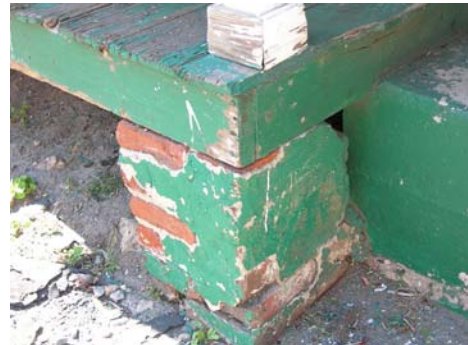
Deteriorated foundation pier

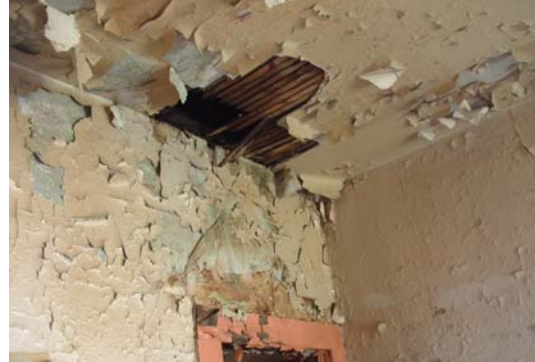
Typical wall and ceiling conditions

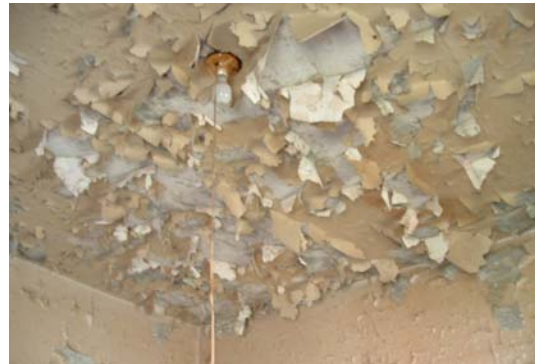
Typical ceiling condition with typical metal light fixture

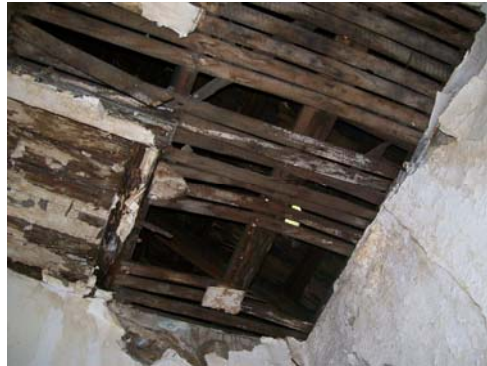
Typical damage to lath and plaster walls and ceilings

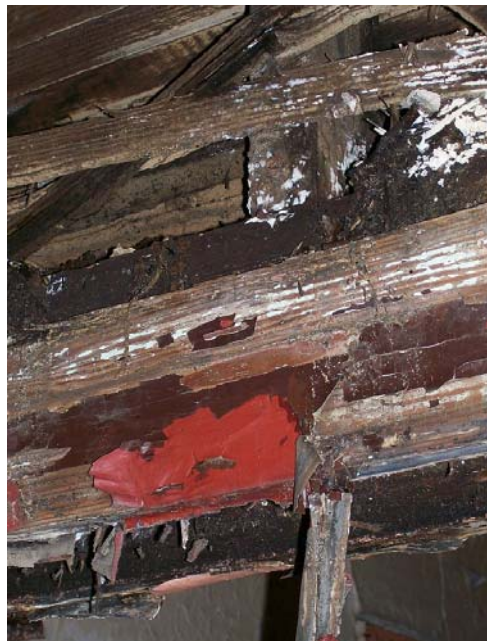
Rotted framing members in attic area

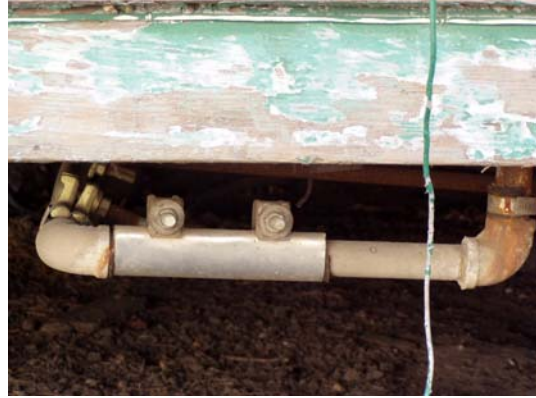
Repair of gas pipe beneath the building, west side

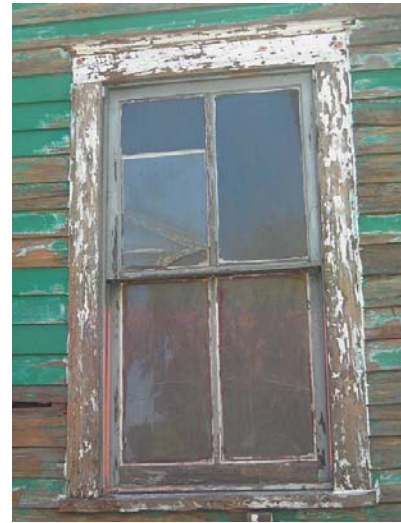
- If windows were not included in the recent maintenance treatments to the building, repair, seal and paint windows to prevent moisture penetration into the buildings at these points.
- Repoint all masonry surfaces except parged chimneys to protect against moisture damage. Replace any severely damaged or missing bricks. Upon completion of pointing work, do not repaint the masonry so that all new work will be clearly evident for future investigation. Ensure that all pointing mortar matches the historic in color, composition and hardness. Mortar samples should be taken to ensure an appropriate match.

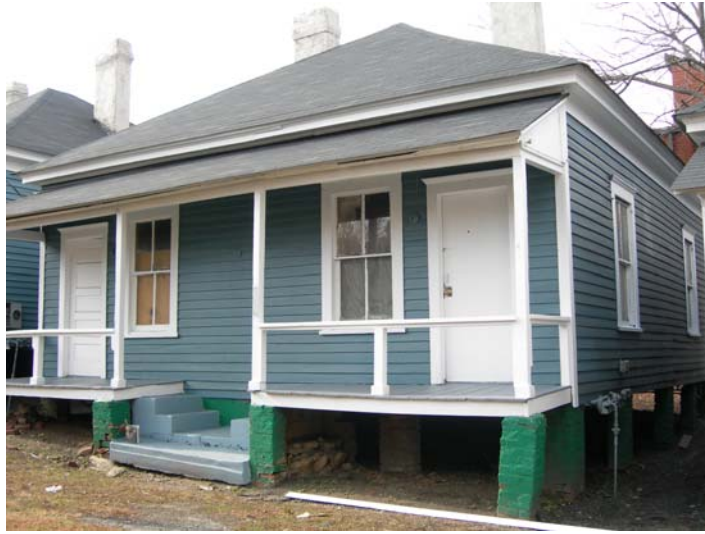
Additional Property Description

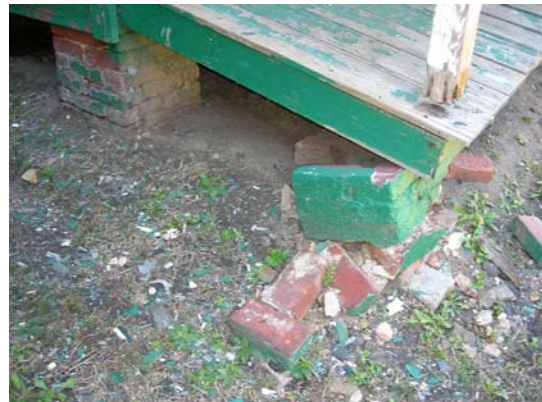
Failed porch piers and rotted porch posts on north side of front porch

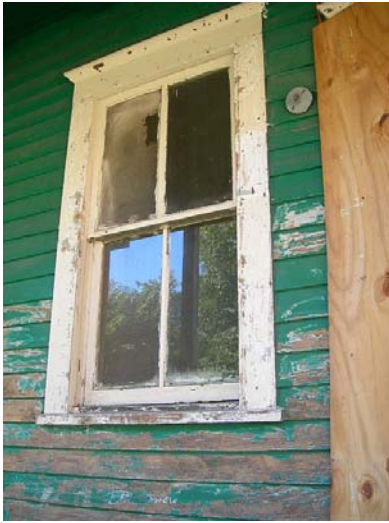
Typical window, east elevation

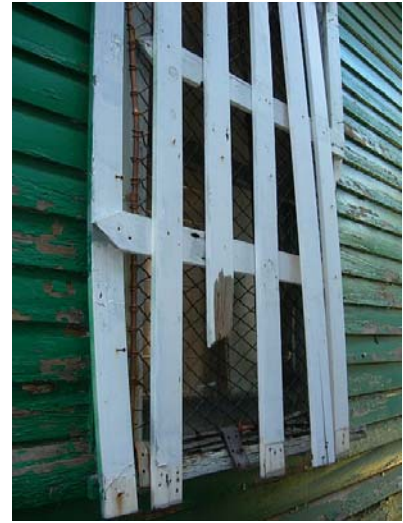
Broken picket of wood lattice over window on south elevation, 2008.

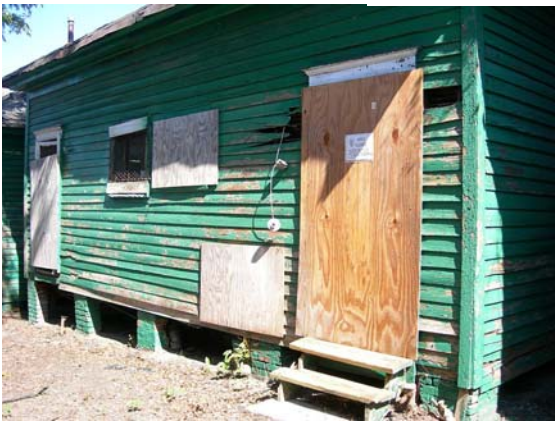
West elevation, 2008

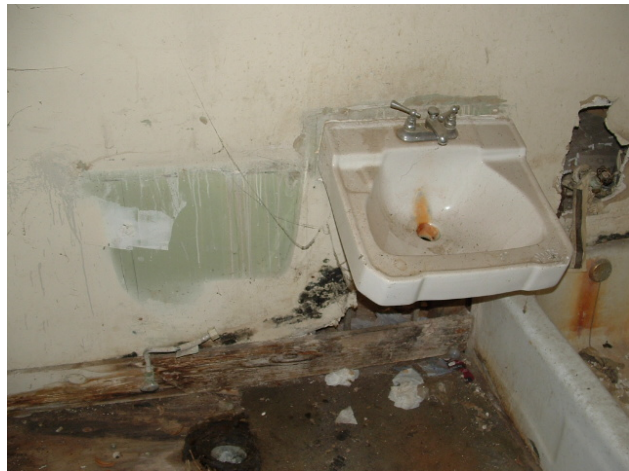
Bathroom fixtures in Unit 4

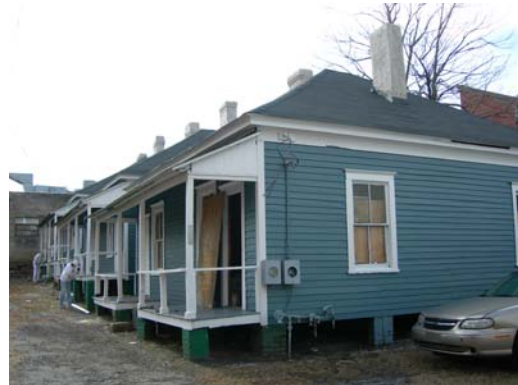
Work proceeding on Alley Houses, January, 2009

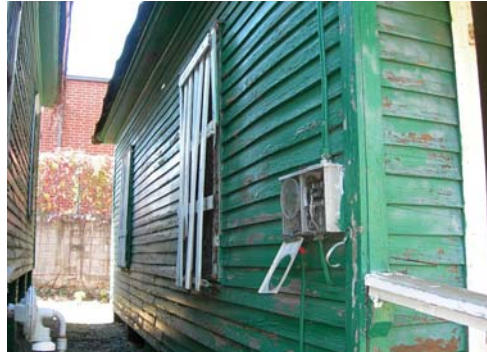
South elevation, looking west. Note wooden lattice window covers

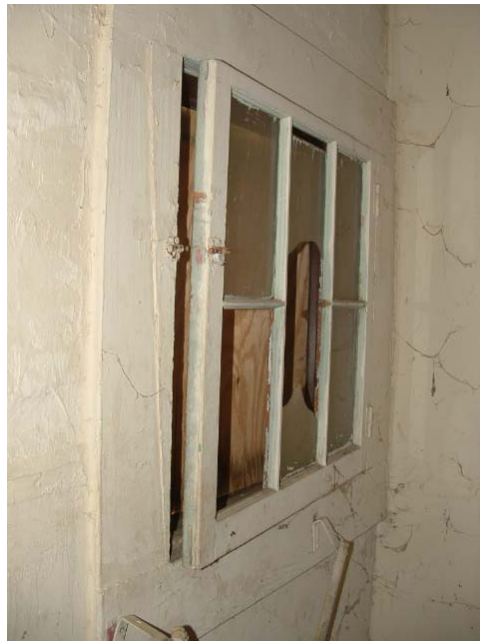
Typical bathroom window

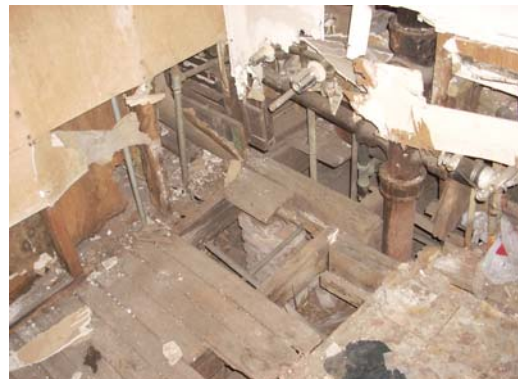
Typical deterioration of floor decking and walls near plumbing penetrations in Unit 3

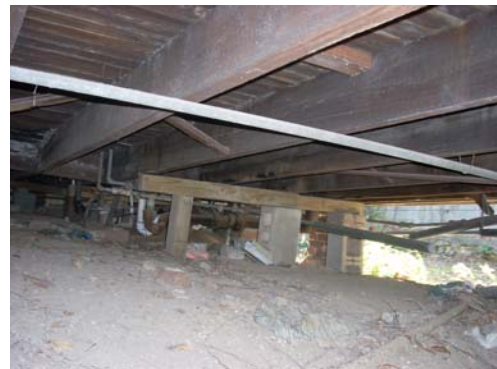
Temporary support beneath west end of building is not adequate

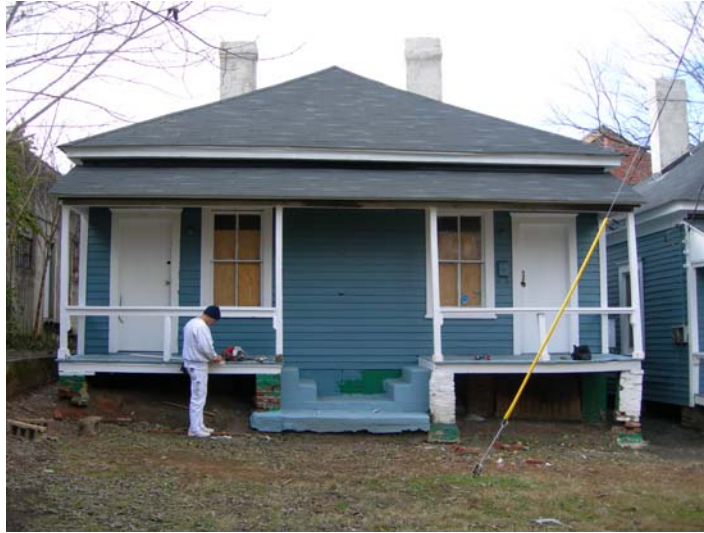
Additional Property Description

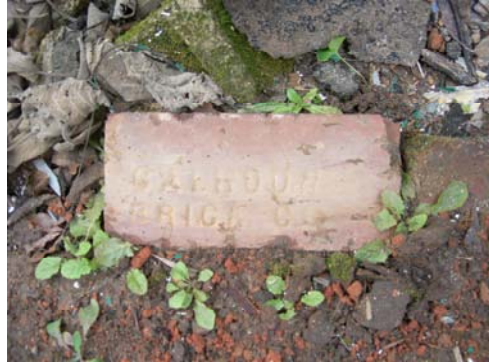
Calhoun Brick Company brick

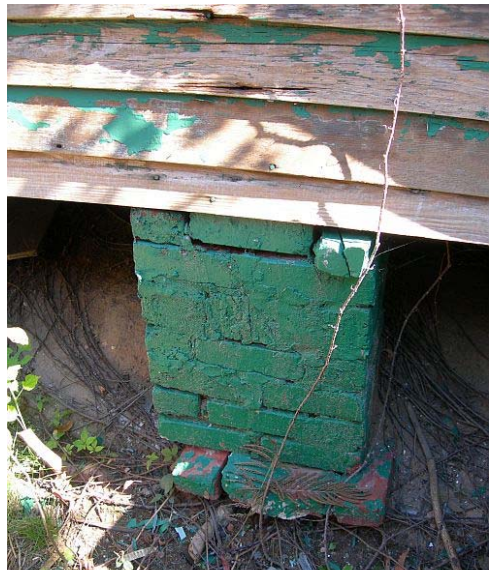
Typical support pier requiring repair

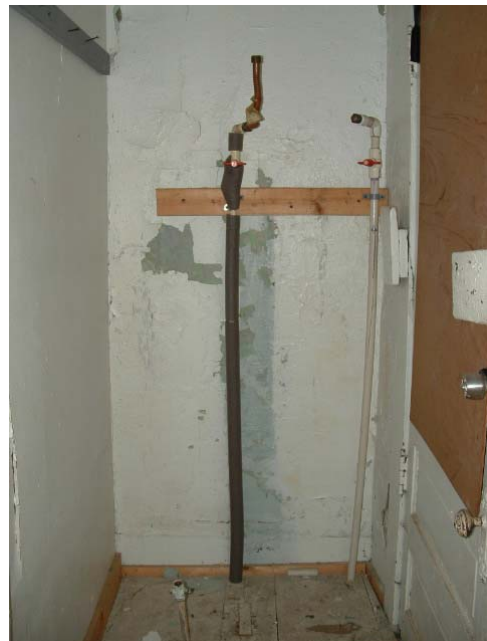
Typical installation for water heater in back hall utility room

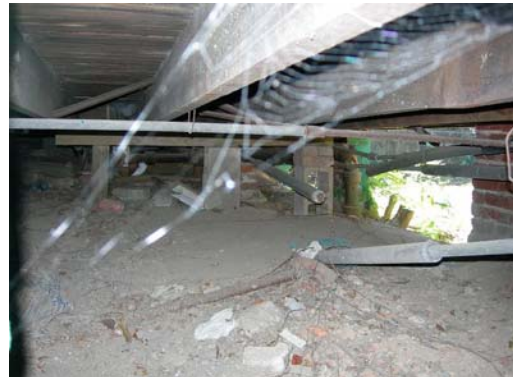
Assorted *ad hoc* floor supports beneath the building

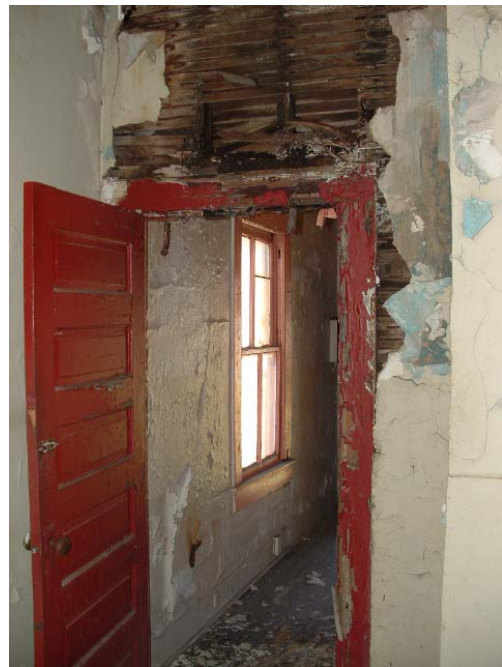
Typical wall and ceiling deterioration

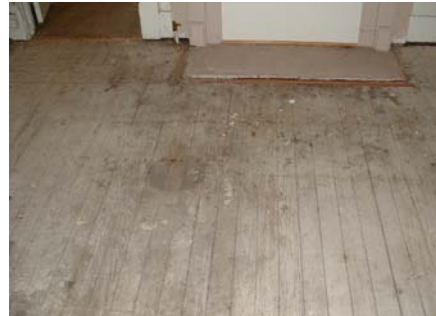
Typical flooring, hearth, and stub-up for gas pipe

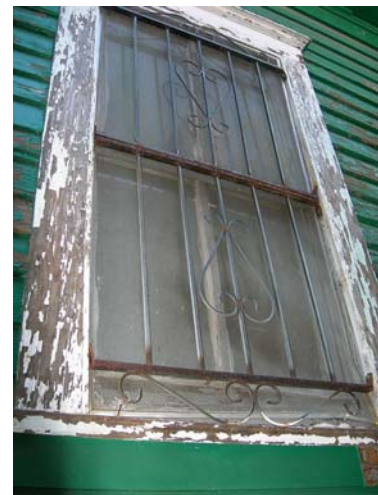
Window on north elevation with decorative iron grille, 2008

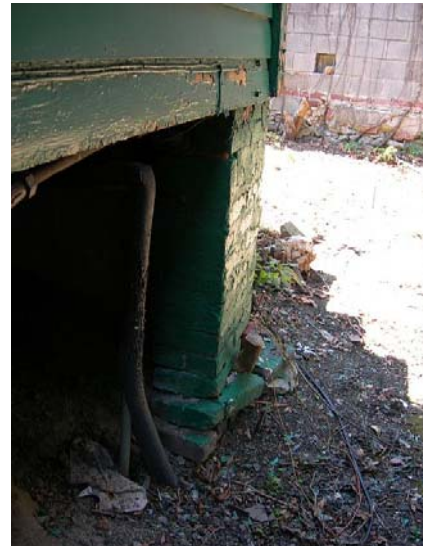
Northwest pier is leaning, missing bricks, and has a tree growing out of it

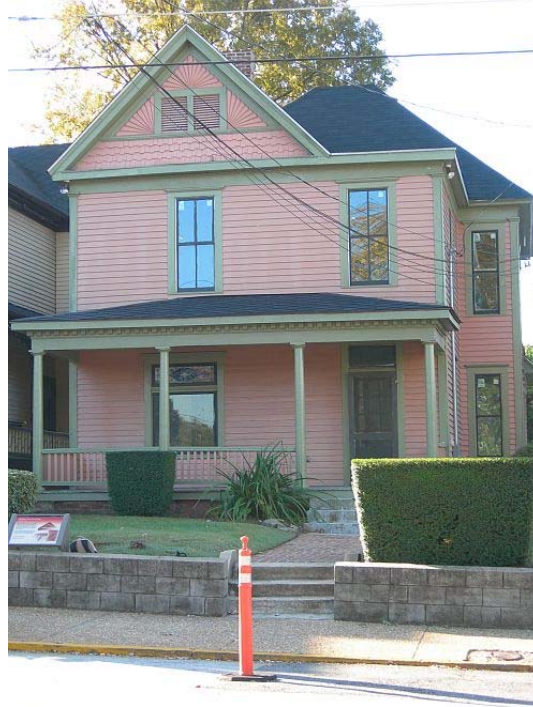
497 AUBURN AVENUE / REID-ZACHARY HOME

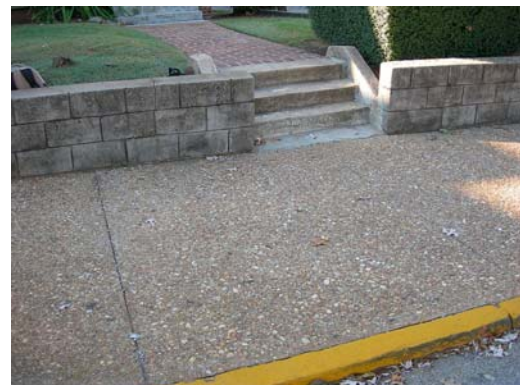
Pebble-dashed sidewalk, CMU wall, and access stairs along north side of property

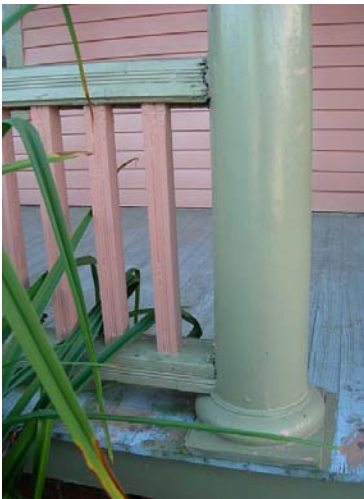
Deteriorated railing to column connection on front porch

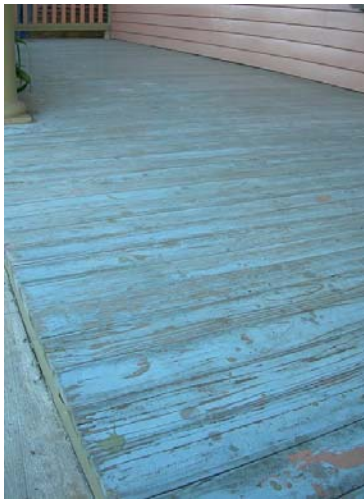
Wood tongue-and-groove porch floorboards

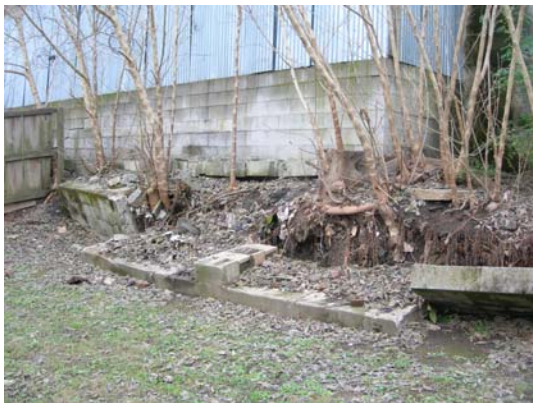
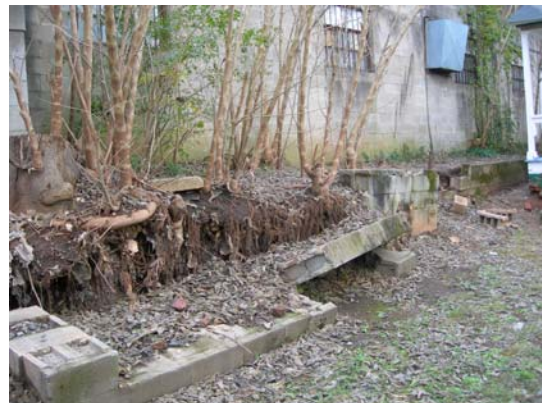
Failed retaining wall at south boundary of property

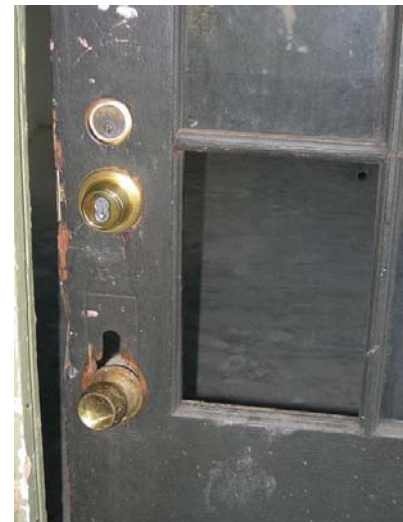
Detail of front door locksets and door handle

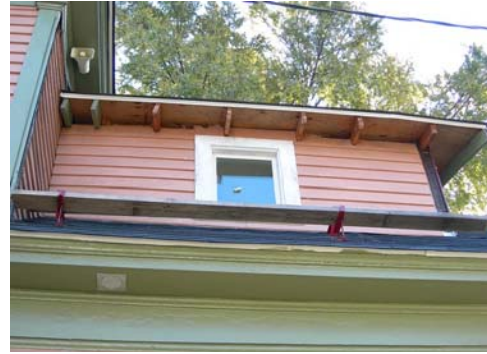
Unfinished work on rear addition dormers

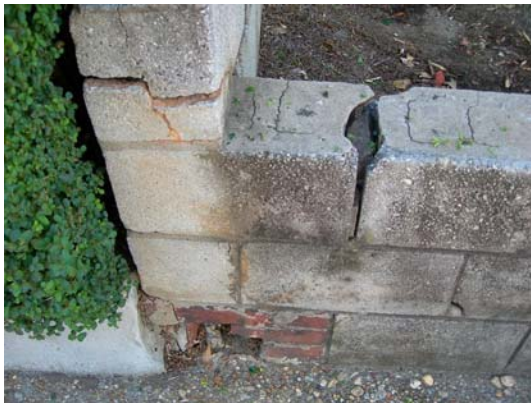
Cracked and deteriorating retaining wall at northeast corner of lot

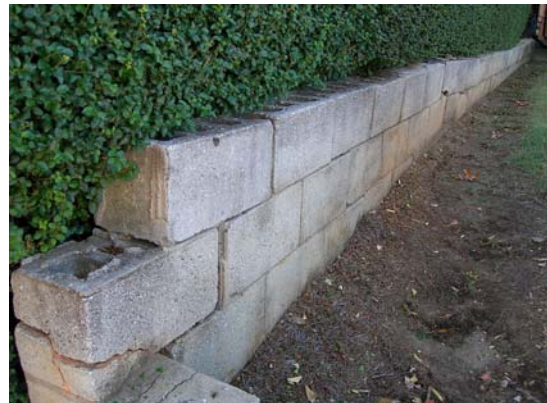
Cracked and damaged retaining wall along east boundary of lot

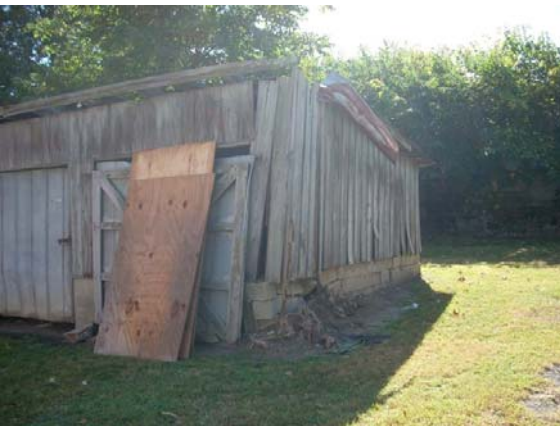
Northwest corner of garage. Note collapsed condition of foundation wall.

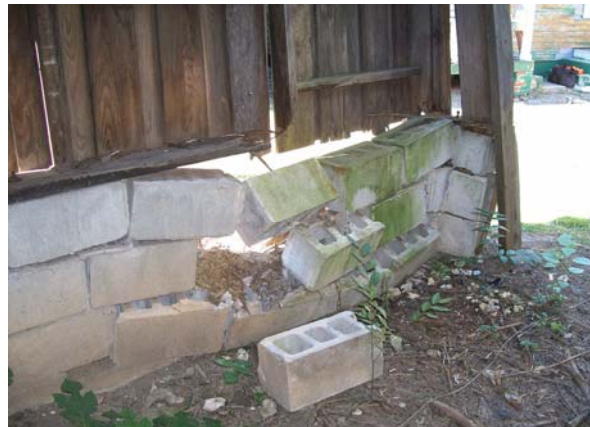
Northwest foundation is near collapse

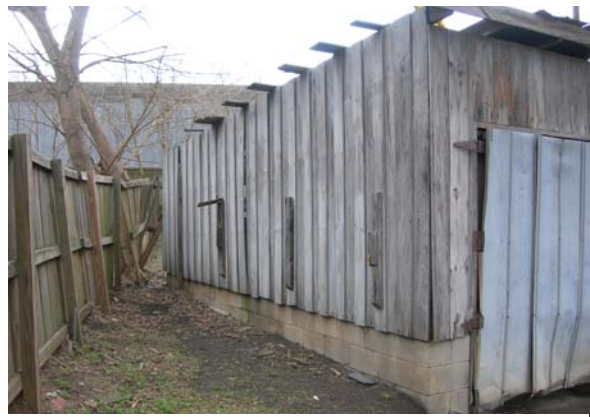
Remnants of former construction on northeast elevation of building

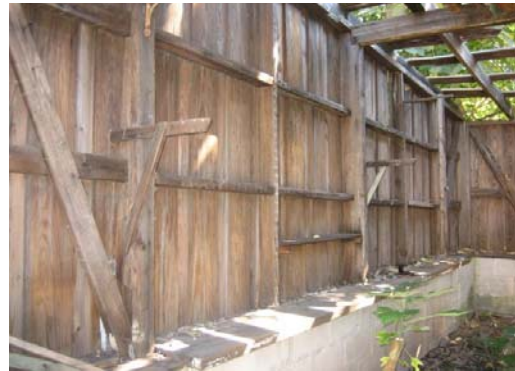
Brackets from former shelving lining interior wall of garage

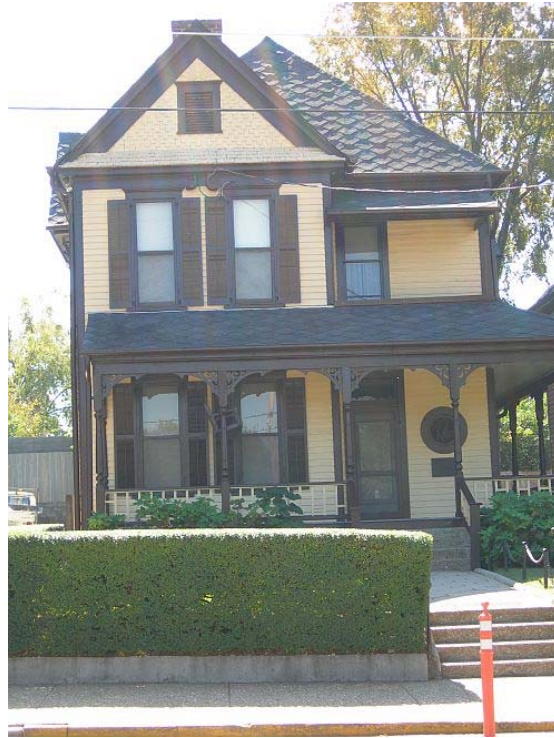
501 AUBURN AVENUE / MARTIN LUTHER KING, JR. BIRTH HOME

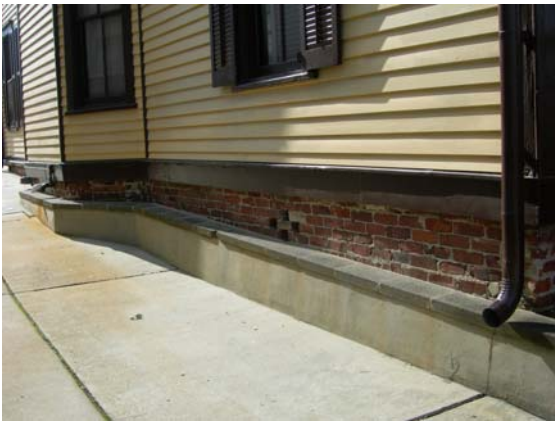
Retaining wall with gray concrete caps and continuous brick foundation on east elevation

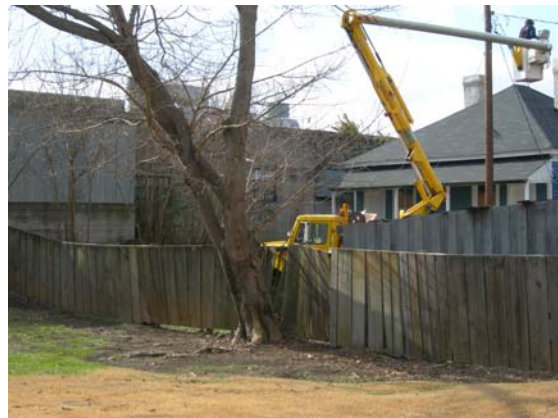
Wood fence of vertical butted boards surrounds the back yard

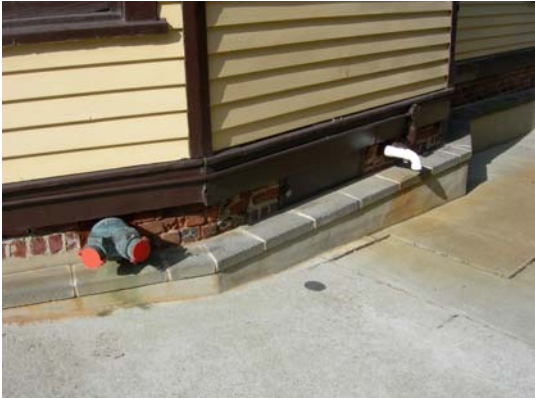
Metal-covered access hatch to partial basement blocked by concrete retaining wall on east elevation

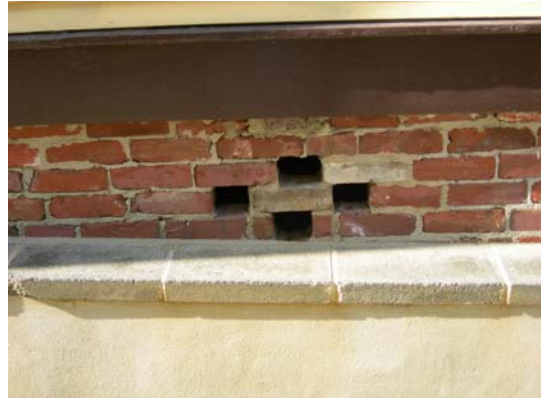
Vents in brick foundation wall on east elevation only

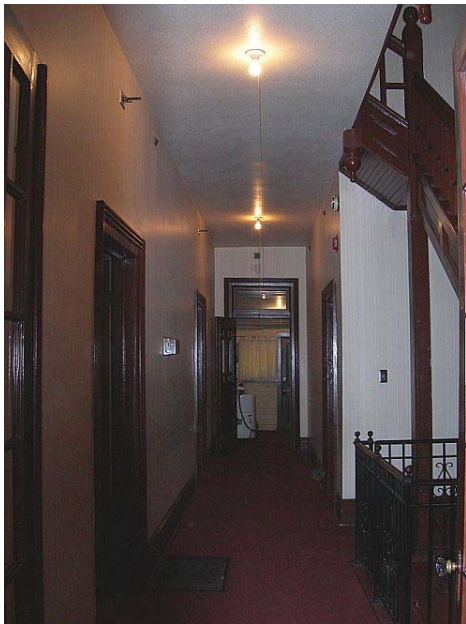
First floor hall, looking south. Note iron railing around the basement hatch to the right beneath the stairs.

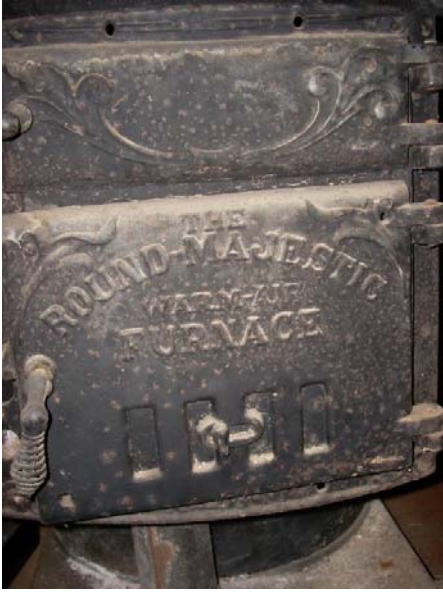
Original furnace in basement

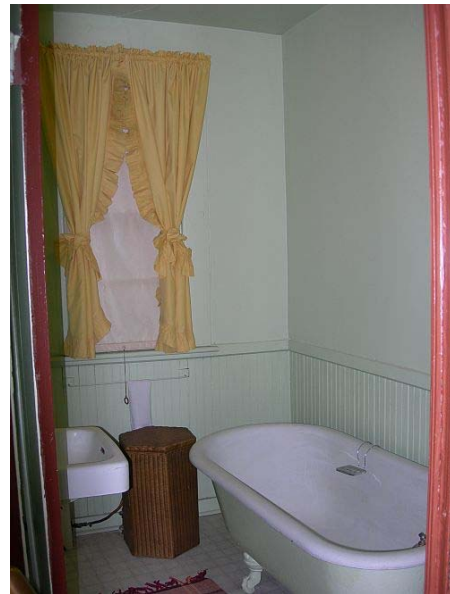
Upstairs bathroom is typical of both bathrooms in arrangement and decor

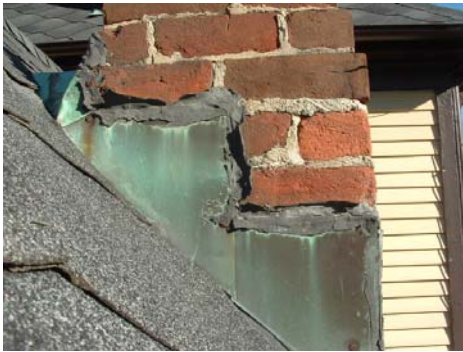
Deteriorated flashing sealant at kitchen chimney

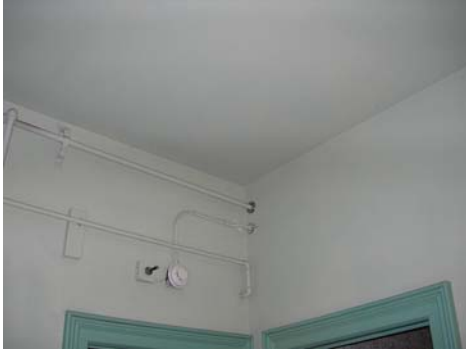
Peeling paint on kitchen ceiling is possibly the result of water damage

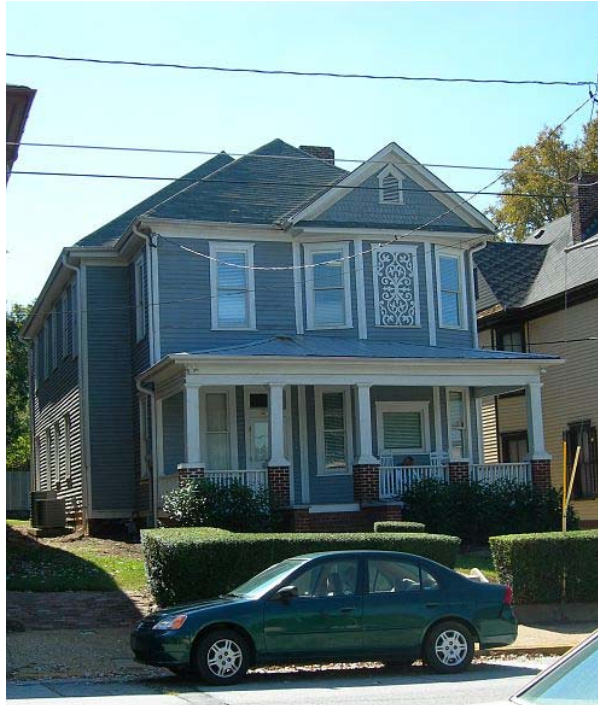
503 AUBURN AVENUE / DARDEN HOME

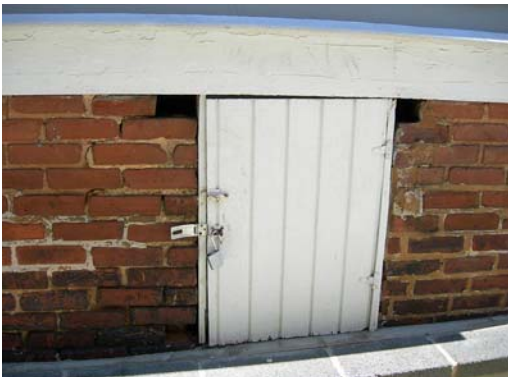
Basement entrance and missing and damaged brick and mortar, west elevation

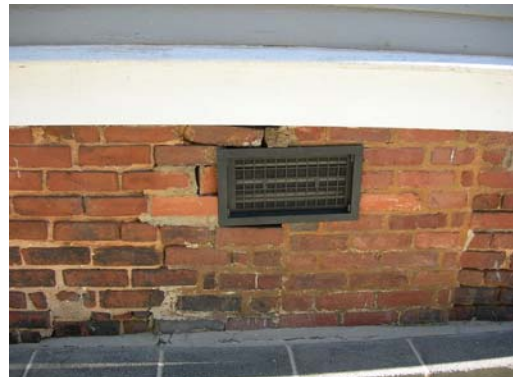
Basement vent, with inappropriate and failing repairs to foundation wall

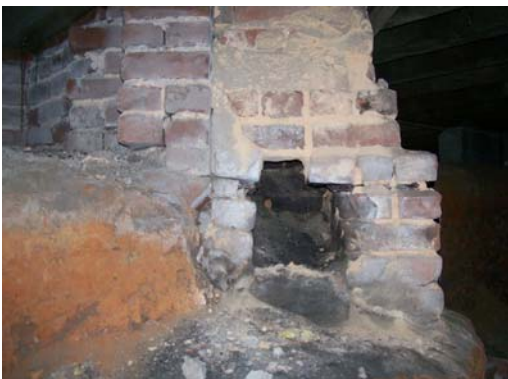
Ash-trap in partial basement is a historic feature

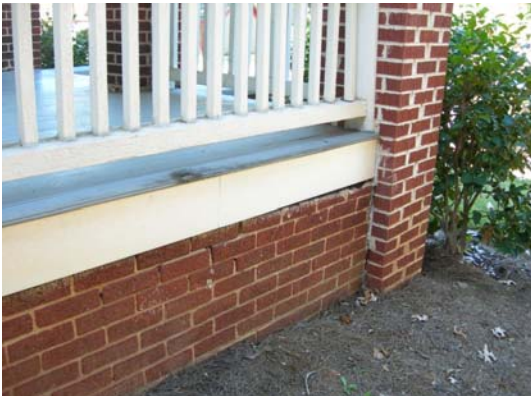
Porch foundation and pier of dissimilar brick and mortar

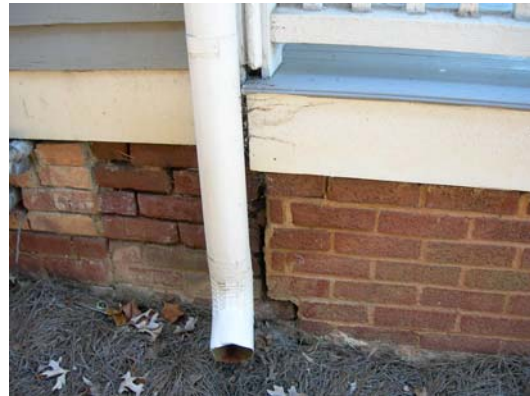
Separation of porch foundation from main building foundation

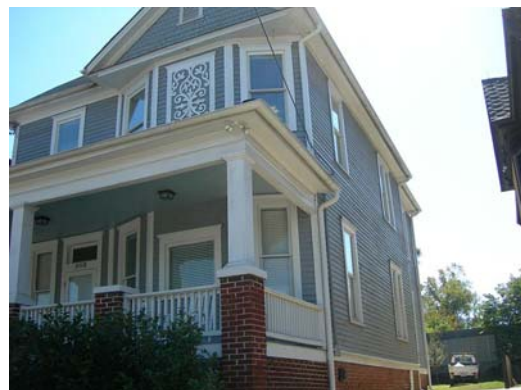
North and west elevations

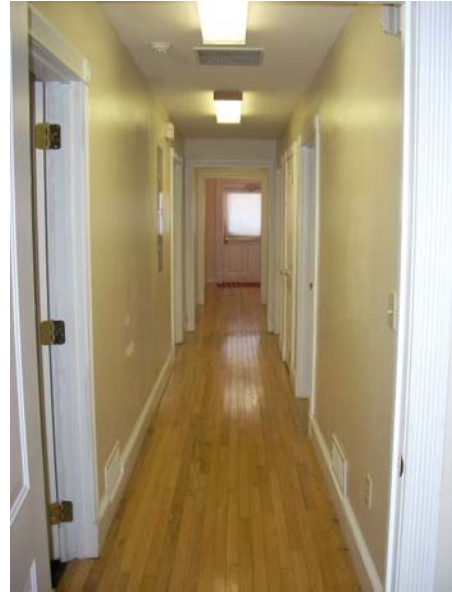
First floor hall, looking south

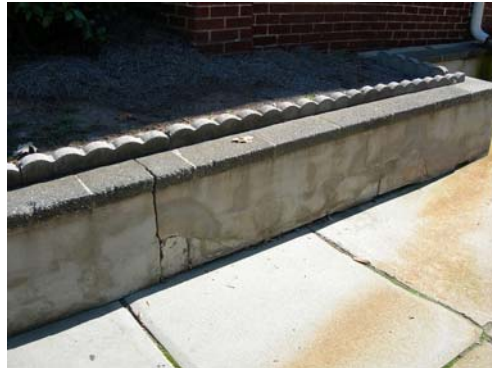
Cracking in retaining wall along west side of building

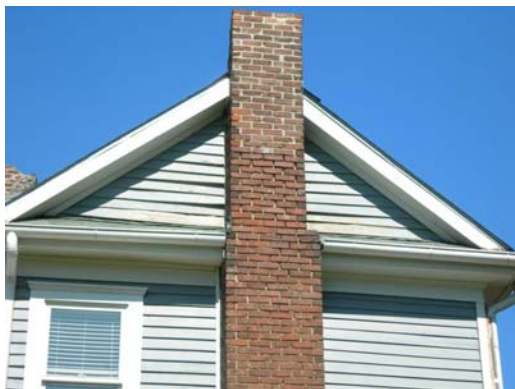
Inappropriate mortar repairs and missing mortar on south chimney
