**Condition Assessment Report
for 13 Buildings in the
Martin Luther King, Jr. Historic District,
a National Historic Landmark**

**Martin Luther King, Jr. National Historic Site
Atlanta, Georgia**

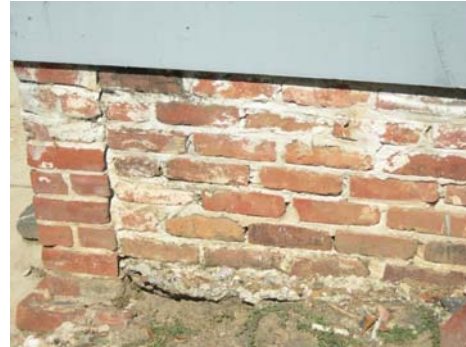
Poorly-constructed back porch foundation and pier

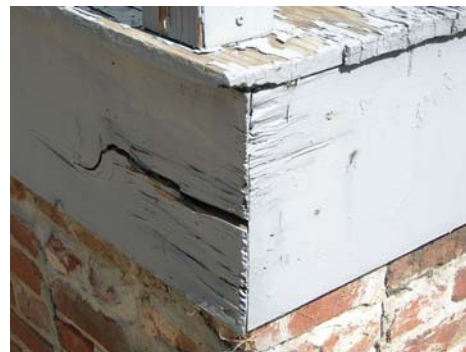
Deteriorating back porch flooring and framing

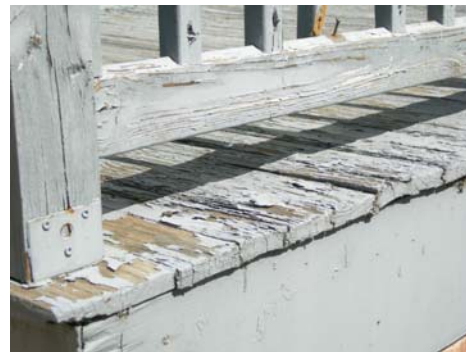
Deteriorated paint finish on back porch flooring and framing

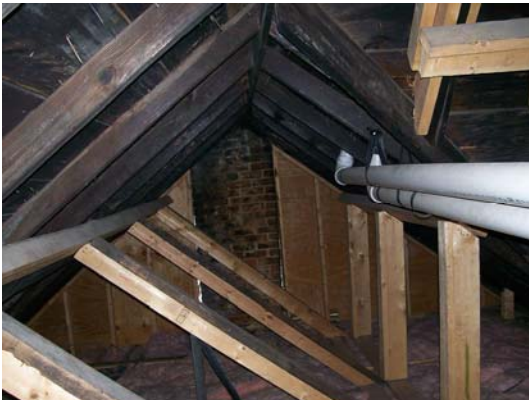
Stud-framed walls at rear chimney are not sealed to the chimney.

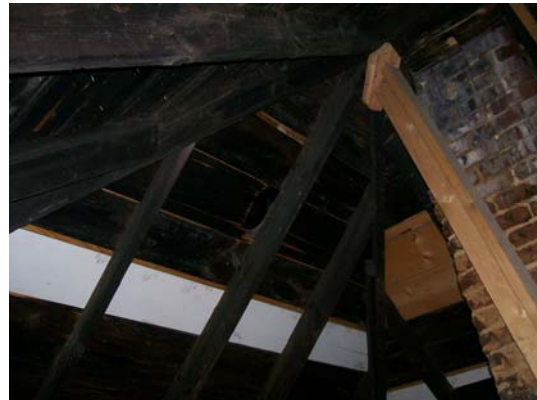
Additional bracing for roof rafters and replacement roof decking

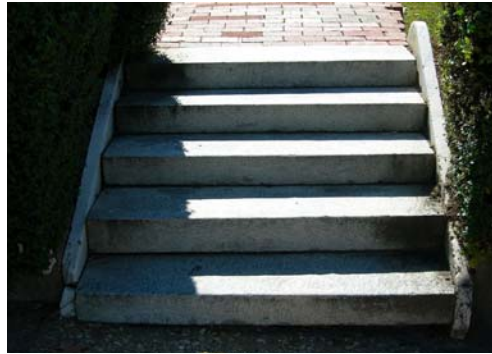
Granite approach stairs with marble cheekwalls

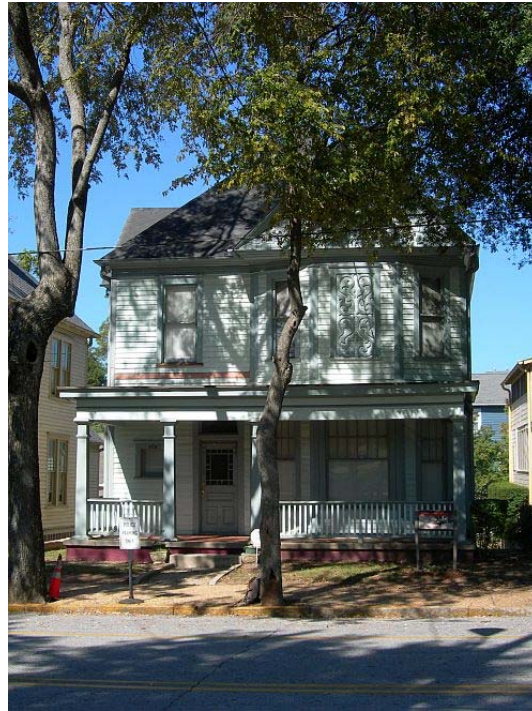
526 AUBURN AVENUE / KIRK HOME

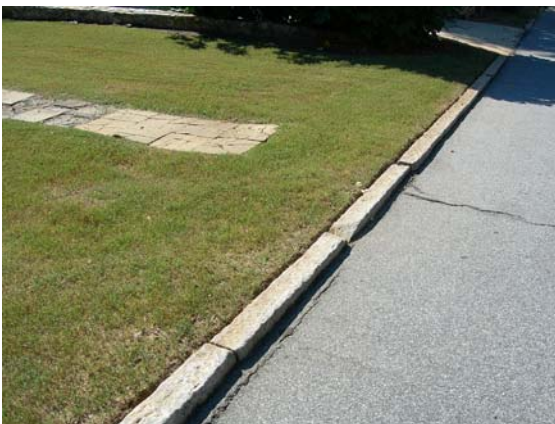
Concrete sidewalk from rear of building toward granite-edged Old Wheat Street

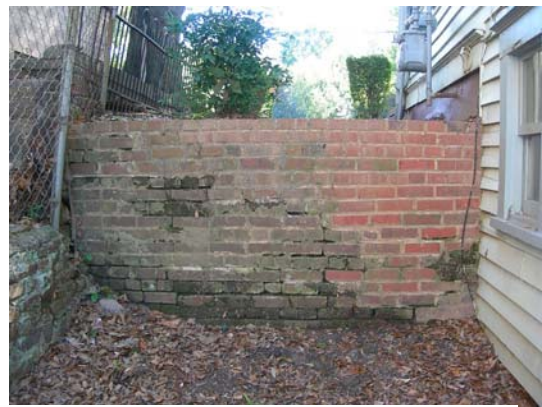
Brick retaining wall east of building

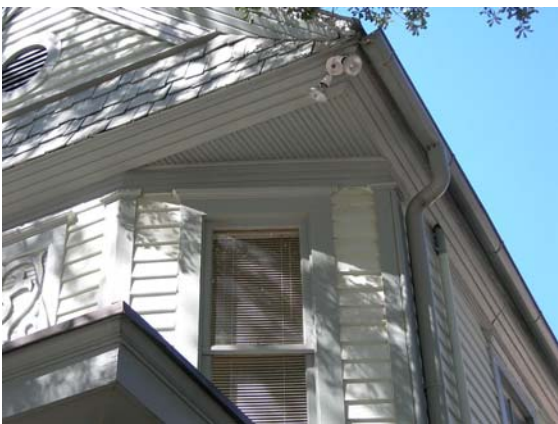
Detail of cut-away bay showing shingles on pent roof, drop siding on fascia, and bead board on soffit

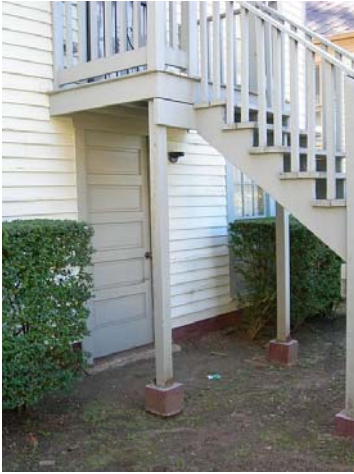
Typical exterior five-panel door and rear entry support posts

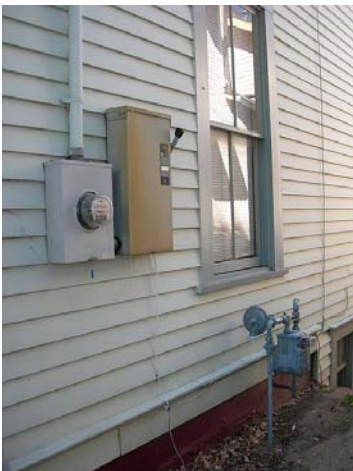
Electric and gas service enter the building at the Auburn Street level side of the east elevation

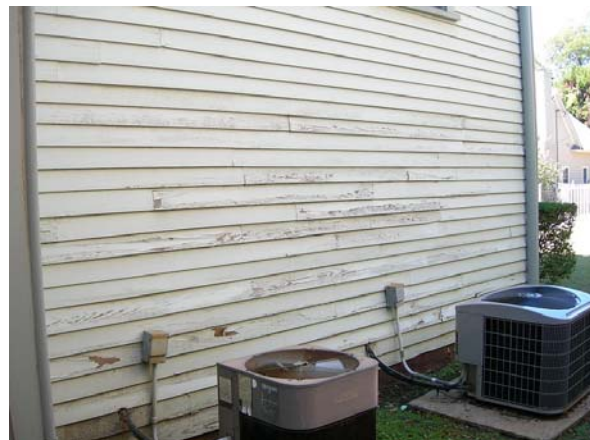
Air conditioning units at basement level of building, east elevation

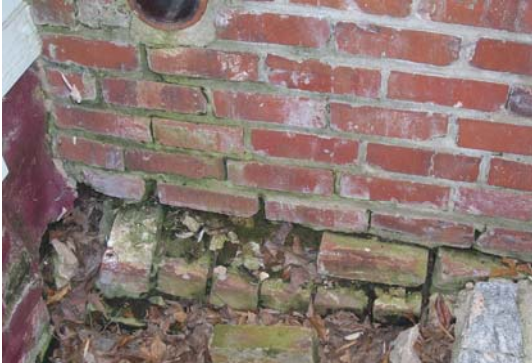
Detail of missing and detached bricks in west front retaining wall, north elevation

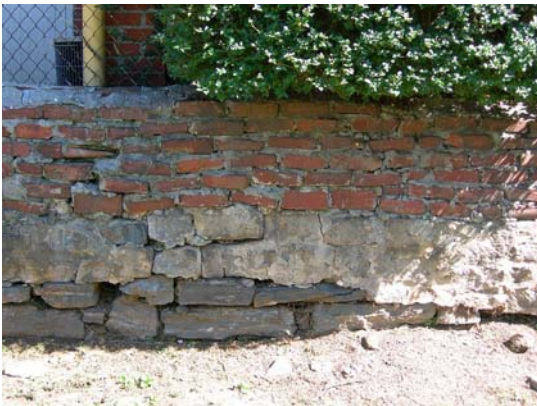
East retaining wall. Note deterioration of brick and mortar.

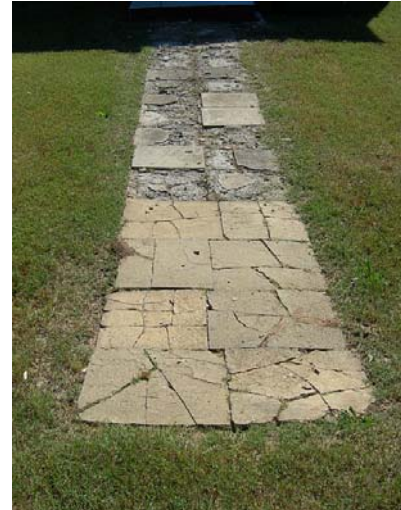
Deteriorated walkway of concrete pavers to back stairs

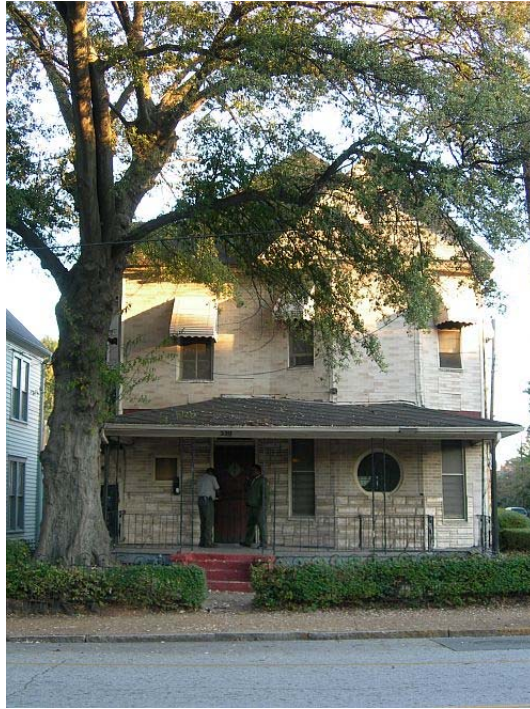
530 AUBURN AVENUE / NOWELL HOME

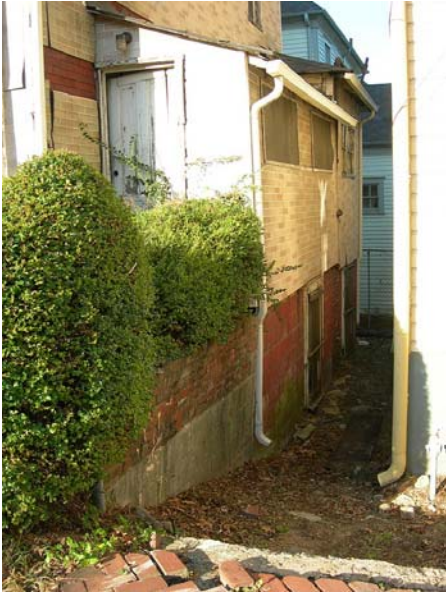
North elevation, showing retaining wall and single-story extensions with basement

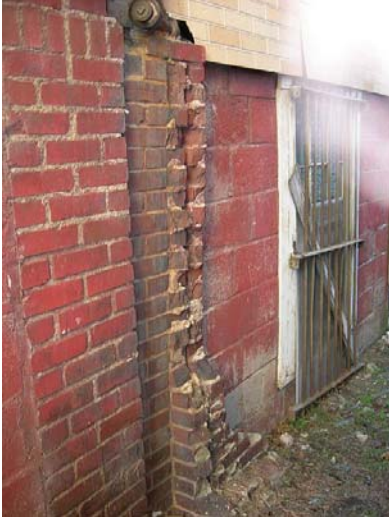
Construction of basement,
north elevation

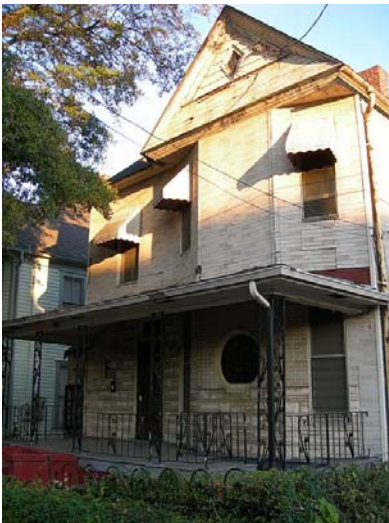
South elevation, showing
porch and embossed siding

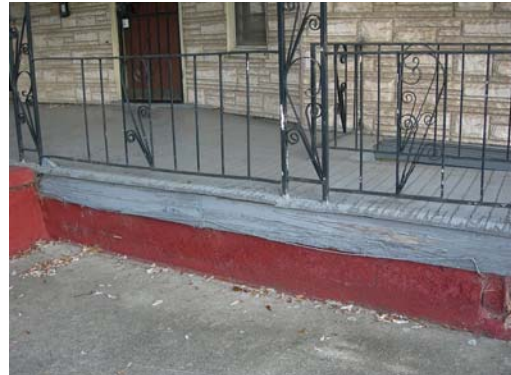
Front porch foundation, wood framing, and wrought-iron railing and porch supports

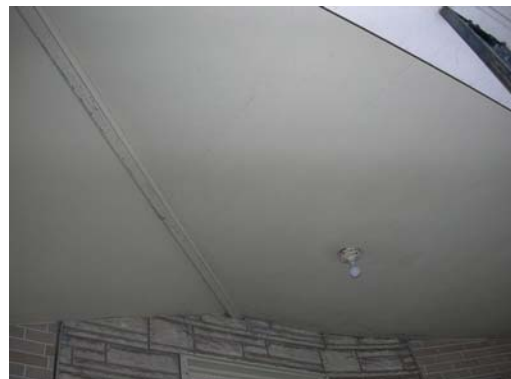
Front porch ceiling and light fixture

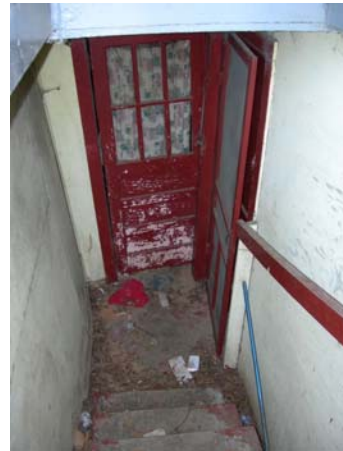
Lower level of stairway to basement

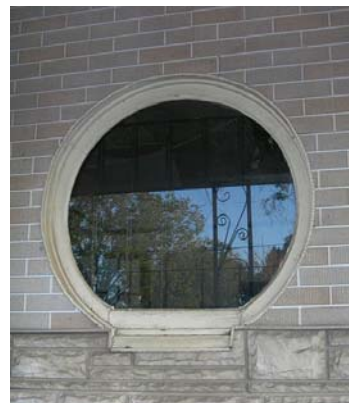
Round window, south elevation

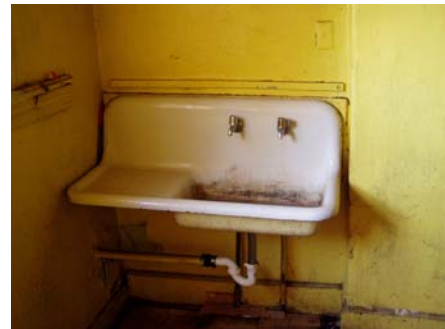
Kitchen sink in first-floor apartment

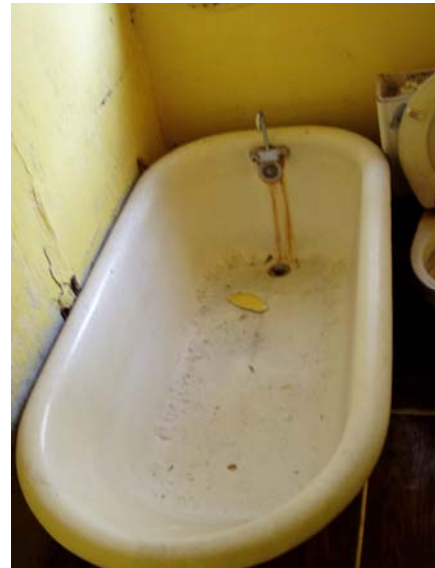
Typical footed tub in bathrooms

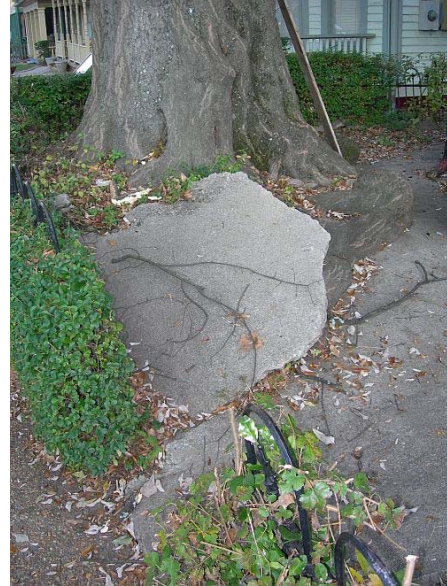
Growing tree has heaved the concrete sidewalk in the front yard

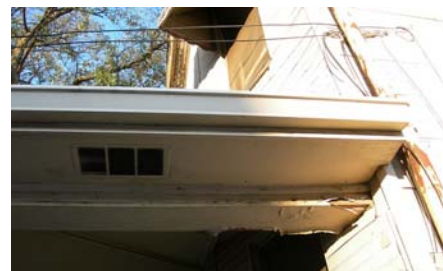
Porch soffit, vent, and gutter

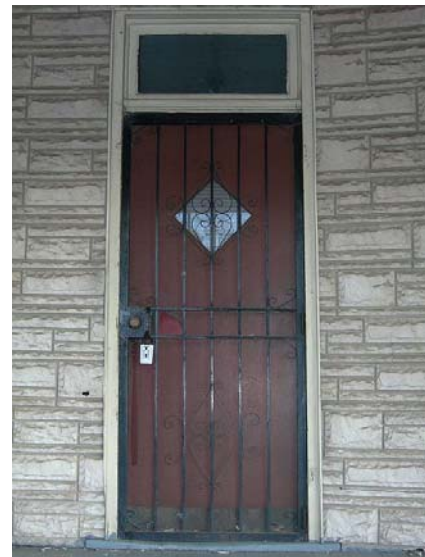
Front door to downstairs apartment

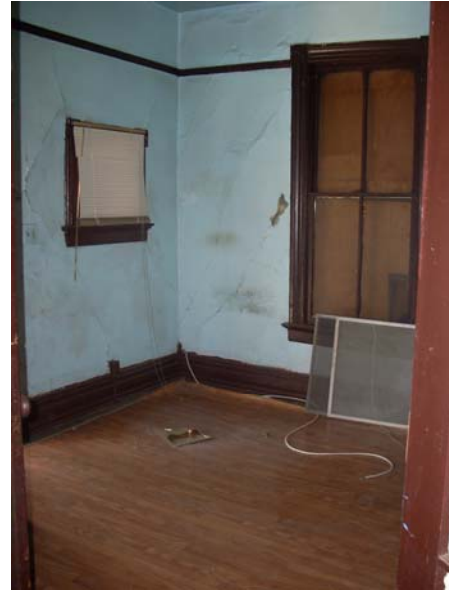
Entry foyer, first floor apartment

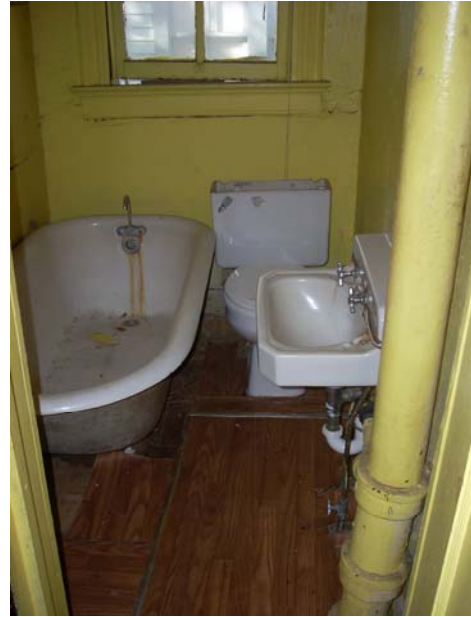
First floor bathroom

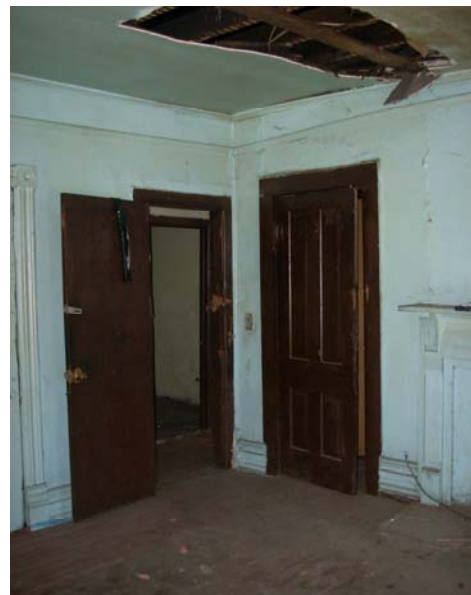
Typical trim and finishes

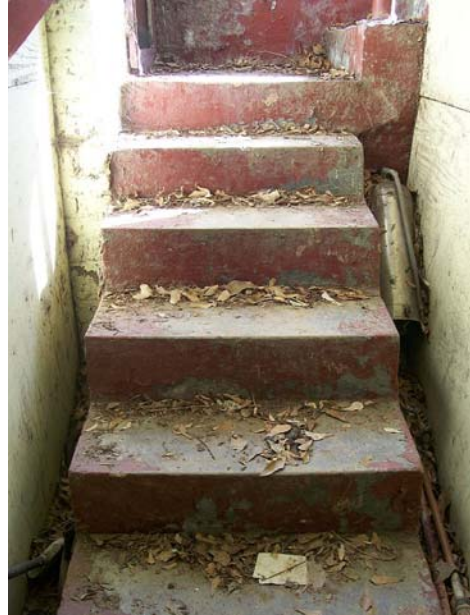
Access stairs to basement apartment, south side of building

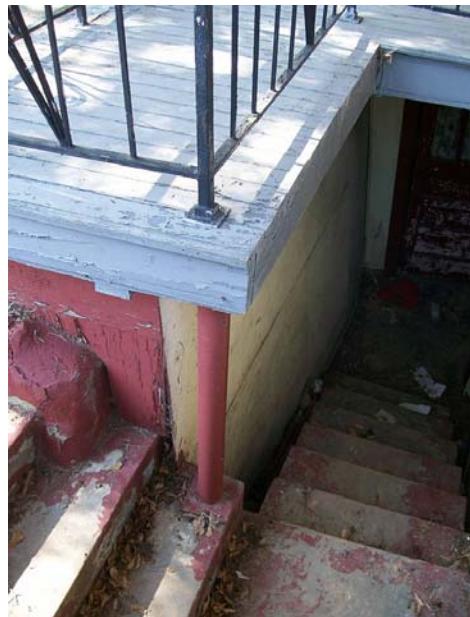
Tubular steel support of front porch at basement access

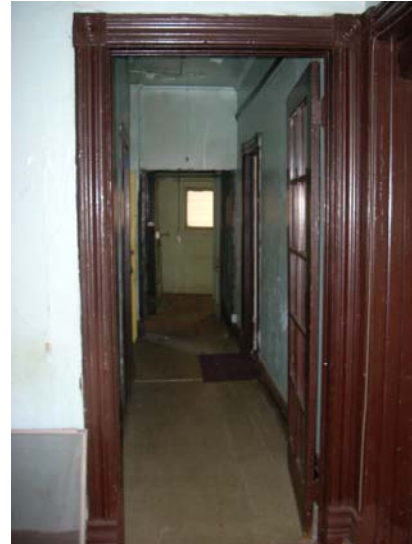
Typical trim and finishes, back hall, first floor apartment

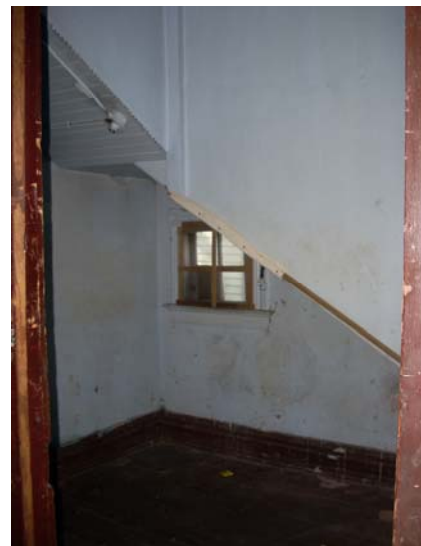
First floor room with added stairway to second floor

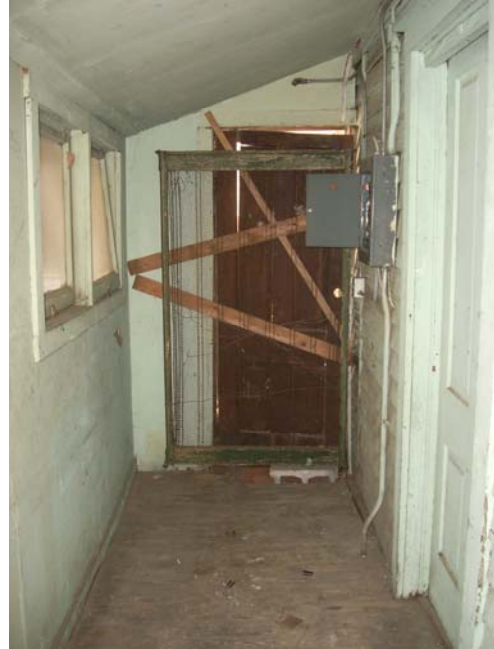
Enclosed back porch, looking east

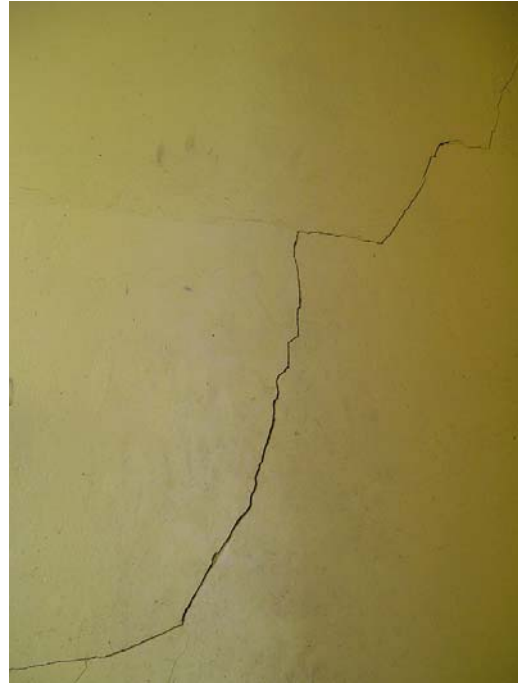
Stress crack in upstairs bathroom

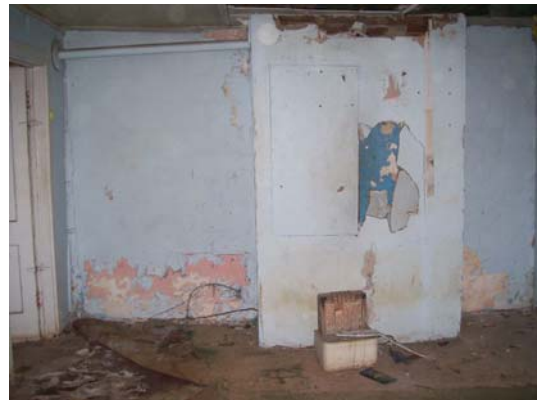
Front room in downstairs basement apartment

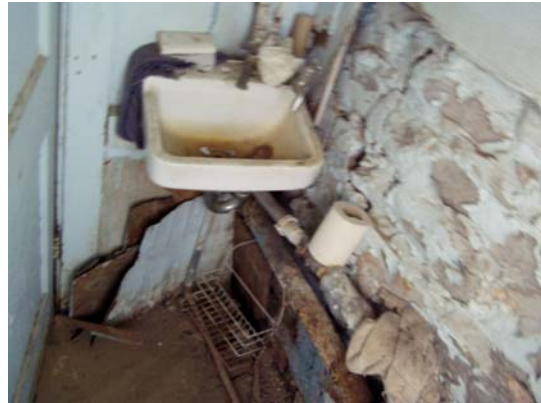
Downstairs basement bathroom

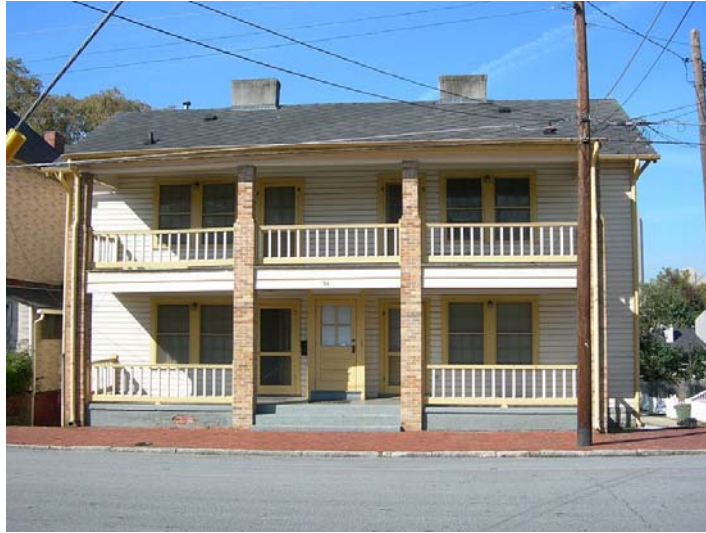
54 HOWELL STREET / APARTMENT HOUSE

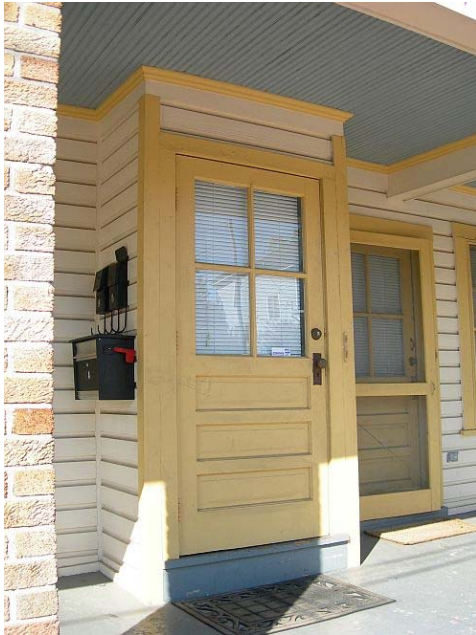
Eastern first floor entrance to staircase to second floor

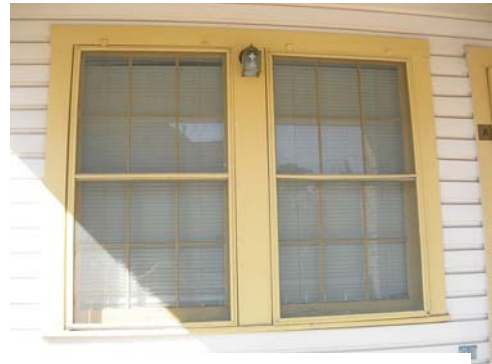
Typical double window

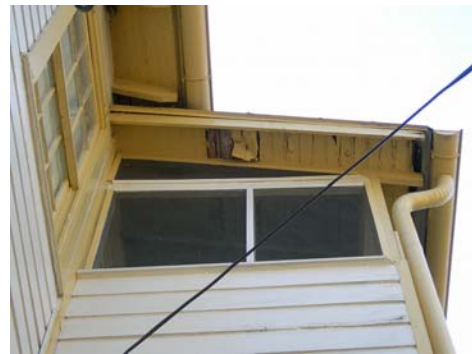
Paint deterioration underside of west porch roof

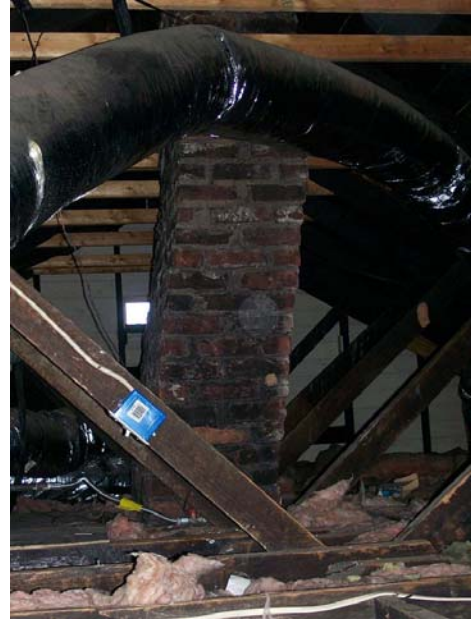
Chimney leans but does not appear to be unstable

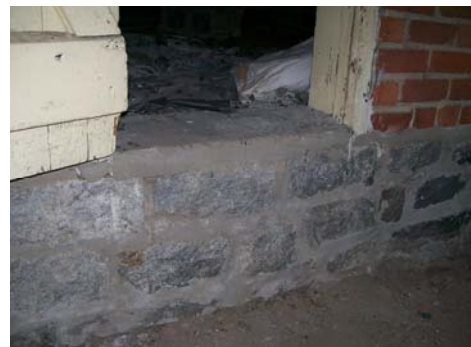
Stone foundation base at entrance to crawlspace

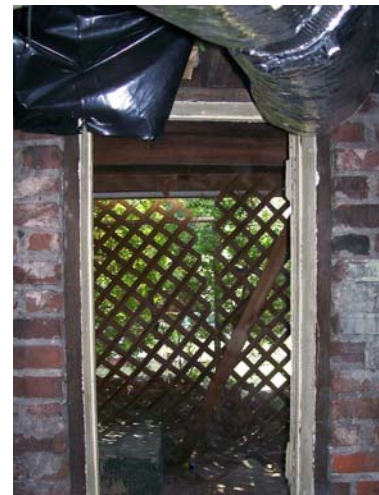
Additional bracing needed over crawl space door

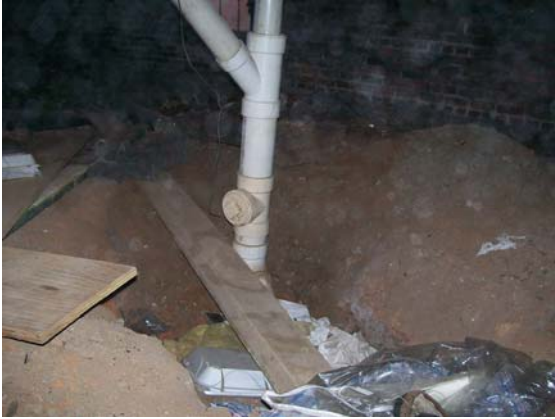
Replace excavated dirt at pipe installation

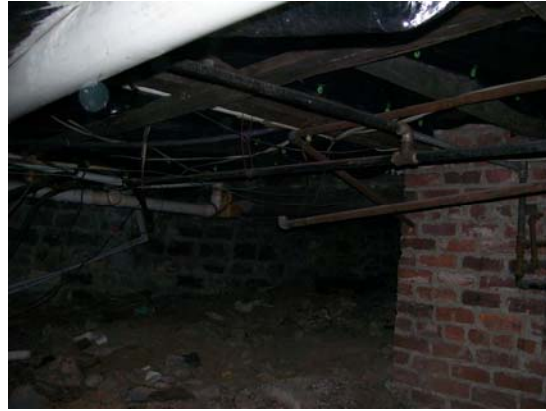
Pipe hanging loose in the crawlspace

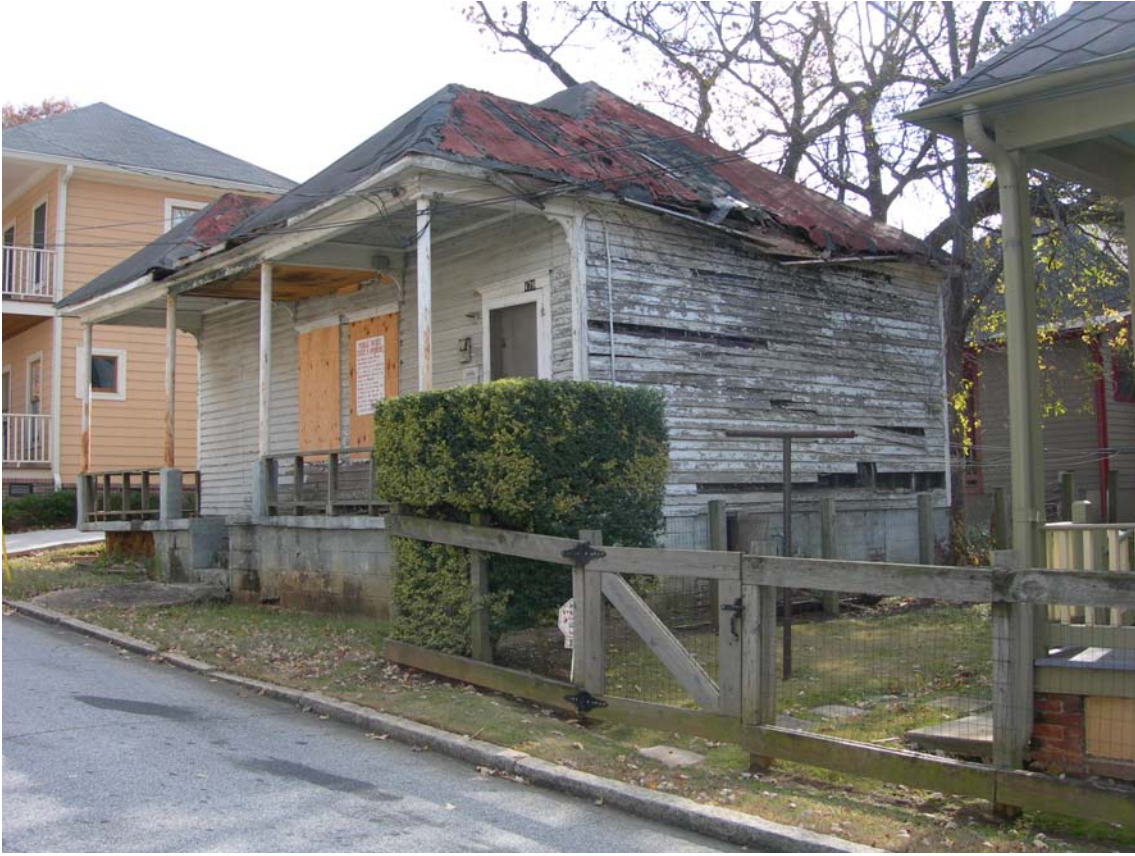
Due to the planned demolition of this building, a Condition Assessment Report was not prepared for this building. As directed, exterior drawings documenting the features and fabric of the building were prepared in lieu of a full assessment. No interior access to the building was granted during this documentation, and the building was demolished in 2009.

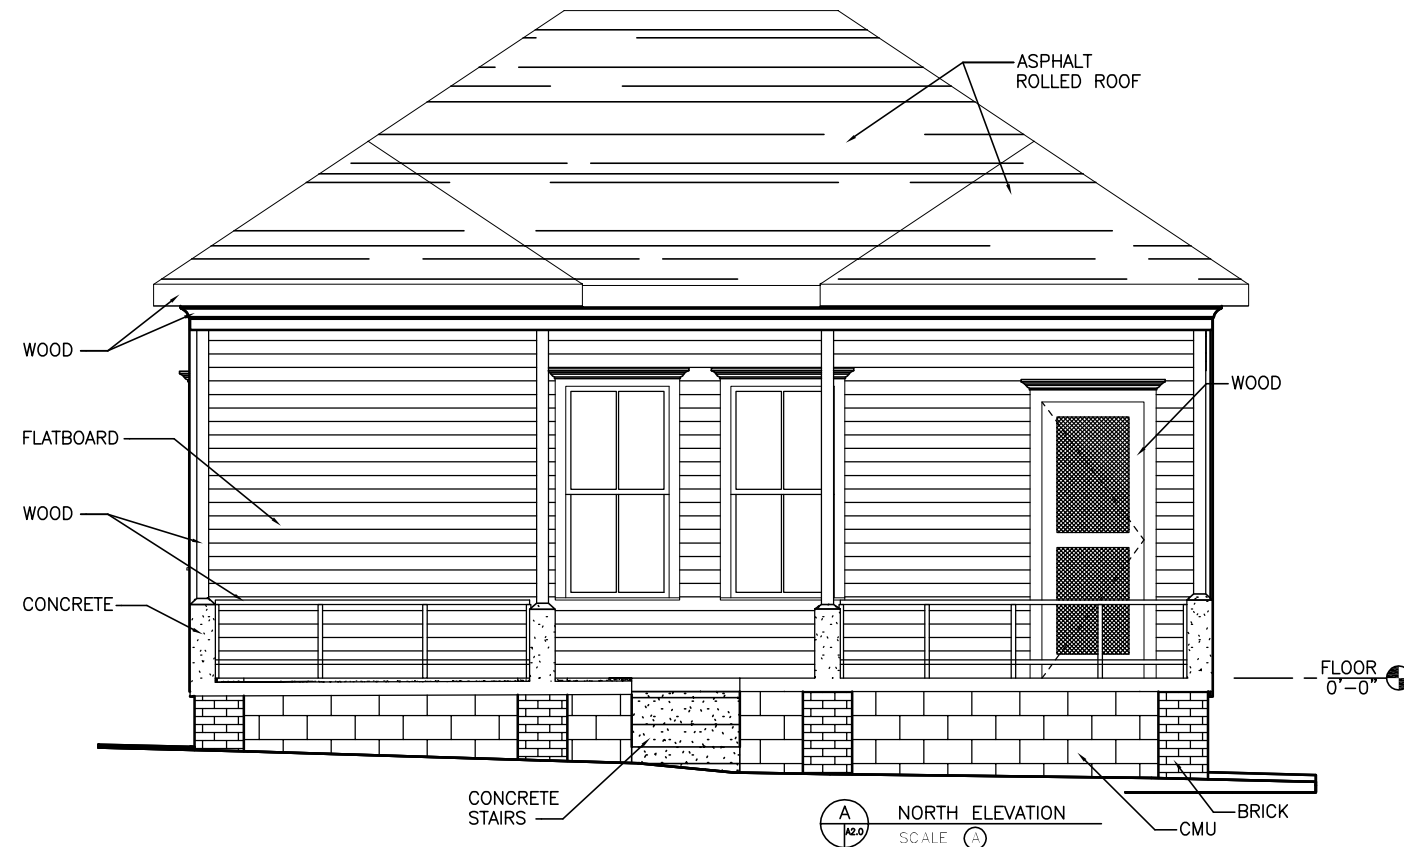
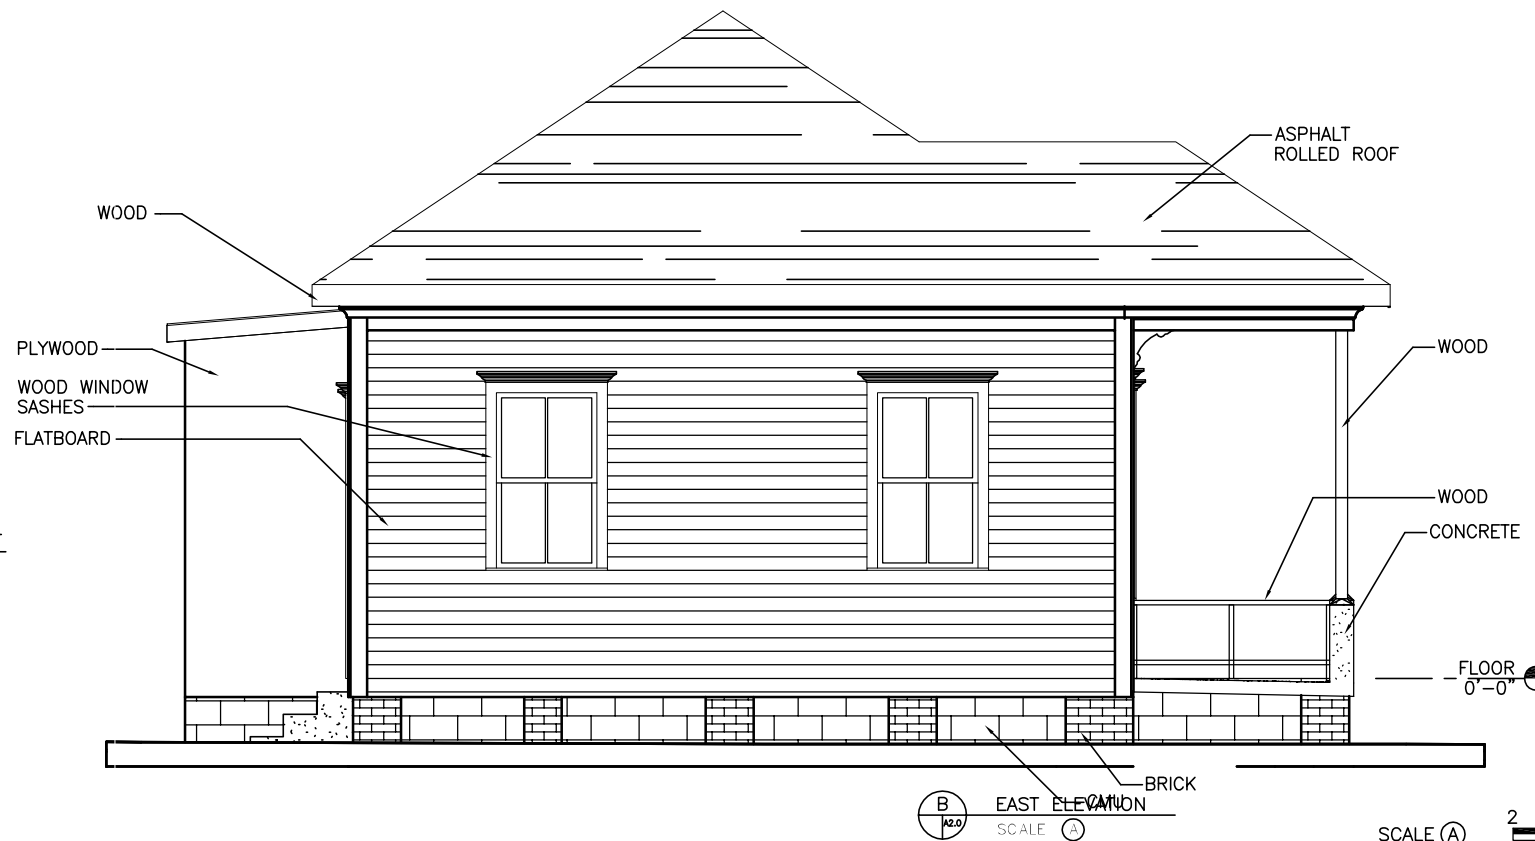
14 NORTH ELEVATION - BRACKET
N.T.S.
