Condition Assessment Report

491 Auburn Ave. NE,
Fulton County, Atlanta, GA 30312

Jennifer Dixon
HIST 8620
September 29th, 2010

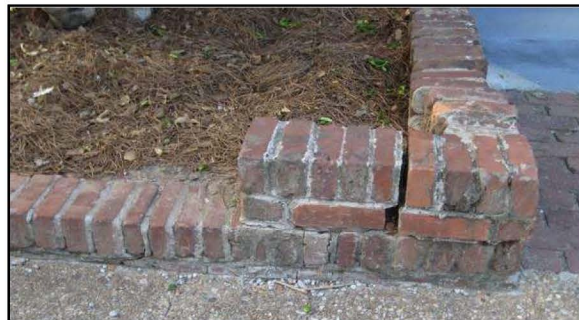
- Loose bricks around exterior pine islands (Fig. 14)

Figure 14 - Detail of loose brick, north

It is recommended that loose bricks be repointed, the driveway be repaired or repaved, and loose materials be cleared in order to remove safety hazards, especially if the building will be for public use.

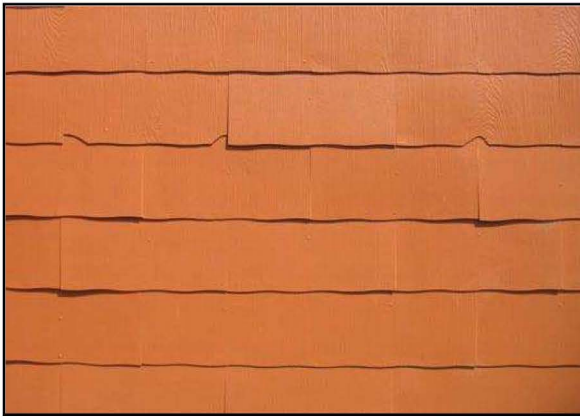
- Brick piers lacking mortar
- Moss growing on brick skirt around porch
- Crumbling concrete foundation on southern addition
- Spider webs and wasp nests evident
- Chipped asbestos siding throughout (Fig. 15)
- Nail holes and nails throughout (Fig. 16)

Figure 15 – Detail of exterior siding (courtesy of Angelica Dion)

It is recommended that brick piers and pilasters lacking mortar be repointed, moss be removed by the gentlest means possible, the concrete foundation be reinforced, and the insect issues be cleaned. The chipped asbestos siding, nail holes and unprepared surfaces do not pose an immediate threat, but should be assessed regularly (Appendix D). A balustrade and means of egress need to be installed on the back porch before the building can serve any purpose. Debris in the crawlspace should be photographed, tagged, and stored in order to decrease hazards. If

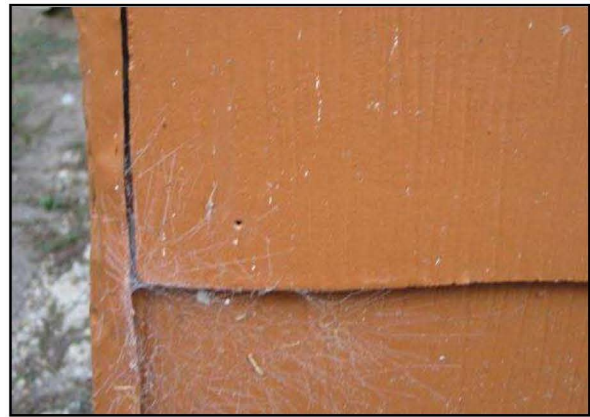
Figure 16 – Detail of nail holes, southeast corner

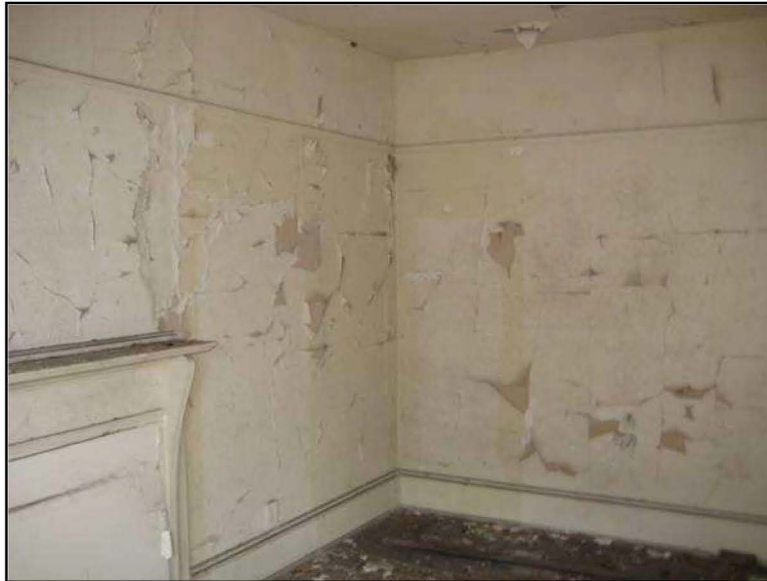
- Walls and Ceilings
 - Peeling plaster, such as in rooms 201 and 207 (Fig. 18)

Figure 18 – Peeling plaster in room 203, southwest

It is recommended that debris be disposed of while the architectural salvage material be photographed, tagged, and stored in a secure location for re-use in the building or elsewhere. All non-historic or non-existing doors should be replaced to match the six-panel, craftsman-style door. The three-light over three-panel door should remain in room 211 to the exterior and a similar door should be installed in room 204 to the exterior. Existing historic hardware should be cleaned and repaired, while the newly installed doors should have in-kind hardware installed. The 6/2 windows in 109 and 110 should be replaced to match the existing 2/2 windows, with a similar design replacing the 4/4 window in room 205. All casement opening hardware should be checked for security and all openings should be cleaned, repaired or replaced, and repainted.

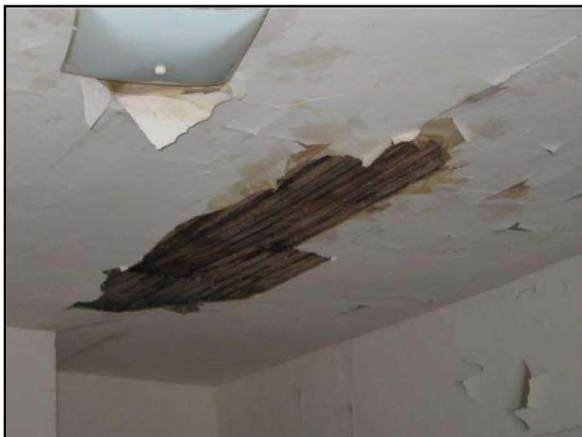
- Damage particularly around perimeter walls and ceilings (Figs. 19 and 20)

Figure 19 – Detail of minimal ceiling damage, room 201, southwest

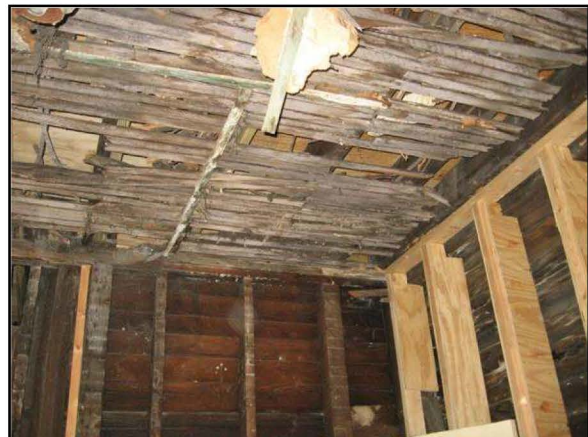
Figure 20 – Detail of extensive damage, room 110, southwest
(courtesy of Justin Hutchcraft)

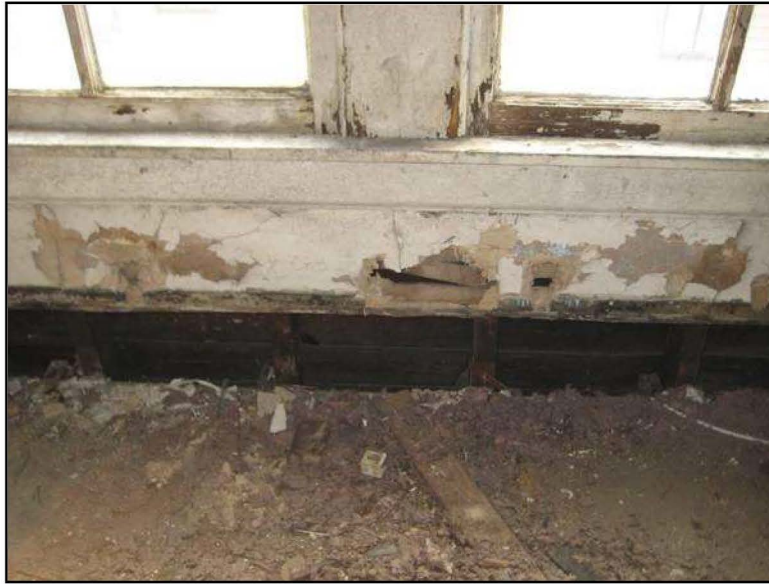
- Damaged surrounds and hearths in room 207 and others
- Decayed or missing trim throughout, such as in room 203 (Fig. 21)

Figure 21 – Non-existent baseboard in room 203, east wall

It is recommended that missing trim be replaced in-kind, including baseboard and mantels. All decayed trim should be cleaned, repaired or replaced, and repainted. Blocking that replaced trim (Fig. 24) should be replaced with in-kind trim as shown in other areas of the building. Other mismatched trim, such as in rooms 202 and 203, should be replaced to match historic trim. Fireplace surrounds and hearths should be replaced with materials significant to

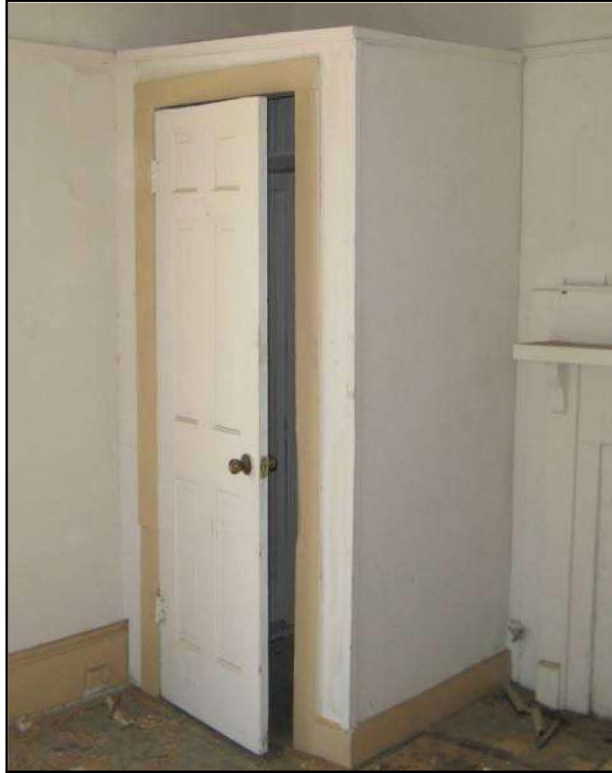
Figure 22 – Non-historic closet in room 201, southeast

Specialty areas, such as those previously used as kitchens and baths, need to be treated dependent on their proposed use. To minimize costs, it is recommended that these rooms be used for a similar purpose. According to NPS, the bathtub in room 212 was in good condition when removed and others were in states of disrepair. If they have been stored properly, these pieces should be retained and reinstalled. The non-historic closet in room 201 should be removed.

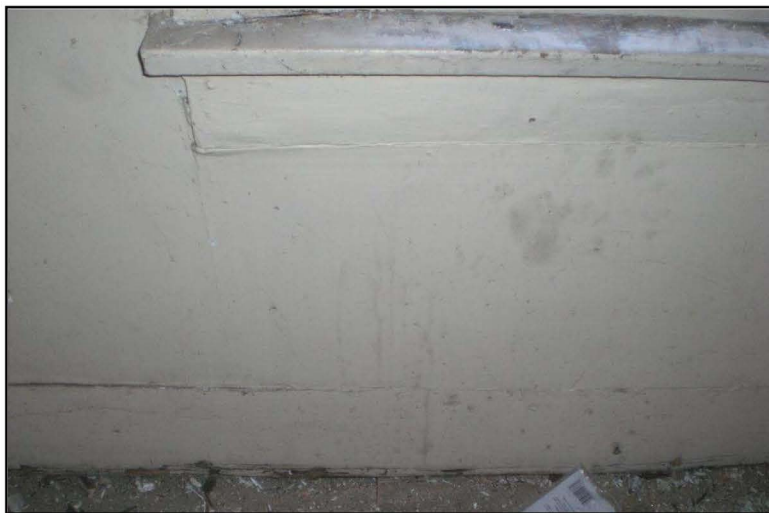
Figure 23 – Improper plaster repair, room 108, west wall (courtesy Rosemary Davis)

Recommendations also include repairing the hole in the floor in room 103. All plywood sheeting and the second type of hardwood flooring in room 108 should be replaced with in-kind hardwood flooring. All hardwood should be cleaned, repaired, and refinished where needed, removing furring strips. Areas intended to be used as wet spaces, such as room 112 or 206, should have impervious flooring installed, such as tile or laminate. Damaged walls and ceilings, whether minimal or expansive, need metal lath and plaster or plastered drywall installed. Rooms in which the walls and ceiling are sound need to be replastered, such as in room 201. Corrective plastering should take place under the window in room 108 (Fig. 23) and other areas that may

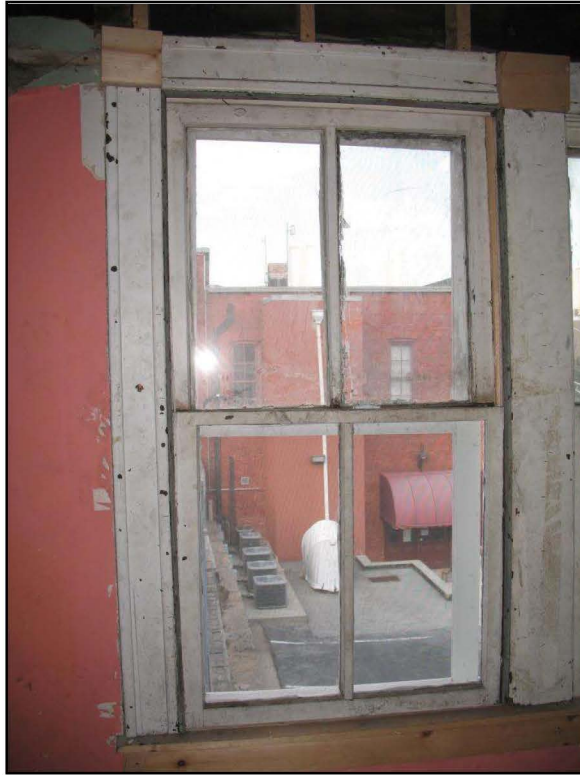
Figure 24 – Inappropriate corner blocking, room 208, west wall (courtesy Angelica Dion)

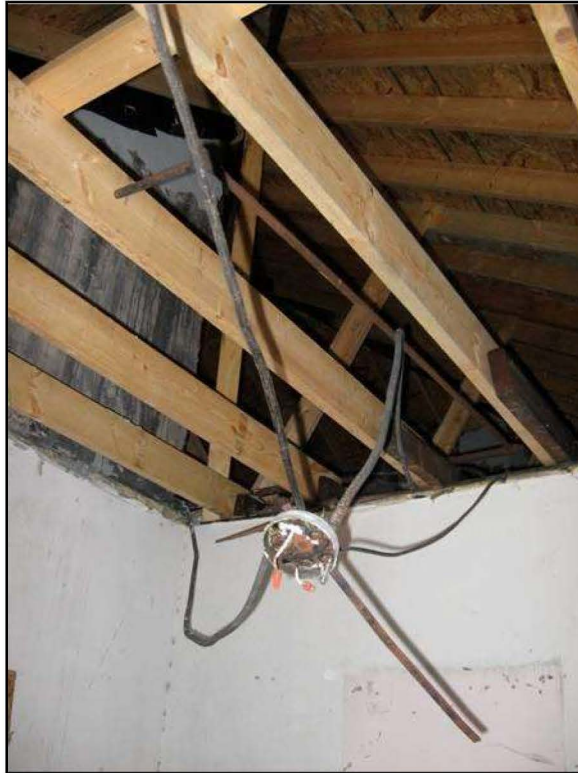
- Non-code compliant electrical wiring (Fig. 25)

Figure 25 – Electrical wiring in room 210 (courtesy of Justin Hutchcraft)

It is recommended that the electrical system be brought up to code with a three-wire, grounded system. Deteriorated piping should be repaired according to the building's proposed use. Gas heaters should be installed, if consistent with the new use of the building. Fire protection systems should be added to bring the resource up to code and weatherproofing should be updated to optimize energy performance.
