515 Auburn Avenue, NE Historic Structure Report

August 2019

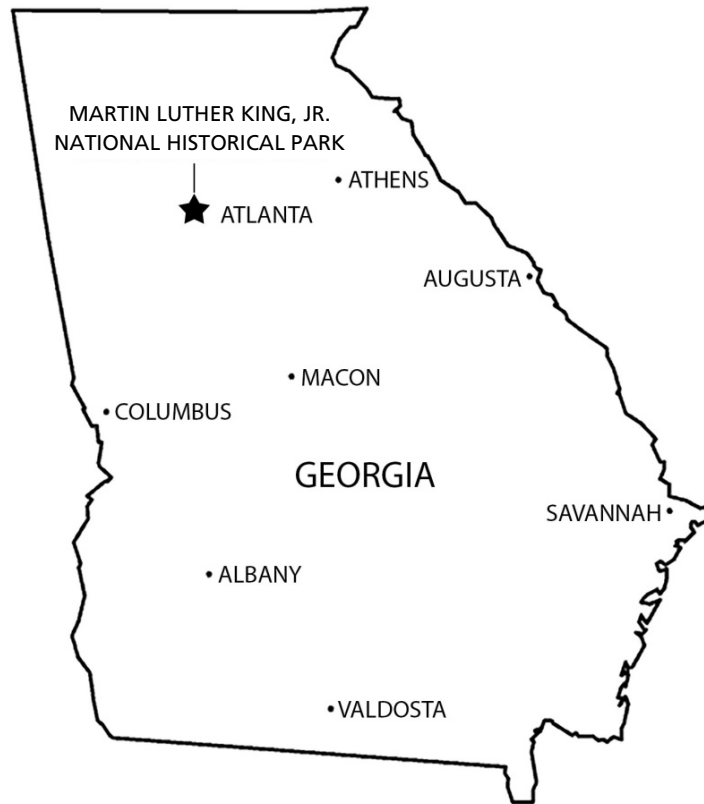
FIGURE 1. Map of Georgia showing location of Martin Luther King, Jr. National Historical Park (star) (not to scale). (Source: US Census Bureau, modified by the authors)

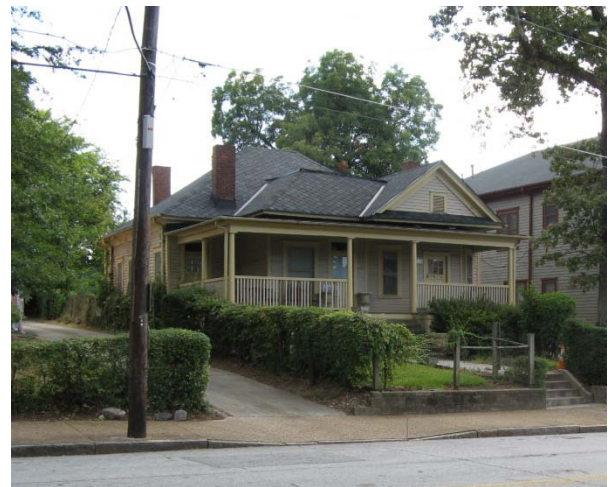
FIGURE 4. Faison House (1909), 515 Auburn Avenue (LCS #090015), MALU. (Source: All photographs by authors in 2016 unless otherwise noted)

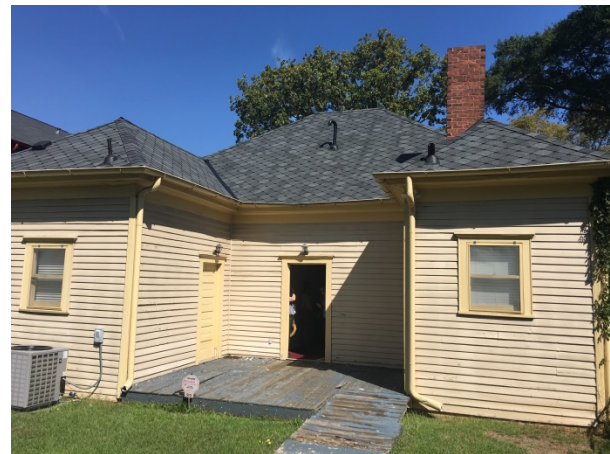
FIGURE 5. Rear, south facade, 515 Auburn Avenue, showing steep, complex roof line, decorative window and door moldings, and 1/1 windows.

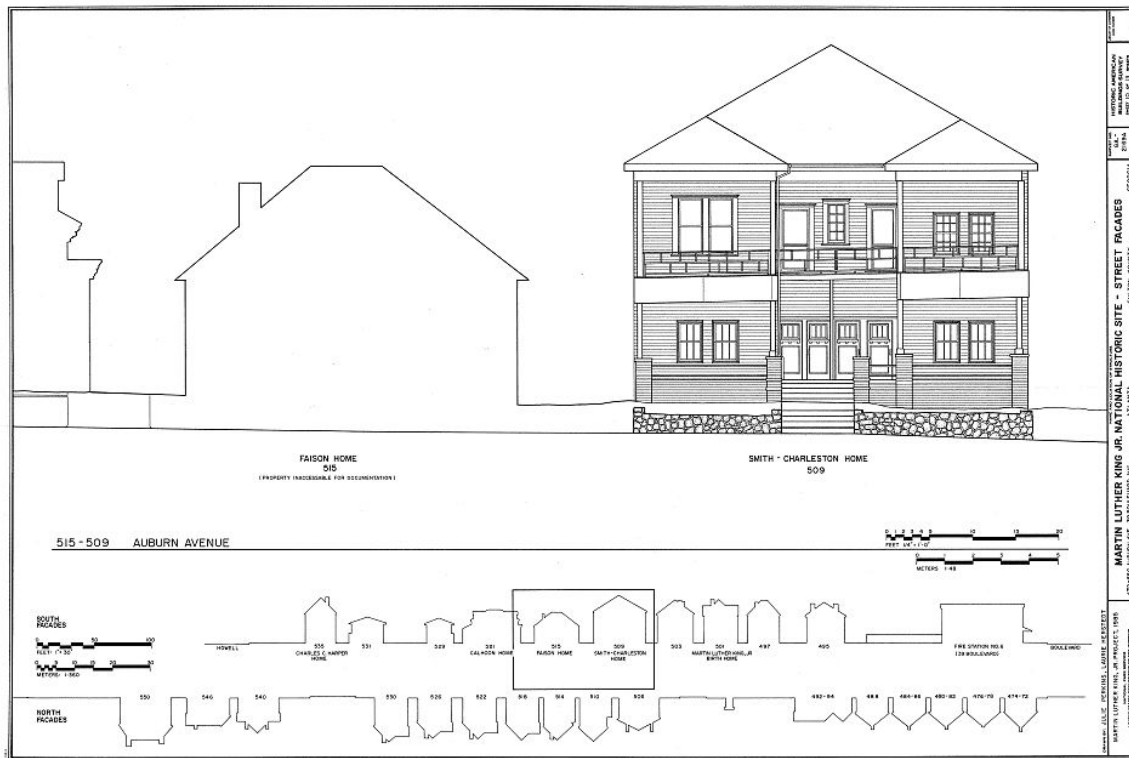
FIGURE 6. HABS Birth Home Block Street Facades, 515 Auburn Avenue, Sheet 10, showing the building as a blank outline because the “property [was] inaccessible for documentation.” (Source: Alexander Hamilton, *472-550 Auburn Avenue & 39 Boulevard, Atlanta, Fulton County, Georgia. Martin Luther King Jr., National Historic Site. HABS GA, 61-ATLA, 49-[Sheet 10 of 13], 1985*)

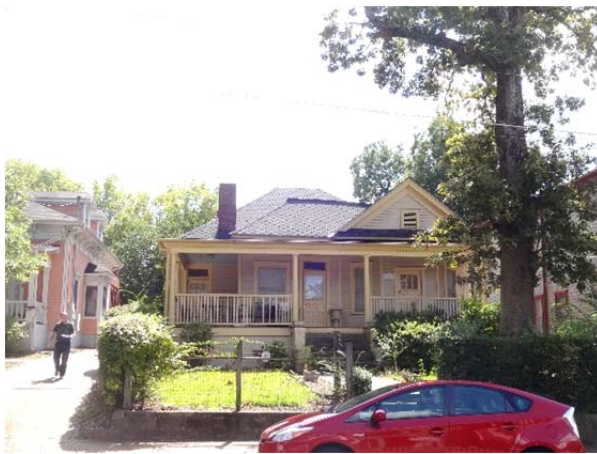
FIGURE 18. Overview of the 515 Auburn Avenue property.

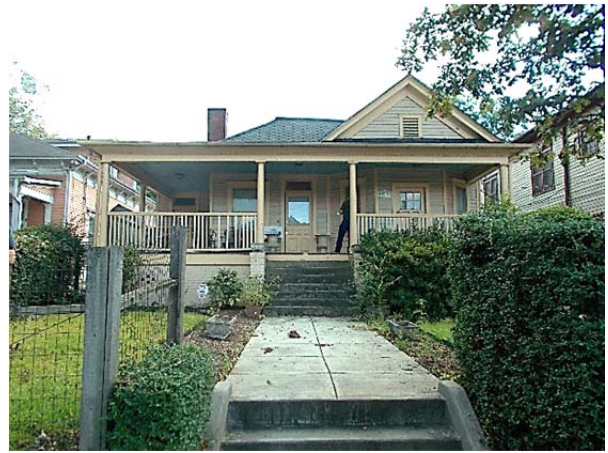
FIGURE 19. Main (north) elevation of building at 515 Auburn Avenue.

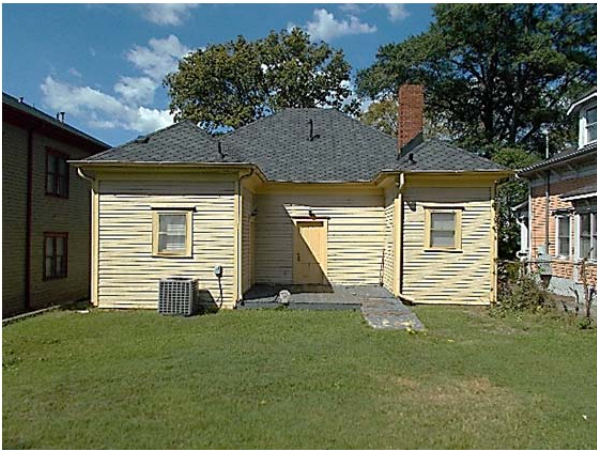
FIGURE 21. South elevation of the building.

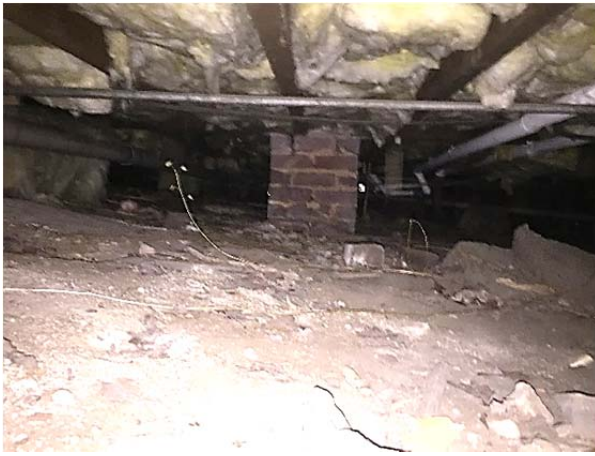
FIGURE 22. Brick pier foundation at center portion of house.

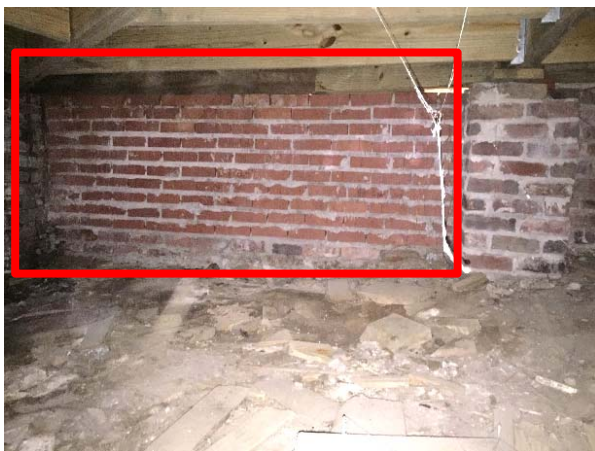
FIGURE 23. Infill brick between pier supports at foundation below north porch.

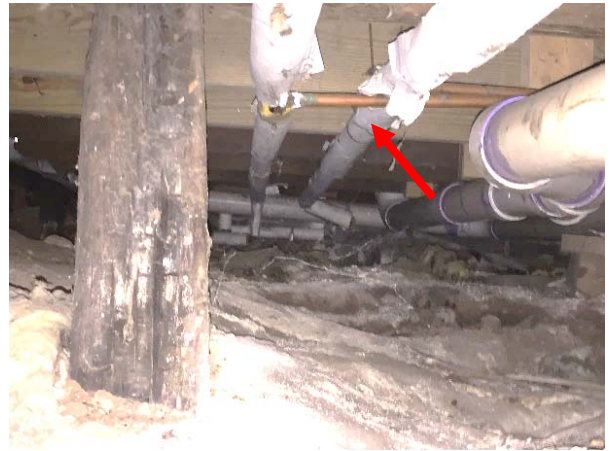
FIGURE 24. Pipes of various kinds suspended from metal straps attached to floor joists.

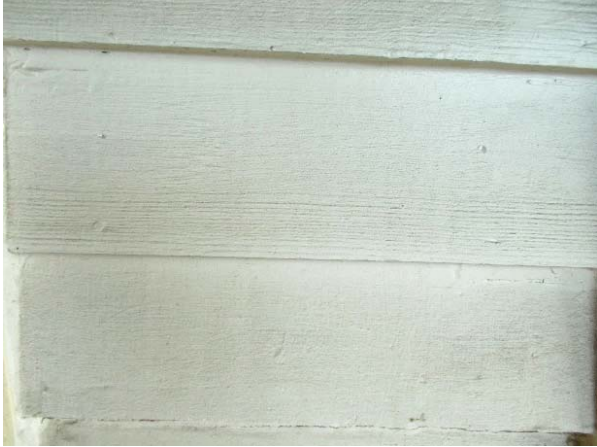
FIGURE 25. Typical horizontal wood siding at building.

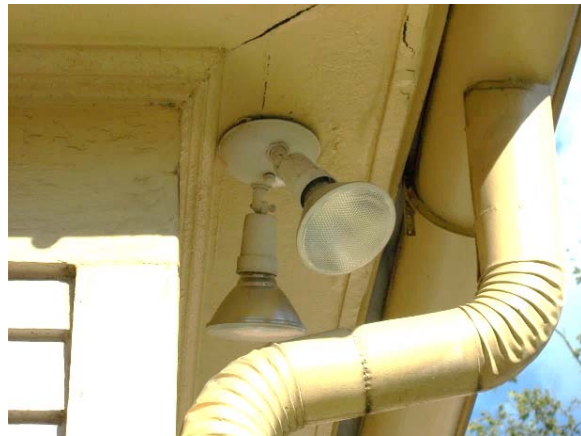
FIGURE 28. Flood light mounted to underside of roof eave.

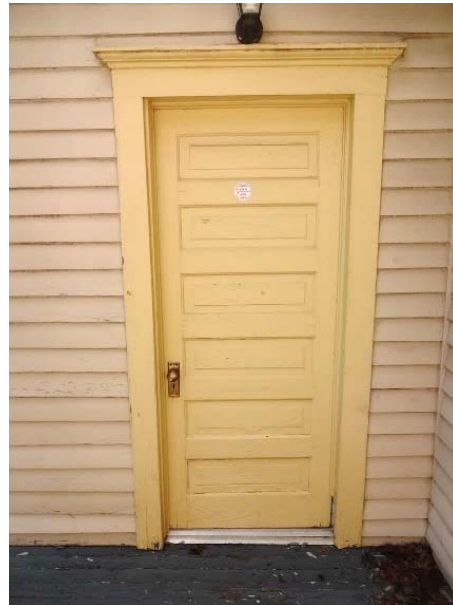
FIGURE 36. Door opening at west side of south elevation, accessed from patio.

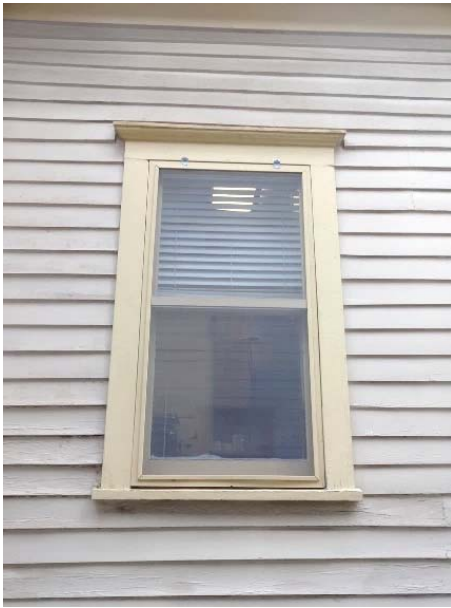
FIGURE 37. Typical window at east and west elevations.

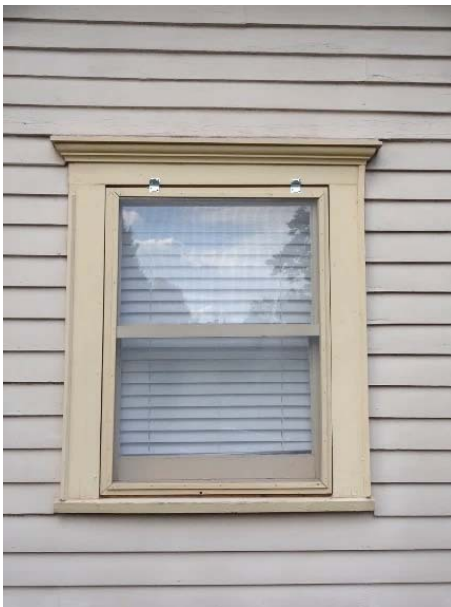
FIGURE 38. Typical window at south elevation.

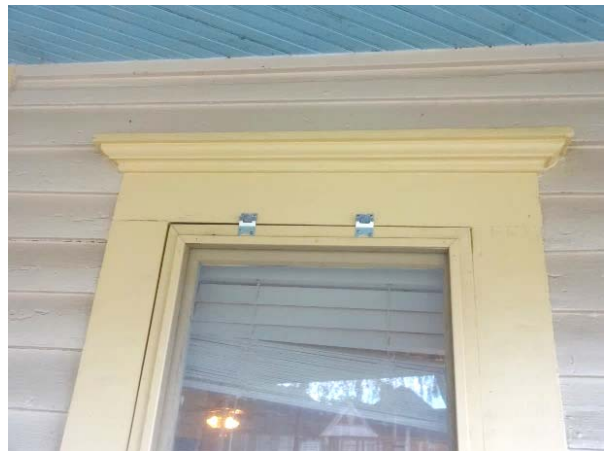
FIGURE 40. Crown molding header casing at window openings. Also note metal hooks for window screens.

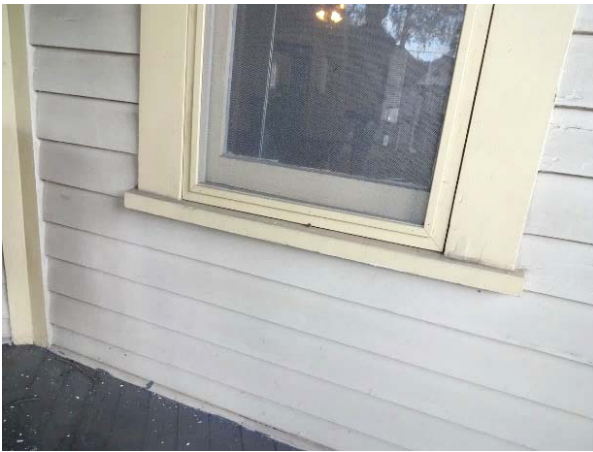
FIGURE 41. Typical sill at window openings.

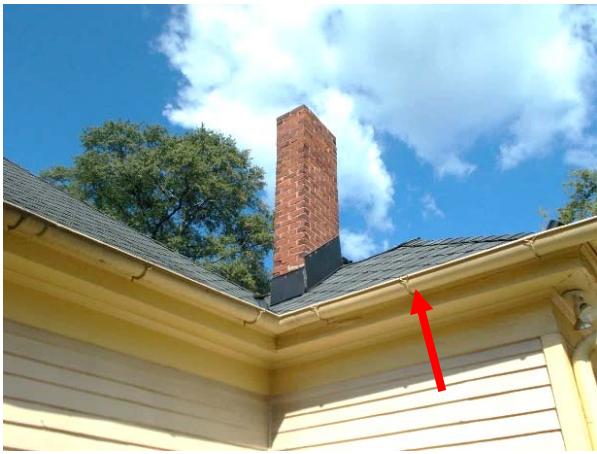
FIGURE 44. Typical gutter with gutter straps (arrow).

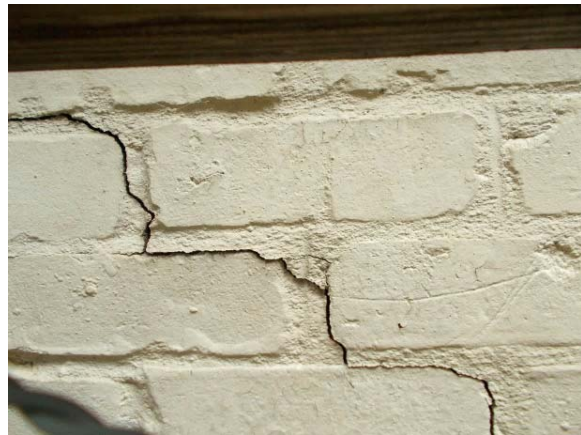
FIGURE 45. Step cracking at the brick foundation wall.

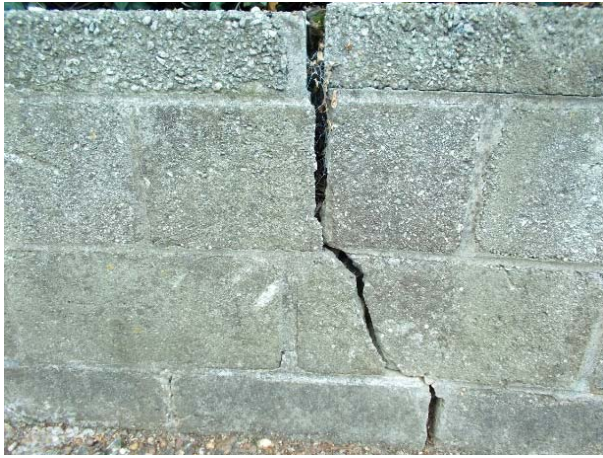
FIGURE 46. Step cracking at the CMU retaining wall.

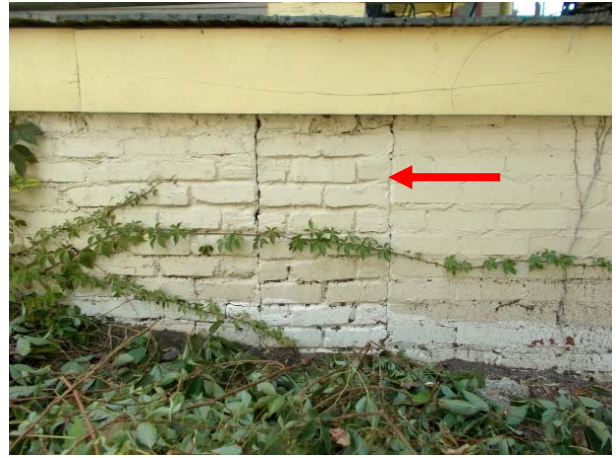
FIGURE 49. Outline of brick masonry foundation piers at porch.

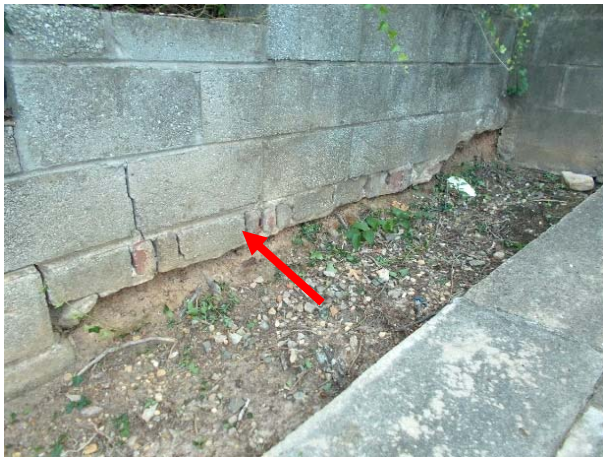
FIGURE 47. The foundation at the west side of the retaining wall has been undermined.

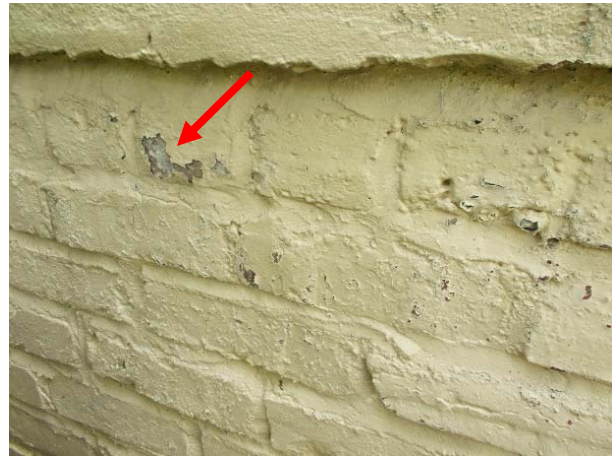
FIGURE 50. Peeling paint at brick foundation walls.

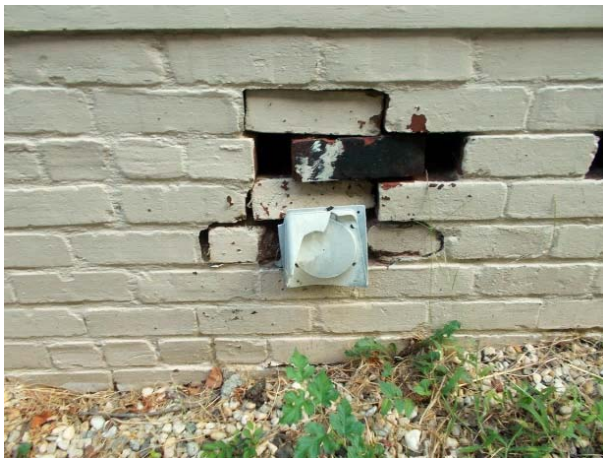
FIGURE 48. Displaced brick associated with previous alterations to the brick masonry.

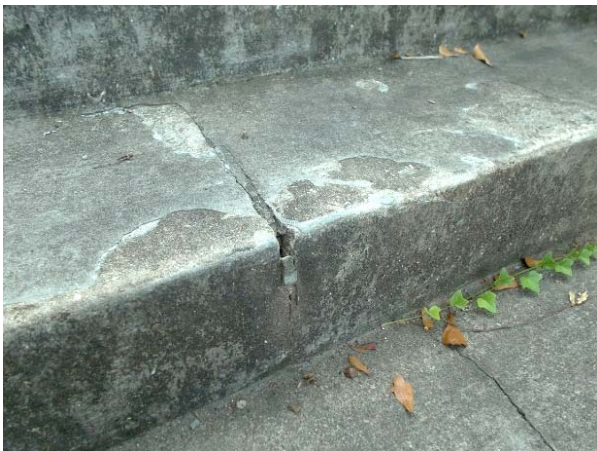
FIGURE 52. Cracking of the concrete at stairs.

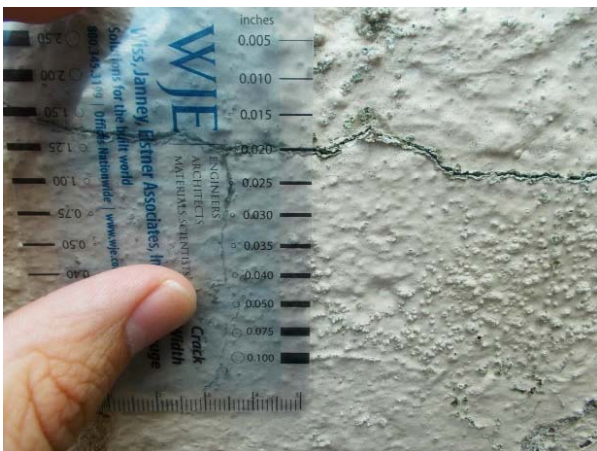
FIGURE 53. Hairline cracking at concrete coping units at cheek walls.

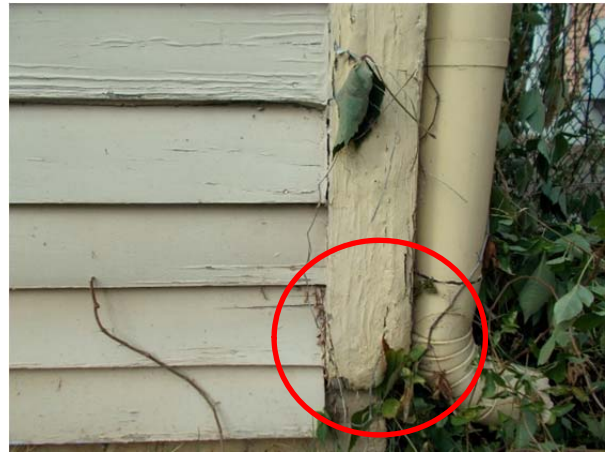
FIGURE 54. Deteriorated wood trim. Note that deterioration is more significant at bottom of trim.

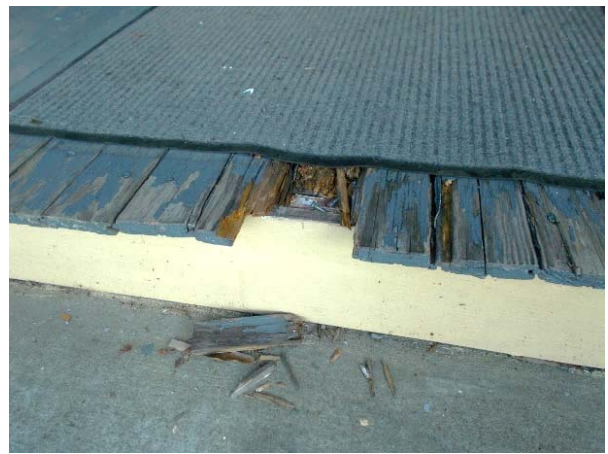
FIGURE 55. Deteriorated wood decking at front porch.

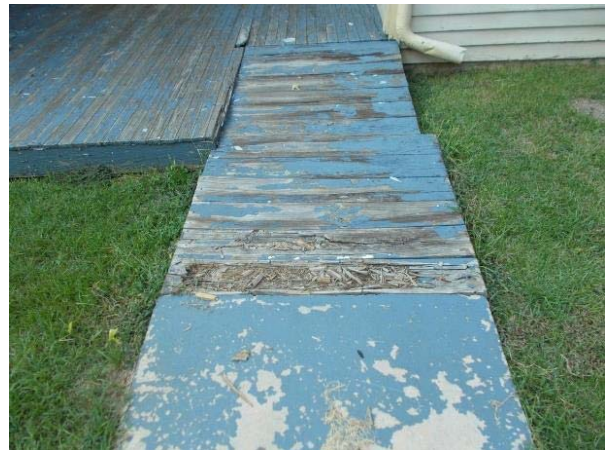
FIGURE 56. Deteriorated wood decking at rear patio.

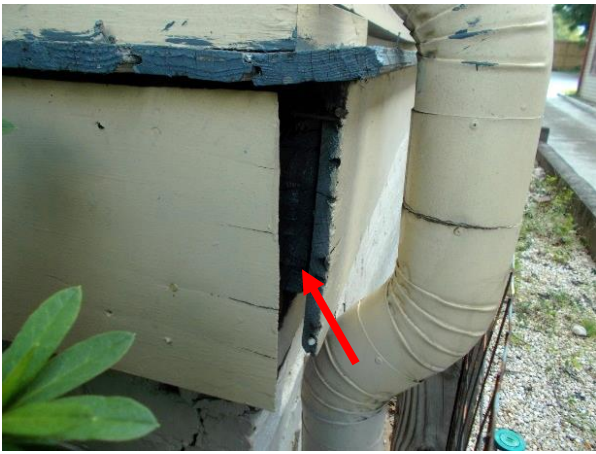
FIGURE 57. Open joint and displacement of wood porch apron.

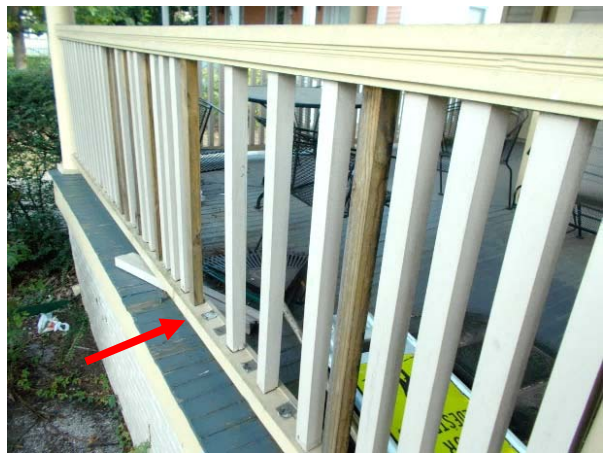
FIGURE 62. Balustrade at north porch with missing spindles.

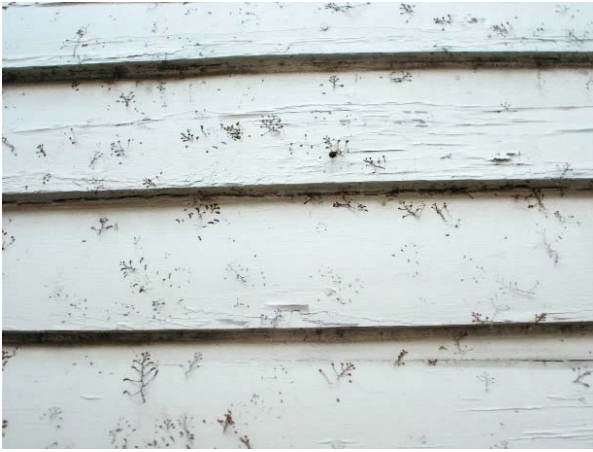
FIGURE 63. Tendrils from previously existing vegetation are attached to siding.

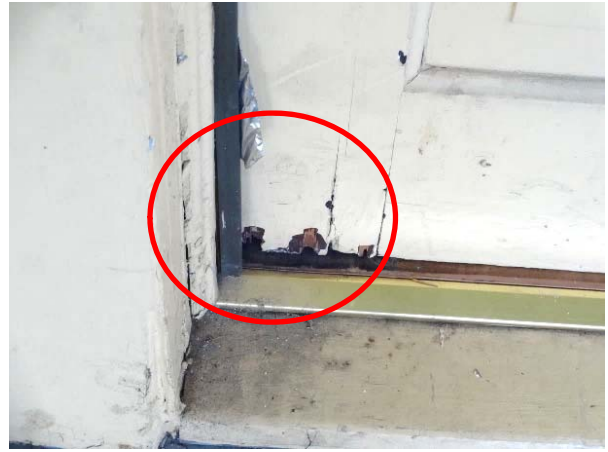
FIGURE 64. Deteriorated wood at bottom stile of the wood door.

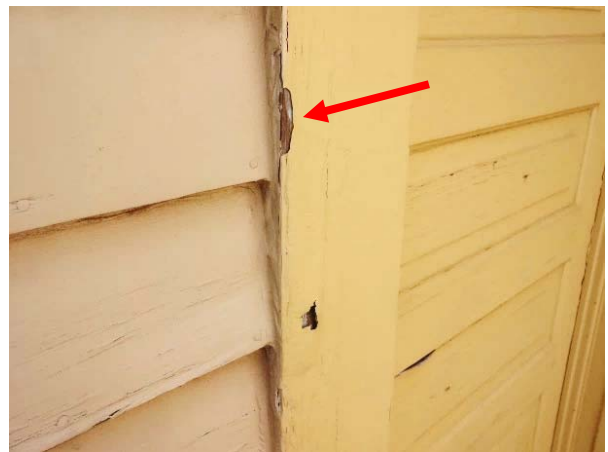
FIGURE 65. Deteriorated paint at wood trim and door leaf.

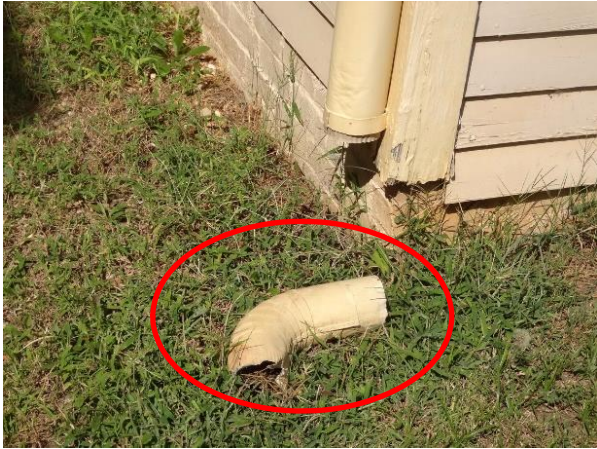
FIGURE 66. Disconnected leader at northwest corner of the building.

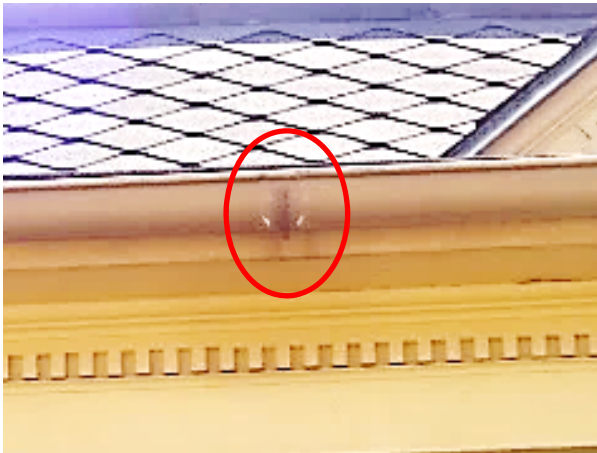
FIGURE 67. Loose and displaced gutter strap.

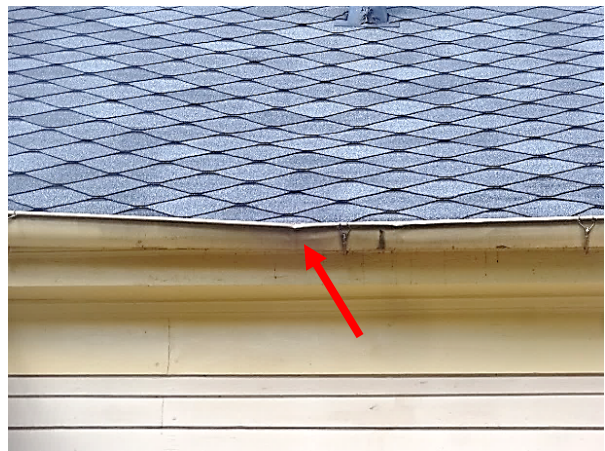
FIGURE 68. Damaged gutter at south elevation of the building.

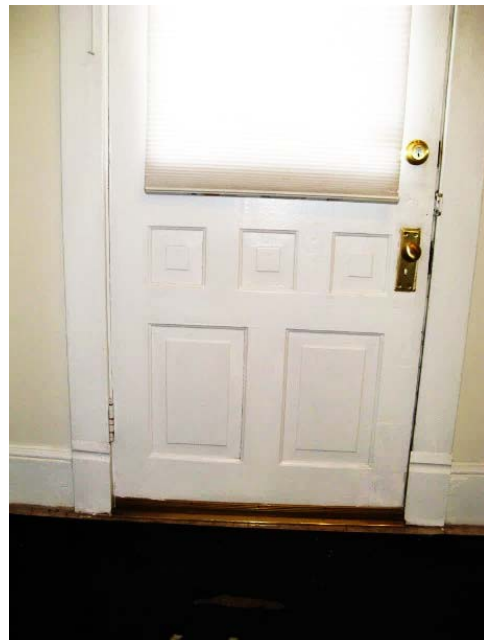
FIGURE 71. Interior side of primary front door.

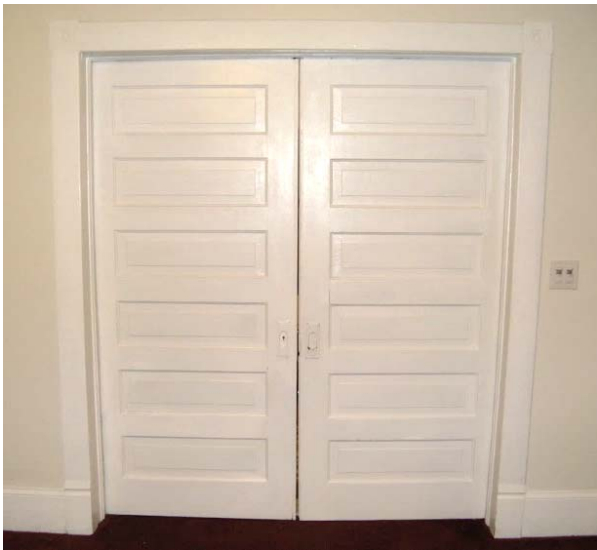
FIGURE 72. Remaining pair of pocket doors.

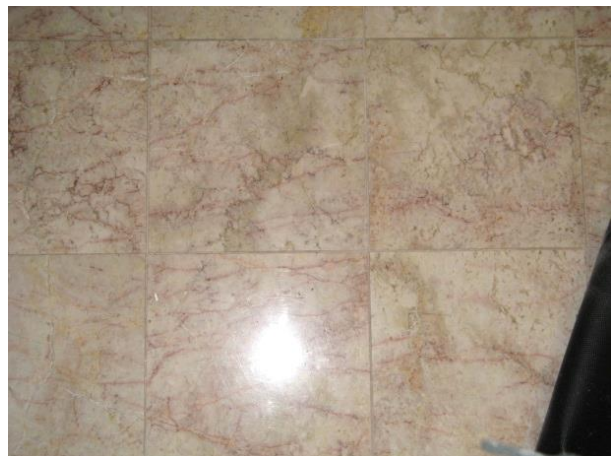
FIGURE 75. Tile flooring in foyer, installed in the early 2000s.

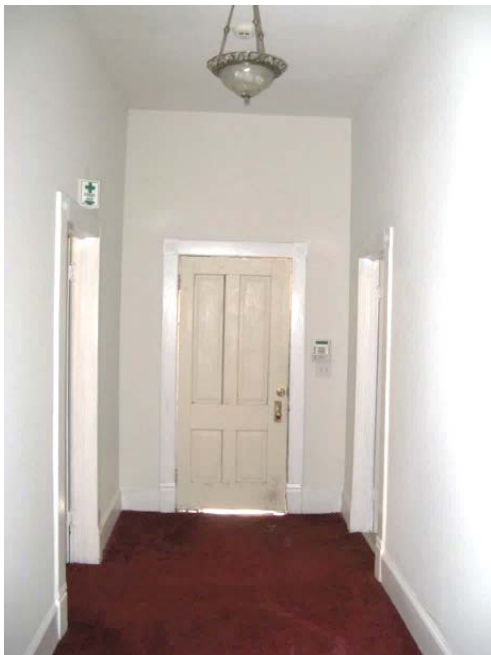
FIGURE 76. Central hall looking south toward rear door.

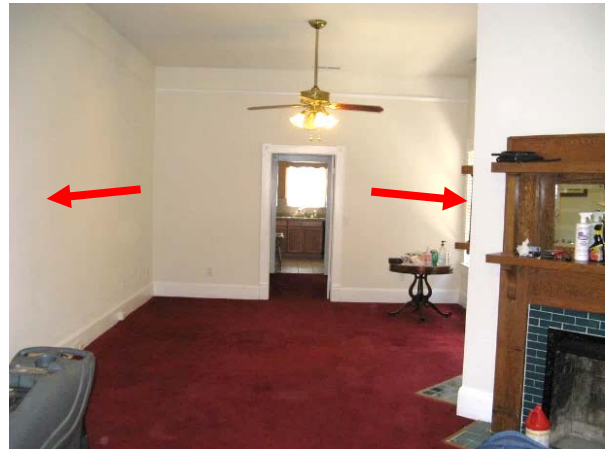
FIGURE 77. Meeting room looking south toward rear hall and kitchen. Note location where original wall was removed.

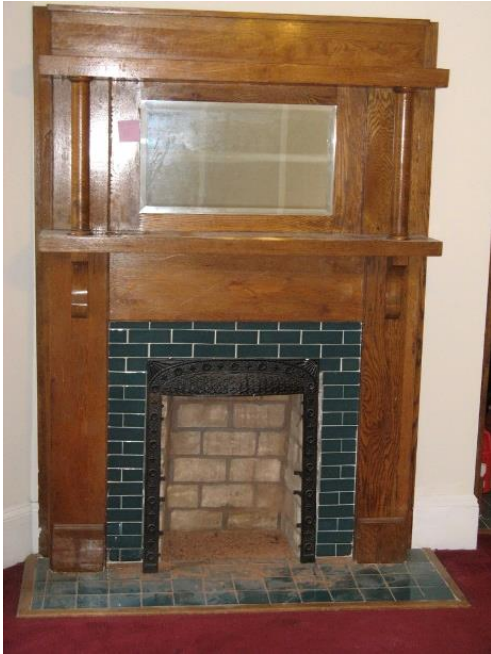
FIGURE 78. Fireplace in meeting room.

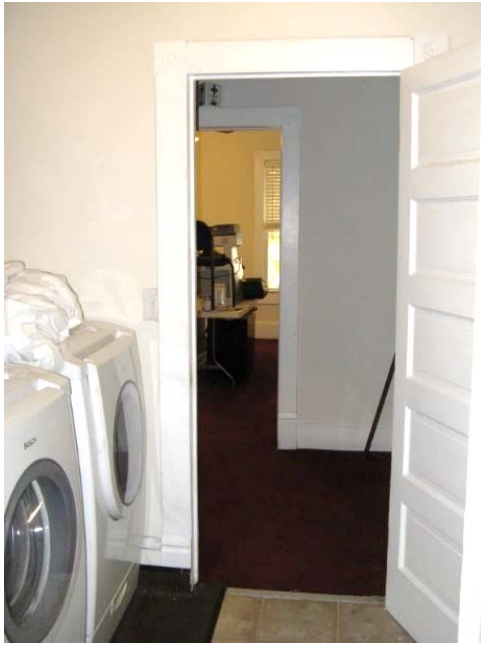
FIGURE 79. View through laundry to central hall.

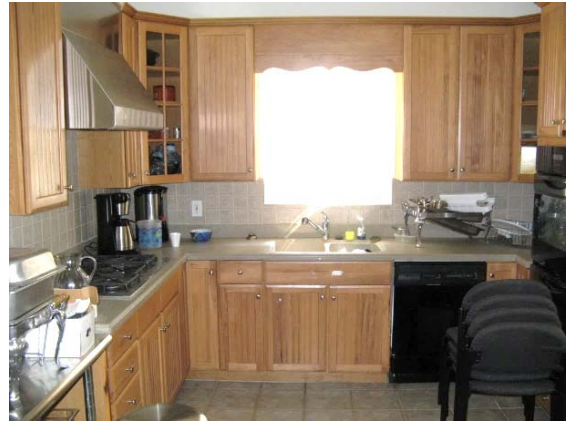
FIGURE 80. Renovated kitchen looking south.

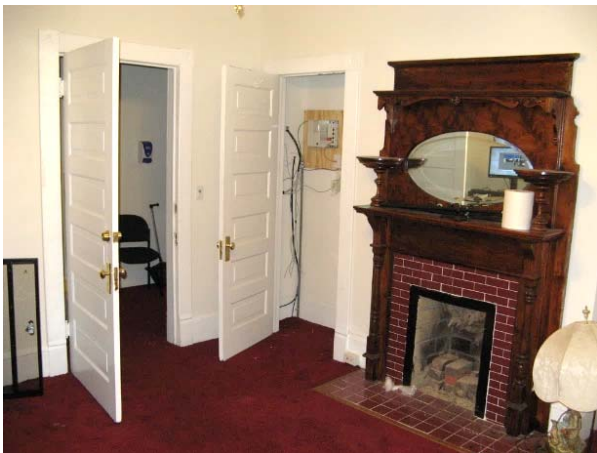
FIGURE 82. North office looking northwest.

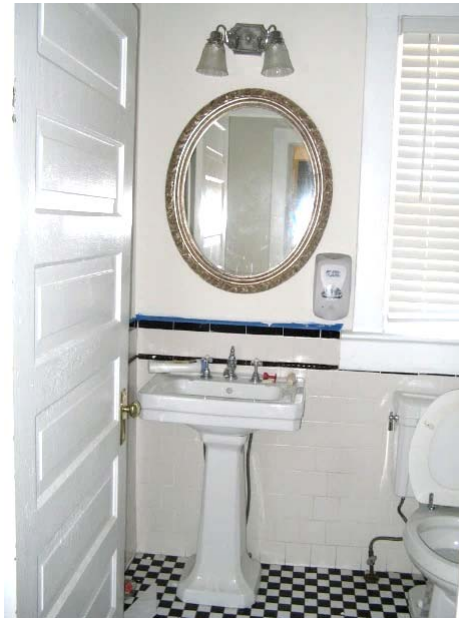
FIGURE 85. West bathroom.

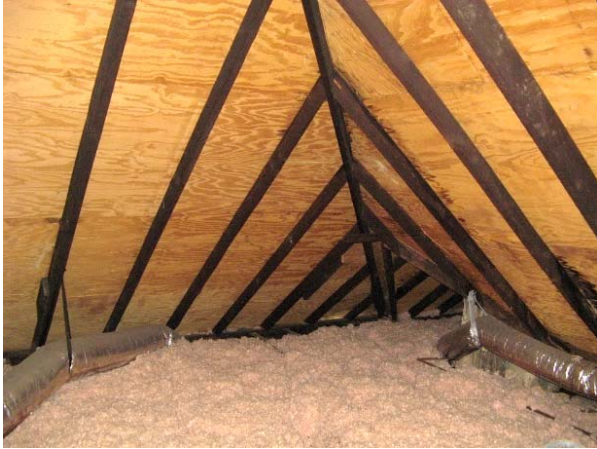
FIGURE 86. Attic with plywood roof sheathing and loose fill insulation.

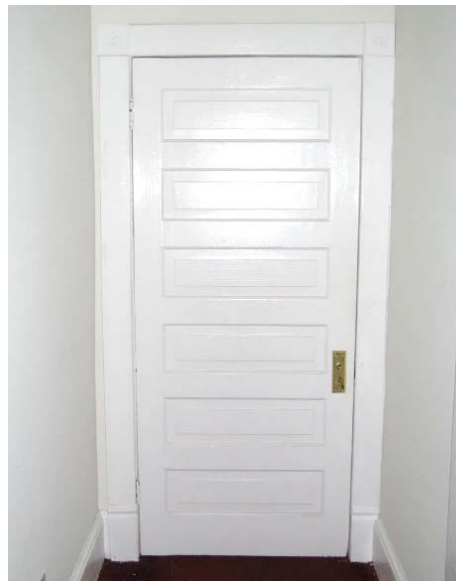
FIGURE 87. Typical six-panel interior door.

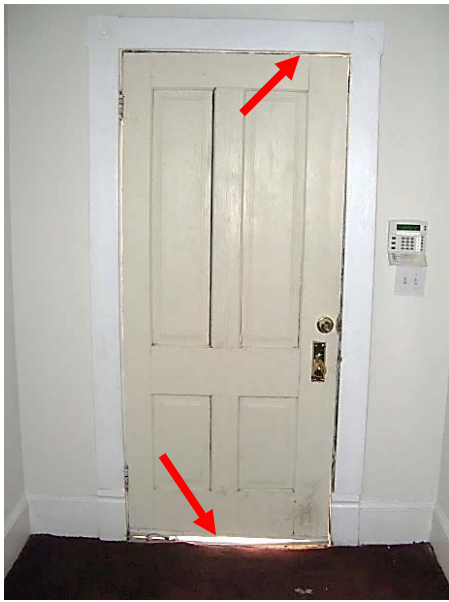
FIGURE 88. Non-original rear exterior door. Note deteriorated threshold and gaps around door.

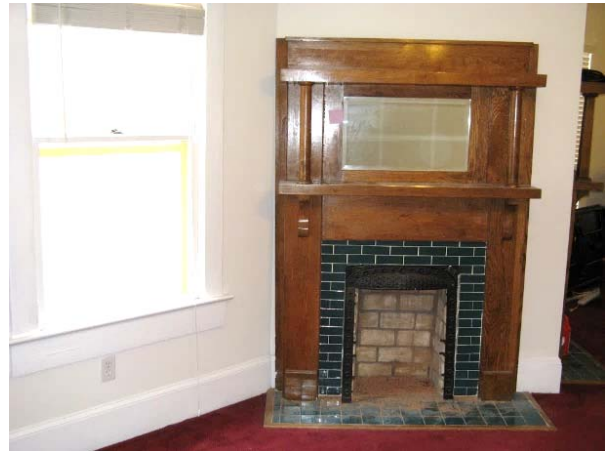
FIGURE 89. Fireplace in meeting room.

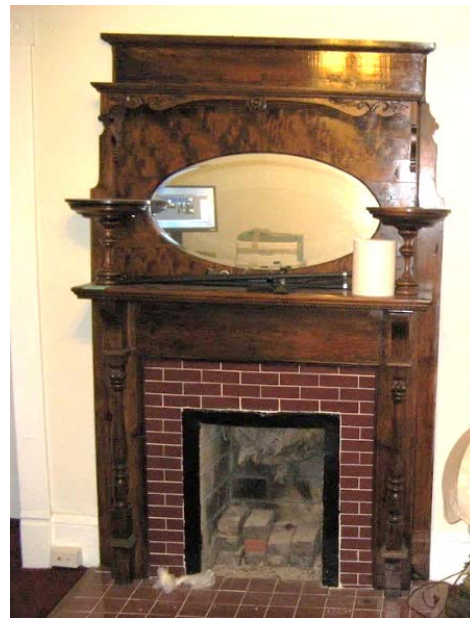
FIGURE 90. Fireplace and mantelpiece in north office.

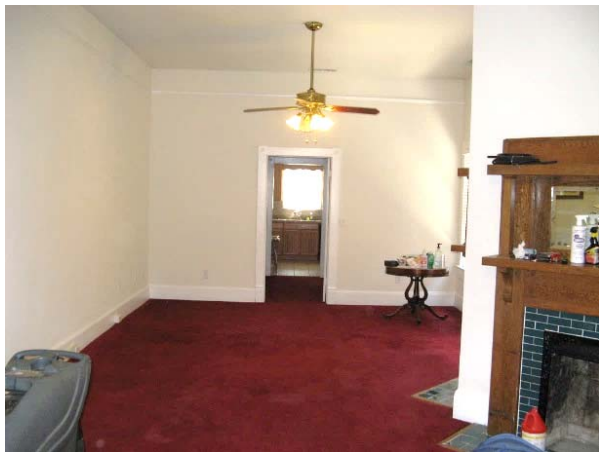
FIGURE 91. Meeting room with ubiquitous red wall-to-wall carpet.

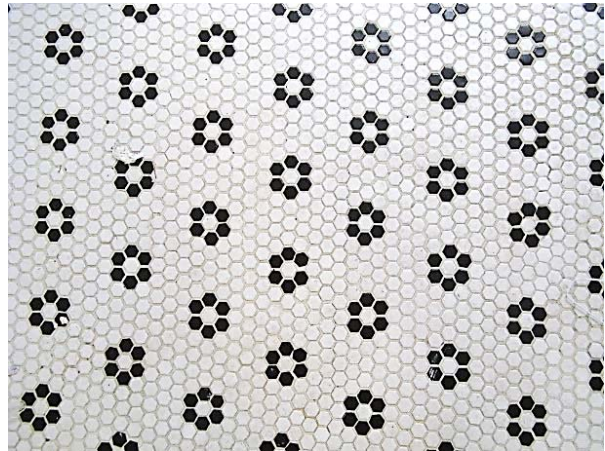
FIGURE 92. Ceramic mosaic tile floor in south bathroom. Note "daisy" pattern.

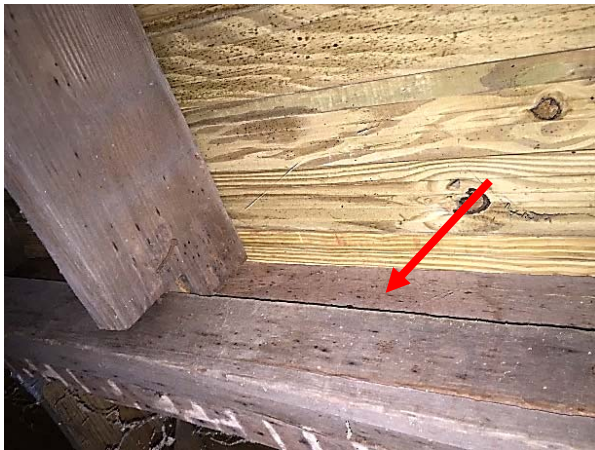
FIGURE 95. Floor structure. An additional 2x4 ledger strip is attached to the bottom of the perimeter wood beam to support the floor joints.

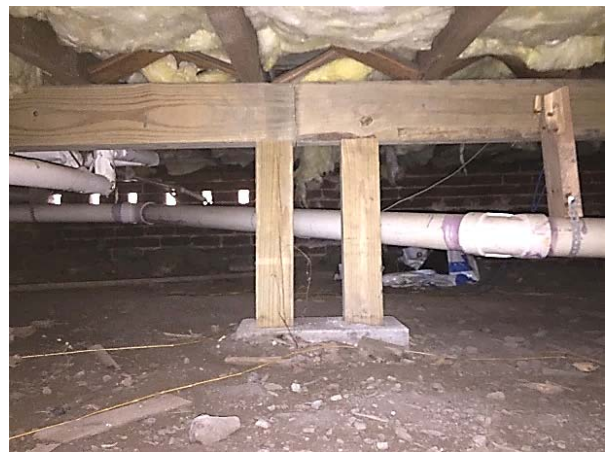
FIGURE 97. Replacement support posts at floor beam.

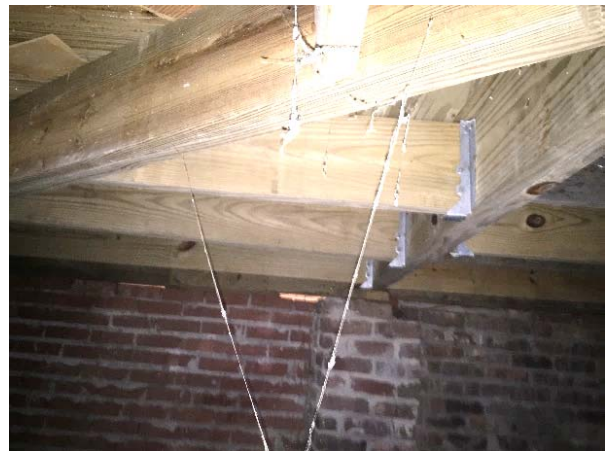
FIGURE 98. Floor joists with joist hangers at porch flooring.

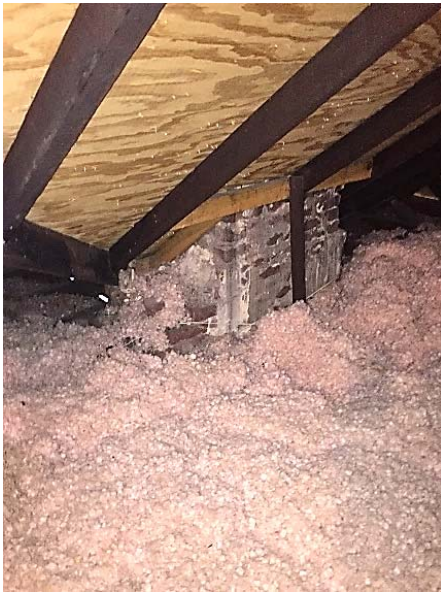
FIGURE 99. Ceiling framing has been covered with blown-in insulation.

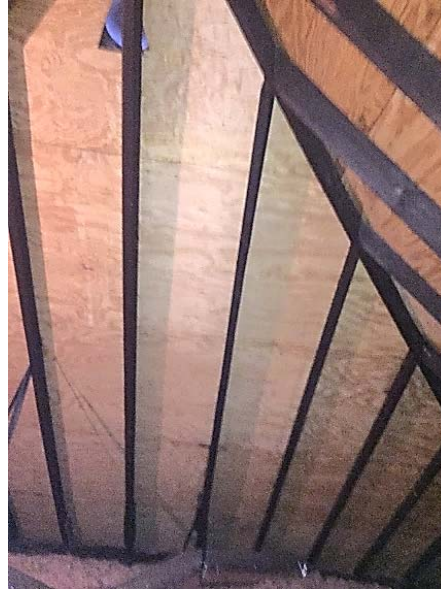
FIGURE 100. Overview of roof framing.

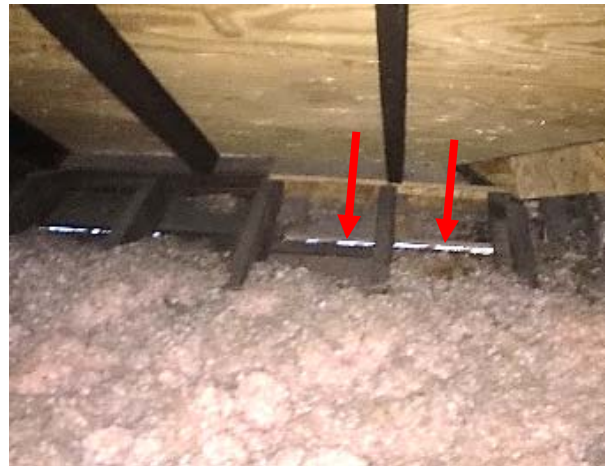
FIGURE 104. Large air gaps between roof and wall framing.

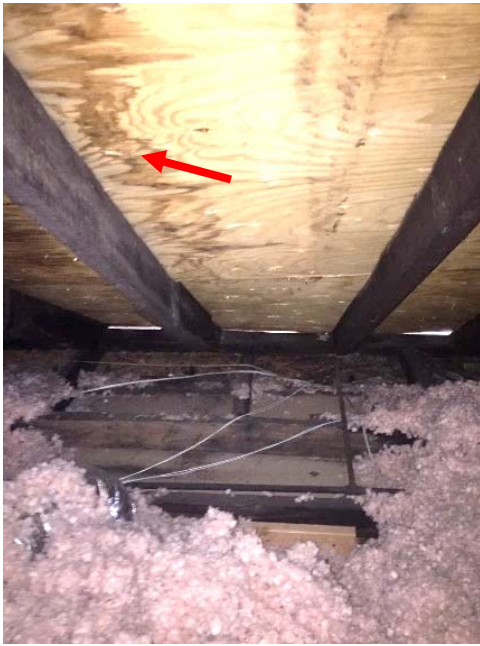
FIGURE 105. Moisture staining on plywood sheathing.

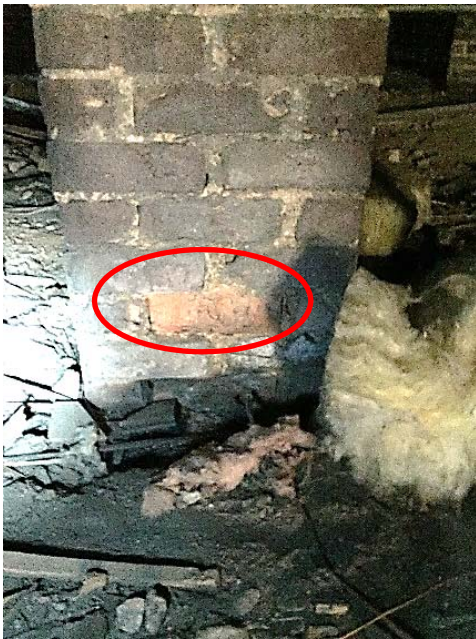
FIGURE 106. Spalling of brick and masonry foundation piers.

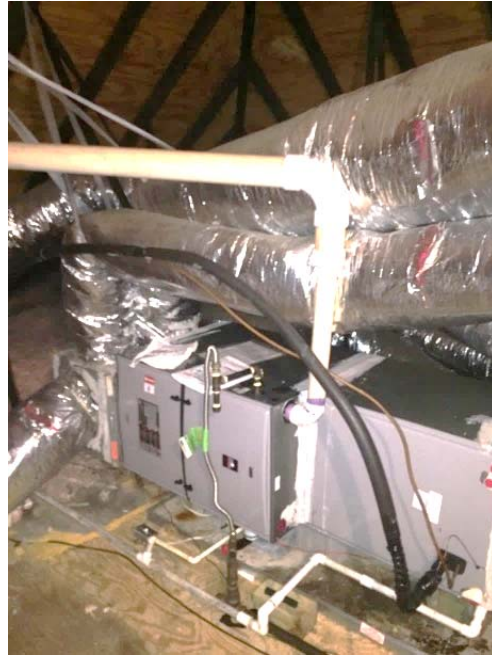
FIGURE 107. New heating and air conditioning unit in the attic.

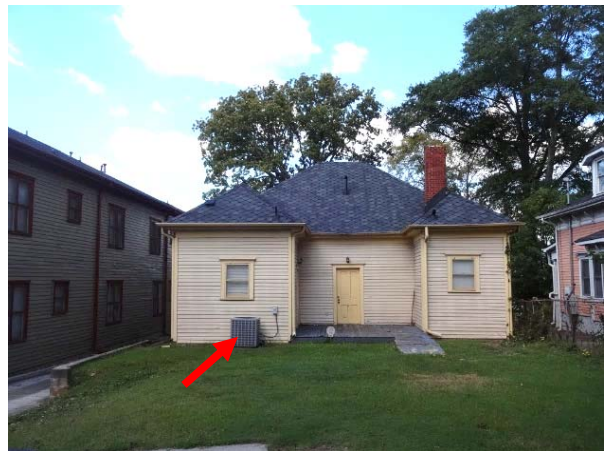
FIGURE 108. New split system condensing unit.

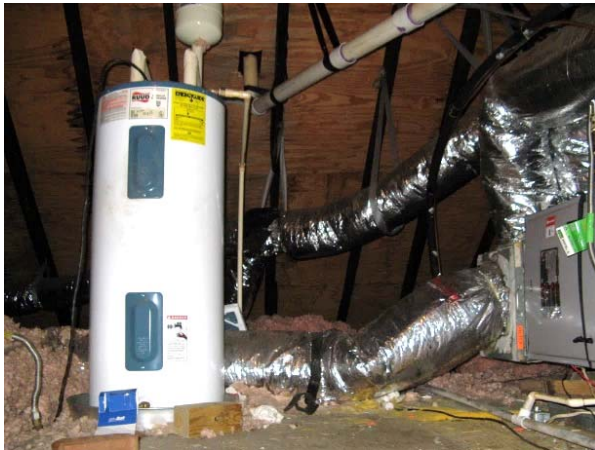
FIGURE 109. Gas water heater in the attic.

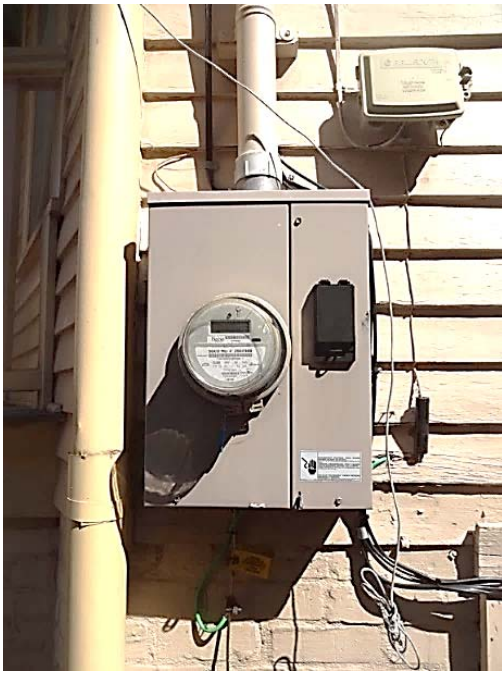
FIGURE 110. Electric service meter base and telecommunications box.

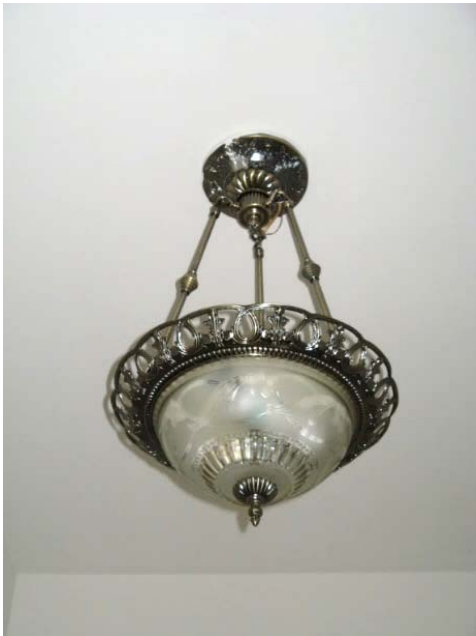
FIGURE 111. Example of ceiling-mounted light fixture from the circa 2001 interior renovation.

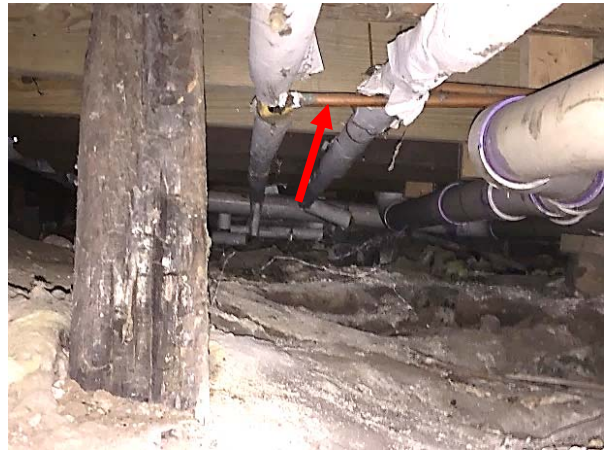
FIGURE 112. Missing insulation on copper water pipes in the crawl space.

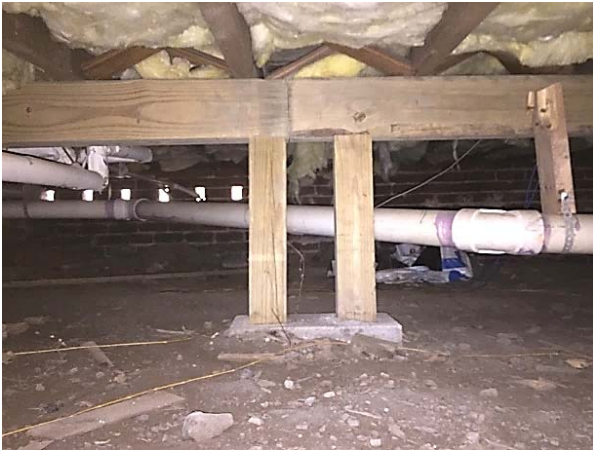
FIGURE 113. PVC waste lines in crawl space.

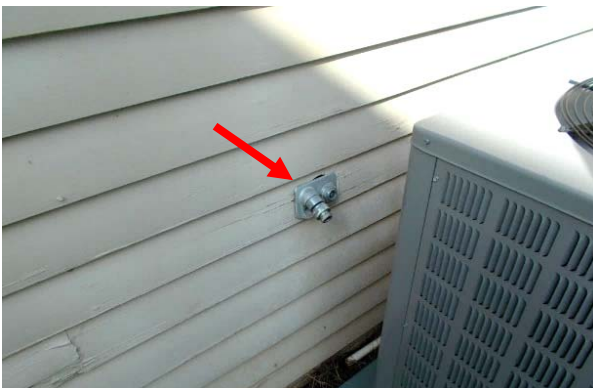
FIGURE 115. Exterior hose bib behind condensing unit.

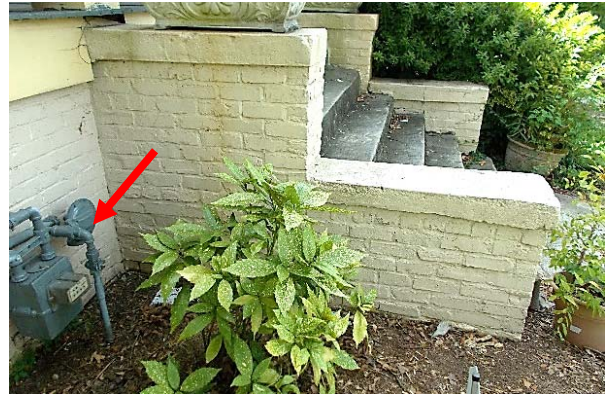
FIGURE 116. Gas meter adjacent to front porch.
