54 Howell Street, NE Historic Structure Report

54 Howell Street, NE
Martin Luther King, Jr. National Historical Park
Atlanta, Georgia

Historic Structure Report

August 2019

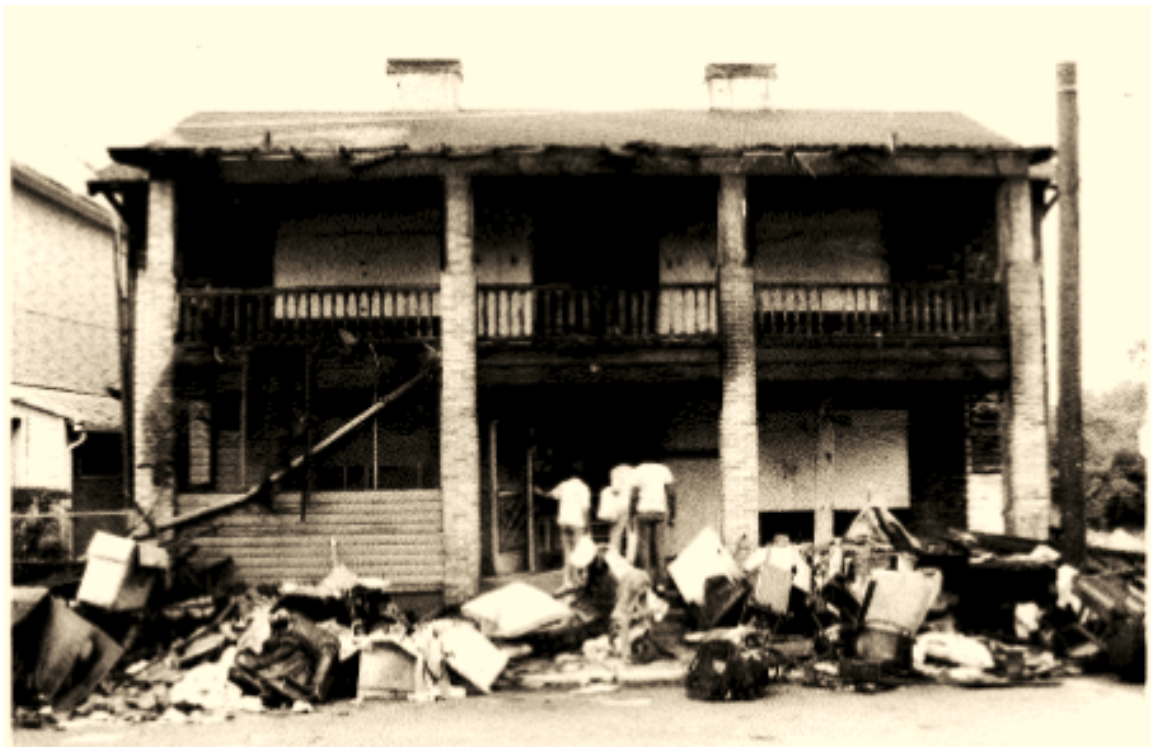
FIGURE 7. 54 Howell Street, front, east, facade after the 1985 fire. (Source: Division of Facilities Management, 1981-1991 – Photographs)

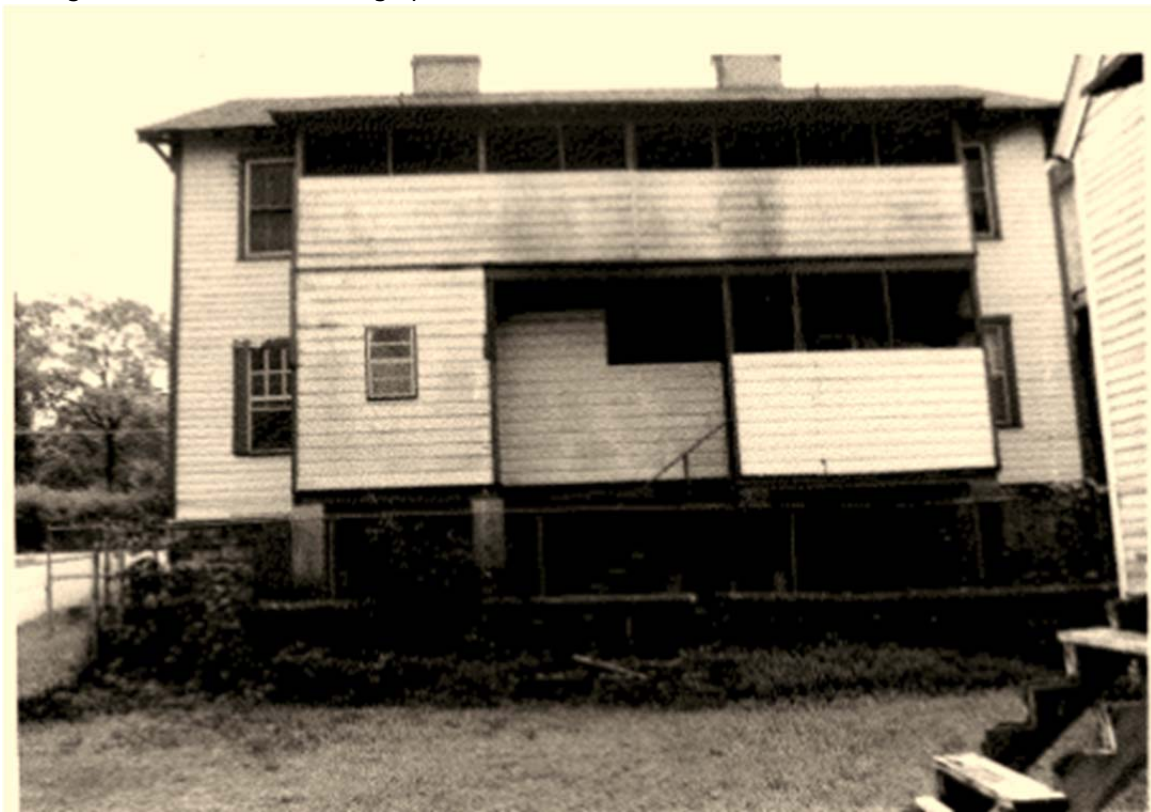
FIGURE 8. 54 Howell Street, rear, west, facade, after the 1985 fire showing what appears to be only smoke damage. (Source: Division of Facilities Management, 1981-1991 - Photographs)

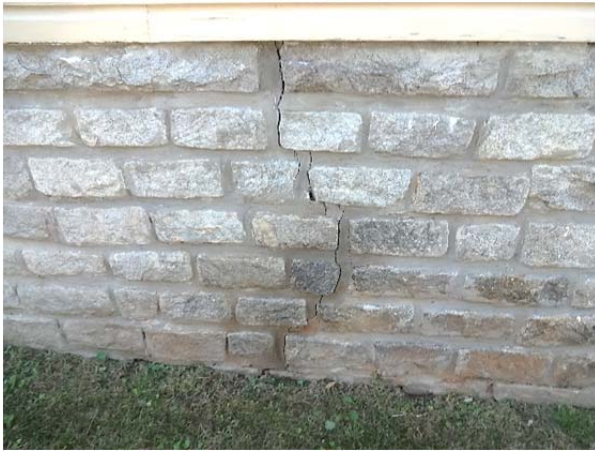
FIGURE 53. Vertical cracking and moisture staining at stone foundation wall.

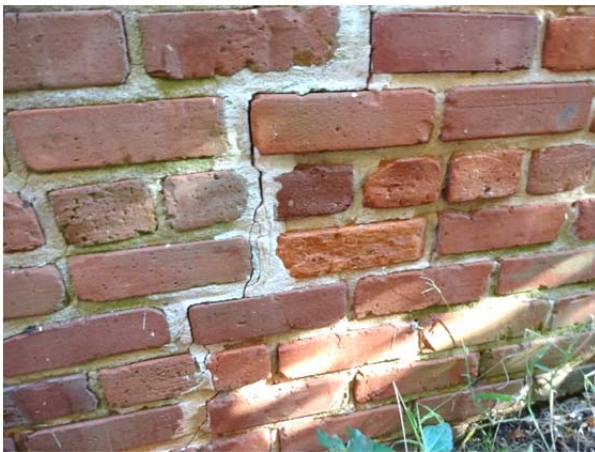
FIGURE 54. Vertical cracking at brick foundation wall.

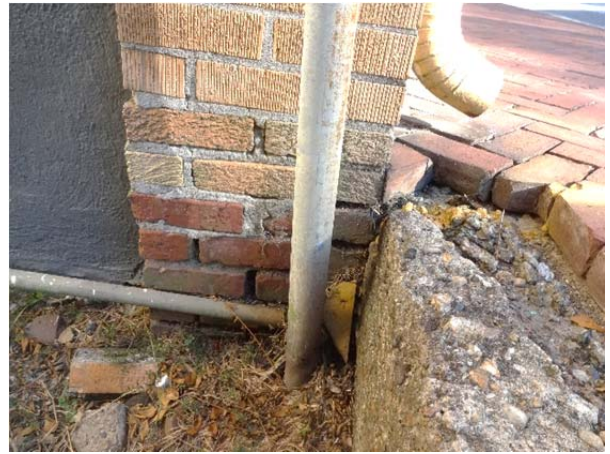
FIGURE 55. Open and exposed joints are located at brick masonry pier.

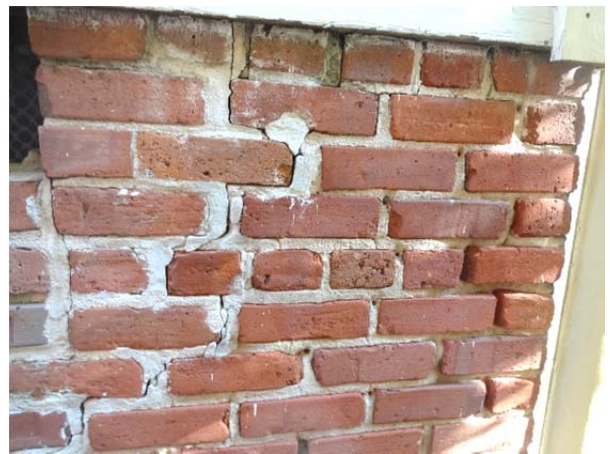
FIGURE 56. Open and exposed joints are located at brick masonry foundation wall.

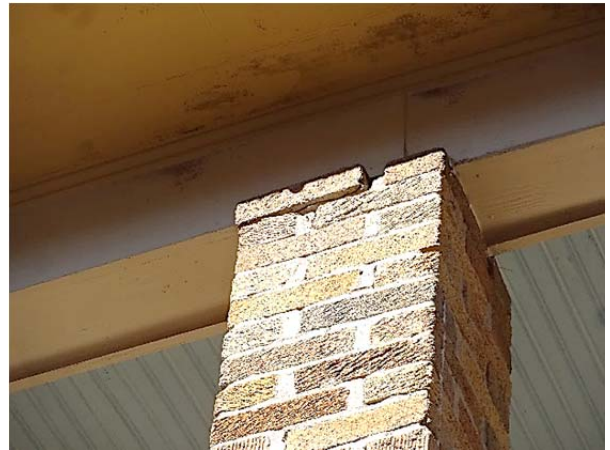
FIGURE 57. Displaced brick unit at top of pier.

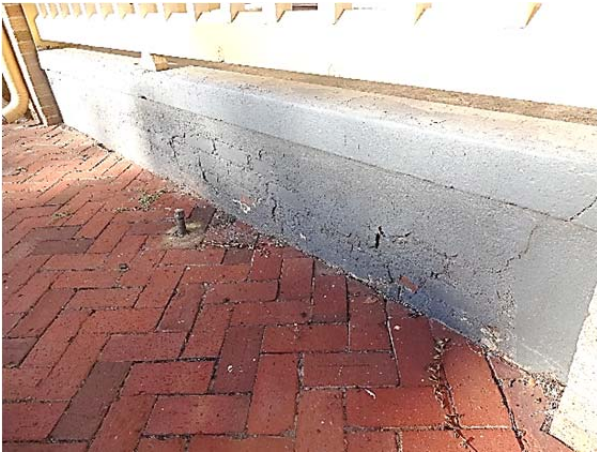
- Missing and debonded parge coating was observed at the brick masonry foundation wall under the front porch (Figure 58). Areas of missing parge coat were located at the south end of the porch. At these areas, some of the brick was exposed to view, and there was evidence of previous repairs to replace the parge coat. The parge coat and exposed brick had been painted grey.
- Non-original penetration openings were observed at the south foundation wall (Figure 59). The penetrations consisted of removal of portions of one brick unit and installation of a flexible duct. There was no waterproofing for the masonry opening or sealant at the perimeter of the duct penetration.

FIGURE 58. Debonded parge coating at front porch foundation.

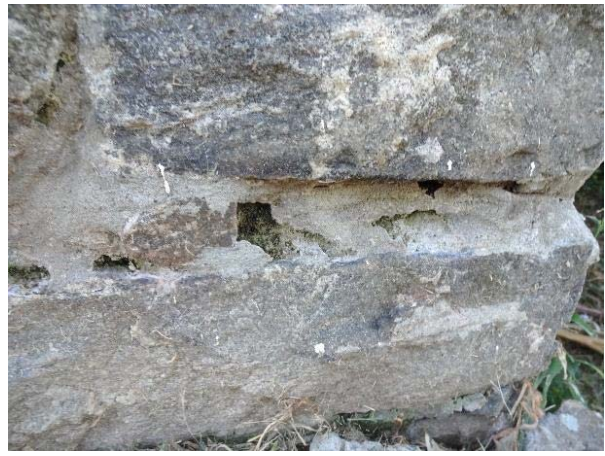
FIGURE 60. Biological growth at joints in foundation wall.

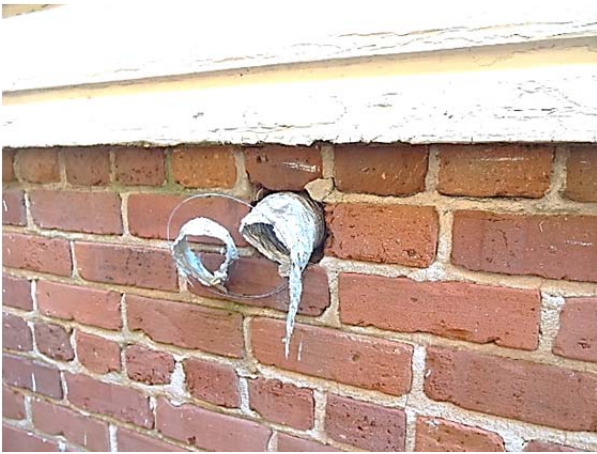
FIGURE 59. Non-original penetration at brick foundation wall.

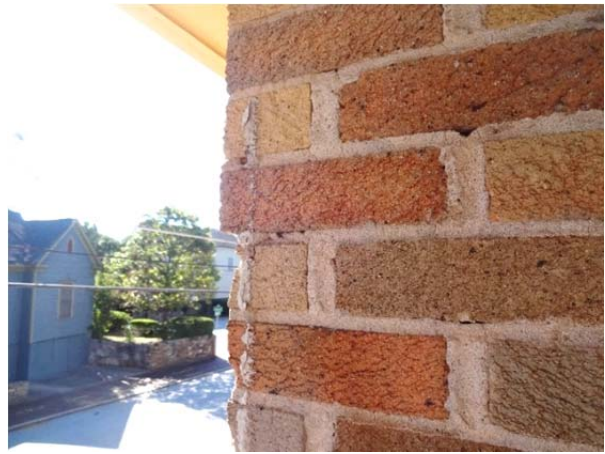
FIGURE 61. Remnants of sealant from previously removed screen wall at front entrance porch.

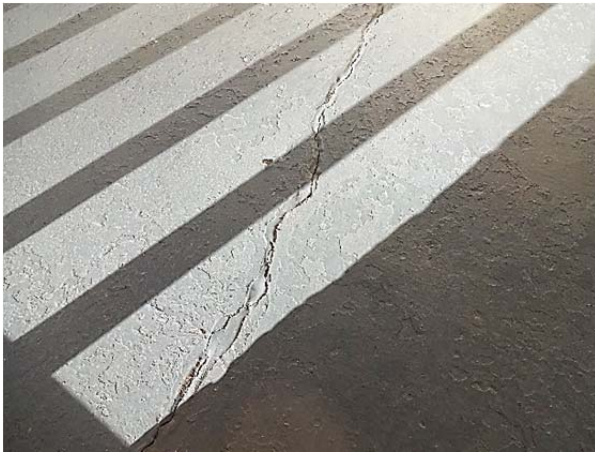
FIGURE 62. Previously repaired crack in concrete deck at front porch deck has failed.

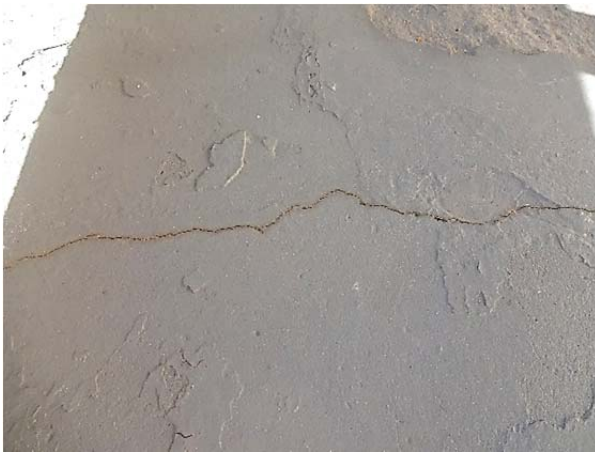
FIGURE 63. Untreated crack in concrete deck at front porch.

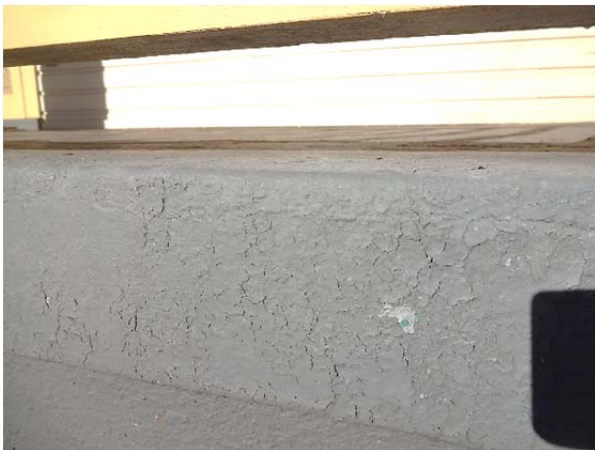
FIGURE 64. Peeling and flaking paint on concrete at front porch.

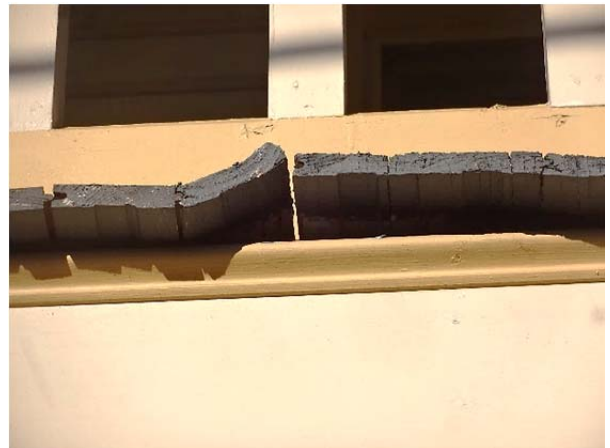
FIGURE 65. Twisted and buckling wood deck boards at front porch.

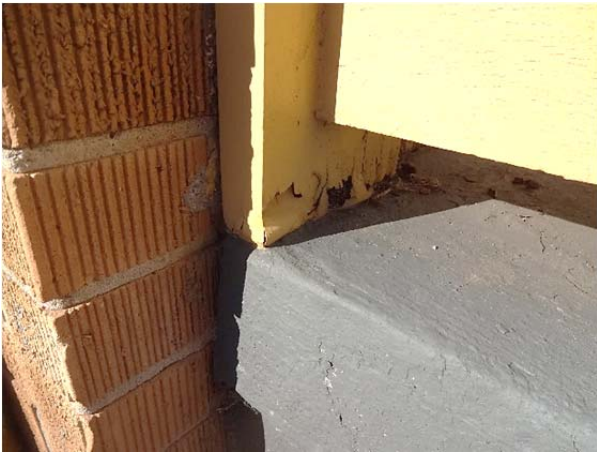
FIGURE 66. Deteriorated wood adjacent to brick piers and concrete decking at front porch.

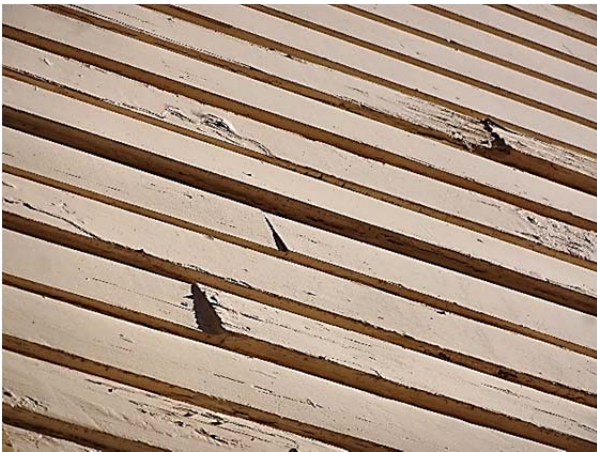
FIGURE 67. Twisting of wood cladding was most pronounced the ends of the boards.

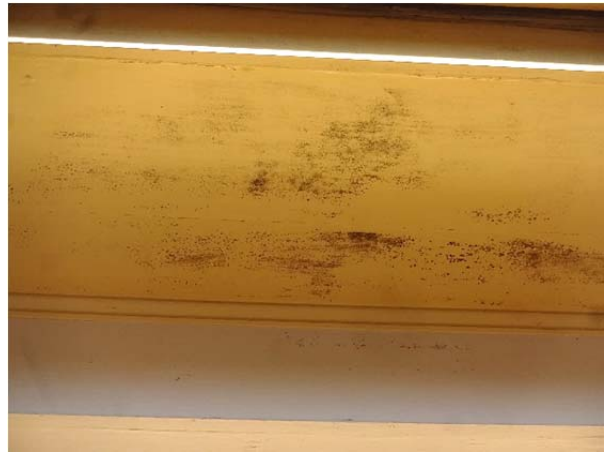
FIGURE 69. Biological growth on the underside of box beams at the front porch.

- Biological growth was observed on the wood on the underside of the box-framed beam at the front porch (Figure 69). The growth had a splotchy appearance and was black in color.
- Open joints were observed between some of the bead-board ceiling boards (Figure 70). Where present, the joints were typically 1/8 inch wide and the paint coating was cracked.
- Cracking, debonding, and peeling of paint were observed at the wood siding, trim, and underside of the decking at the overhanging eaves (Figure 71). The pattern of peeling paint typically followed the graining on the boards. At these locations, some of the wood was exposed to view. The paint failure may be related to poor surface preparation.

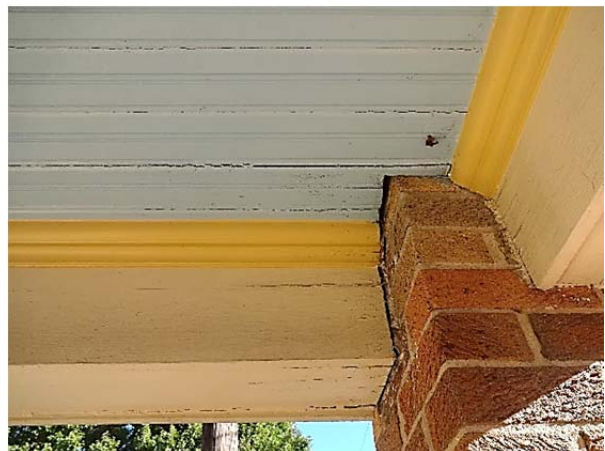
FIGURE 70. Open and displaced bead boards at the first-floor ceiling of the front porch.

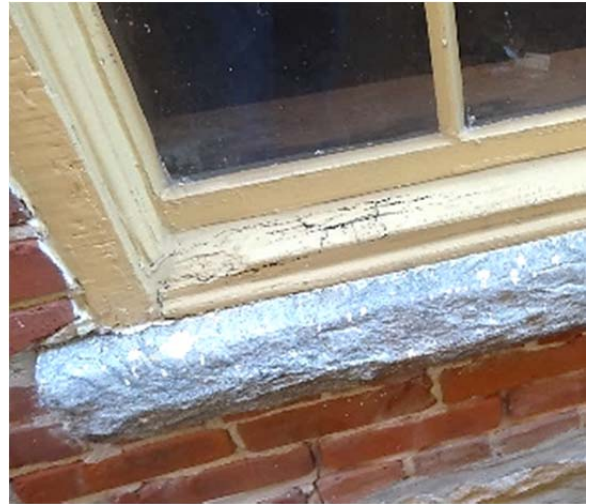
FIGURE 73. Deteriorated and decayed wood at basement windowsill.

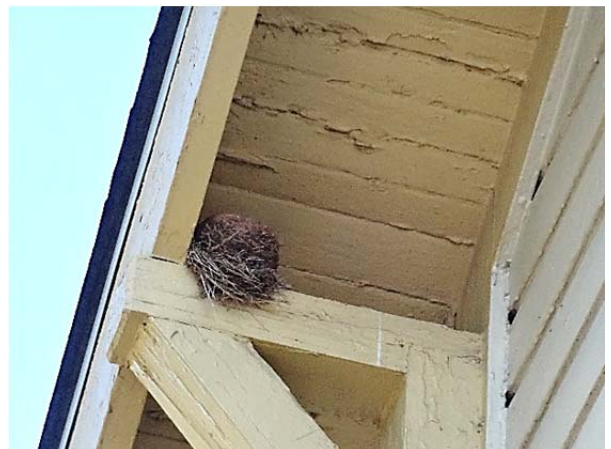
FIGURE 74. Bird's nest at roof bracket and eave.

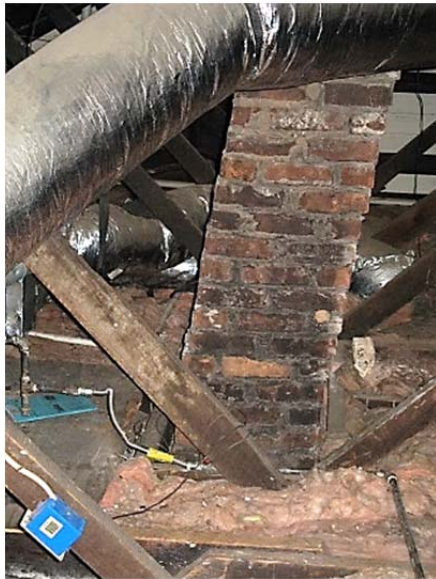
FIGURE 114. Curvature at chimney.

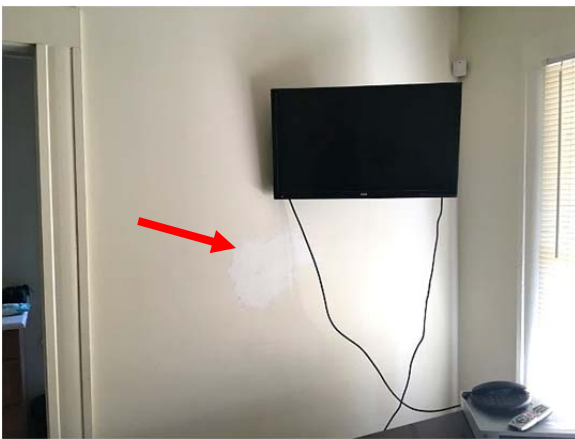
FIGURE 117. Patch at living room wall.

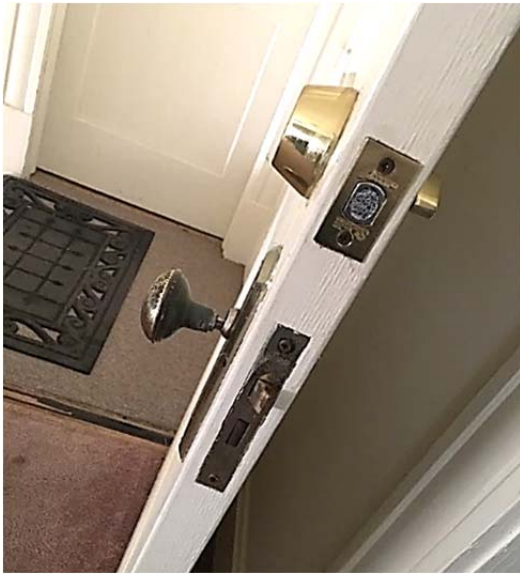
FIGURE 118. Typical non-original hardware at entrance doors. Knobs are loose and / or missing due to wear and deterioration.

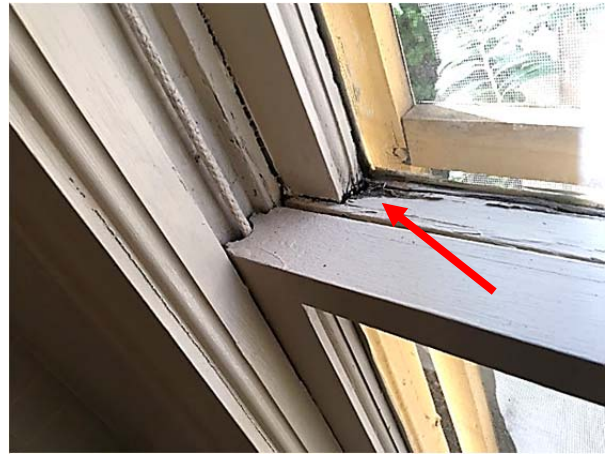
FIGURE 121. Moisture damage at interior of window sash.

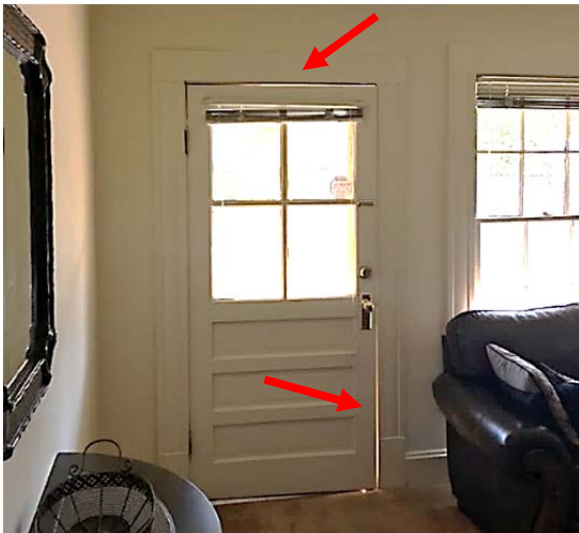
FIGURE 119. Air gaps at perimeter of exterior door.

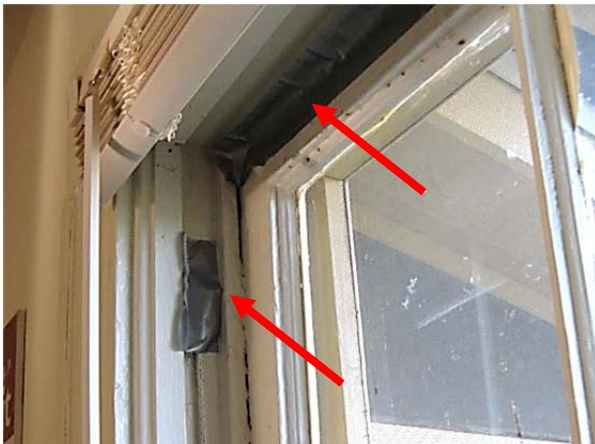
FIGURE 120. Tape covering points of air infiltration at perimeter of sash.

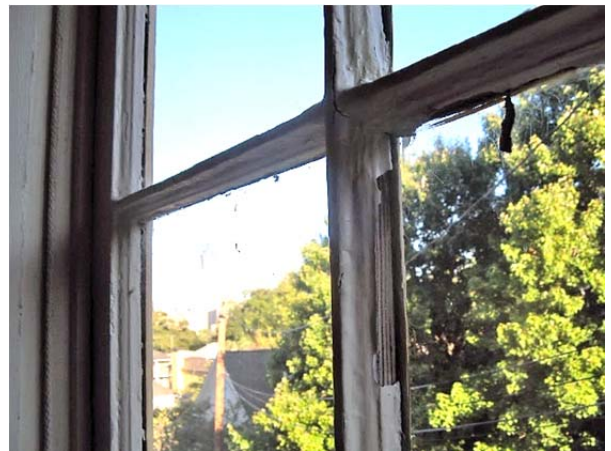
FIGURE 123. Paint delamination at muntin.

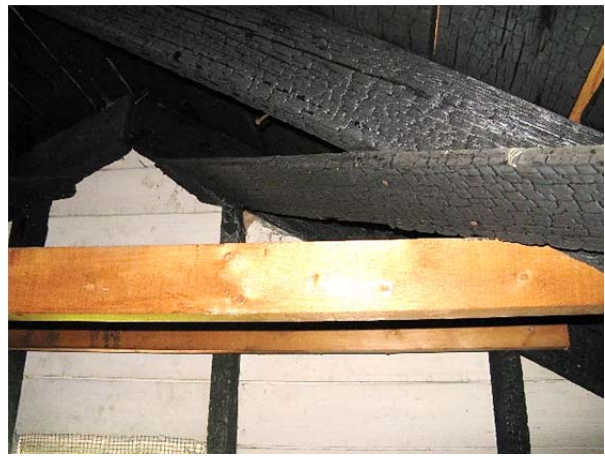
FIGURE 133. Severe fire damage at diagonal cross bracing at north end gable roof framing.

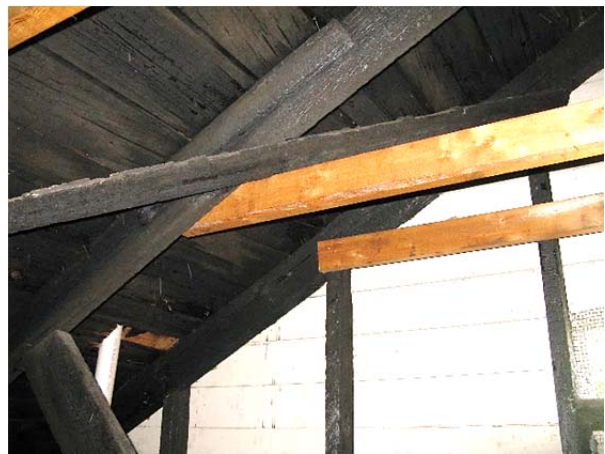
FIGURE 134. Fire damage observed at wood rafters at north end of roof.

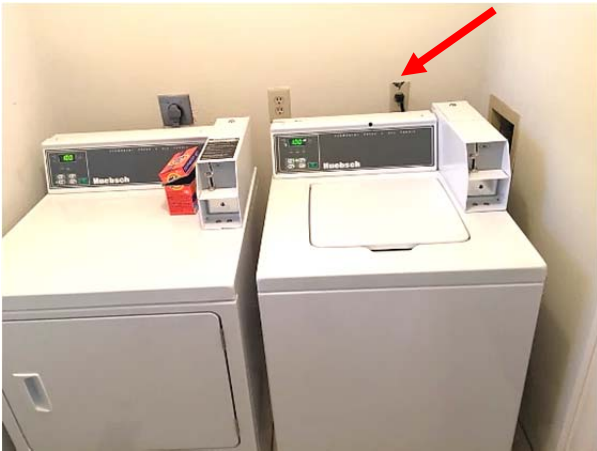
FIGURE 138. Broken face plate at washer receptacle adjacent to washing machine water and drain outlet box.
