historic structure report
architectural data section
volume 1
june 1985

HISTORIC STRUCTURE REPORT

LINDENWALD

MARTIN VAN BUREN NATIONAL HISTORIC SITE

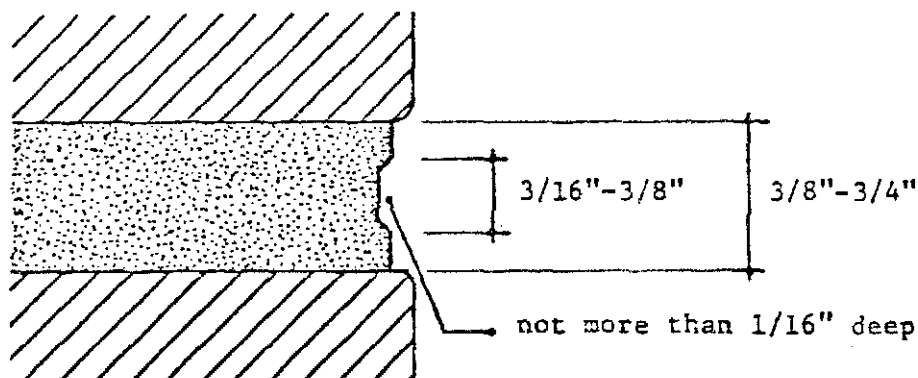
The 1797 mortar joints are tooled and ruled to create the profile shown below:

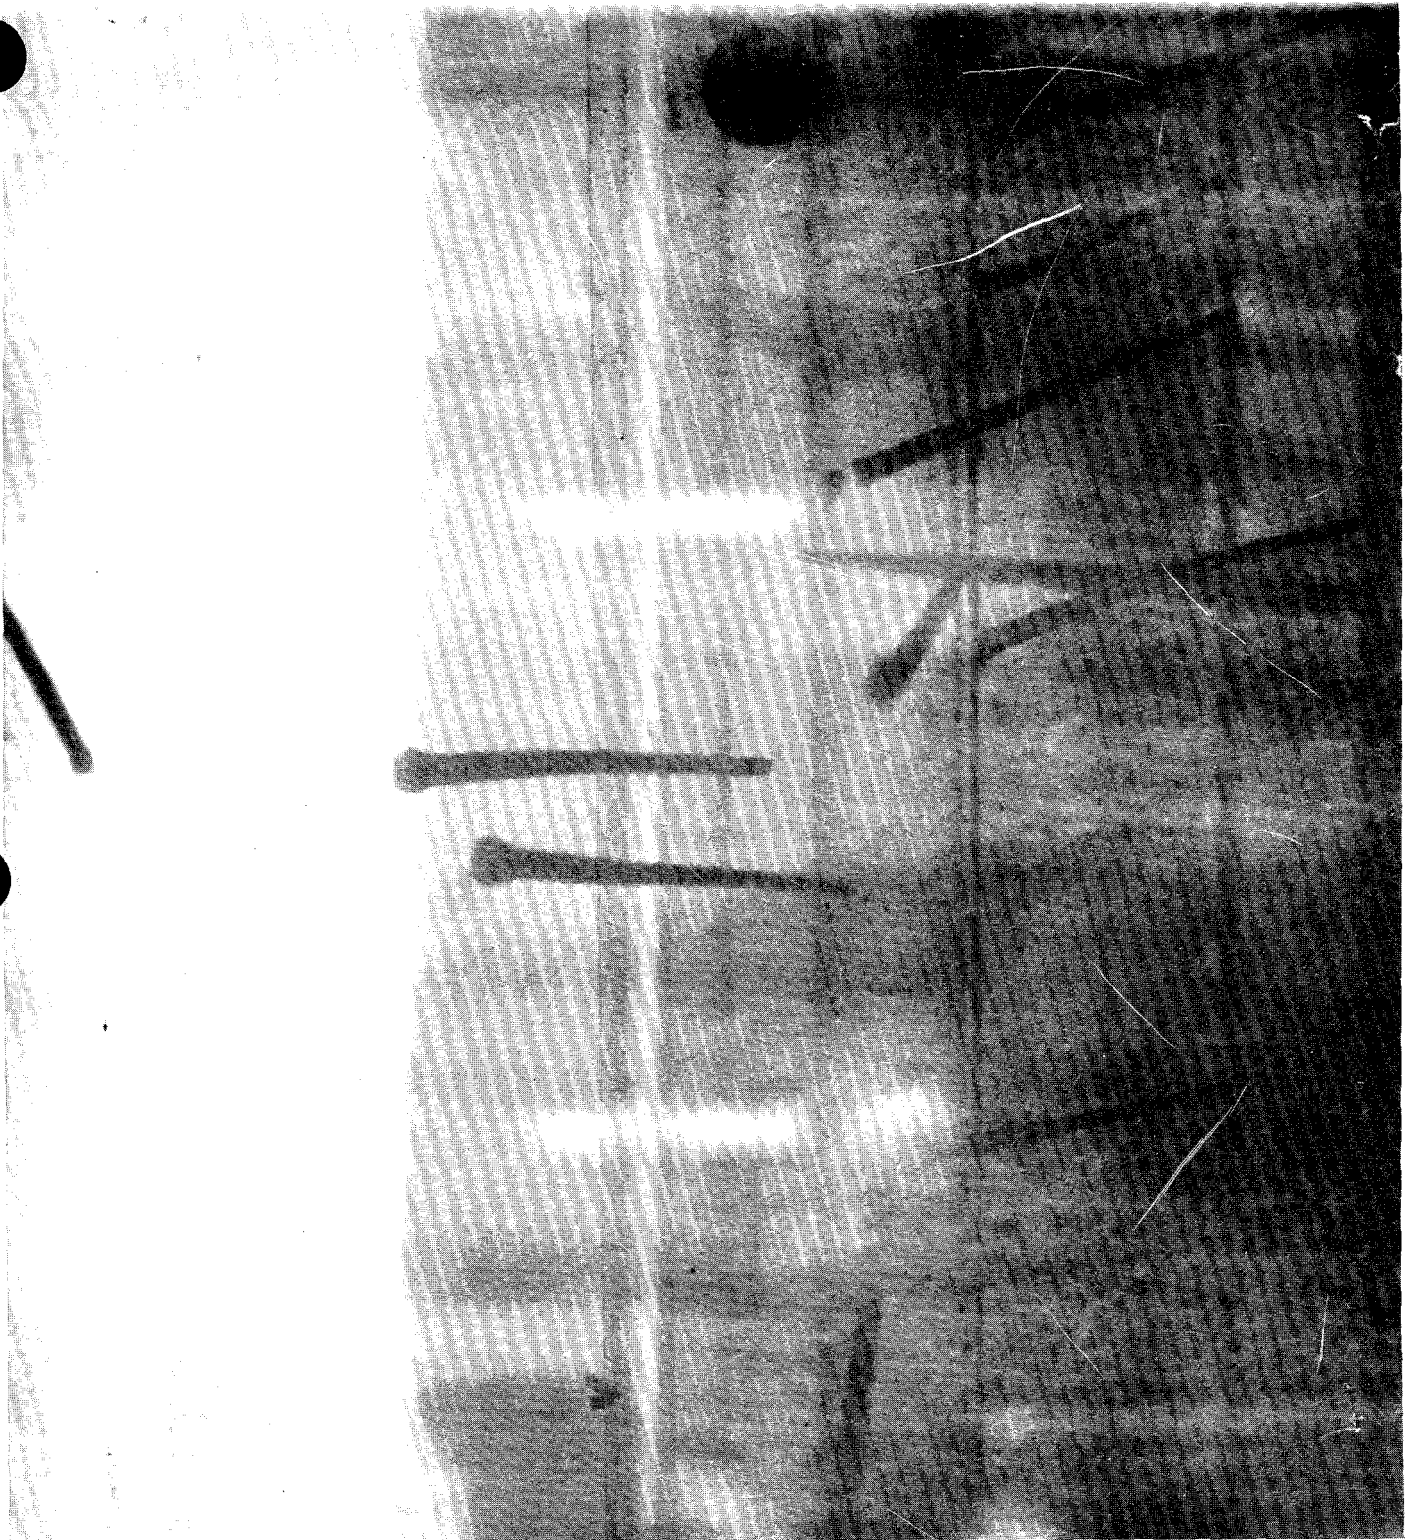
MAVA 01 X001

Room 105, south wall, east jamb of door 130, looking south 36" above the floor.

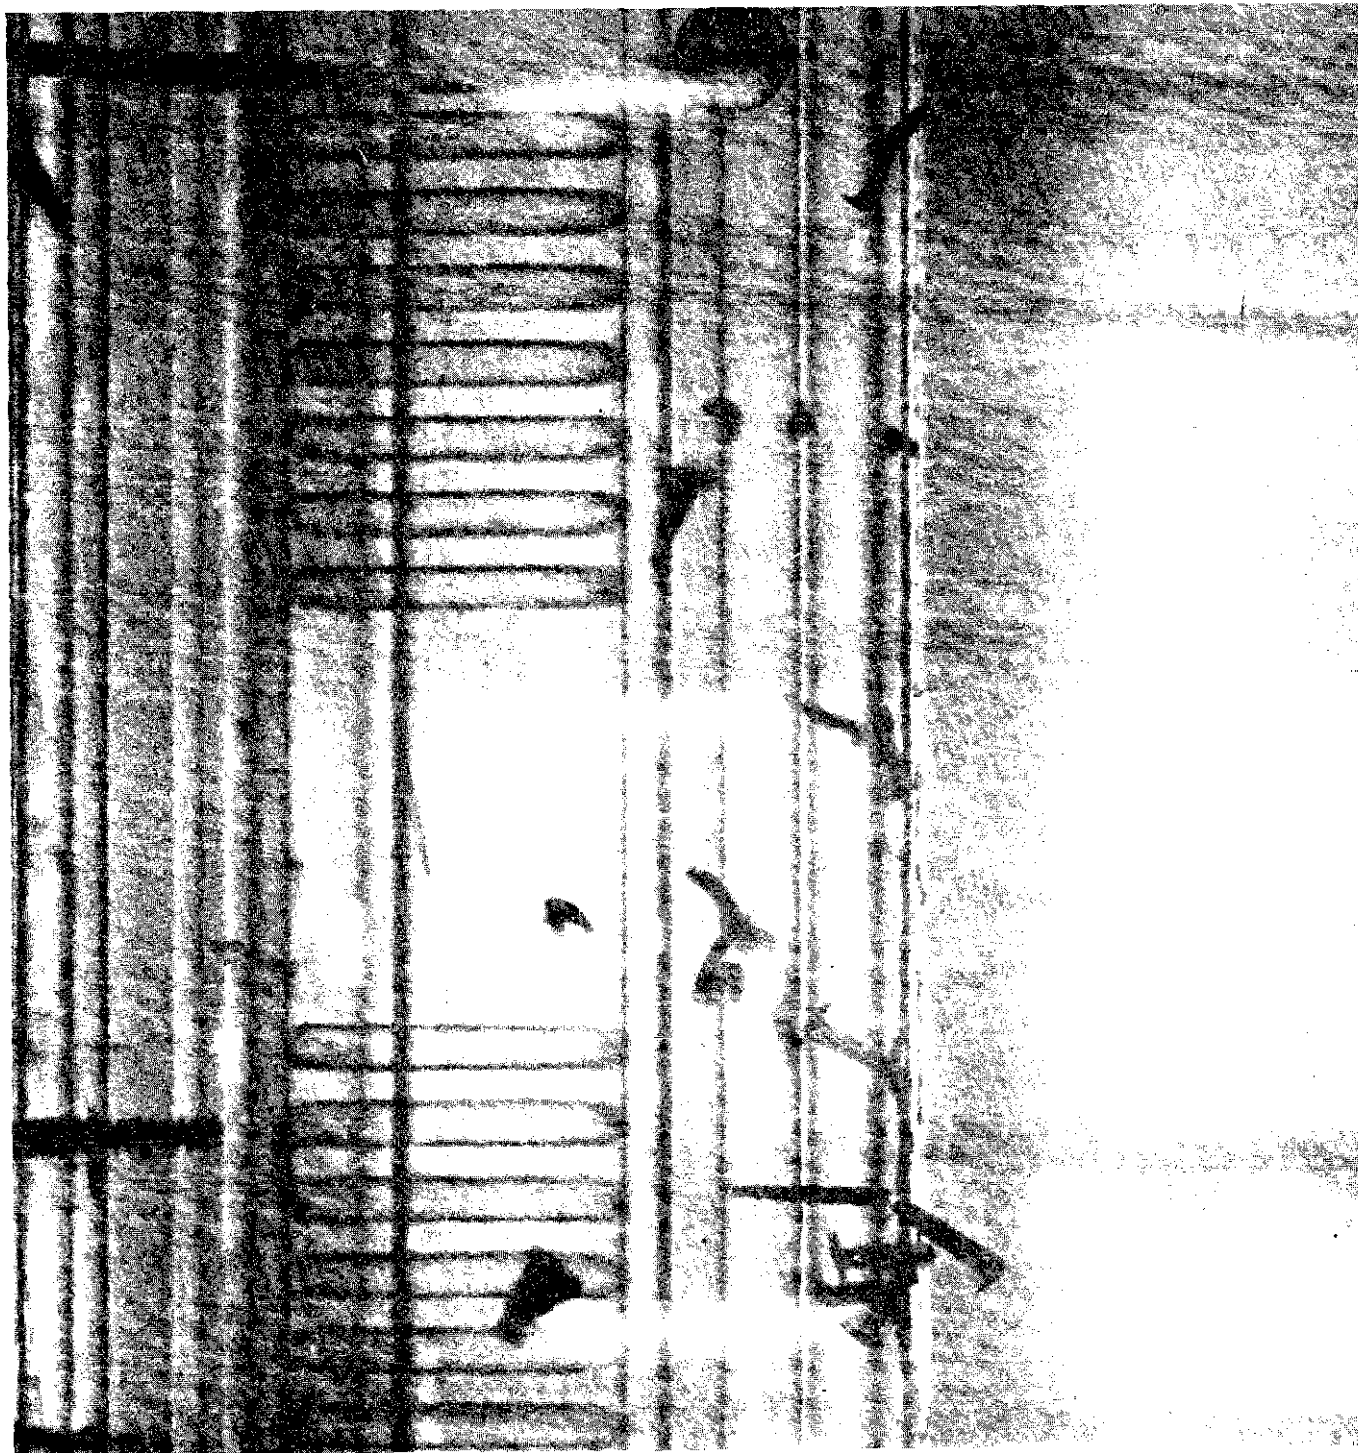
MAVA 01 X002
Room 106, door 136, east jamb, looking north 3/4" above the floor.

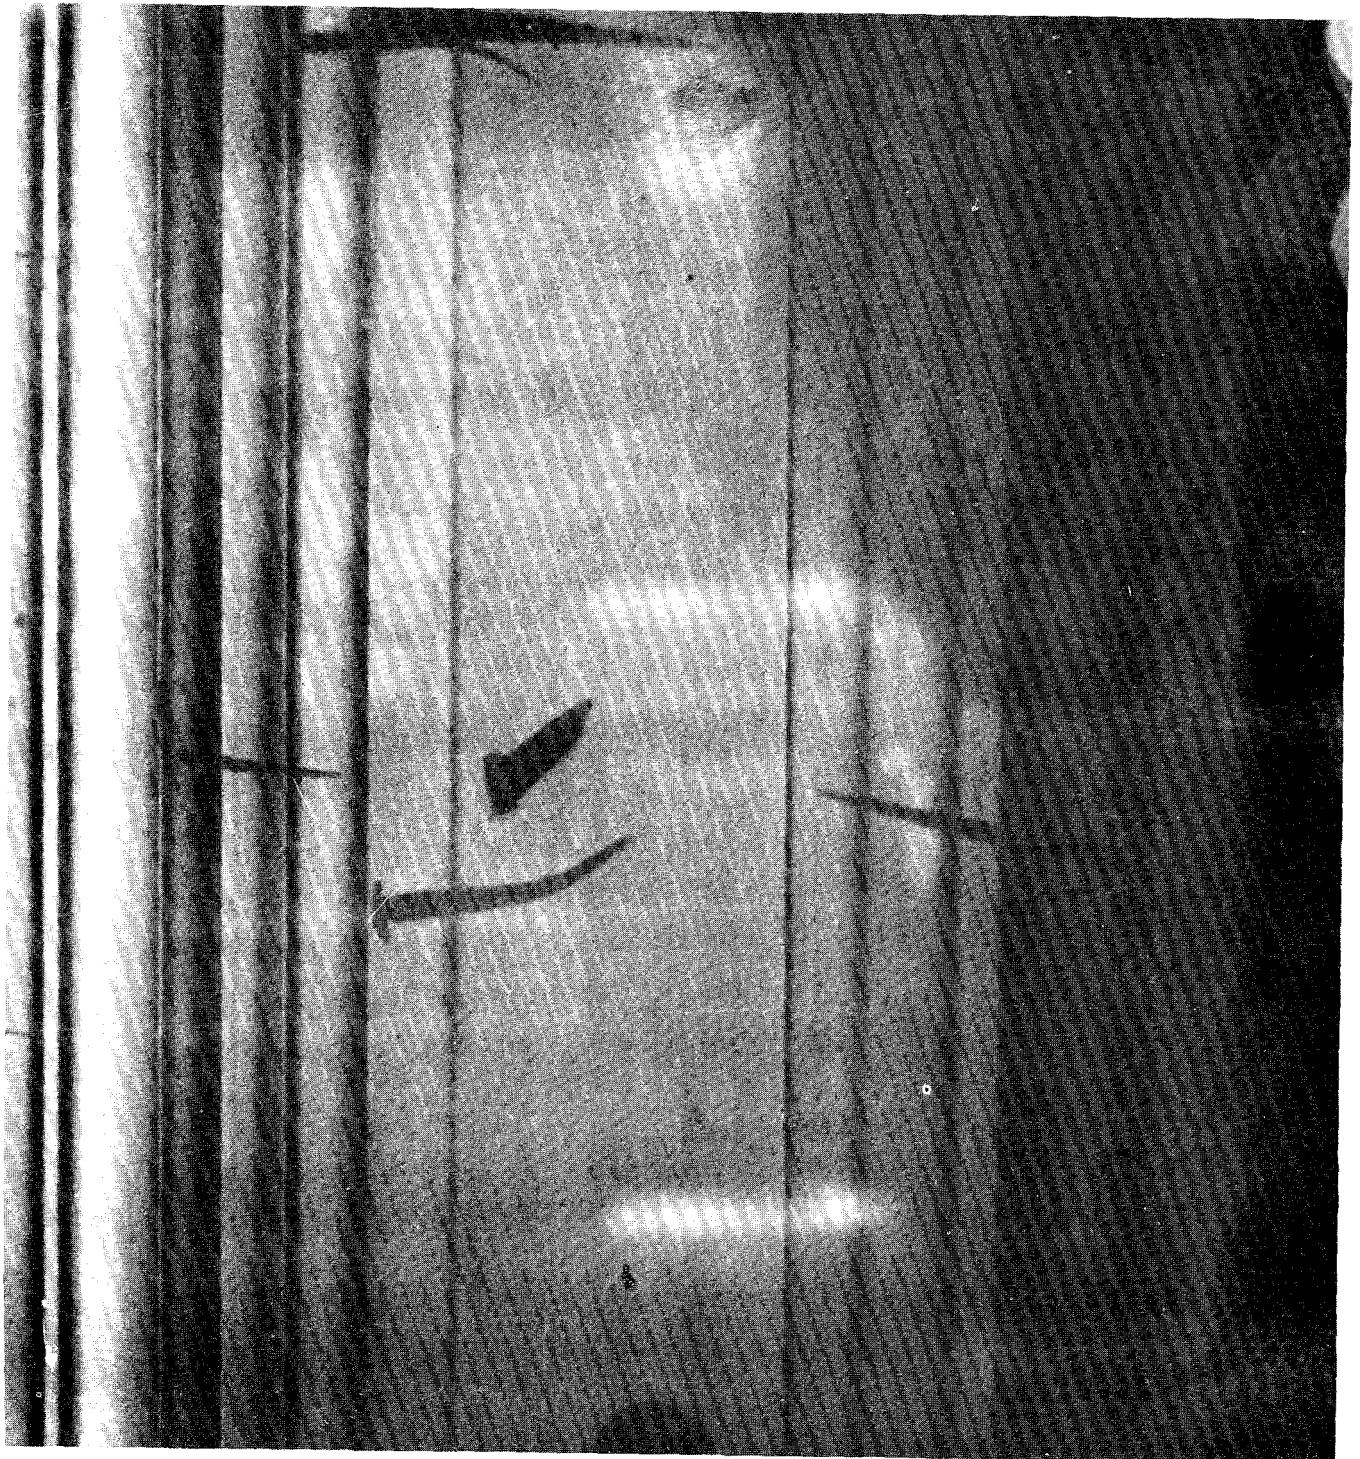
MAVA 01 X003
Room 106, west wall, looking west 3'4" above the floor.

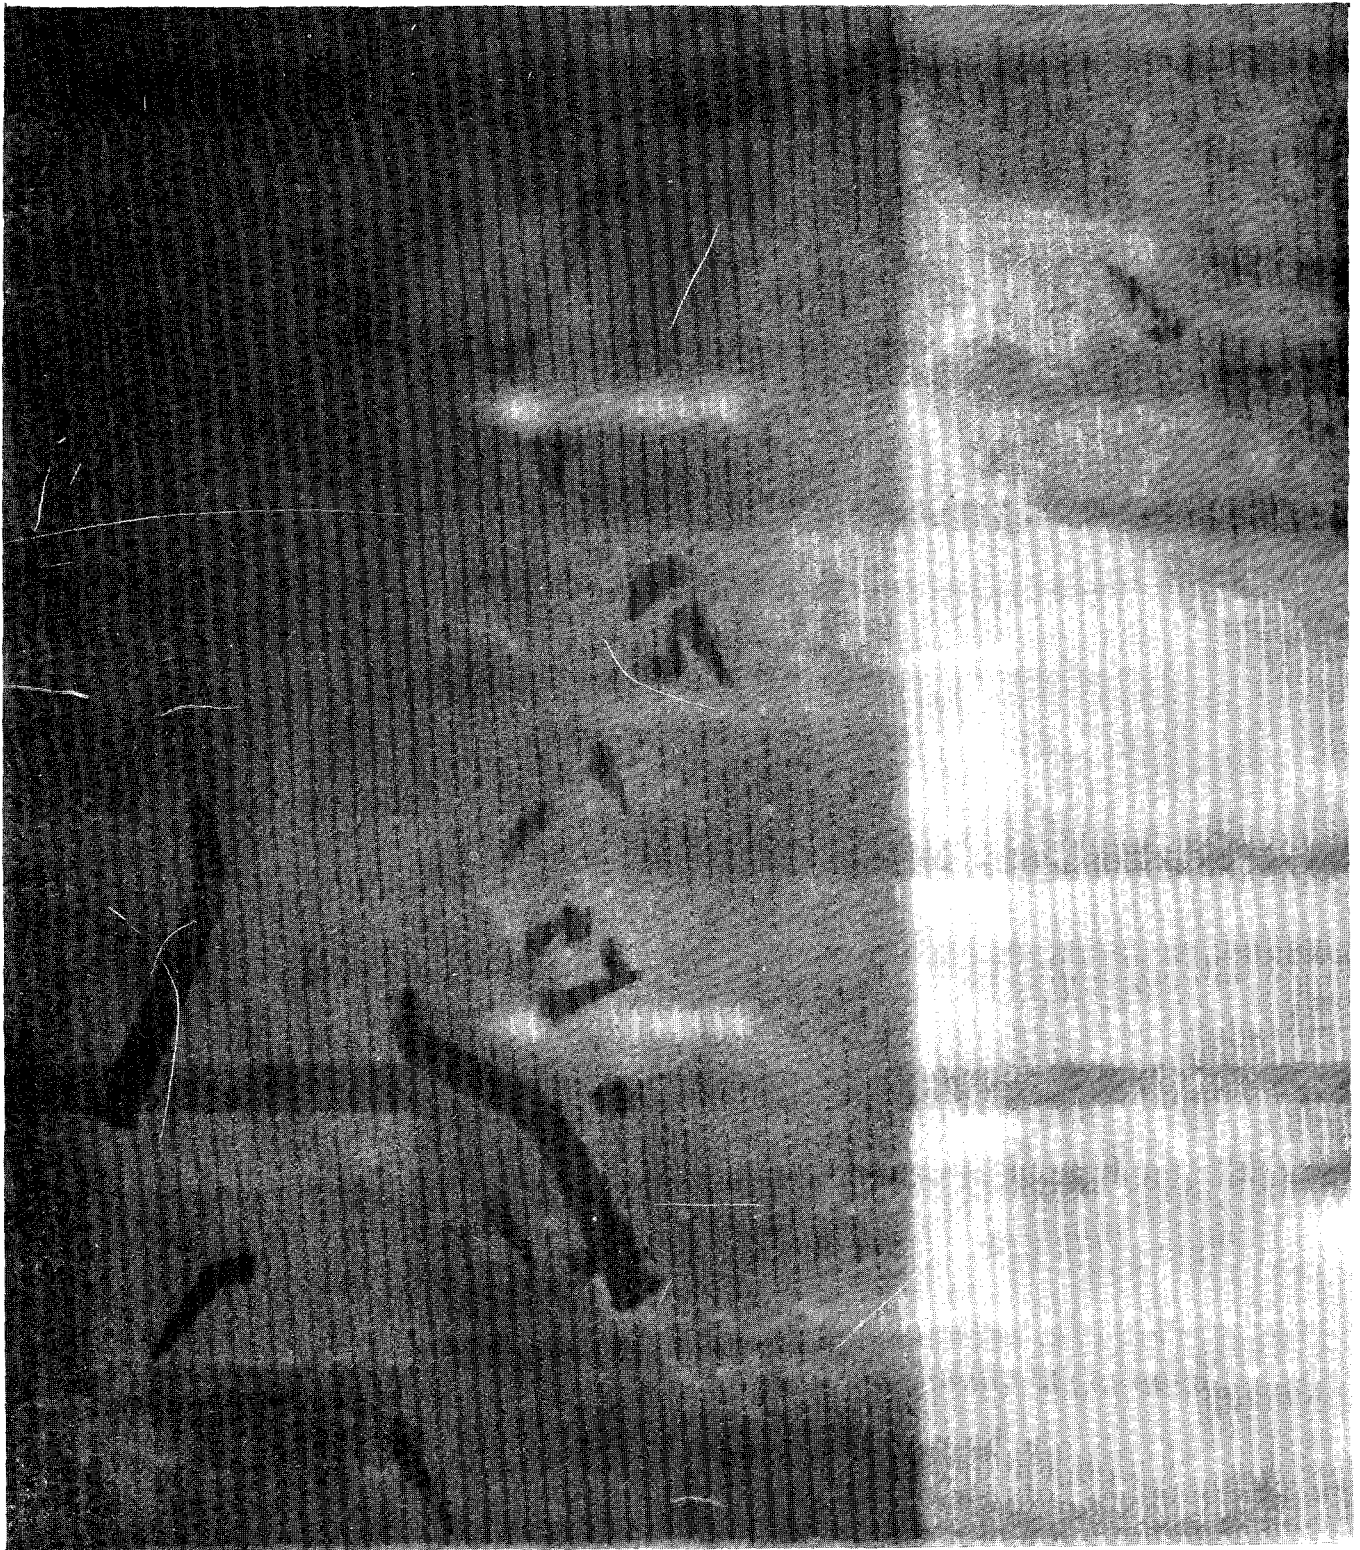
MAVA 01 X013

Room 208, north wall, ghost of door opening, looking north 2'10" above the floor.
