historic structure report
architectural data section
volume 2: appendixes

MARTIN VAN BUREN

NATIONAL HISTORIC SITE / NEW YORK

LINDENWALD

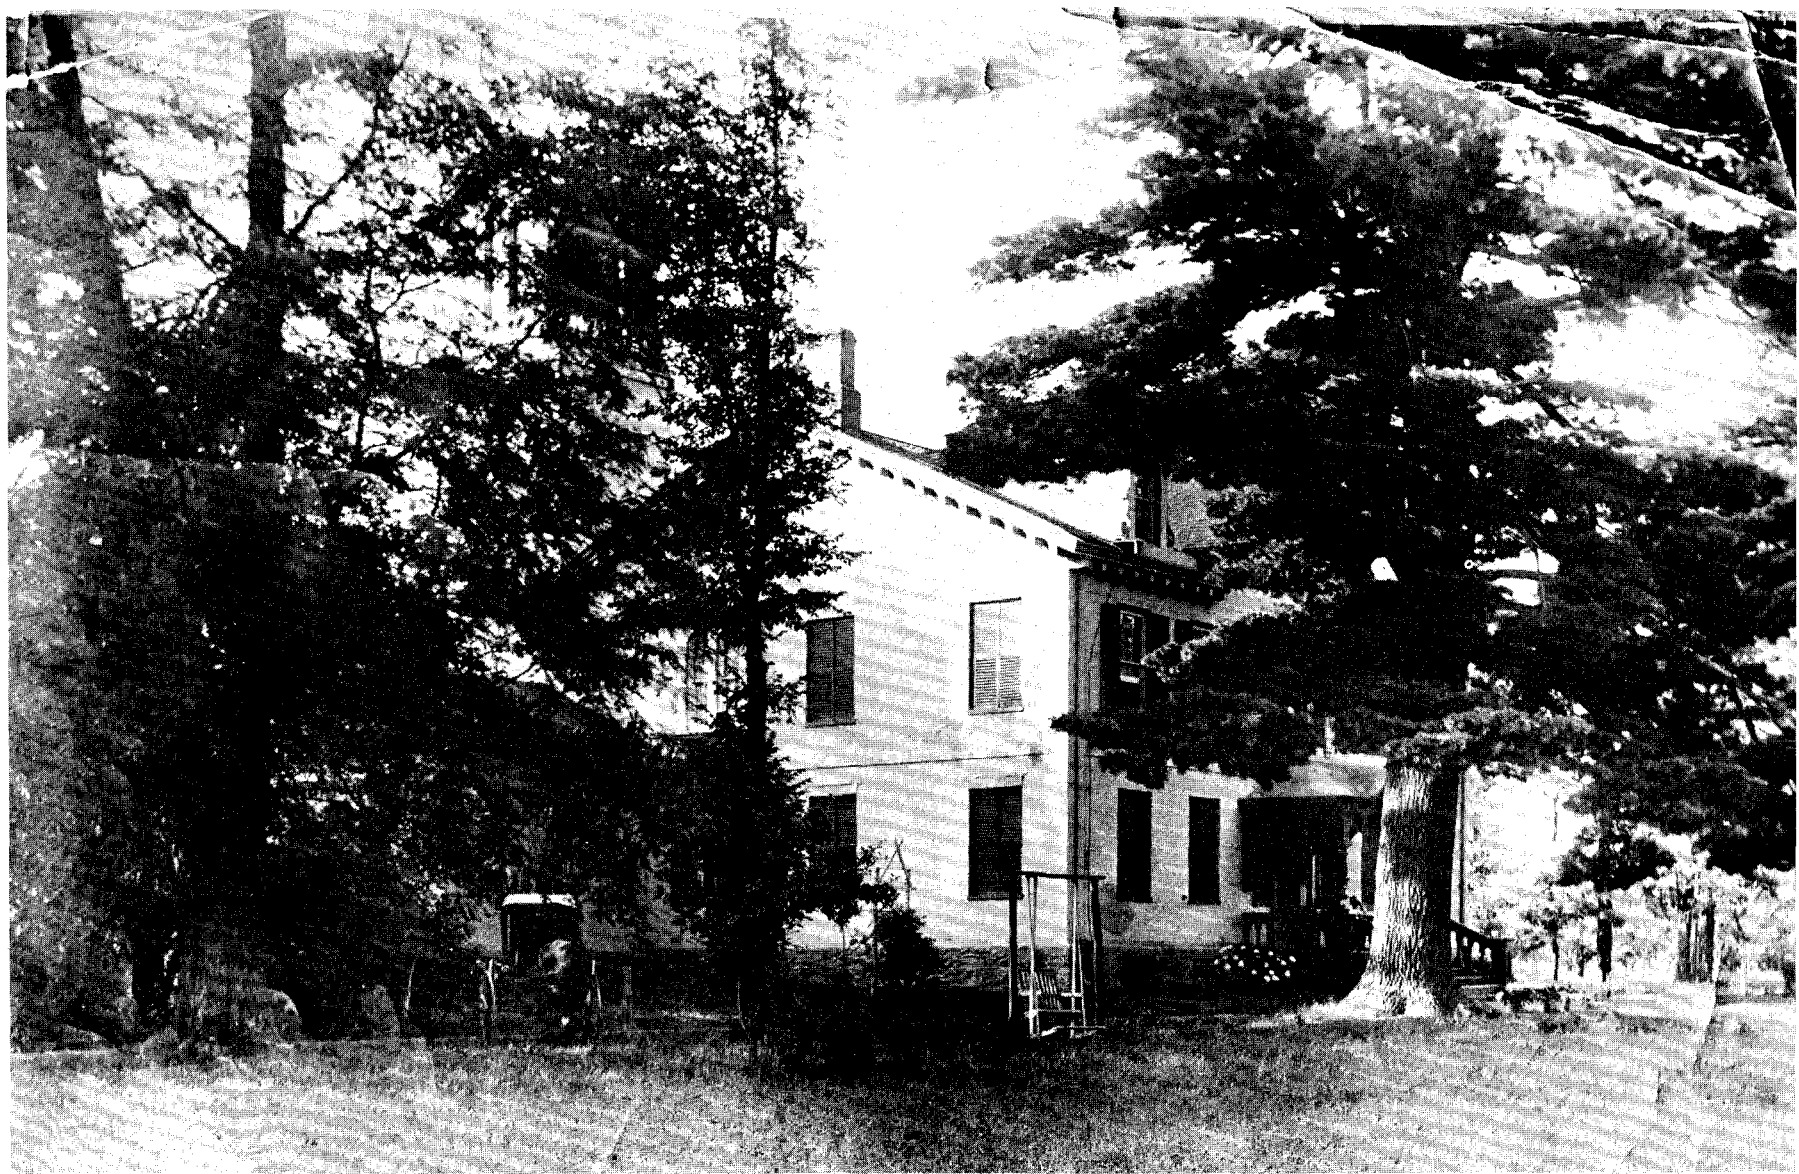
HP8. Lindenwald, ca. 1910-1917. This photograph is dated ca. 1910-1917 on the basis of the growth of the small foreground tree compared to HP6 and the presence of lightning rods compared to HPI8. Note also the following details:

The foundation has been painted so that repointing at the southeast corner is no longer visible. The shutters, window frames, porch, and foundation are a dark tone. The bricks and cornice are painted a lighter tone.

Some of the bricks are loose in the flat arch over window 127.

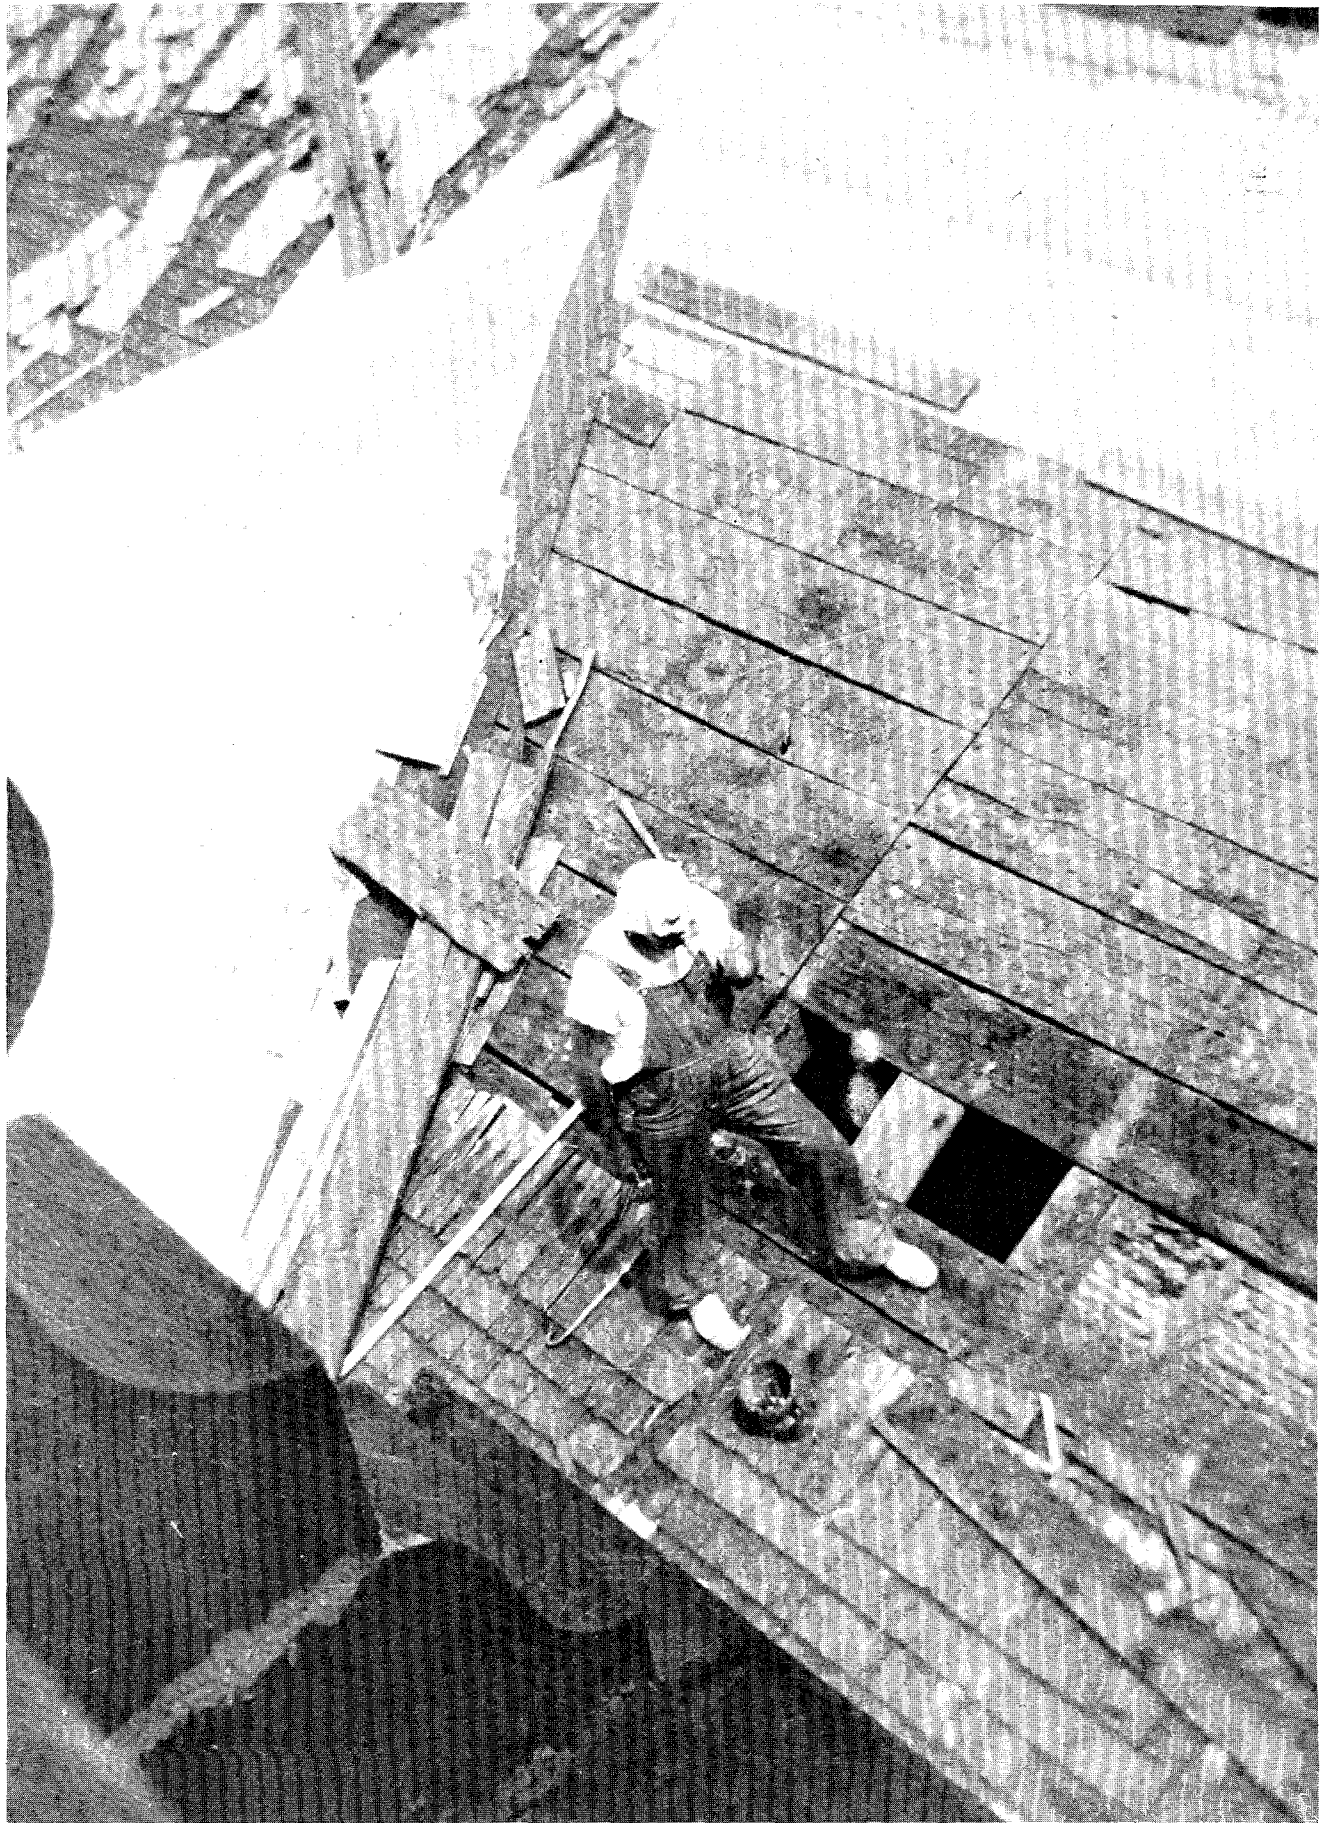
HP14. West Slope of ca. 1797 Roof, ca. 1918-1920. This photograph shows Dr. Bascom Birney removing wood shingles in preparation for the slate roof. Family tradition dates this event to the early years of their ownership of Lindenwald, probably before 1920. Note the following details:

condition of sheathing boards

missing and broken plaster keys over room 307

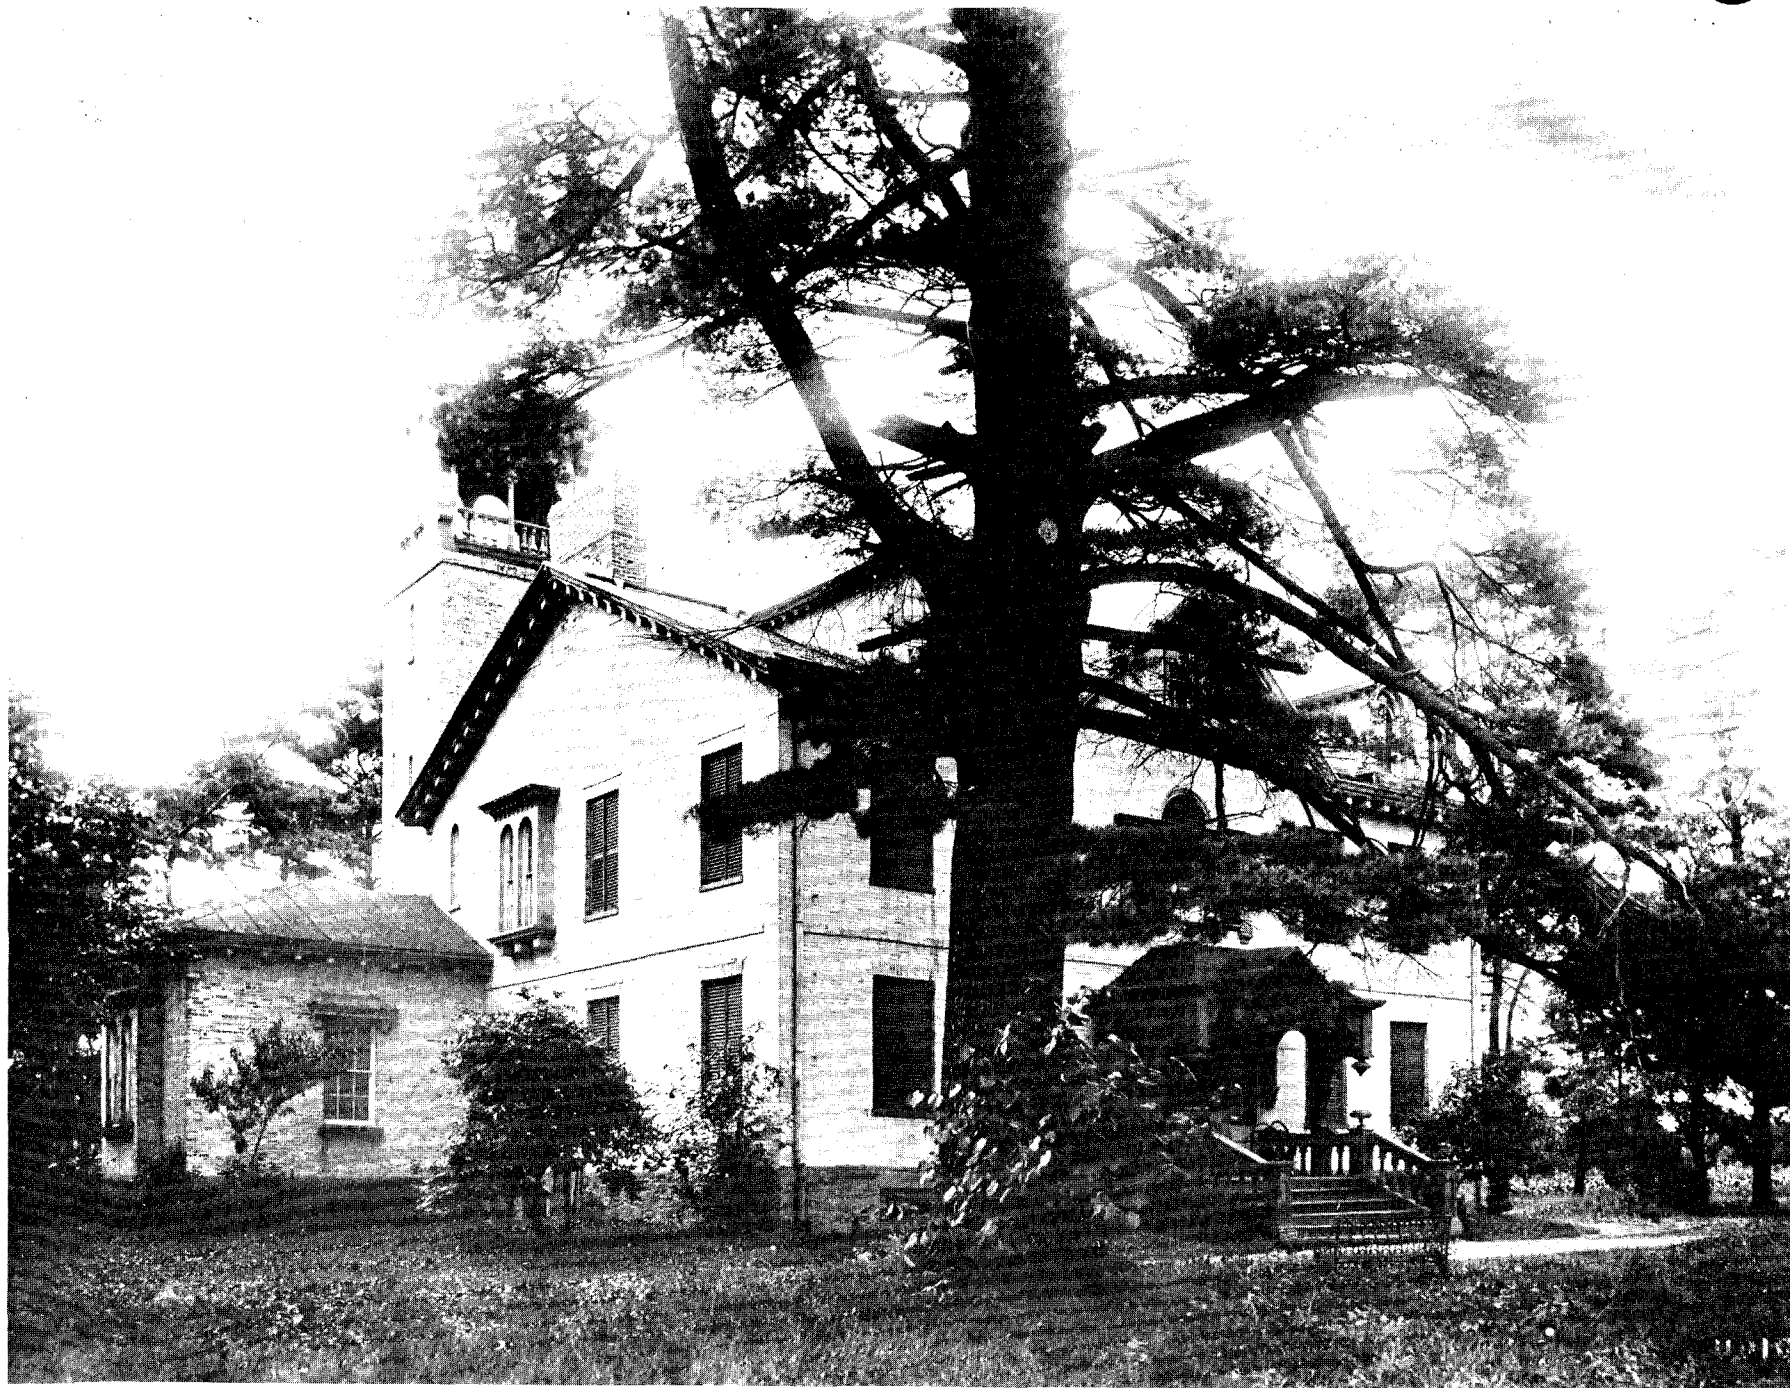
HP18. South and East Facades of Lindenwald, ca. 1917-1925. This photograph is considered to postdate 1917 because the lightning rods are missing from the front of the house and because roofing brackets and a plank are still attached to the roof (indicating that roofing work is still in progress). It is considered to predate 1925 because the tie rod is still in place on the front porch, and shutters are still in place on the Venetian window (see HP22). This photograph was taken by Rowles Studios. The following details should be noted:

The return for the sill at the north dormer is missing.

Bricks are loose in the flat arch over window 127.

Sheet-metal gutters have been added to the south dormer.

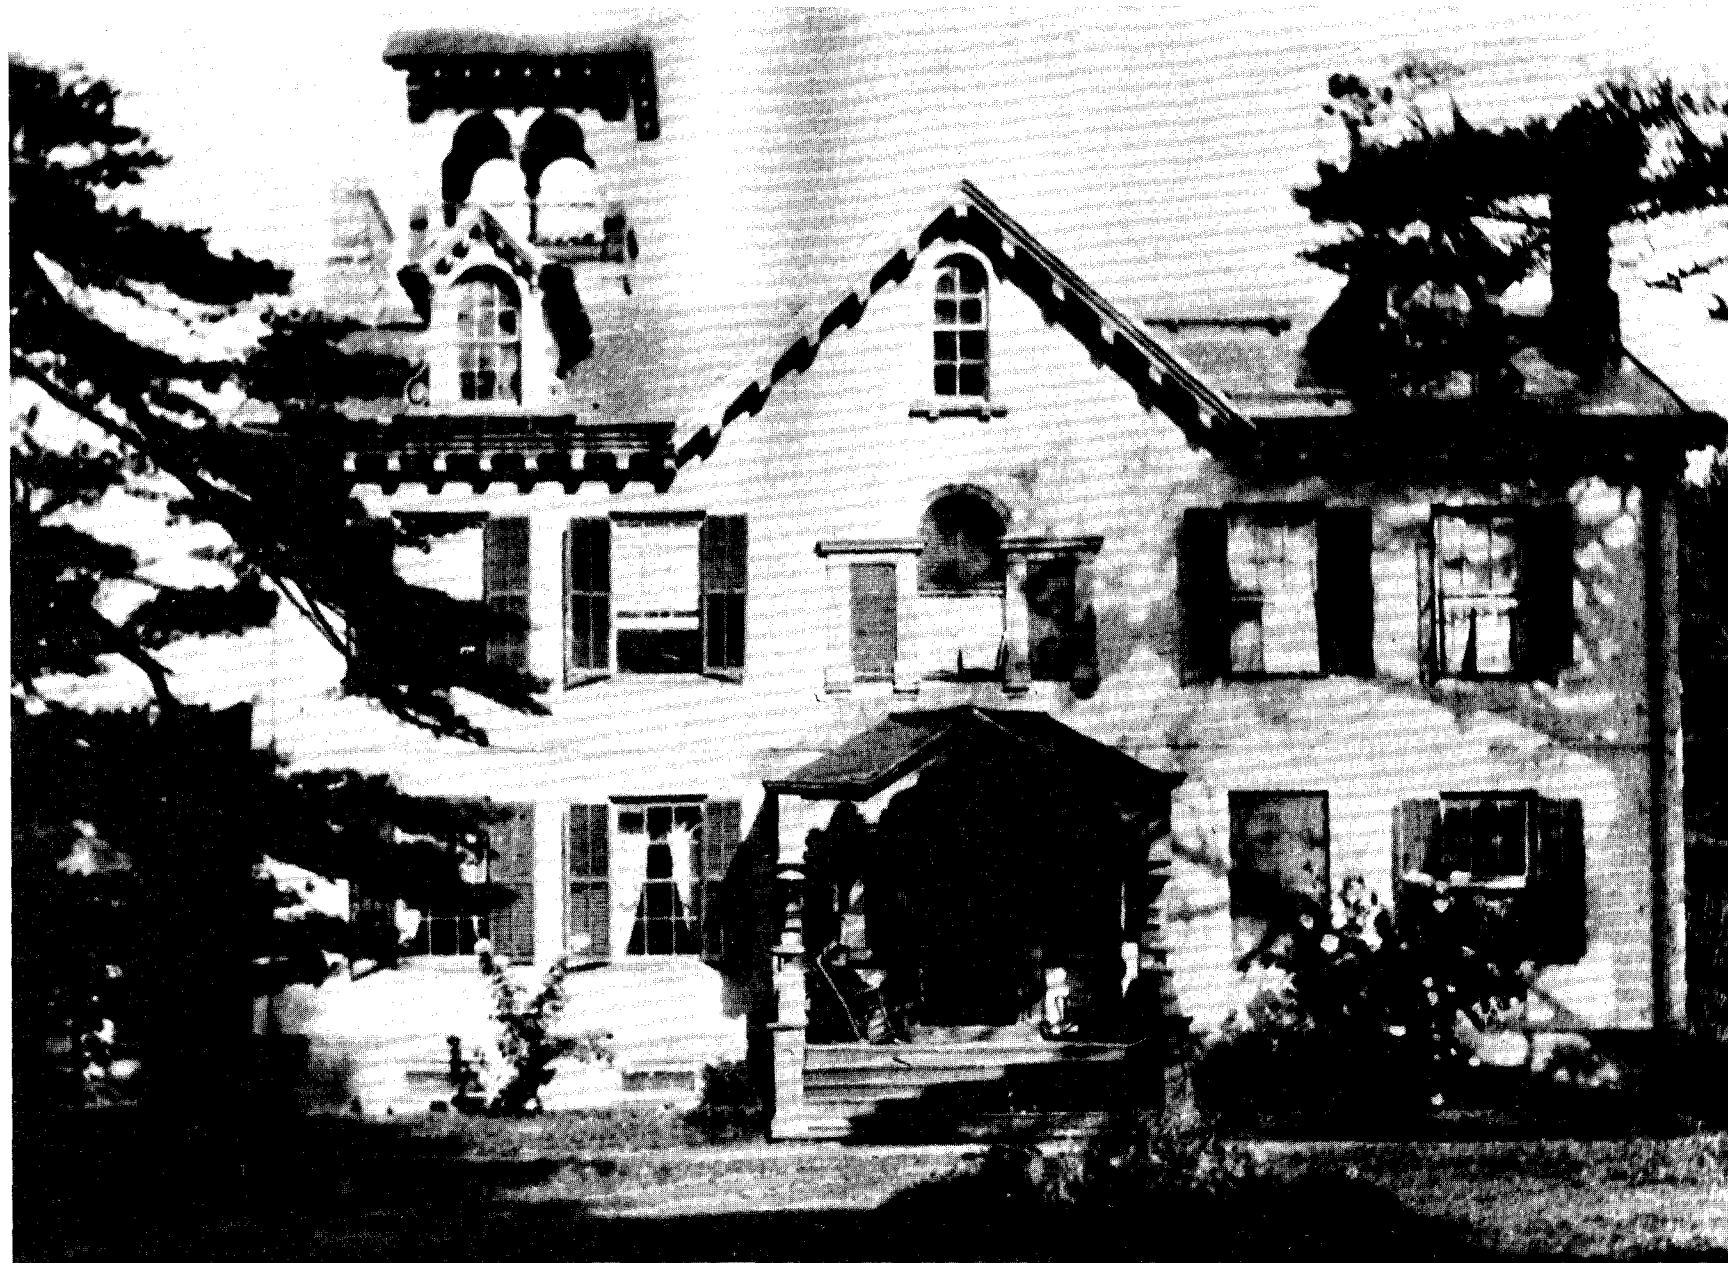
HP20. Lindenwald, ca. 1917-1925. Because of the absence of front lightning rods and the presence of roofing brackets and planks, the tie rod on the front porch, and the shutters on the Venetian window, this photograph is associated with HP18 and assigned the same range of dates. The following details should be noted:

The front board of the sill box under the south dormer is missing.

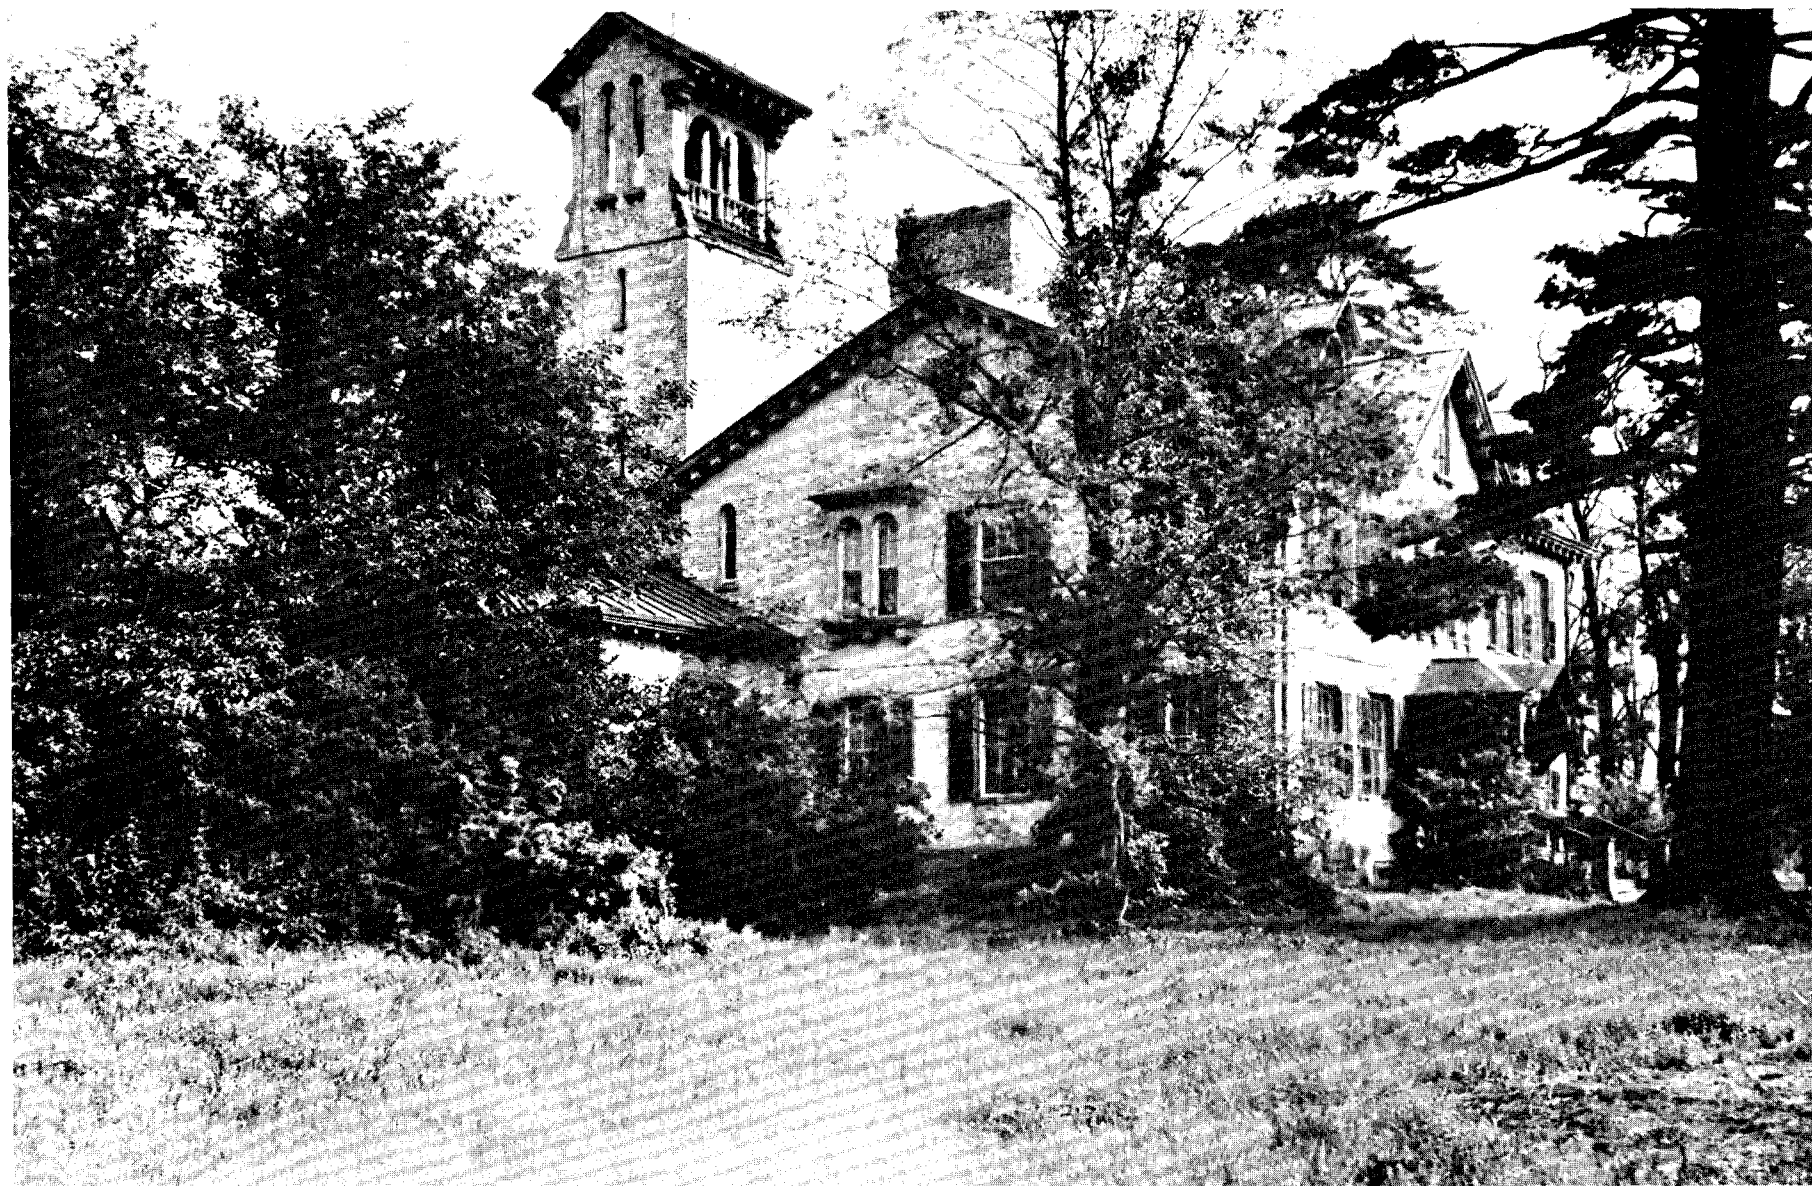
HP23. South and East Sides of Lindenwald, 1936. This photograph was taken by Melvin Weig, National Park Service historian, on August 3, 1936. This date is documented in the captions of all the photographs in his report "'Lindenwald,' the President Martin Van Buren Homestead, near Kinderhook, New York" dated November 3, 1936. The following details should be noted:

Some bricks are missing from the cap of the south chimney.

The light paint on the brickwork is very weathered and most brick courses on the south elevation can be seen. Sash has also been painted a light tone, but now the cornice appears to be a dark tone. Foundations, window frames, and the front porch are painted a dark tone. Shutters appear to be painted an even darker tone.

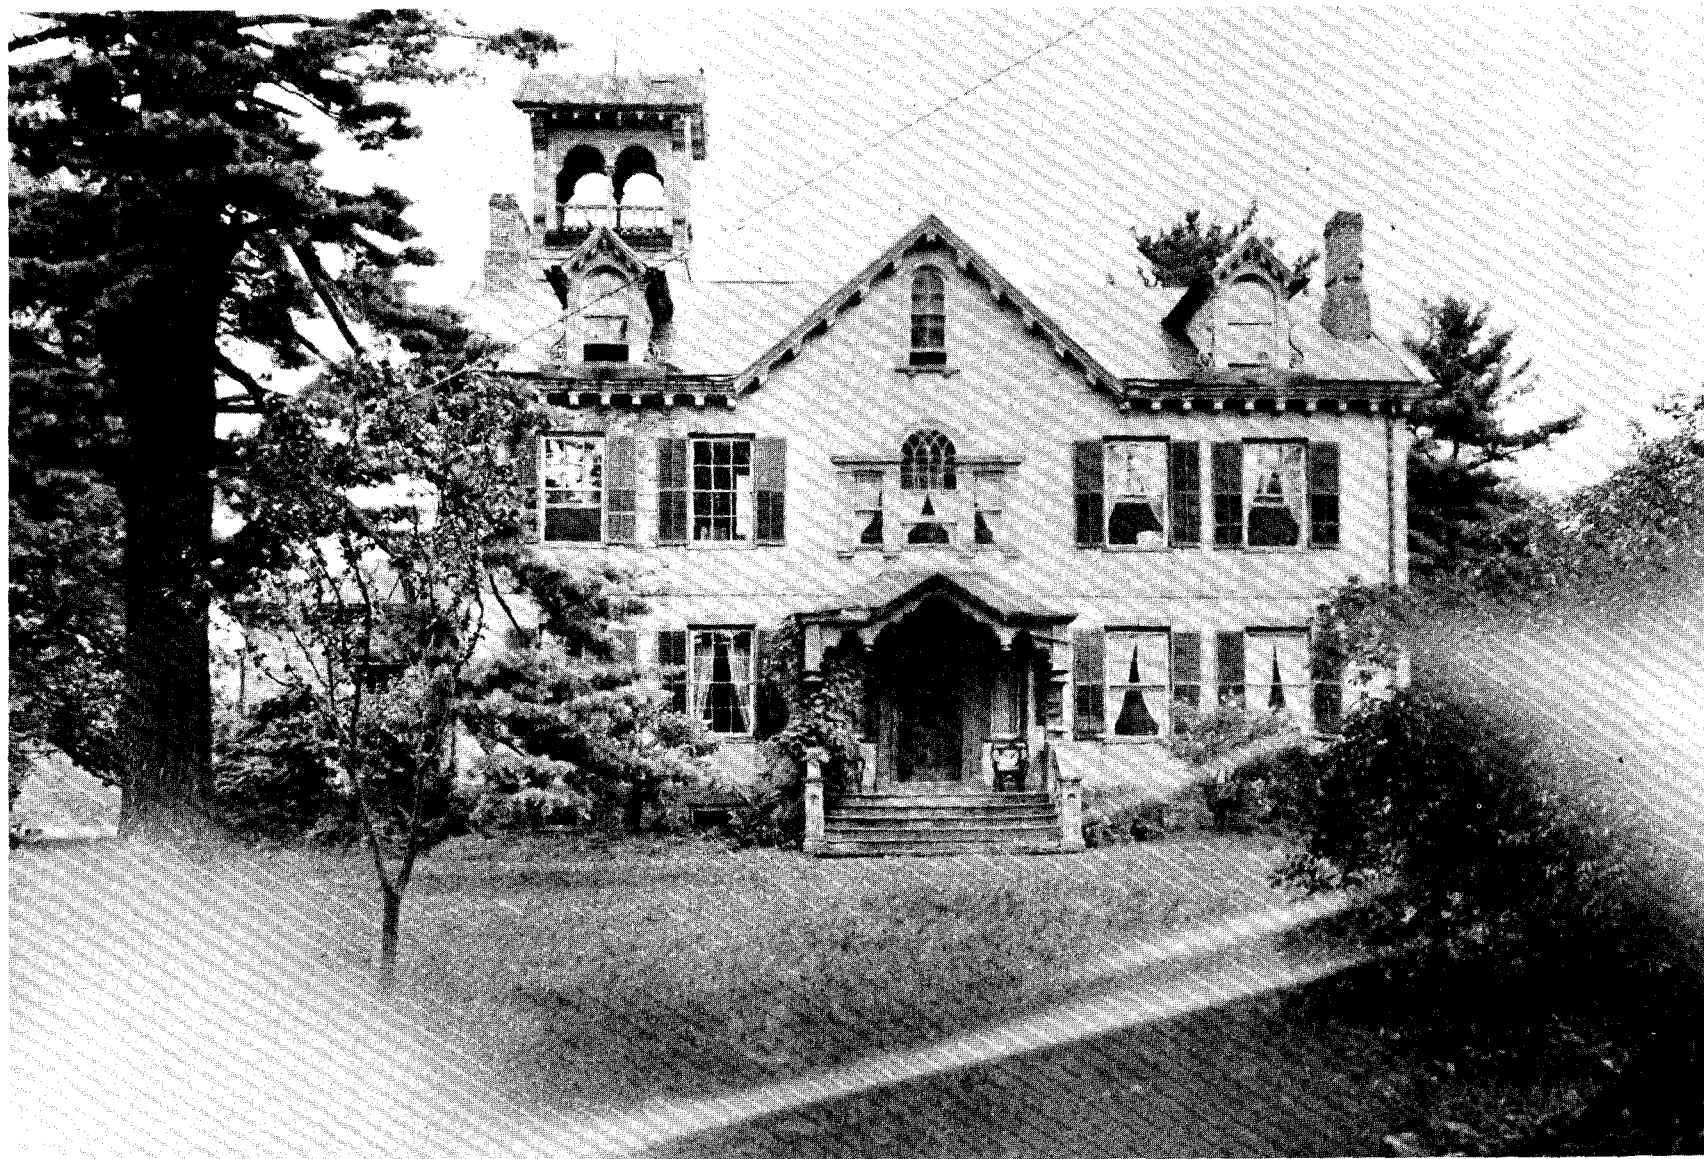
HP24. Lindenwald, East Elevation, 1936. This photograph was taken on August 3, 1936, by Melvin Weig. This date is also documented in his report, "'Lindenwald,' the President Martin Van Buren Homestead, near Kinderhook, New York." The following details should be noted:

Some bricks are missing from the cap of the south chimney.

The light paint on the brickwork is very weathered, and most brick courses on the east elevation are discernible. Sash has also been painted a light tone, but now the cornice appears to be a dark tone. Foundations, window frames, and the front porch are painted a dark tone. Shutters appear to be painted an even darker tone.

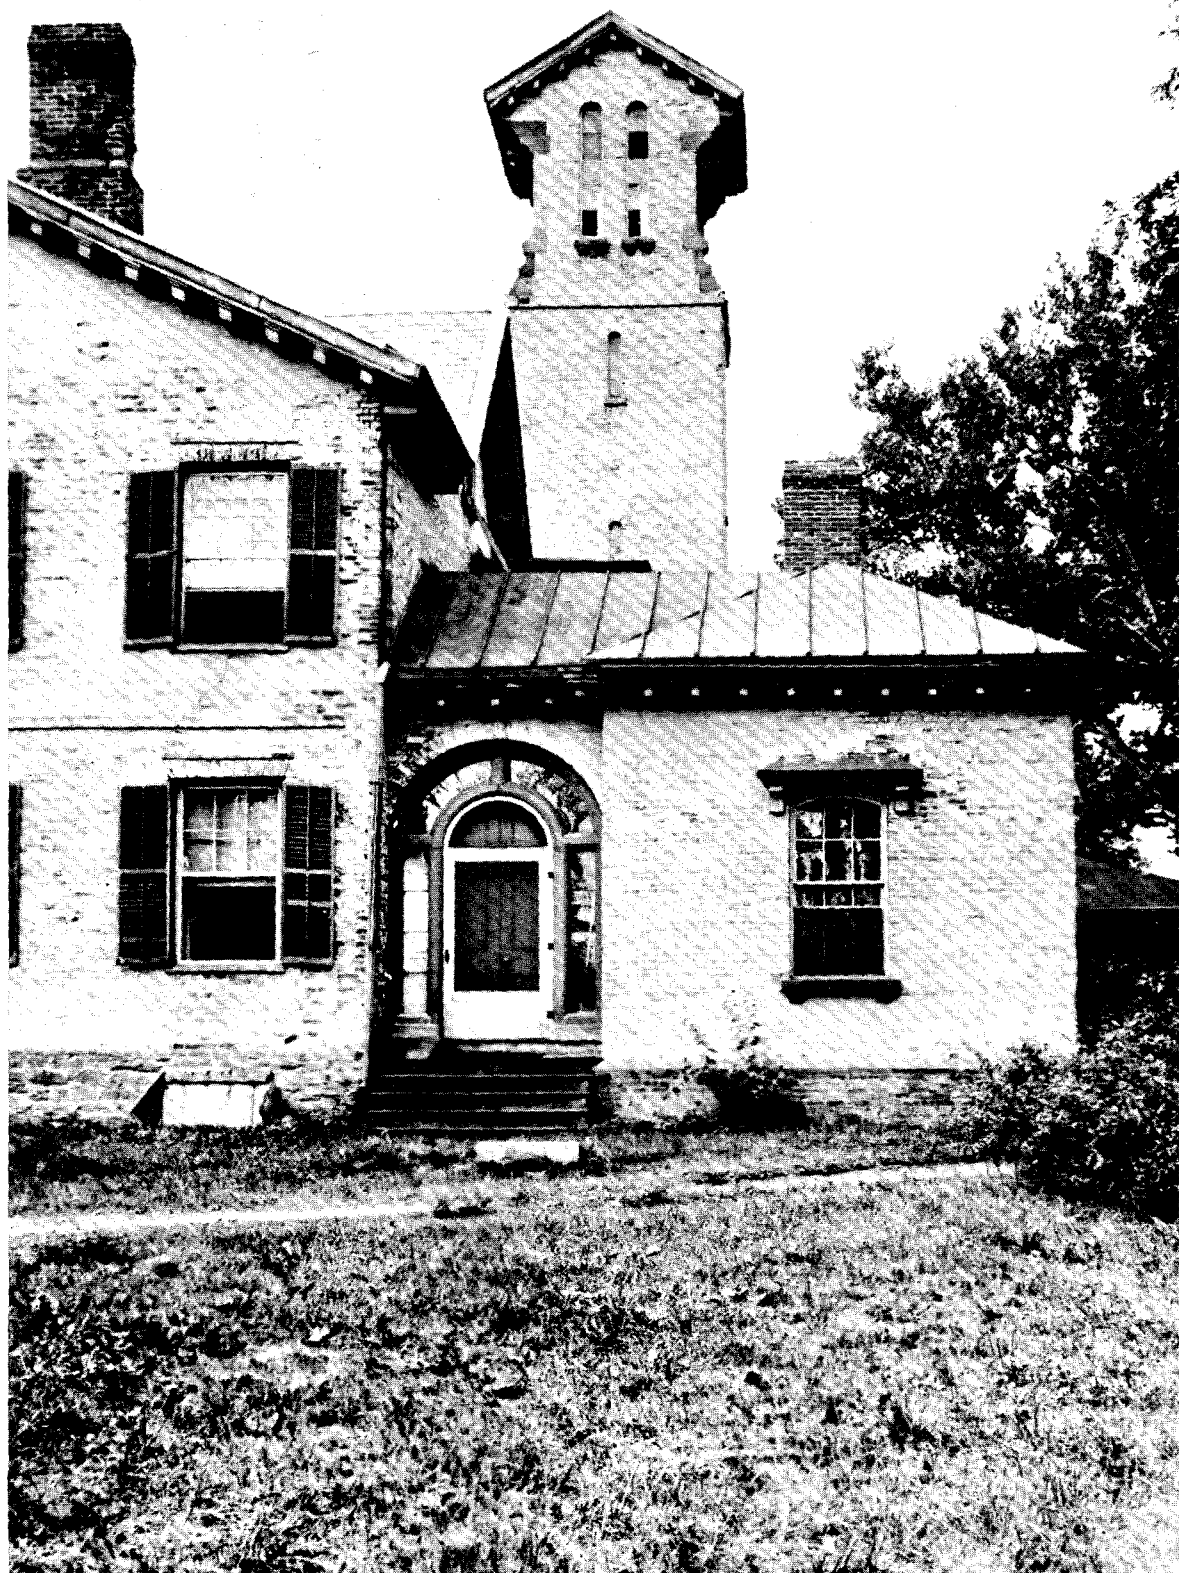
HP27. West End of the North Elevation of Lindenwald, 1936. This photograph was taken by Melvin Weig on August 3, 1936. The following details should be noted:

The belvedere windows are missing lights.

The lower section of the downspout is stock corrugated sheet metal (replacement).

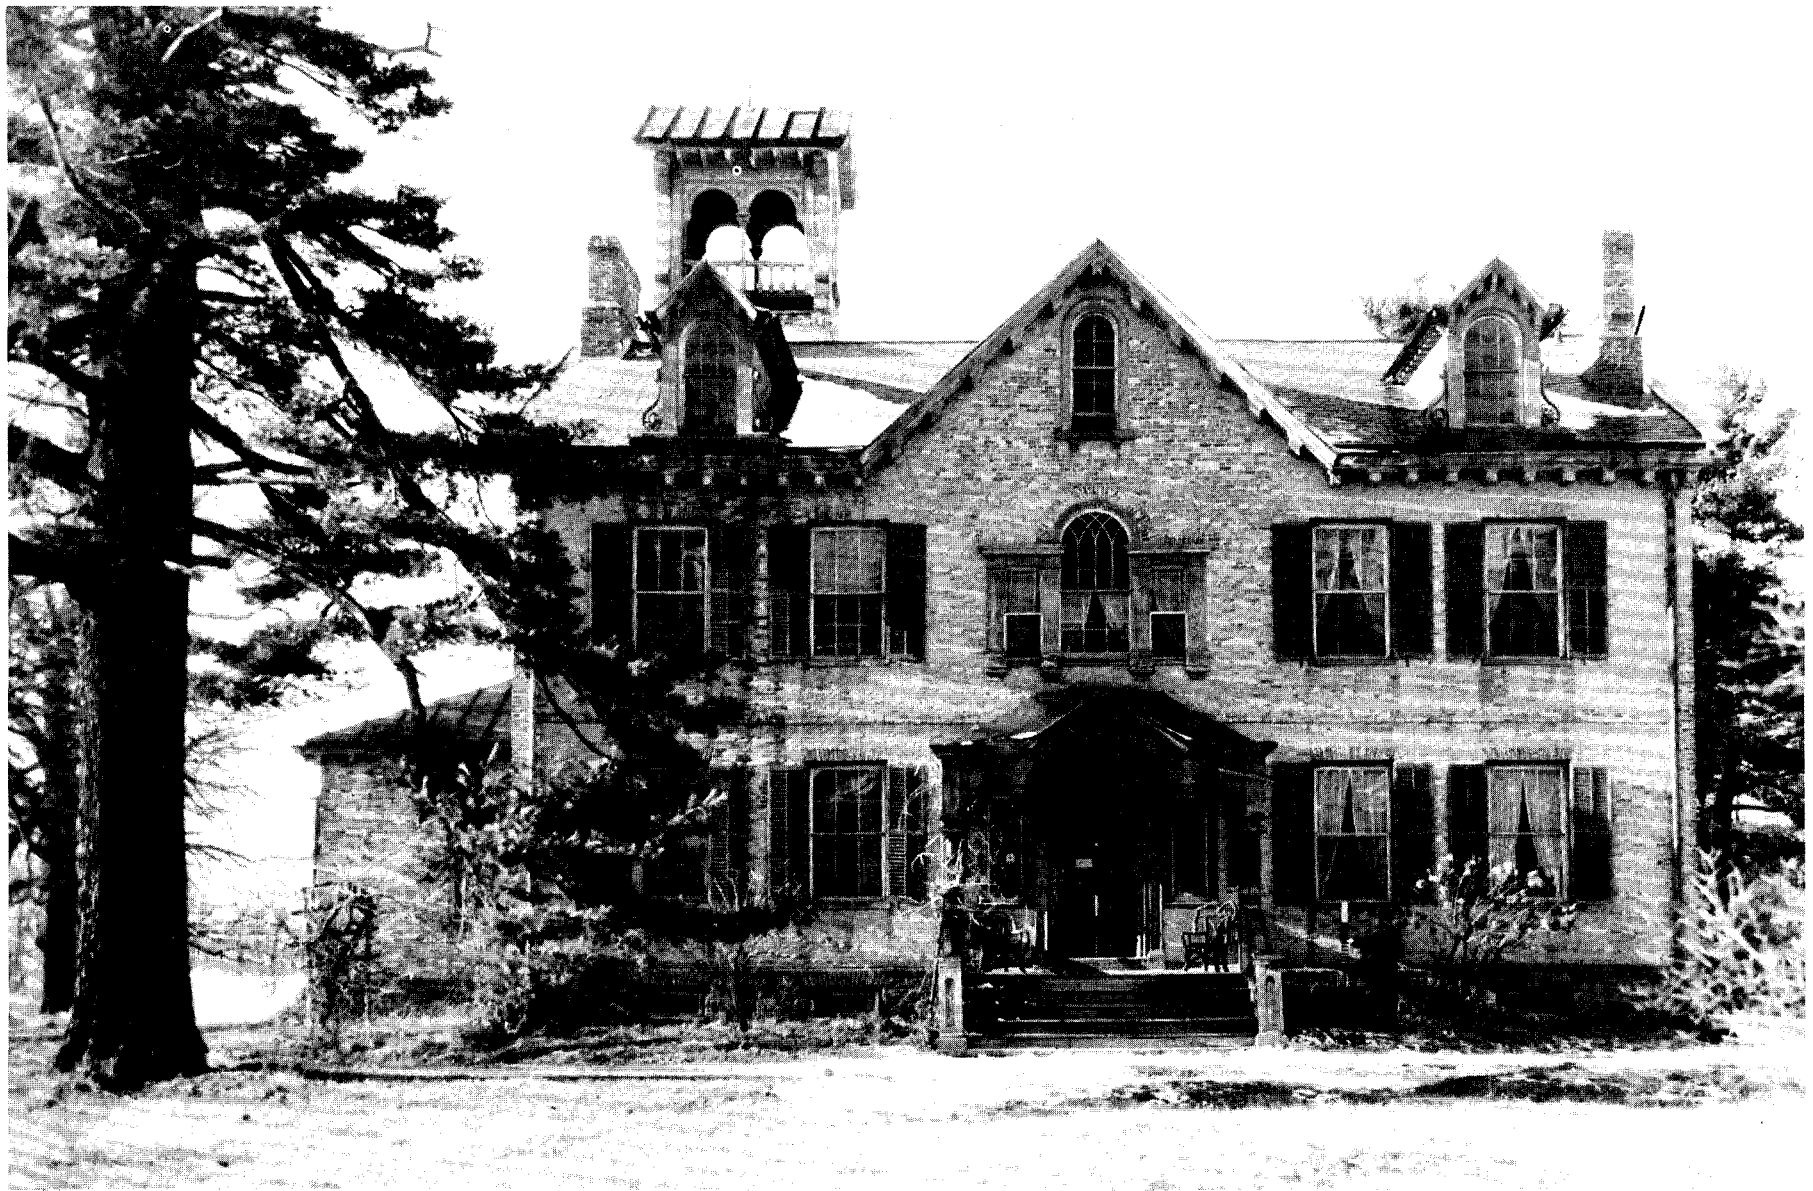
HP34. Lindenwald, East Elevation, 1937. This photograph was taken by Nelson Baldwin in January 1937. The following details should be noted:

The main cornice crown molding is deteriorating at the joints.

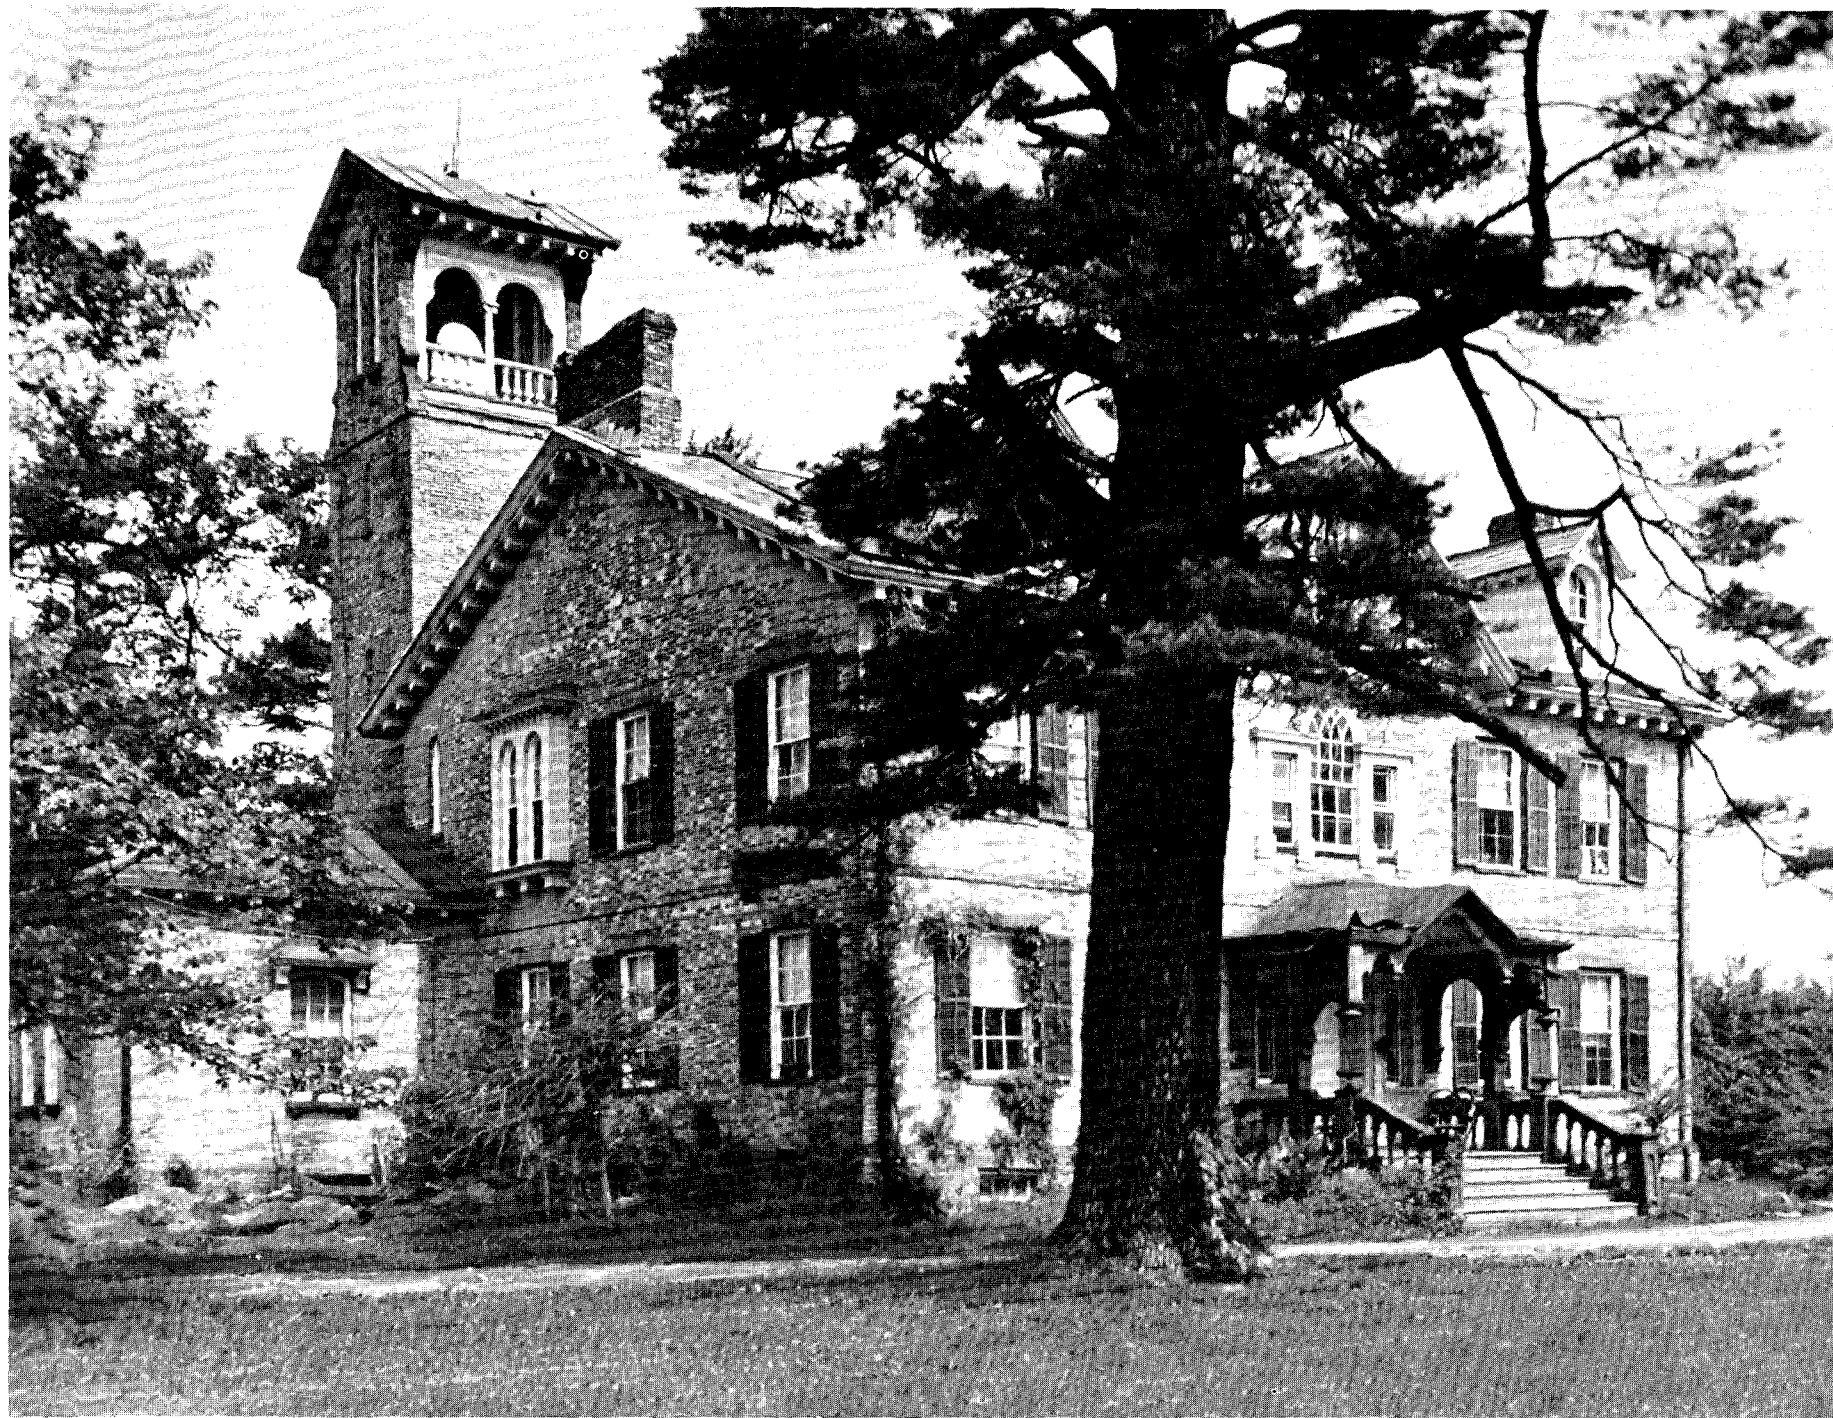
HP41. Lindenwald, ca. 1946-1950. This color photograph of the south and east facades of Lindenwald was donated to the National Park Service by the DeProsse family. It has been assigned a date between ca. 1946 and ca. 1950 on the basis of two DeProsse family recollections (W.N. Jackson, "Oral History Report," September 5, 1979). The painting of windows and doors is reported to have been done in 1946. The front porch is reported to have been removed in 1950. The following details should be noted:

repairs to tower roof

missing scrolls on north dormer

condition of porch roof

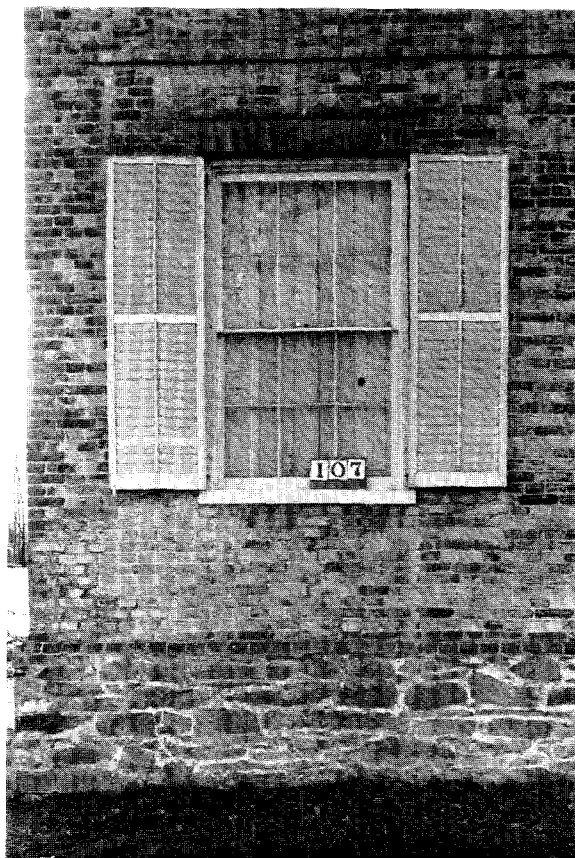
IP002, N012-14. Closure pattern at east corner of north wall.

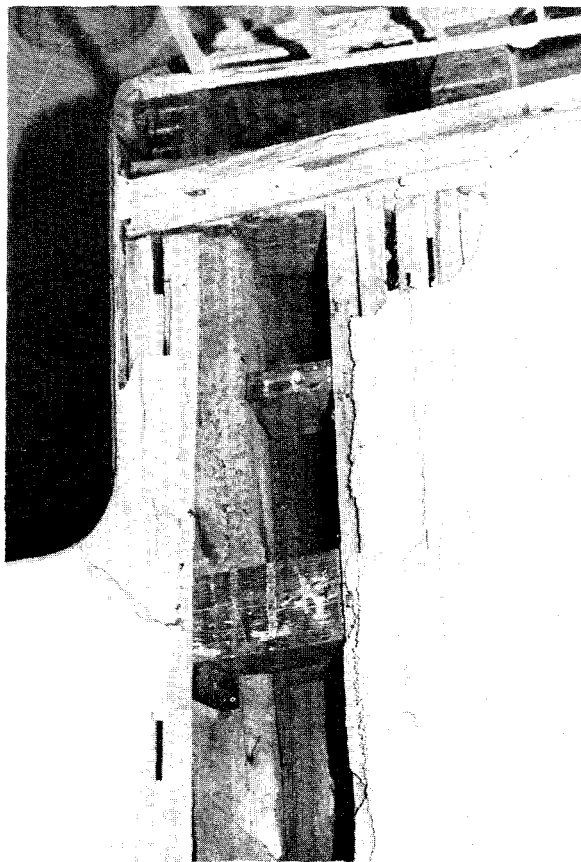
IP073, N041-12. Typical condition of cantilever joist wedged into masonry pocket.
