HISTORIC STRUCTURE REPORT

ARCHITECTURAL DATA

SPALDING AREA

NEZ PERCE NATIONAL HISTORICAL PARK

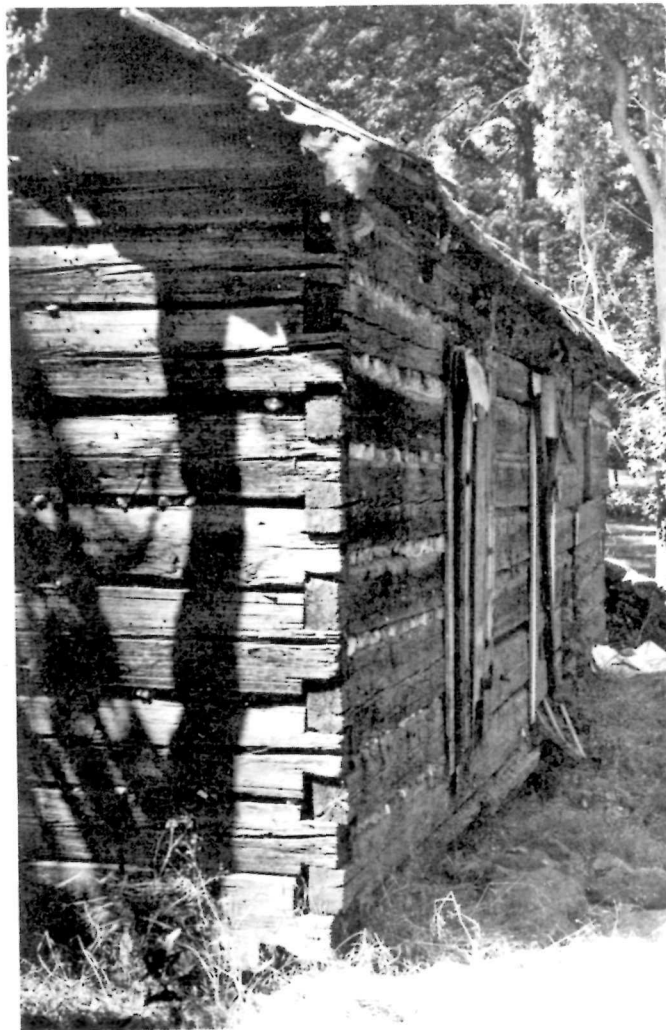
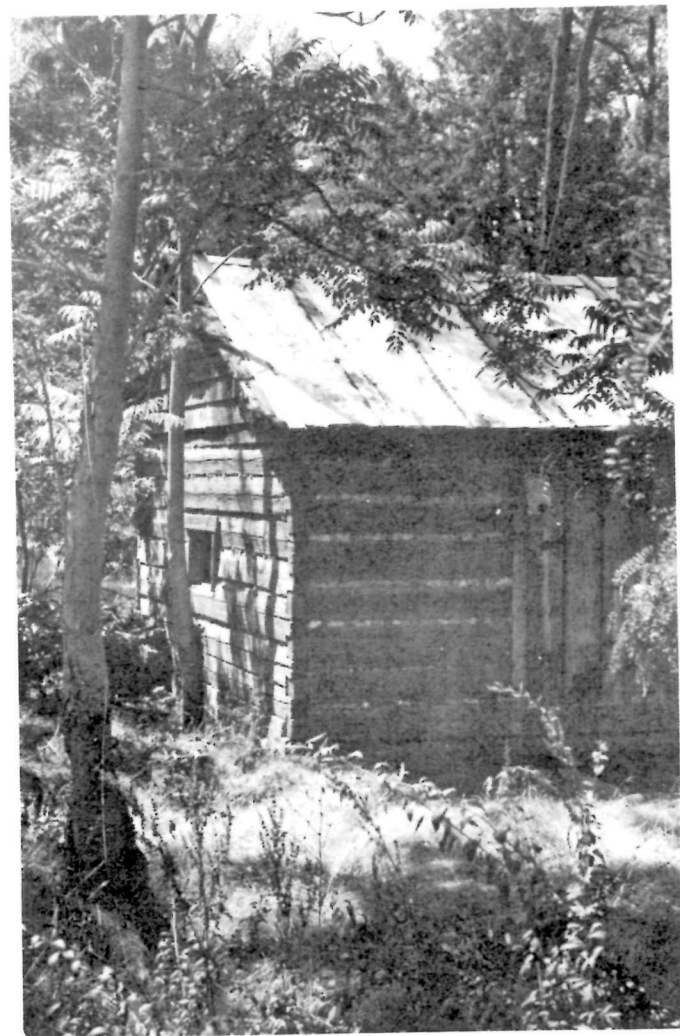
Agency Log Building, 1972. Note large stones in chinking.
Window in end wall, right photo, added after 1936.

Stone fragments should be removed and joints filled with period mortar. Ceiling boards should be replaced and nail holes should be filled.

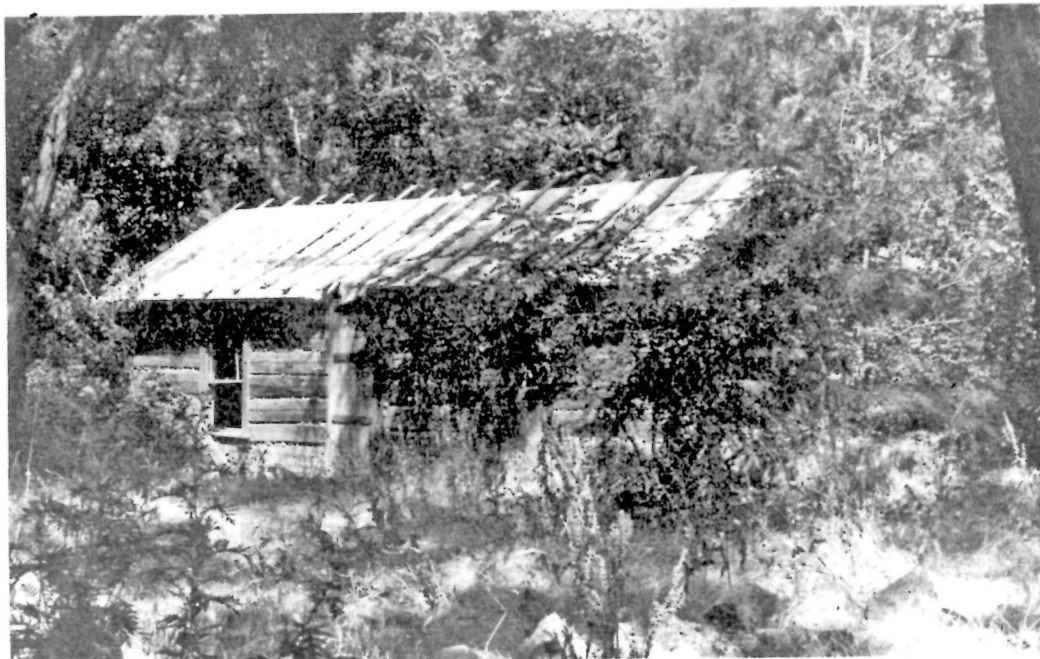
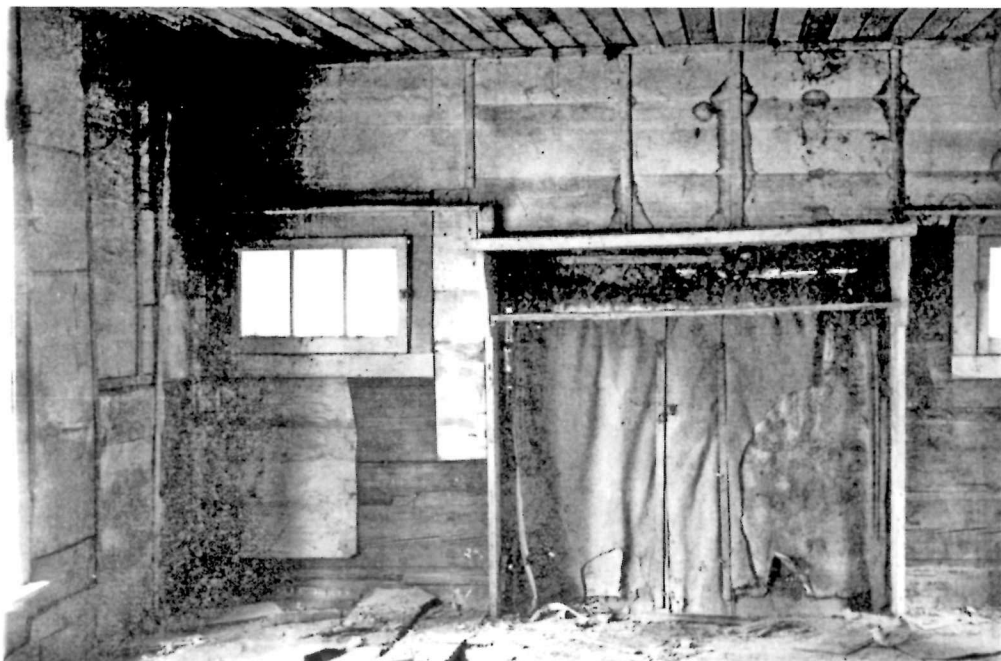
Agency Log Building, 1972. Ceiling, casement windows, fireplace surround and floor added after 1936.

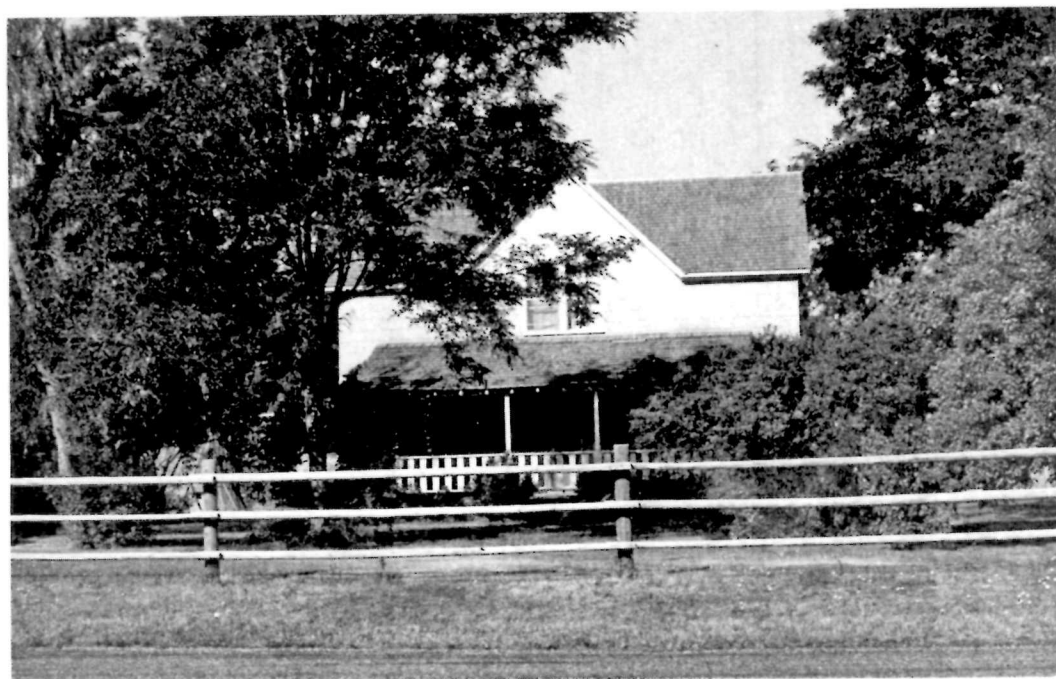
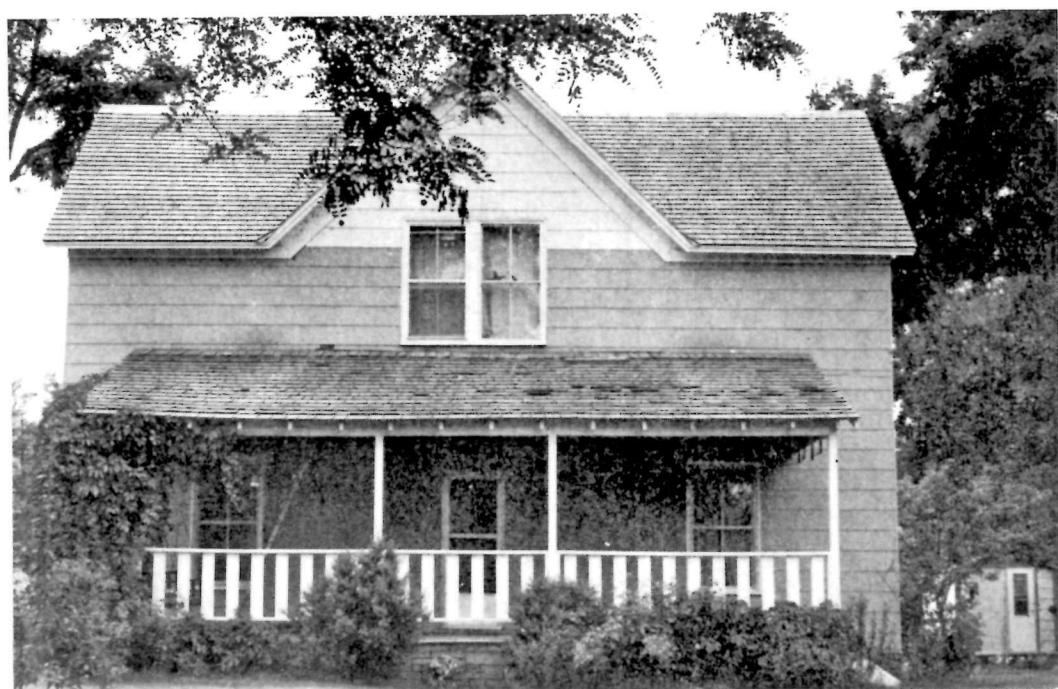
Agent's Residence, occupied by Park Superintendent.
Views from the east, 1972. Railing added by park,
1971. Note permastone skirting in lower photo.

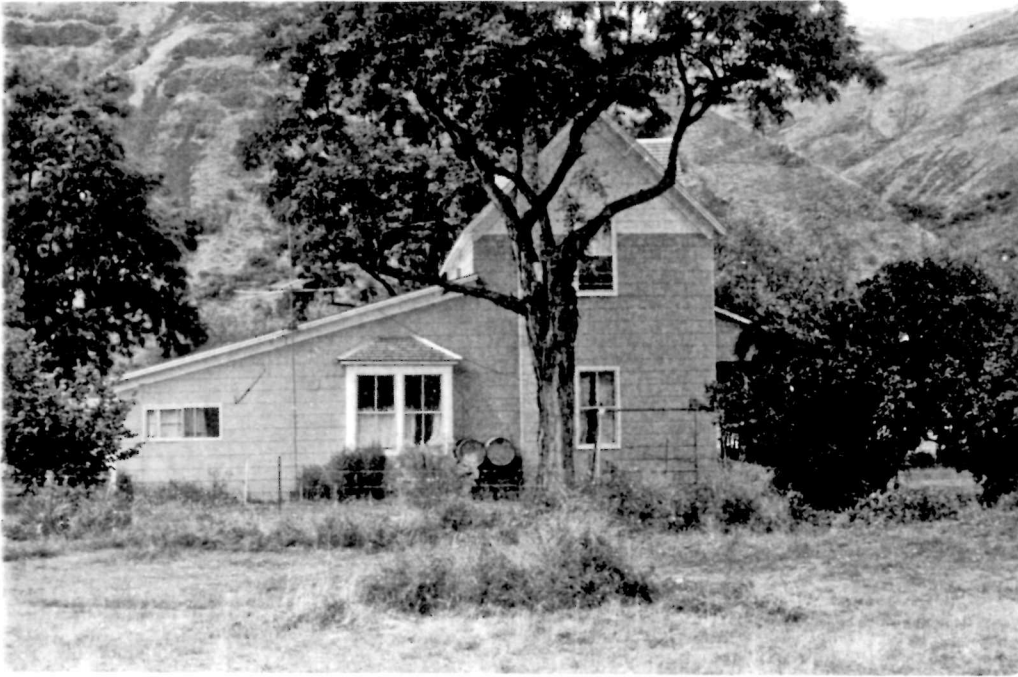
Top -- Agent's Residence, view from the south,
1972. Note later exterior concrete block
chimney.

At the front of the house the porch should be removed and the original stoop reconstructed. The front door should be replaced by a period 4-panel door. The concrete block chimney would be demolished when the siding is removed and the period brick chimney should be reconstructed above the roof at this location.

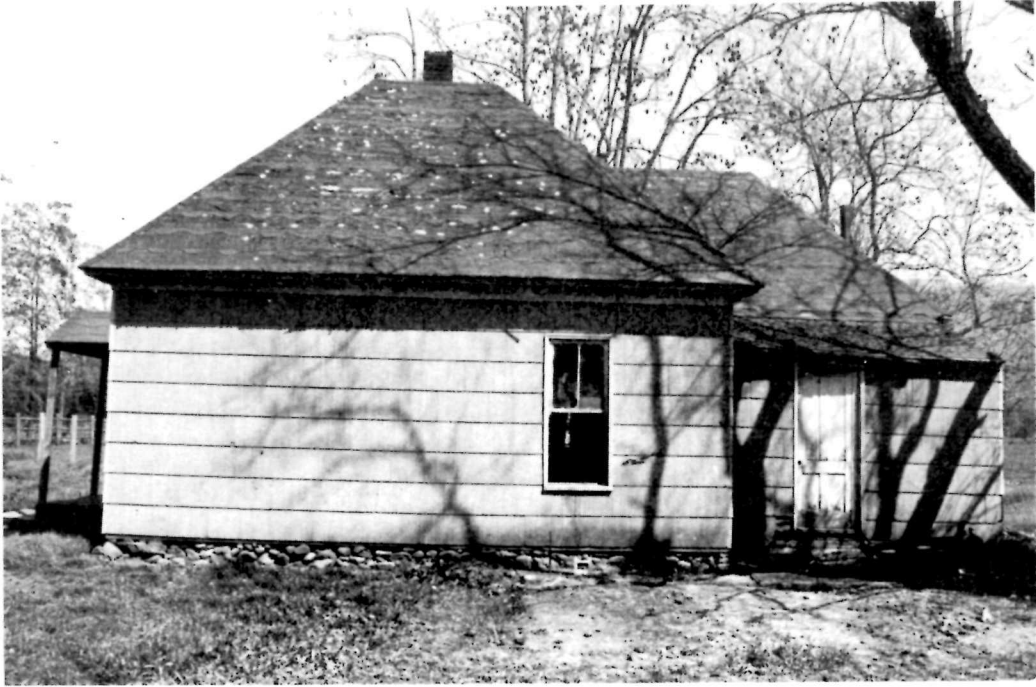
The rear screen porch, the bathroom, and the front stoop, poorly constructed to begin with, are in the worst condition. They sag and are generally dilapidated.

Top -- Agency Employee House, view from west, 1973.
Bathroom addition at right.

Under this proposal only the exterior of the house would be restored. This would require removal of the rear screen porch addition and the bathroom addition, reconstruction of the front porch, and reroofing with period wood shingles. New period two-over-two double hung windows and four-panel doors would be needed. The present asphalt siding would be removed, the brick moulds at openings replaced by period casings, and the wood siding patched and repainted. The chimney would need reflashing, repointing, and waterproofing.

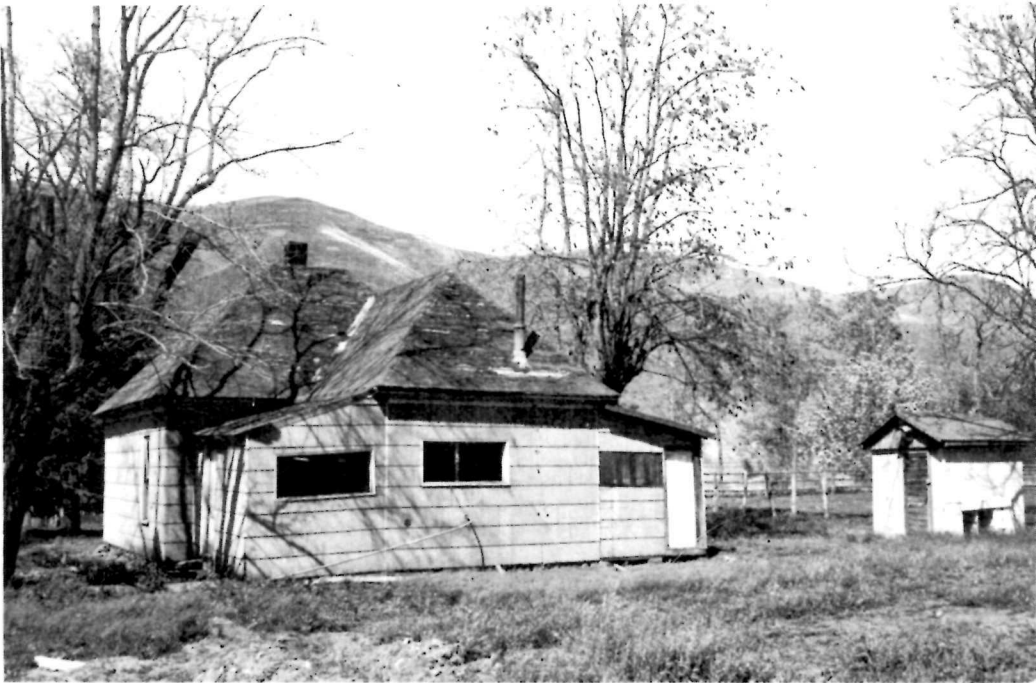
Bottom -- Agency Employee House, view from south-
west, 1973. Bathroom addition at left,
porch addition, right. Beyond is c. 1960
concrete block pumphouse.

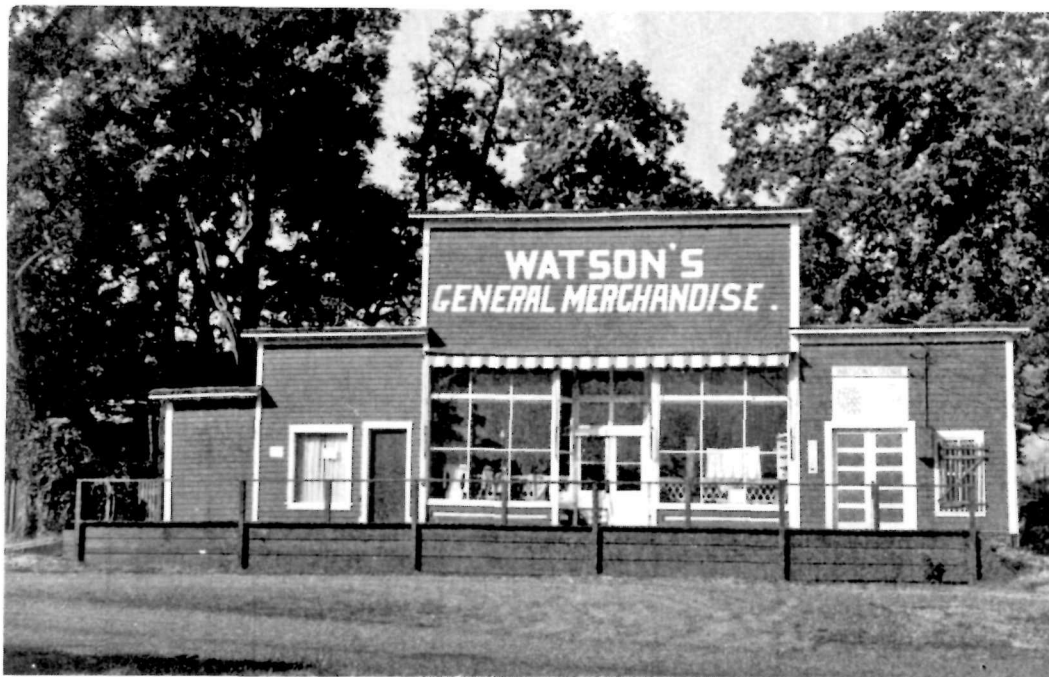
Bottom -- Watson's Store, view from northeast,
1972. Platform rebuilt by park, 1967.
Bathroom at left, added in 1949, was
removed in 1972.

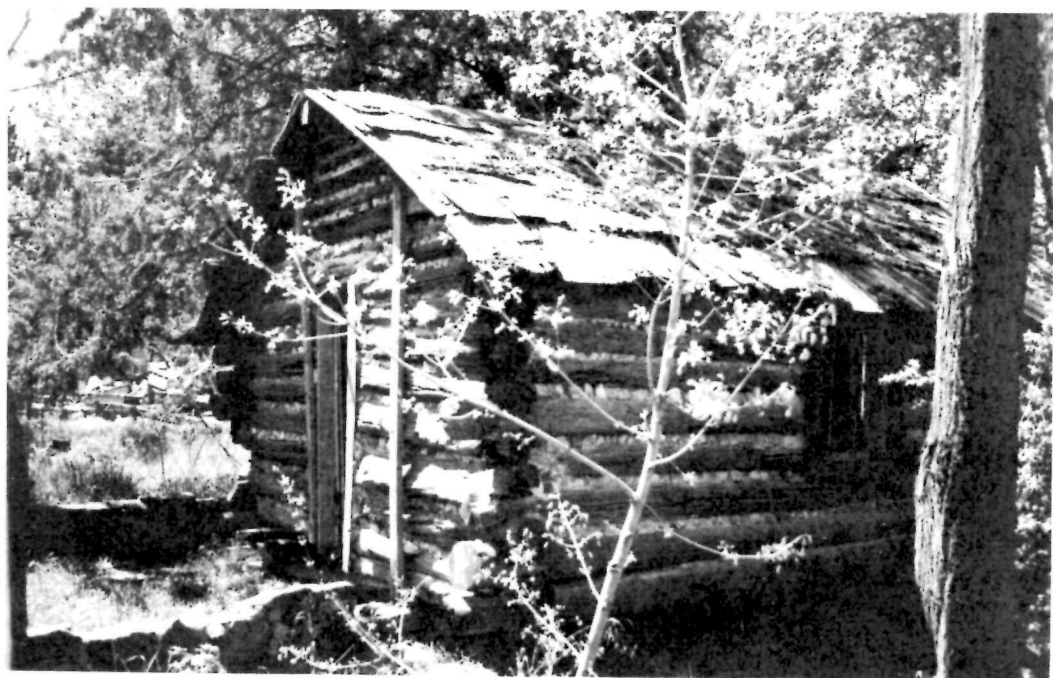
Bottom -- Log Cabin. View at entrance, 1973.
Note hand-split cedar roof boards,
large stones in chinking.

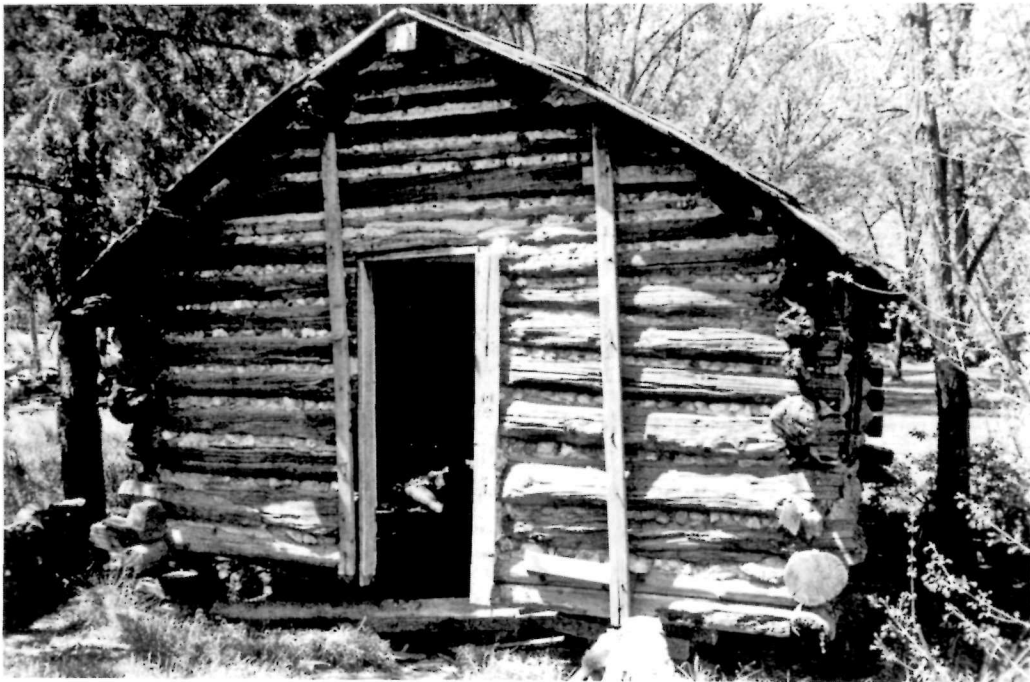
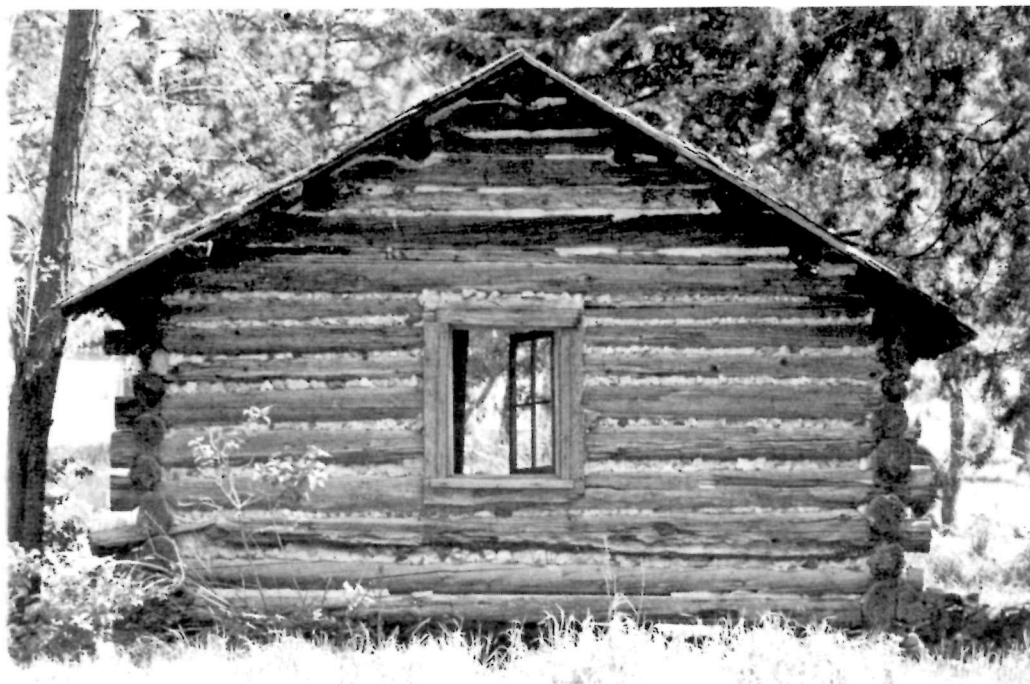
The cabin was not only dismantled and reassembled when the Evanses moved it from Coyote Gulch, but logs have been changed. This is shown by the fact that the present wall logs project irregularly at the corners from 4 inches \pm to 24 inches \pm , whereas the logs in the 1900 photo project fairly uniformly, about 6 inches. The logs also appear larger in the photo than the present 5-to 10-inch size. In the 1900 photo much of the entrance end is covered with rough boards. Some of the gable logs are missing, indicating later replacement.

Log Cabin. Note uneven projection of logs at corners in both views. 1973.
