Courtney Cabin

NORTH CASCADES NATIONAL PARK SERVICE COMPLEX, WA

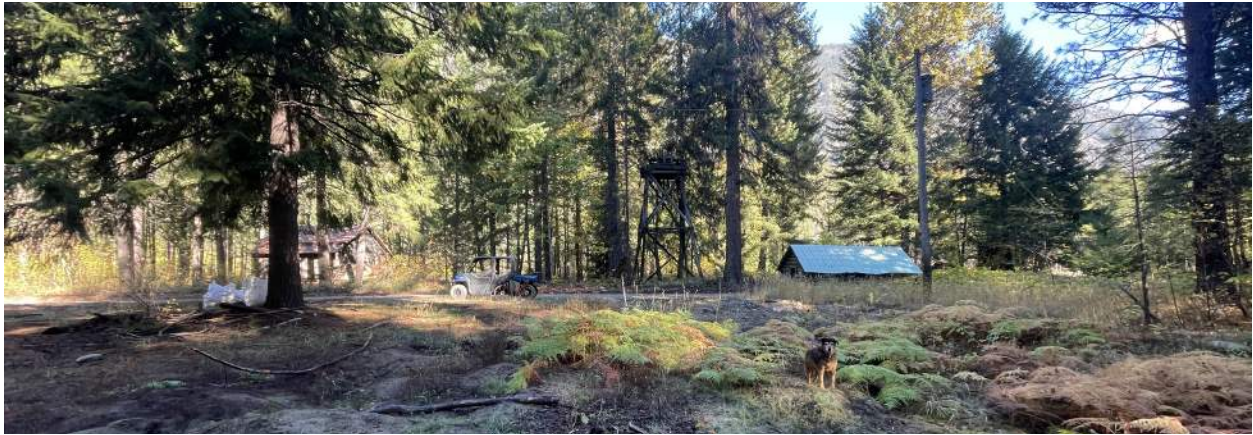
Image 1: Courtney homestead, 2023

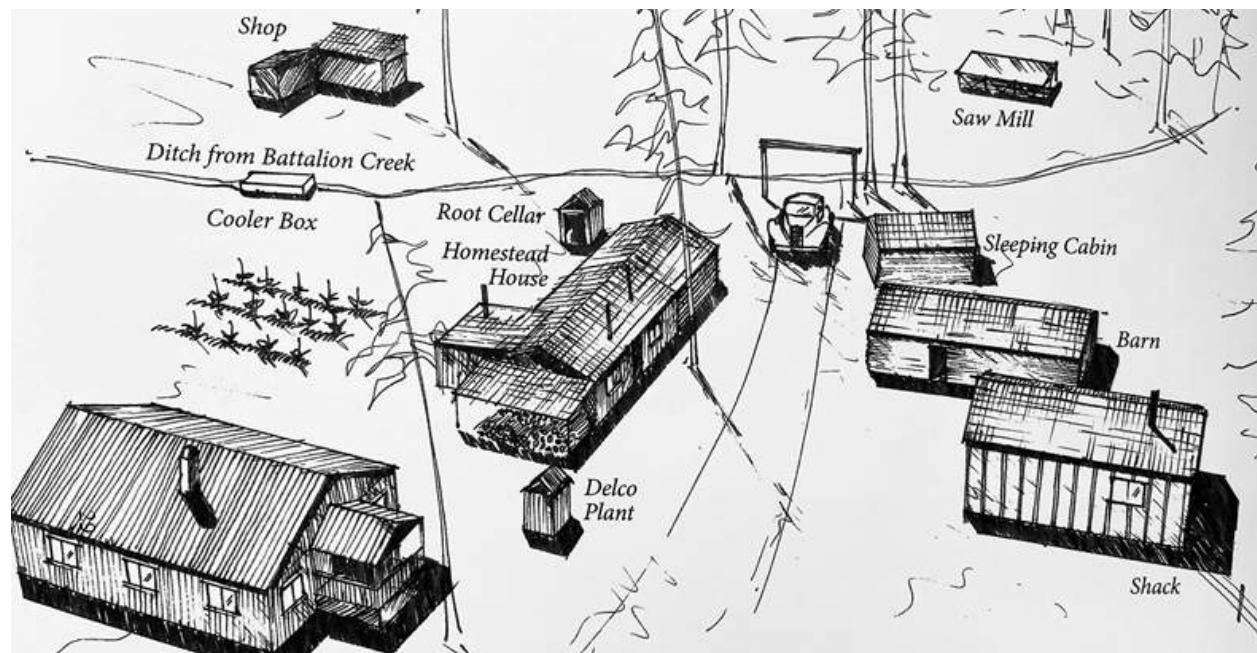
Image 5: Courtney Homestead drawing by Chelsea Courtney Olson. Image sources from *At Home in the Woods - A Stehekin Family History - the Moores and Courtneys*, by Mike Barnhart.

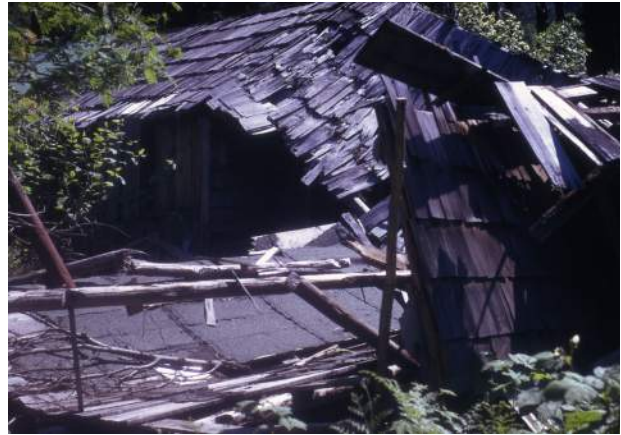
Image 7: Collapsed Courtney addition documented in 1973. NPS, North Cascades NPS Complex Museum Collection, NOCA 21818-282.

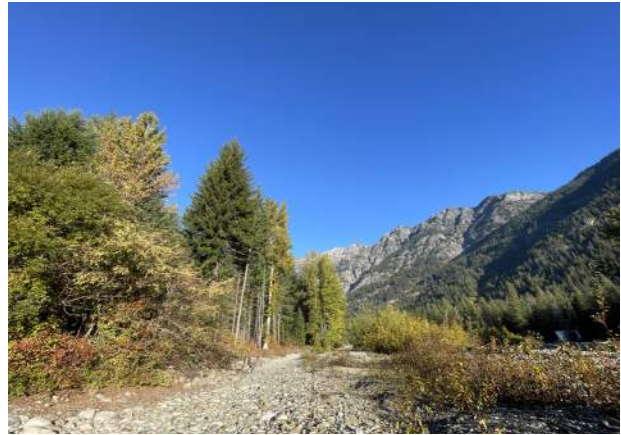
Image 14: The Stehekin River is approximately 80 feet east of the Courtney Cabin.

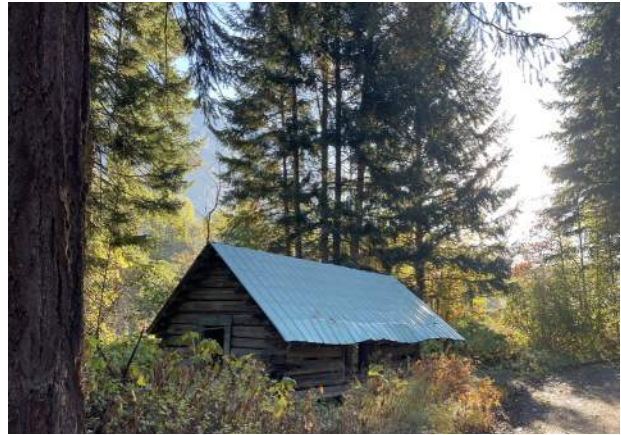
Image 17: Evergreens and bushes surround the cabin.

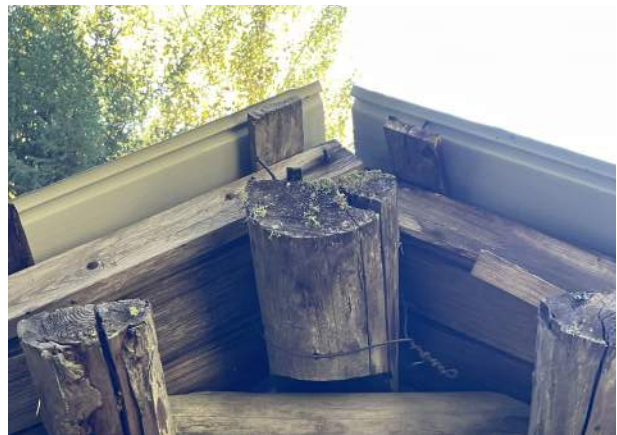
Image 20: The temporary metal roof is missing a ridge cap, allowing water to enter the roof system.

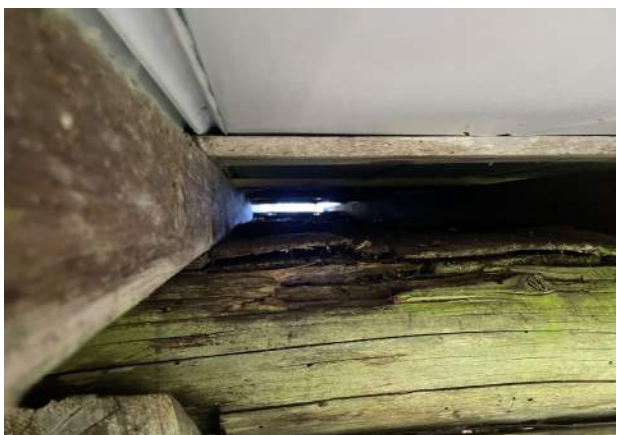
Image 21: The metal roof superstructure sits on wood purlins. Shakes are deteriorated.

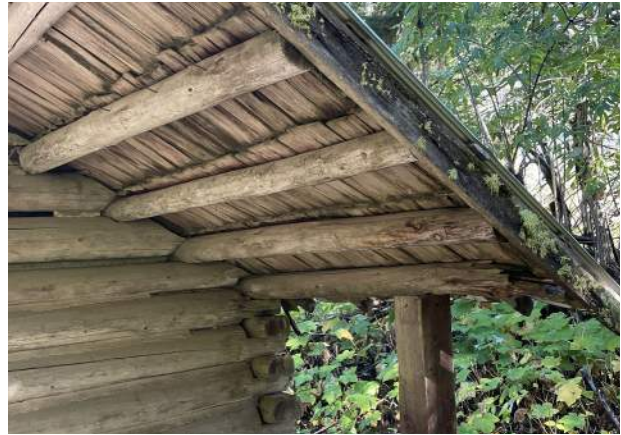
Image 22: The east most purlin is severely deteriorated and collapsing.

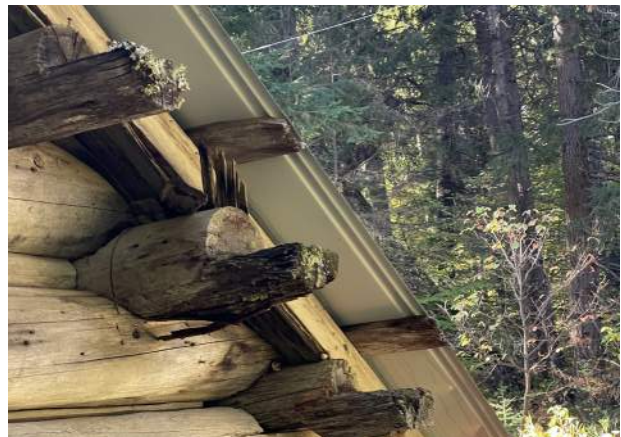
Image 23: Purlin ends on the north elevation are exposed.

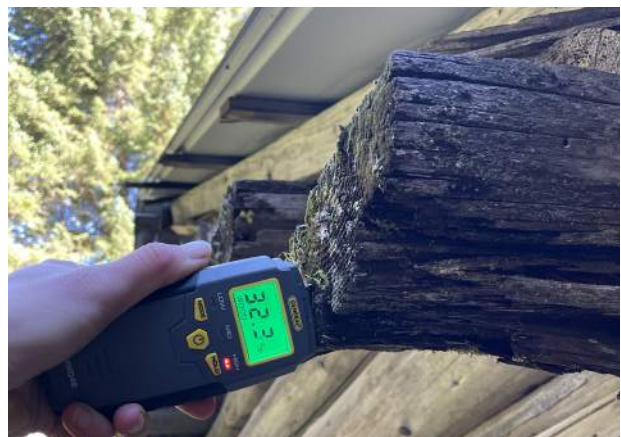
Image 24: Uncovered purlin ends have high moisture content.

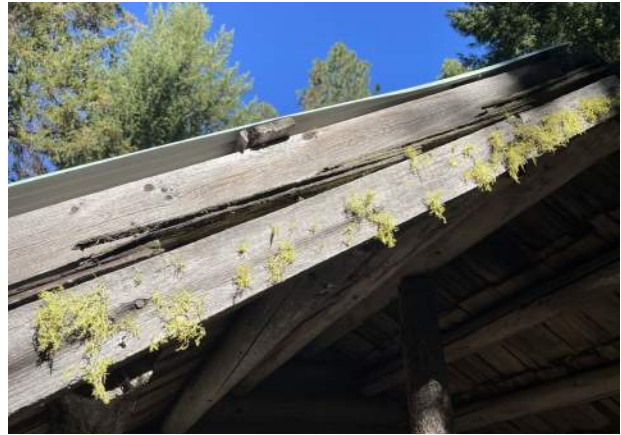
Image 25: Biogrowth present on south elevation fascia board.

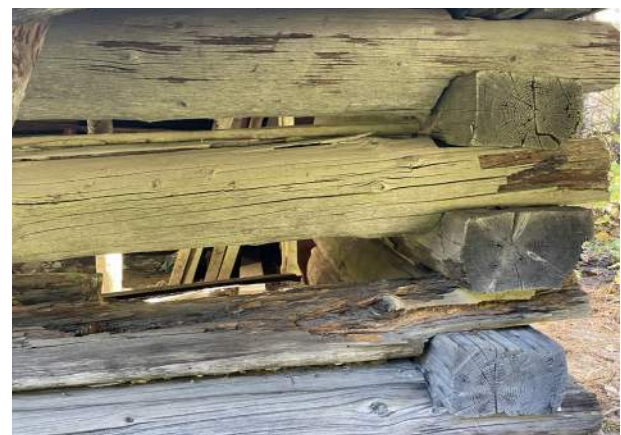
Image 28: Wall logs are severely deteriorated in locations, as seen here at the southwest wall corner.

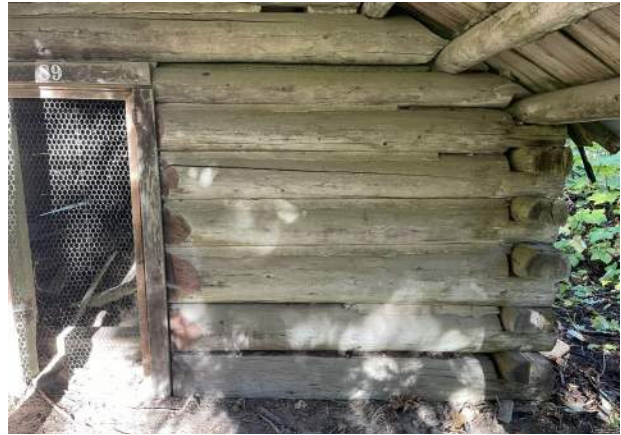
Image 29: The east portion of the south wall.

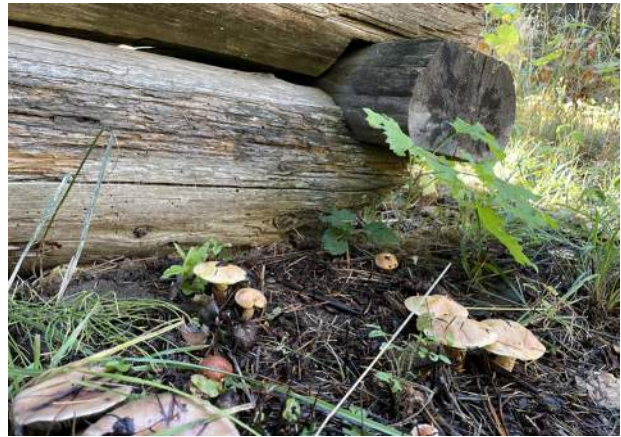
Image 32: The northwest corner of the cabin is sinking into the ground.

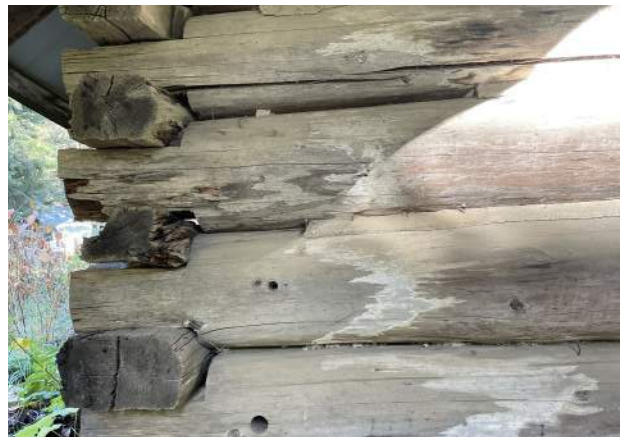
Image 33: Water staining on the south elevation.

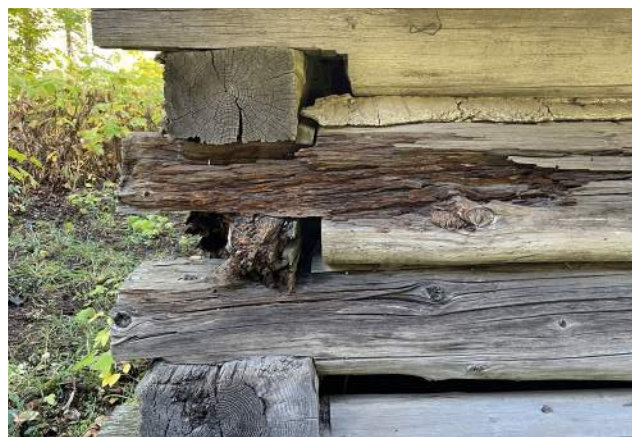
Image 34: The northwest exterior corner.

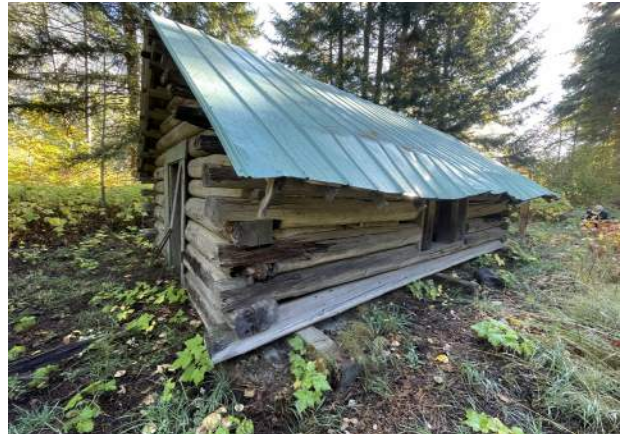
Image 35: The cabin does not have a foundation.

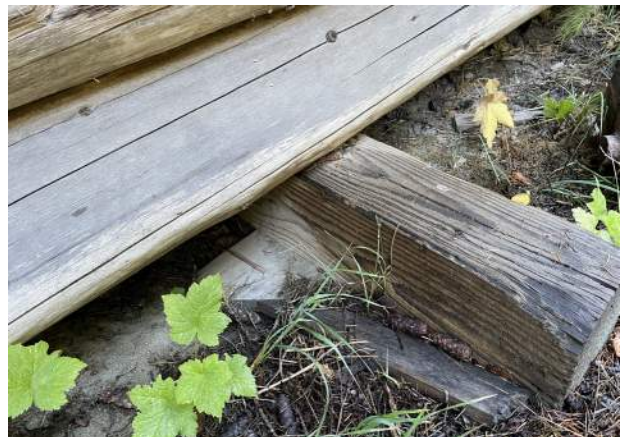
Image 36: Pressure treated sleepers are used to keep the building off the ground,

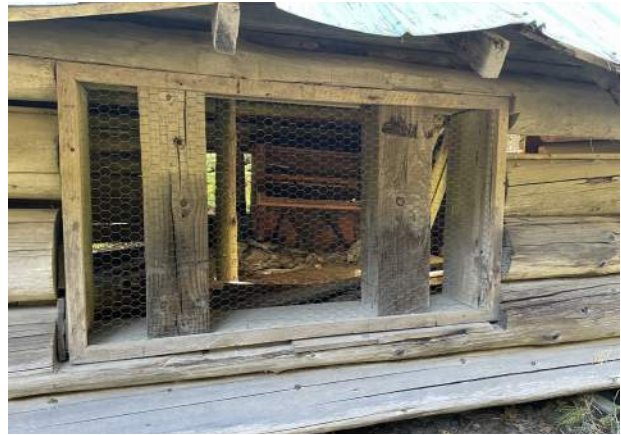
Image 38: The west elevation window opening.

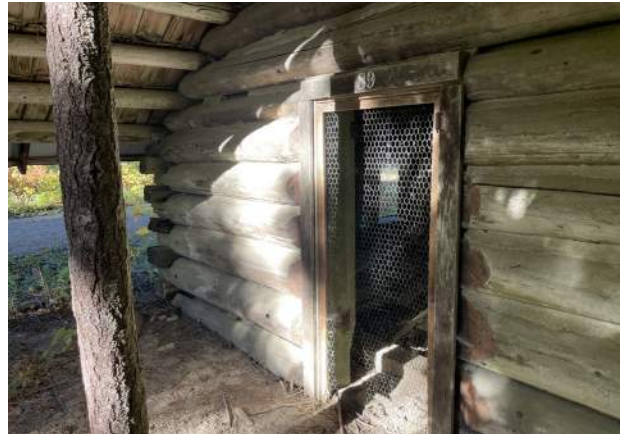
Image 41: The south door opening is secured with wire mesh in wood frame.

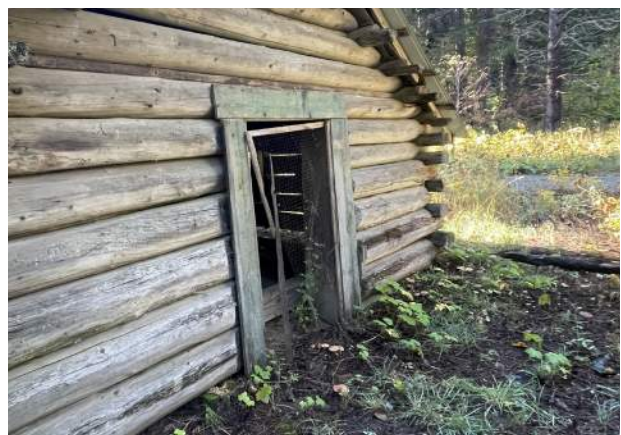
Image 43: The north elevation door opening is not secured. Wire mesh in wood frame broken.

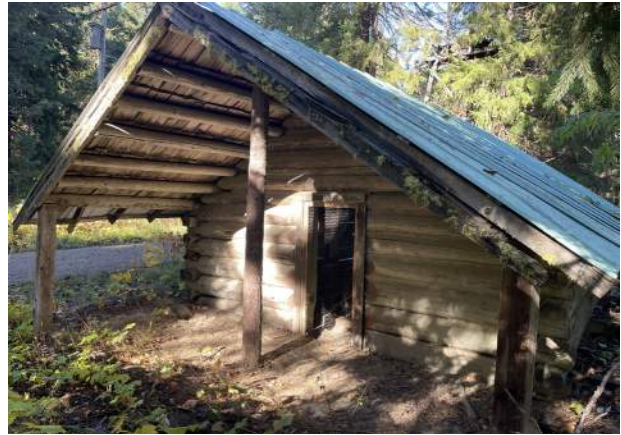
Image 44: The cabin porch is not extant.

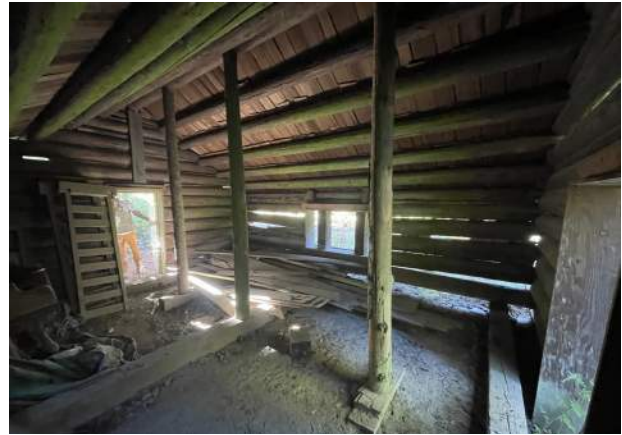
Image 45: The cabin interior is not finished.

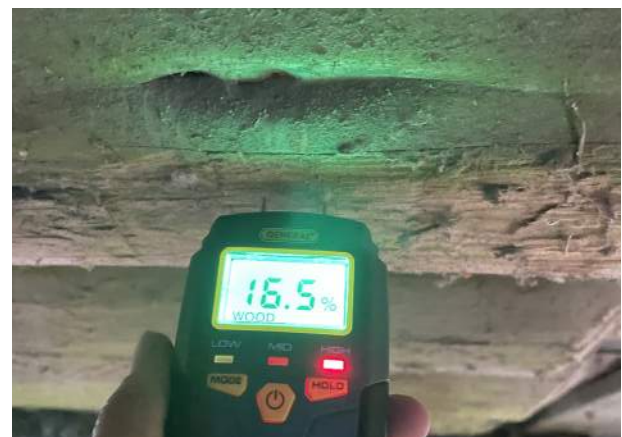
Image 47: Interior logs have high moisture content.

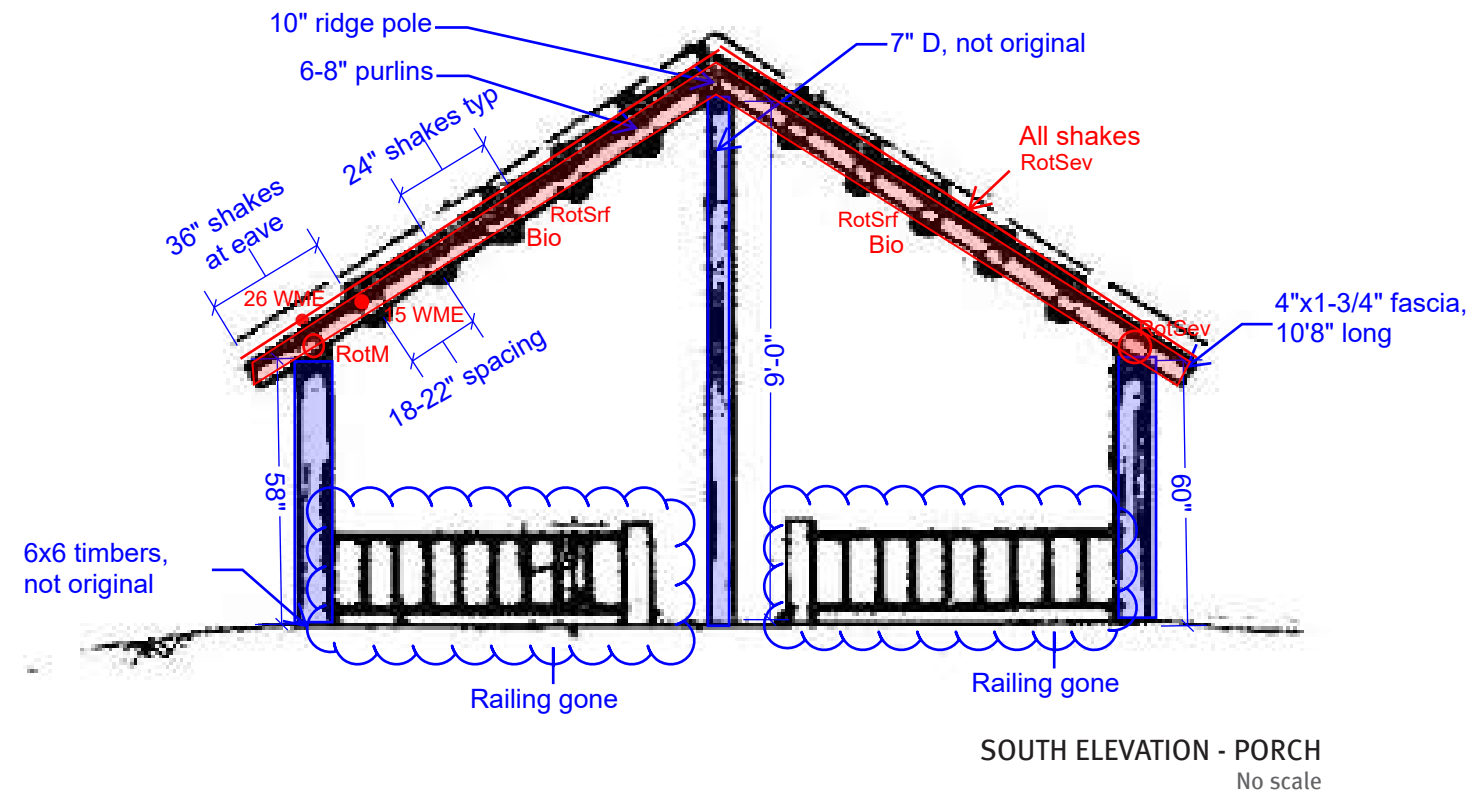
Exterior Elevation Condition Mapping

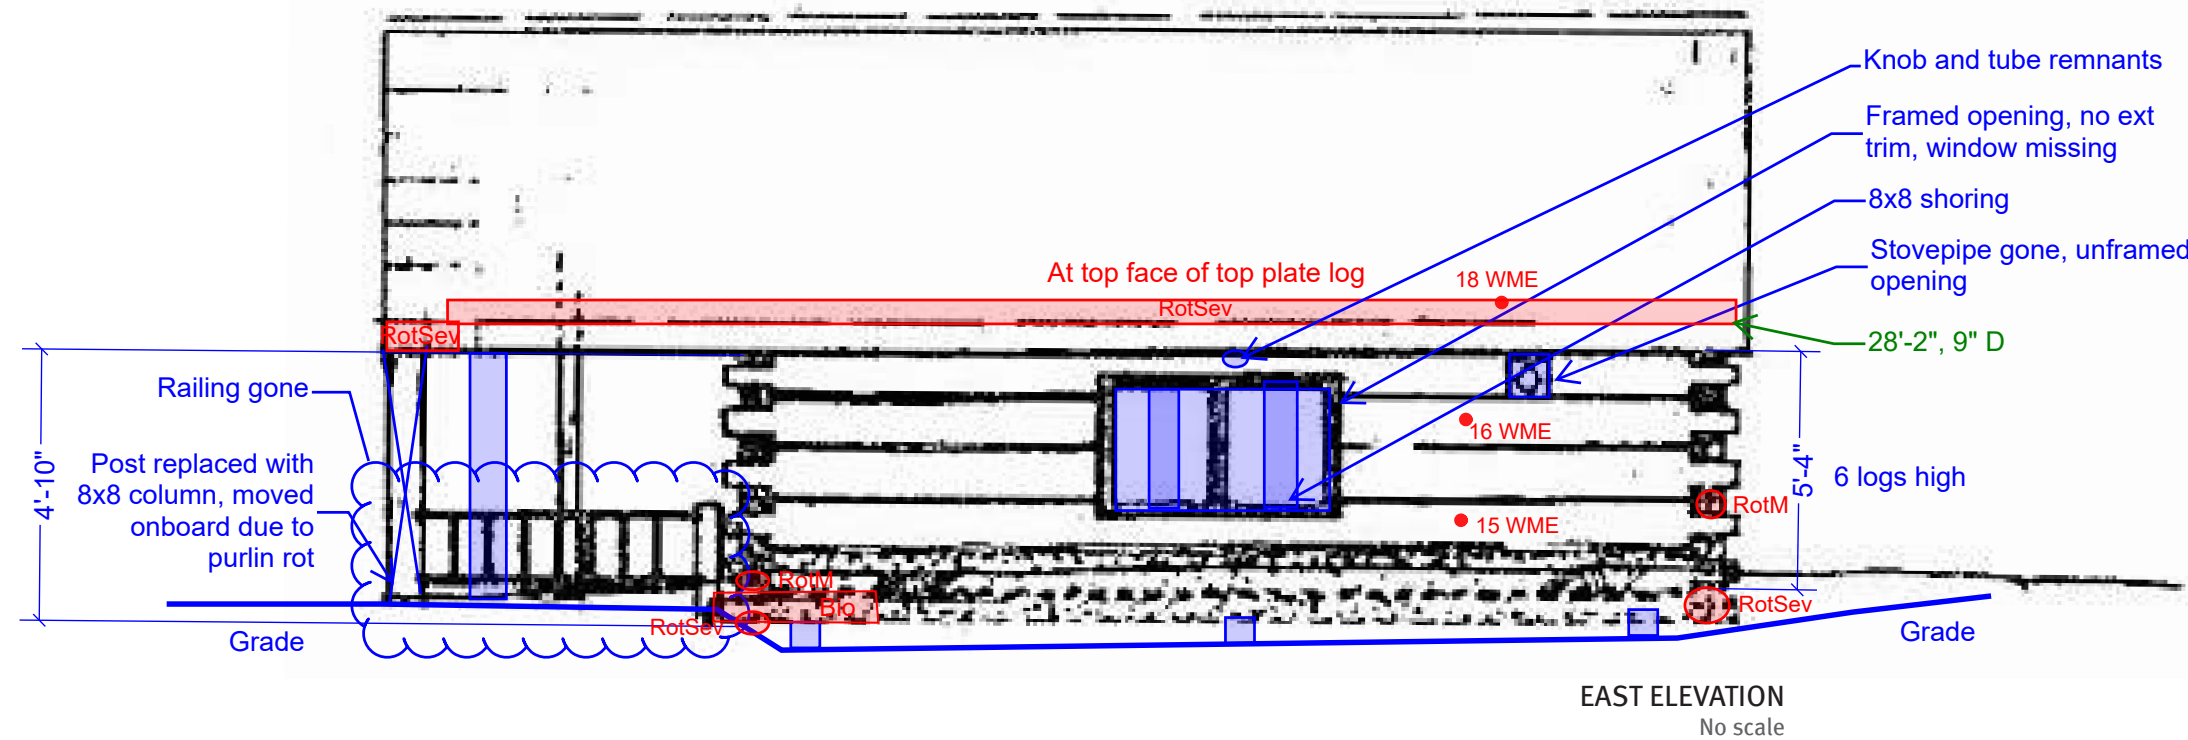
Exterior Elevation Condition Mapping

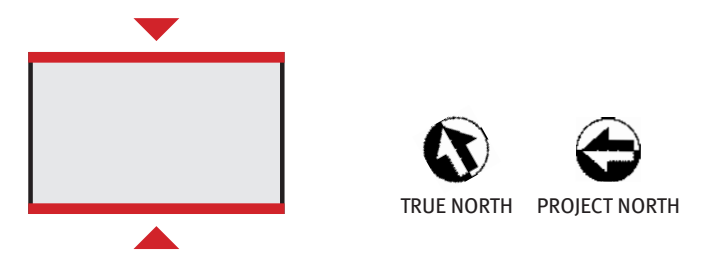
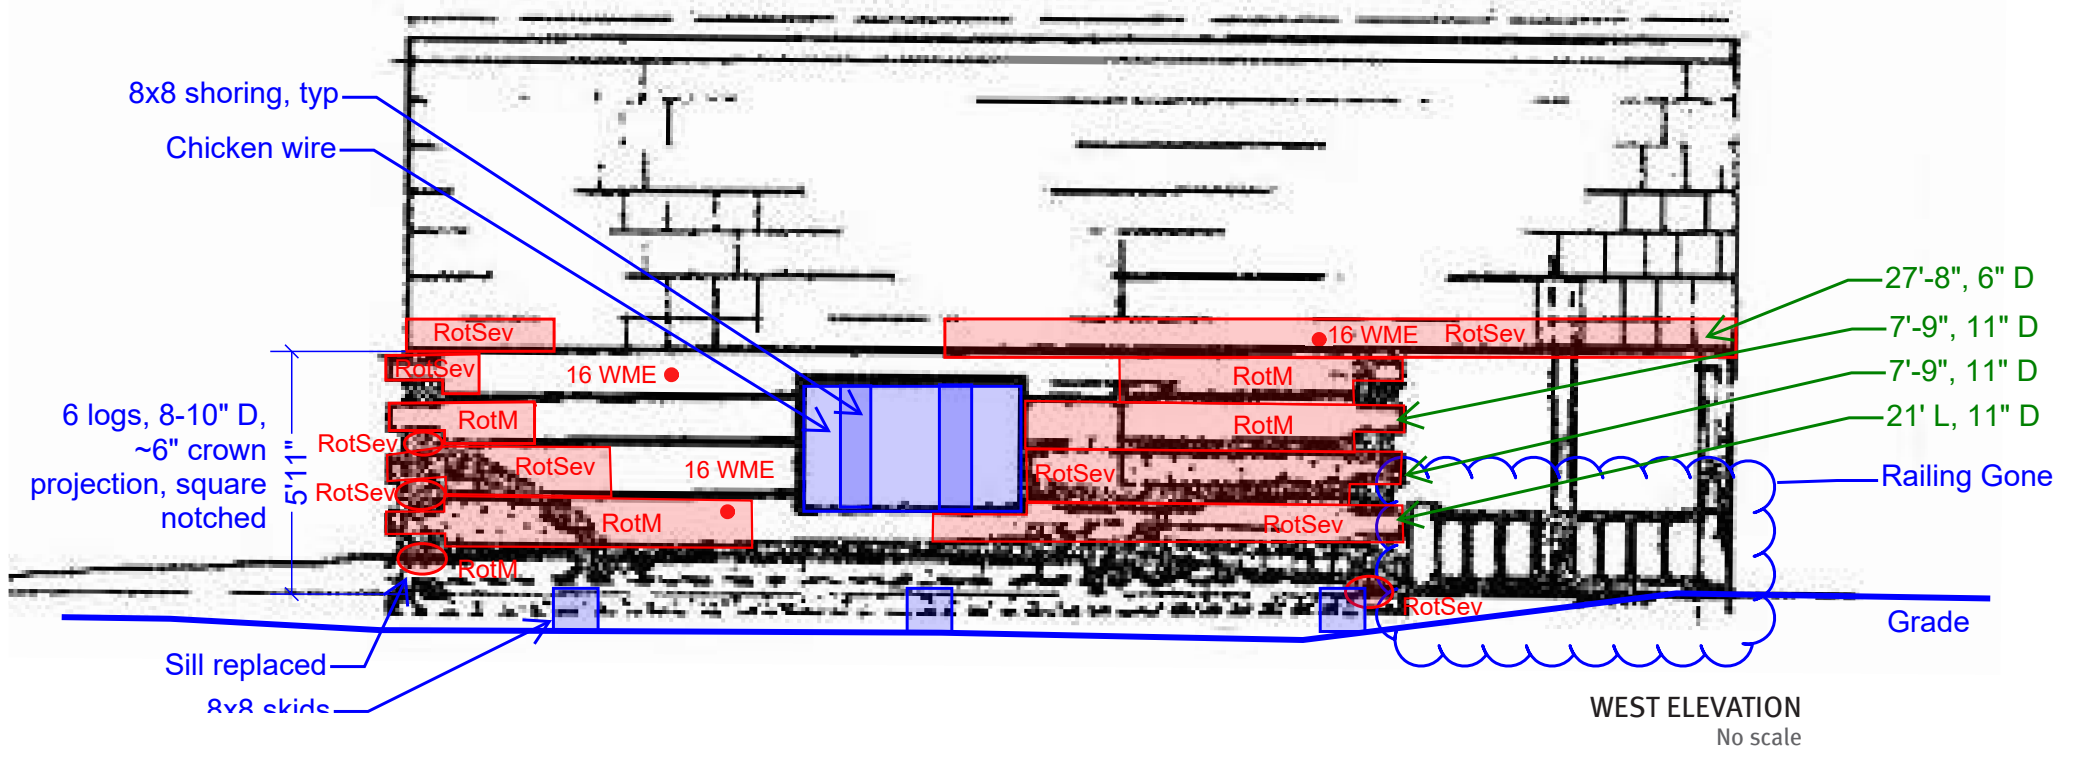
Exterior Elevation Condition Mapping

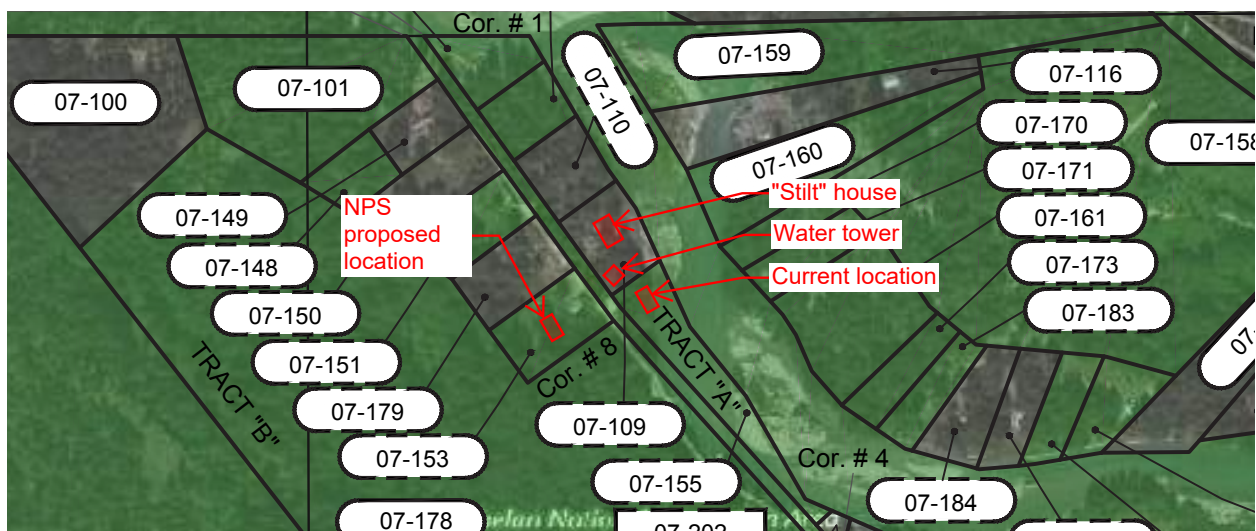
Image 49: Existing and proposed site locations.

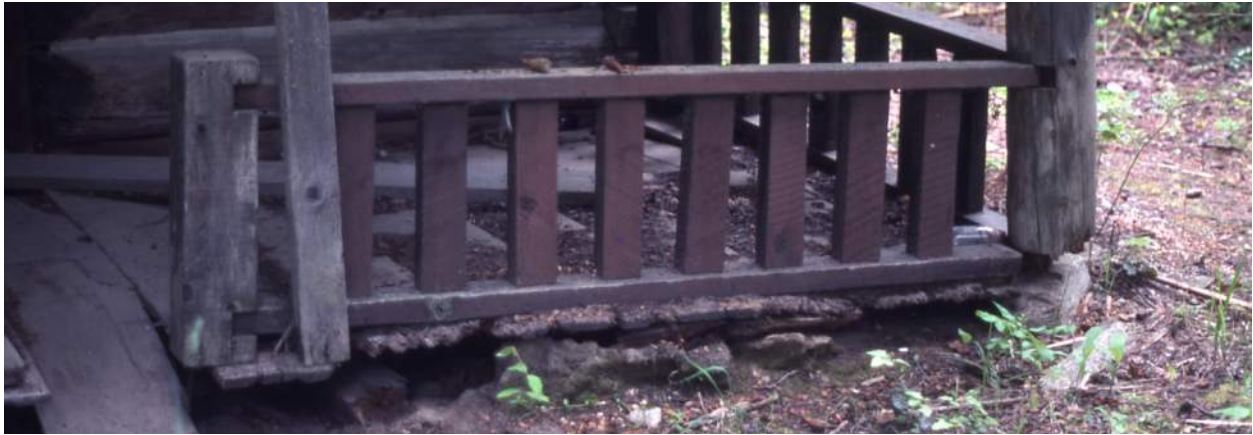
Image 51: Front porch details, no longer extant (National Park Service, North Cascades NPS Complex Museum Collection, NOCA 17314-25m)

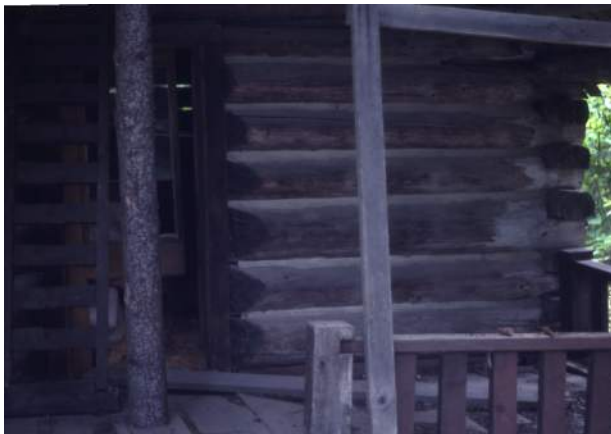
Image 52: Cementitious chinking observed in 1990. National Park Service, North Cascades NPS Complex Museum Collection, NOCA 17314-25n.

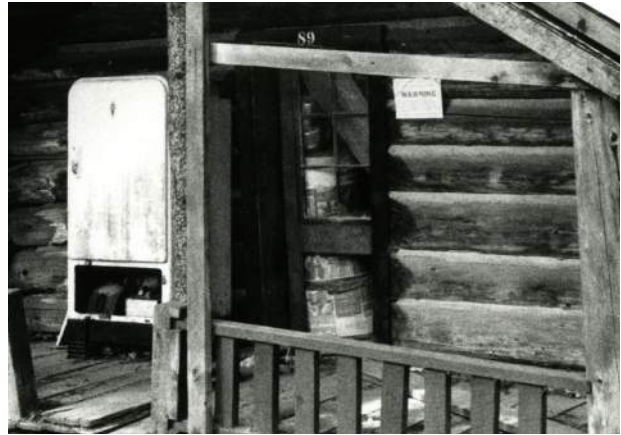
Image 53: Partially dismantled south door missing bottom panel at the Courtney Cabin captured in 1984. National Park Service, North Cascades NPS Complex Museum Collection, NOCA 17312-57.

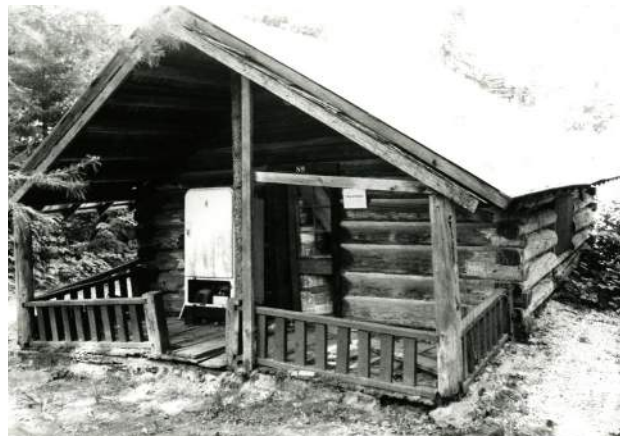
Image 55: Porch assembly in poor condition captured in 1984. National Park Service, North Cascades NPS Complex Museum Collection, NOCA 17312-57.

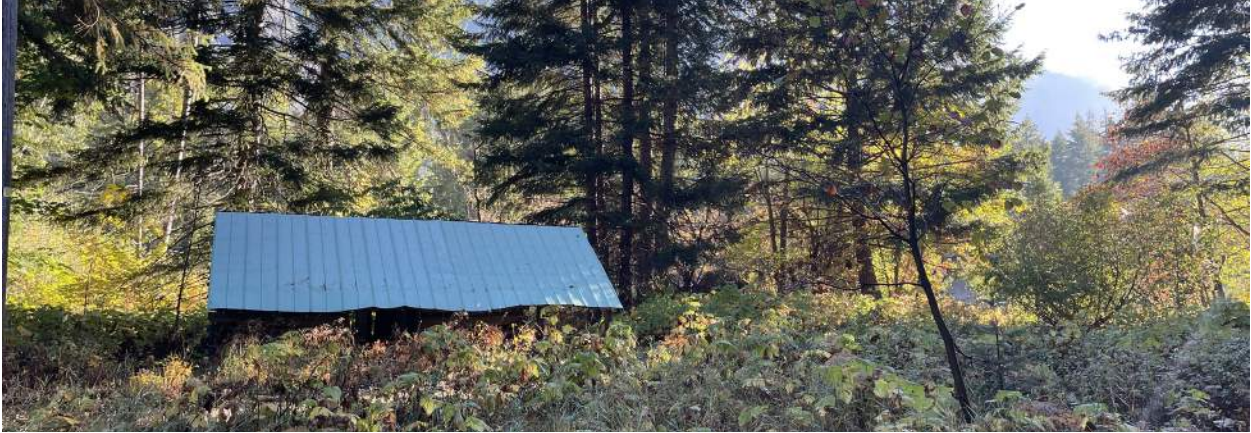
Image 56: View of Courtney Cabin west elevation, 2023.

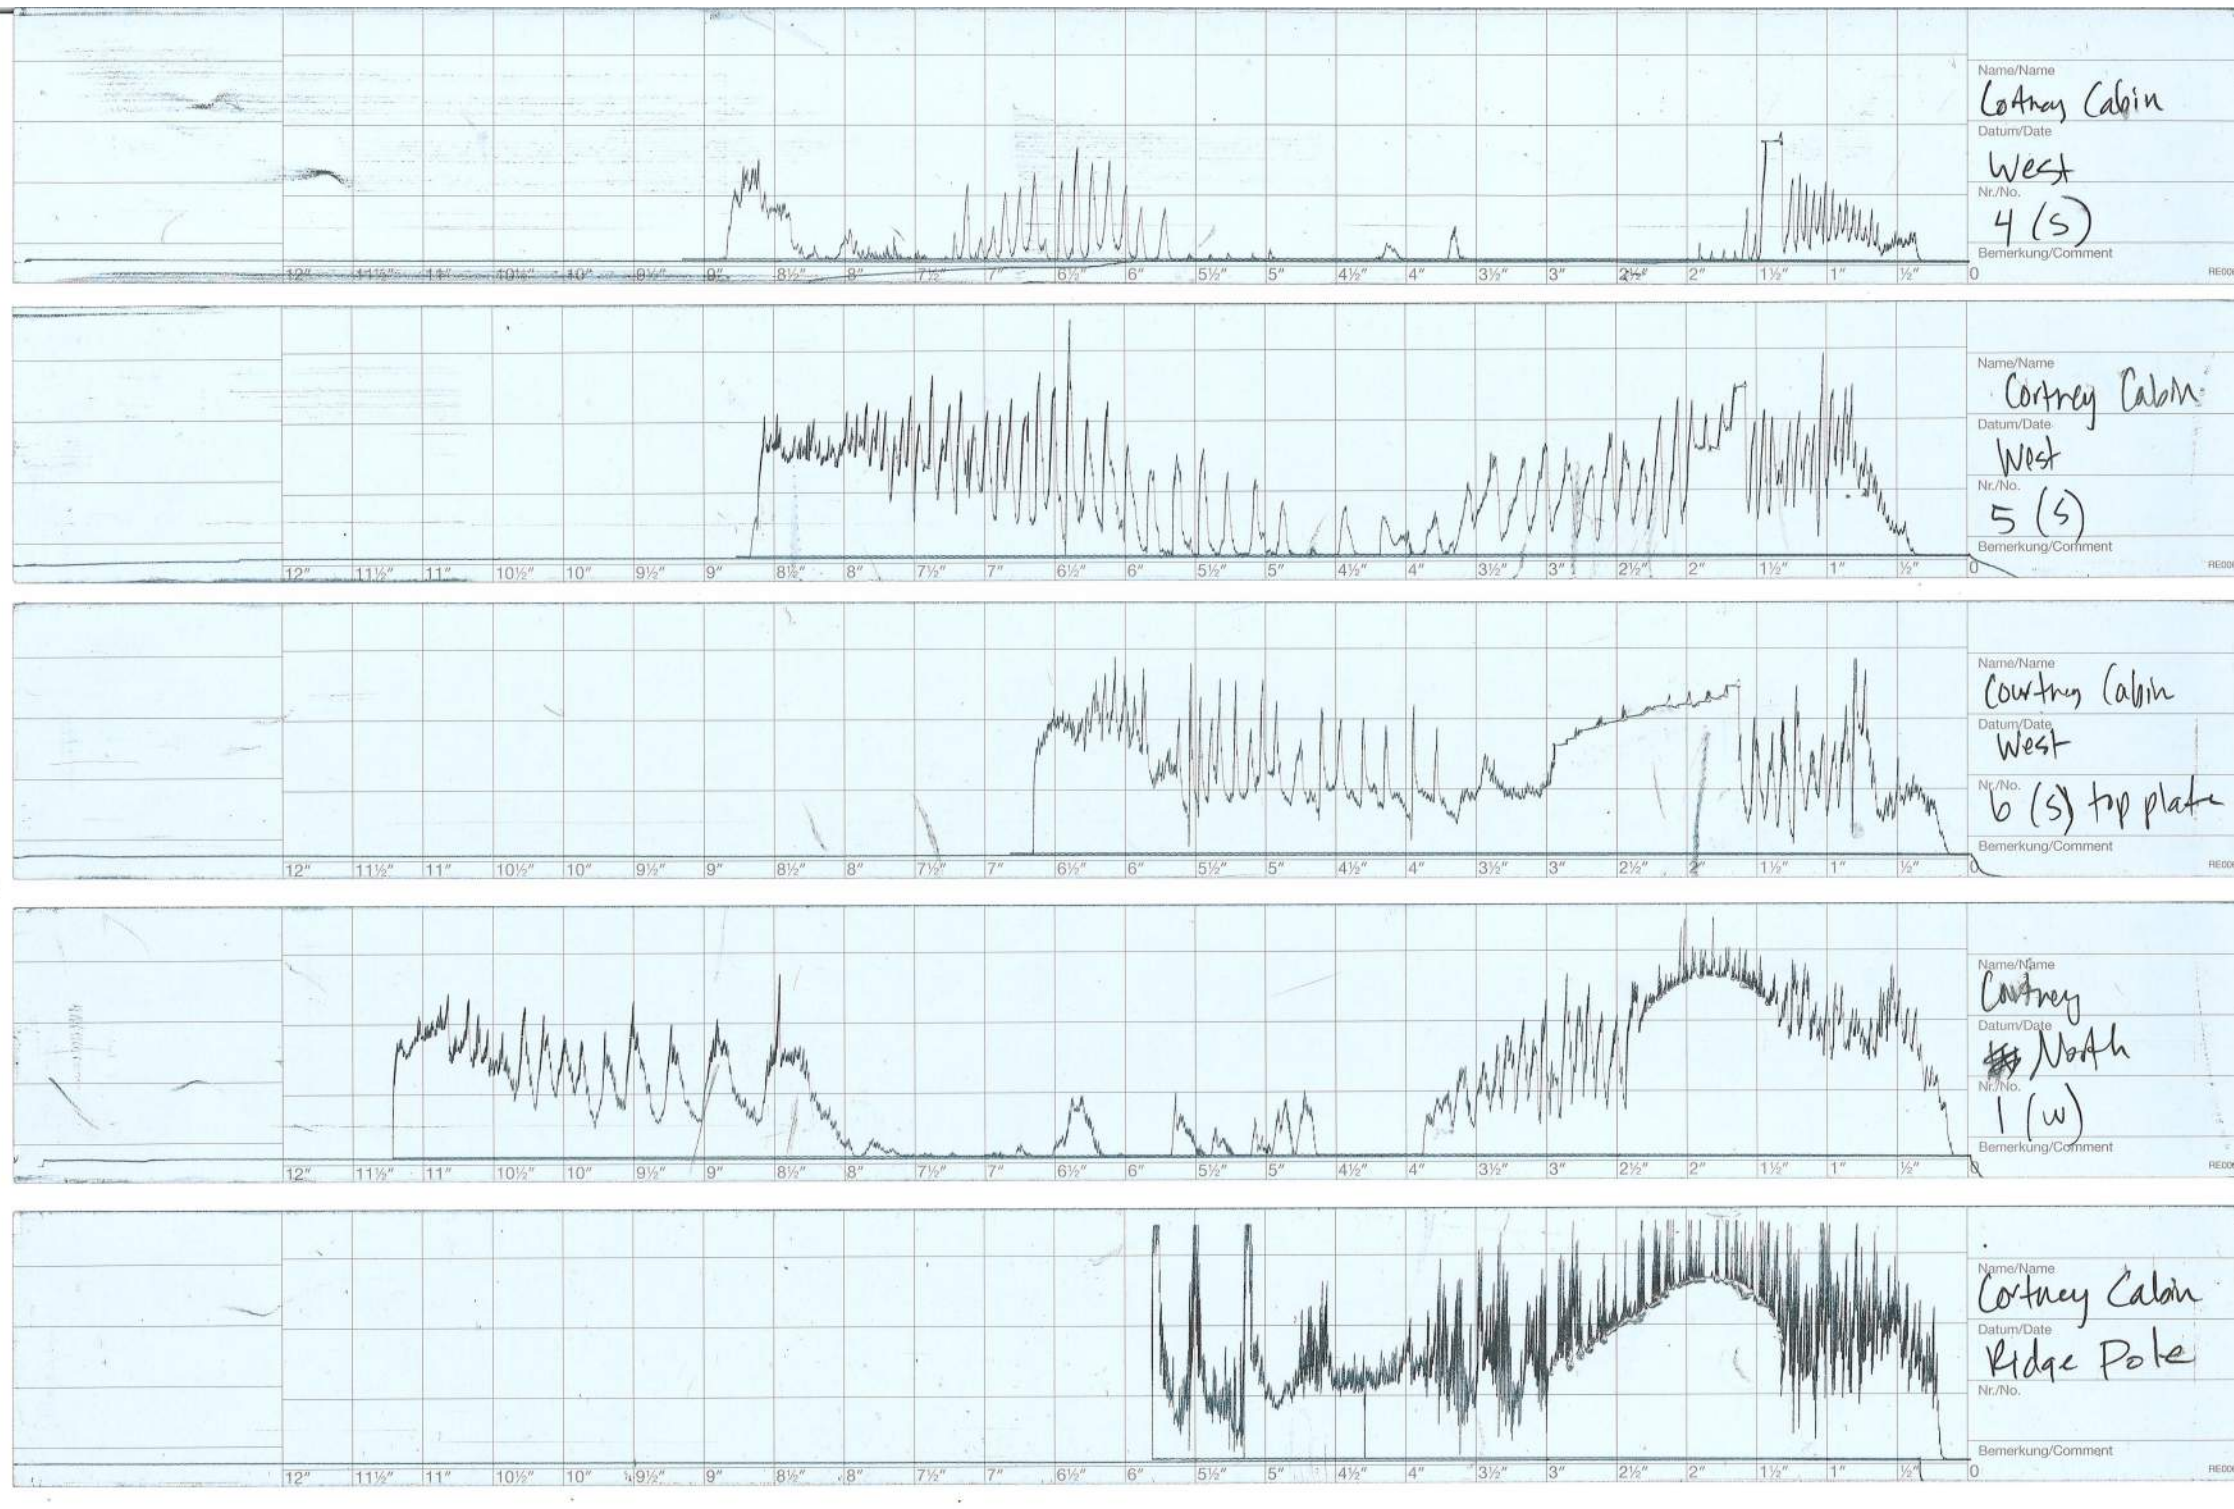
(Page intentionally left blank.)

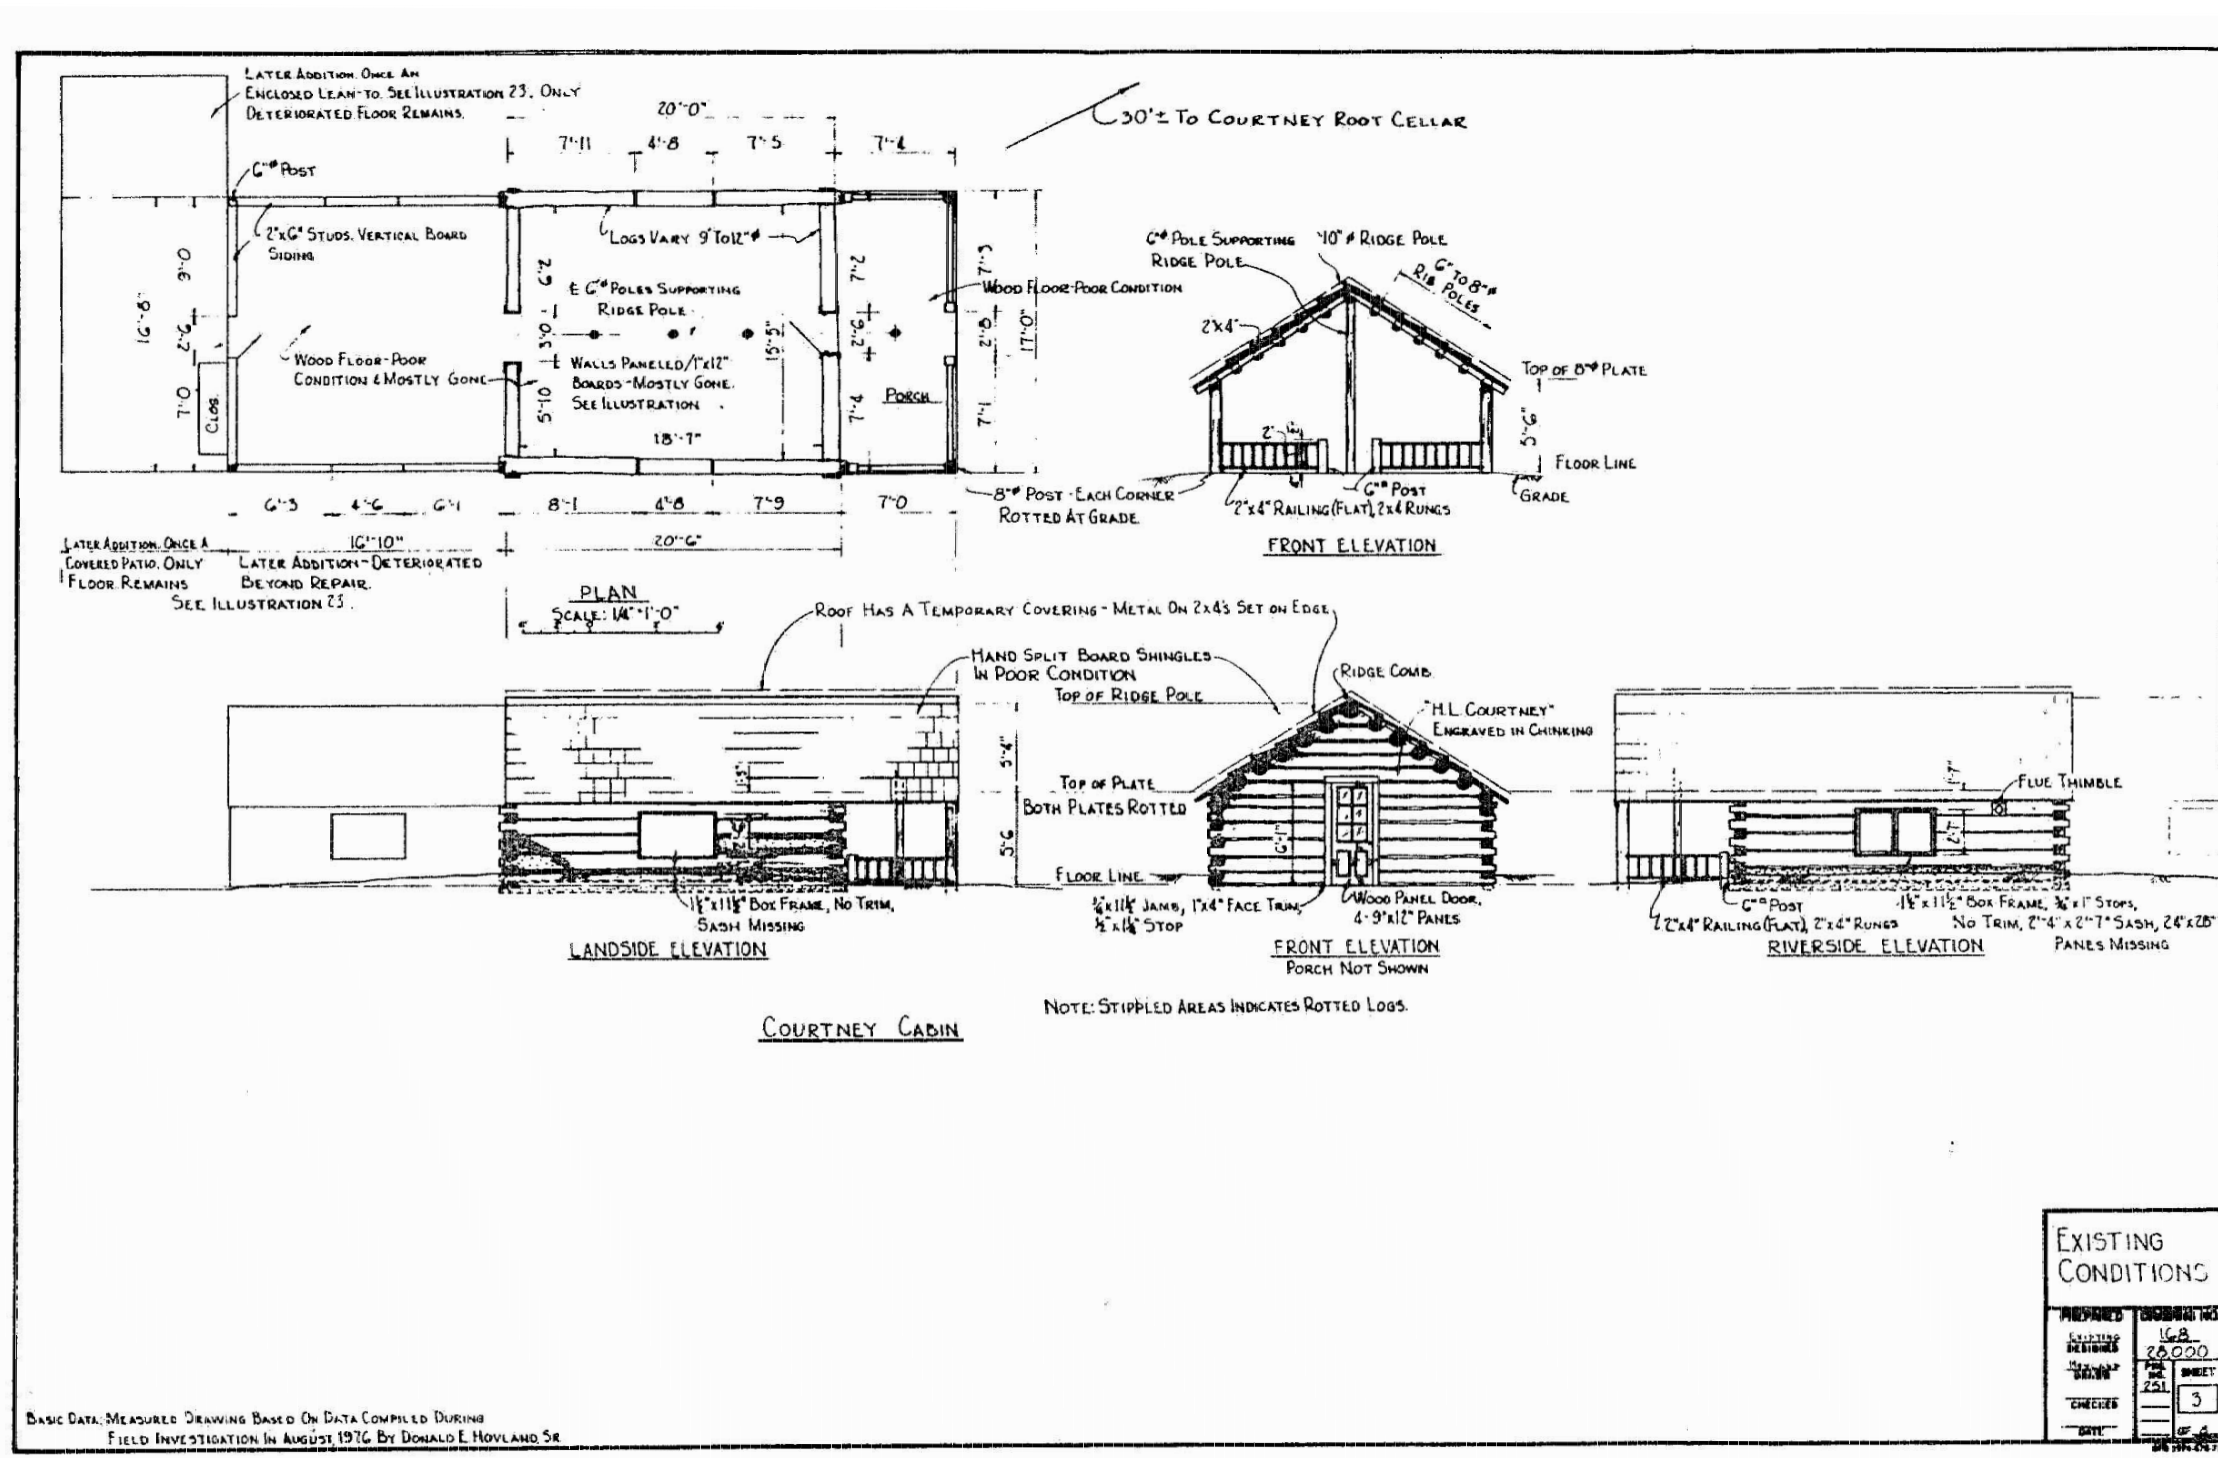
(Page intentionally left blank.)
