Subject: Selecting New Windows to Replace Non-Historic Windows

- Applicable Standards:**
- 2. Retention of Historic Character
 - 6. Repair/Replacement of Deteriorated or Missing Features Based on Evidence

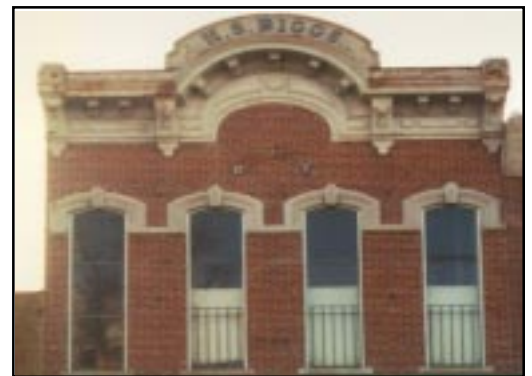
Application 1 (*Incompatible replacement*): An 1880s Italianate commercial building was rehabilitated for use as an office building. The main elevation of this small building is dominated by the fenestration on the second floor. Prior to rehabilitation, the four large, second-story windows contained incompatible replacement, three-part fixed sash. The owner had the option to retain these windows or replace them with compatible sash. While historic photos did not clearly illustrate the configuration of the original windows, double-hung sash with segmental arched tops or double-hung sash with a small transom would have been historically appropriate. Instead, the owner replaced the windows with three-paned pivot windows, similar to the windows in place before rehabilitation with heavy frames and meeting rails, that were not compatible with the historic character of the building. These replacement windows did not meet the **Secretary of the Interior's Standards**.

The second story of the primary facade showing non-historic fixed sash before rehabilitation.

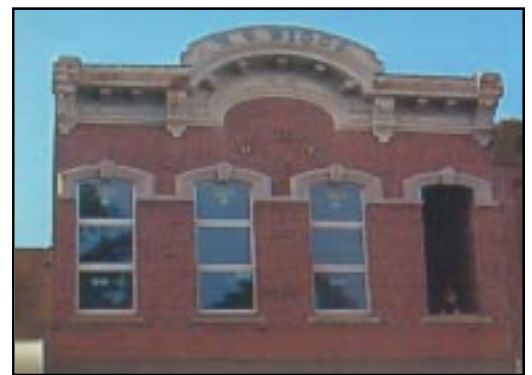
After rehabilitation, the new windows have a three-part configuration that is inappropriate to the historic style of the building.

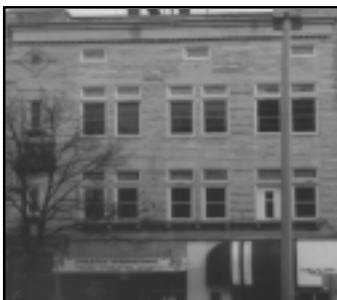
Before and after rehabilitation, one-over-one sash helped retain this commercial building's historic character.

Application 2 (*Incompatible treatment, later modified to meet the Standards*): A 1903 limestone Romanesque revival building was rehabilitated for use as apartments. Extant frames and multi-paned transoms were in place on the primary facade, but all sash had been replaced with one-over-one double-hung sash. Though the windows were not original, the one-over-one configuration was compatible with the building. A secondary facade revealed some remaining two-over-two double-hung sash. Owners had the option to retain the windows or replace them with historically appropriate sash. They installed two-over-two wooden sash on the primary facade based on the secondary elevation window configuration. Since there was no evidence that the front windows had ever been two-over-two, this treatment failed to meet the **Secretary of the Interior's Standards**. In order to meet the Standards, the owner subsequently changed the windows on the primary facade to one-over-one sash. The resulting fenestration is compatible with the historic character of the building.

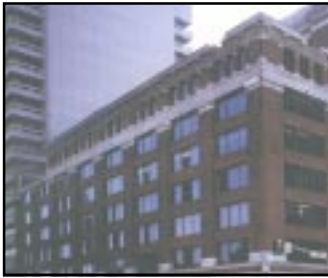
Application 3 (*Compatible replacement based on physical evidence*): A 1920, seven-story commercial warehouse located on a corner was rehabilitated for use as a hotel. Both street facades were heavily fenestrated. At the time of rehabilitation, the historic windows had been replaced with three-part, horizontal sliding windows, inappropriate to the building. One original window, a multi-pane steel industrial sash, was still extant. Based on this, the owner was able to reproduce the historic windows using fixed, steel, multi-paned sash, thereby reintroducing these distinctive features and reestablishing the historic character of the building.

Prior to rehabilitation the building had inappropriate modern windows.

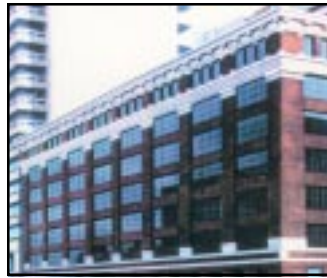
Installing multi-pane steel sash helped restore the building's historic appearance.

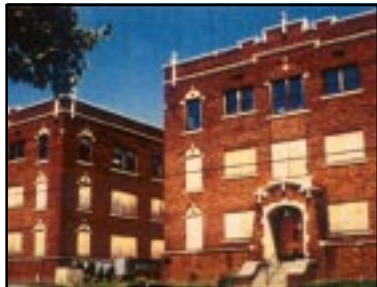
Application 4 (*Compatible replacement based on historic documentation*): A large brick apartment complex, built in 1927, was rehabilitated for its original use. The windows in the buildings had been replaced in the 1960s with one-over-one steel sash, out of character with the buildings. Because these windows were in place when the owners purchased the apartment complex they could retain the existing windows, use historic photographs to recreate the original windows, or install windows appropriate to the building. The owners chose to use photographic evidence to replicate the historic, multi-paned configuration of the apartment windows using vinyl-clad wood windows. The decision satisfied Standard 6 which requires that “replacement of missing features shall be substantiated by documentary, physical, or pictorial evidence.”

Prior to rehabilitation showing one-over-one sash. Similar sash is concealed by plywood covers on the first and second floors.

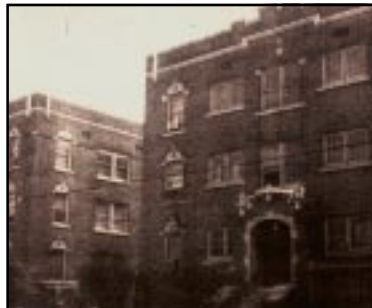
Historic pictorial evidence shows the original multi-pane configuration of the windows.

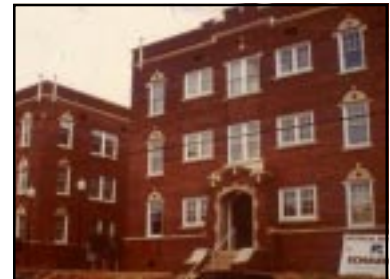
After rehabilitation the new multi-paned sash are appropriate to the historic style and character of the apartment buildings.
