# SAGAMORE HILL HOME OF THEODORE ROOSEVELT

Sagamore Hill National Historic Site  
Oyster Bay, New York

Historic Structure Report

Marie L. Carden  
with  
Richard C. Crisson

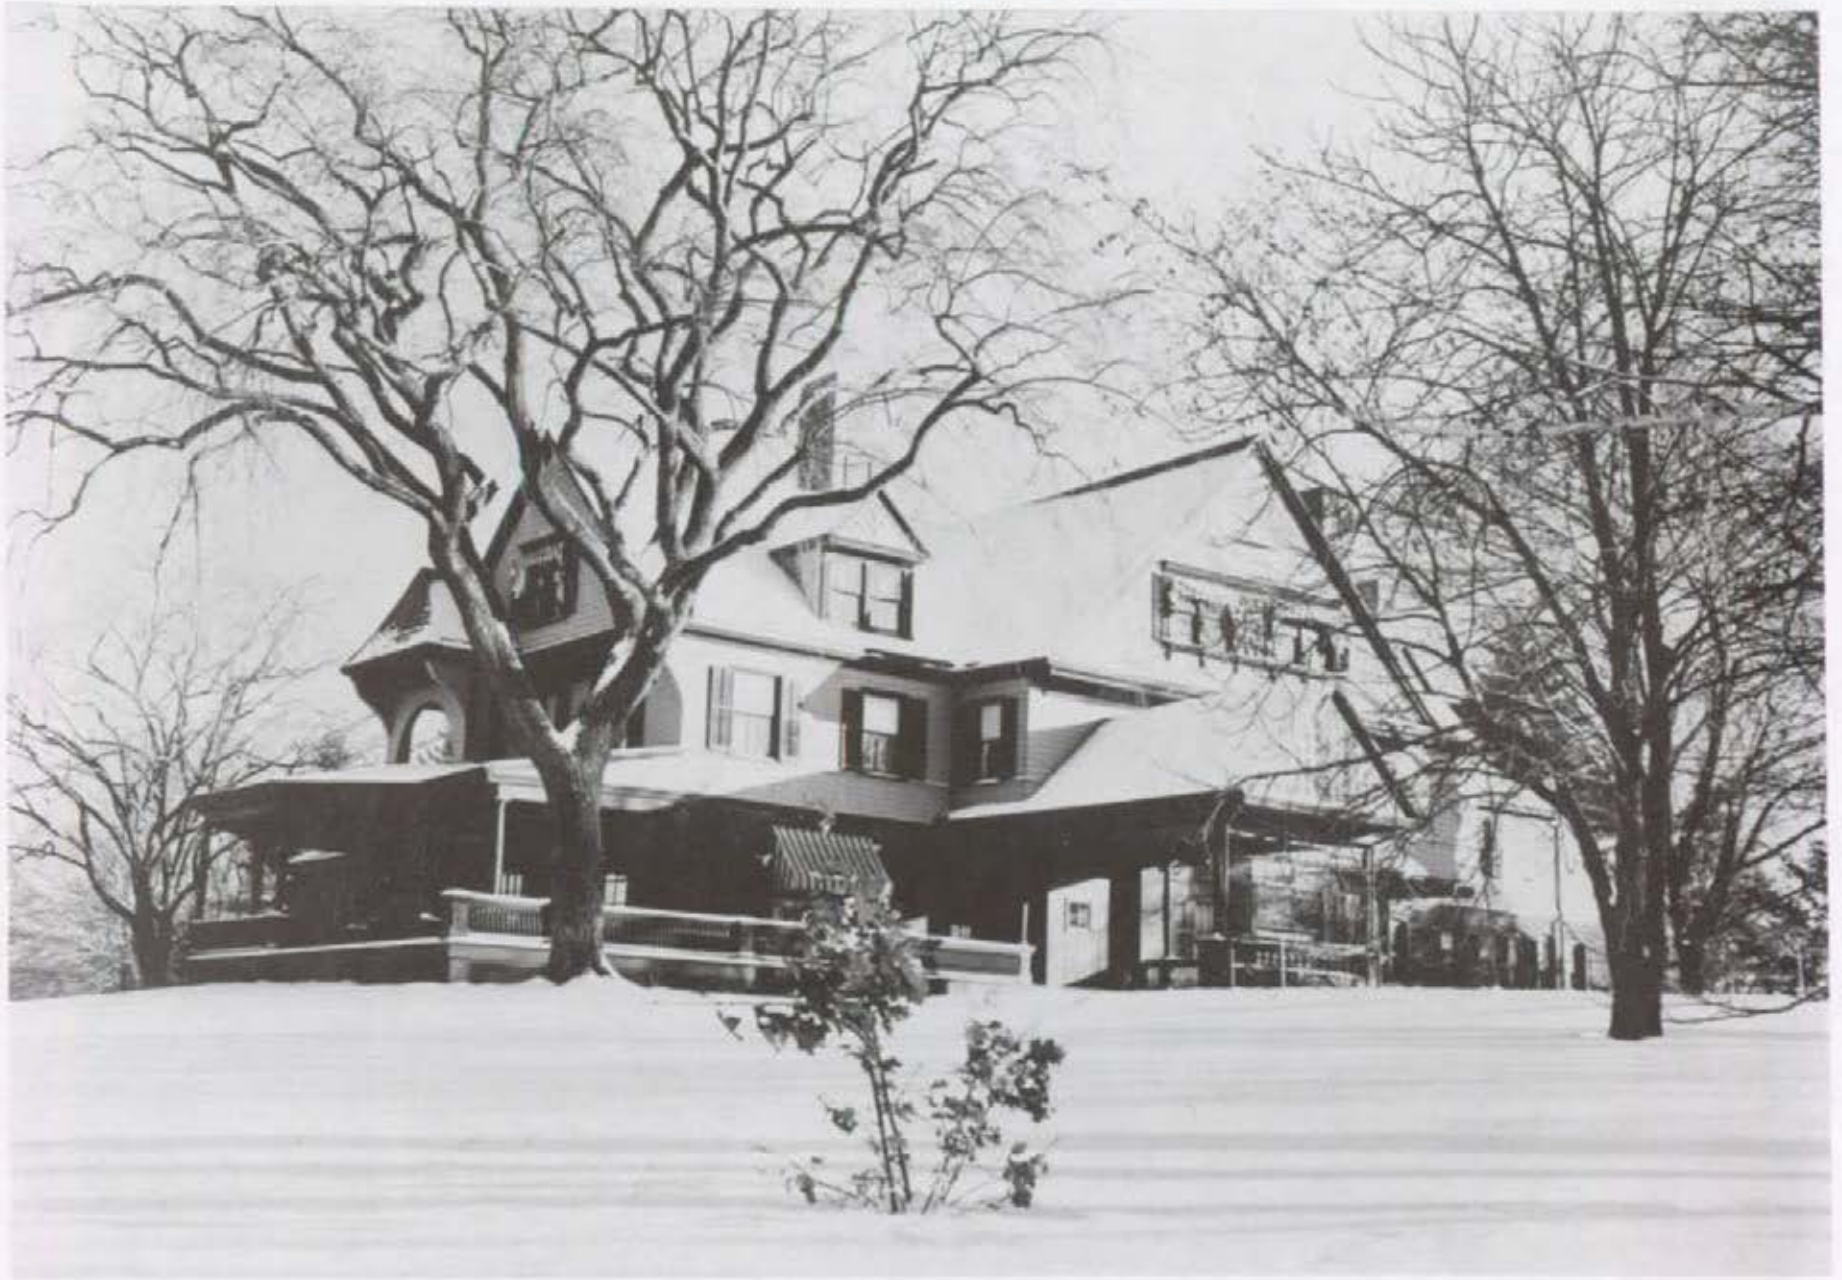
Figure 20. TR Home in winter, 1959. Storm shelter hides south entrance door.

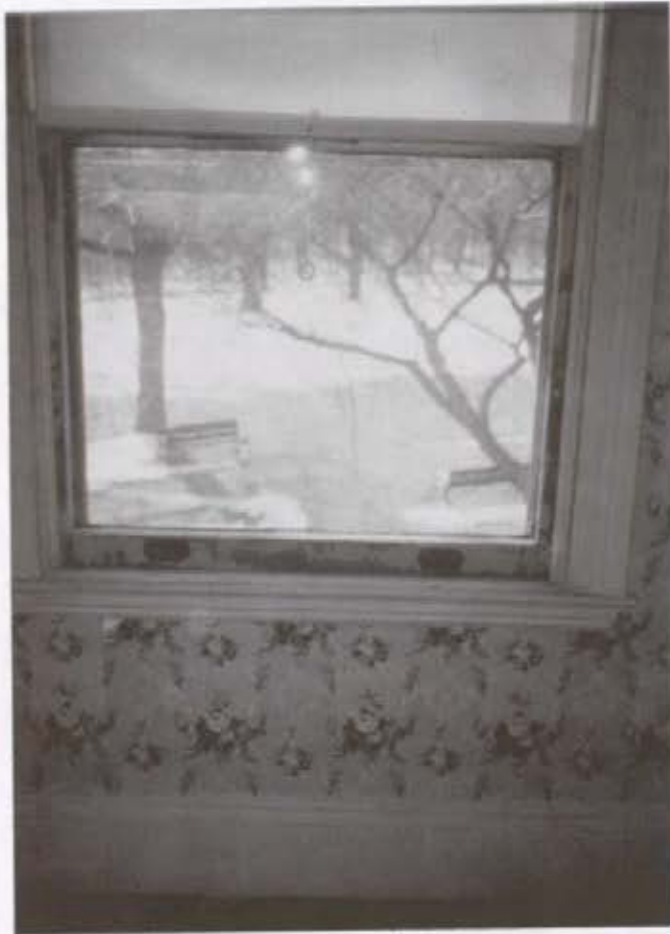
Typical Window Sash Condition Before Restoration

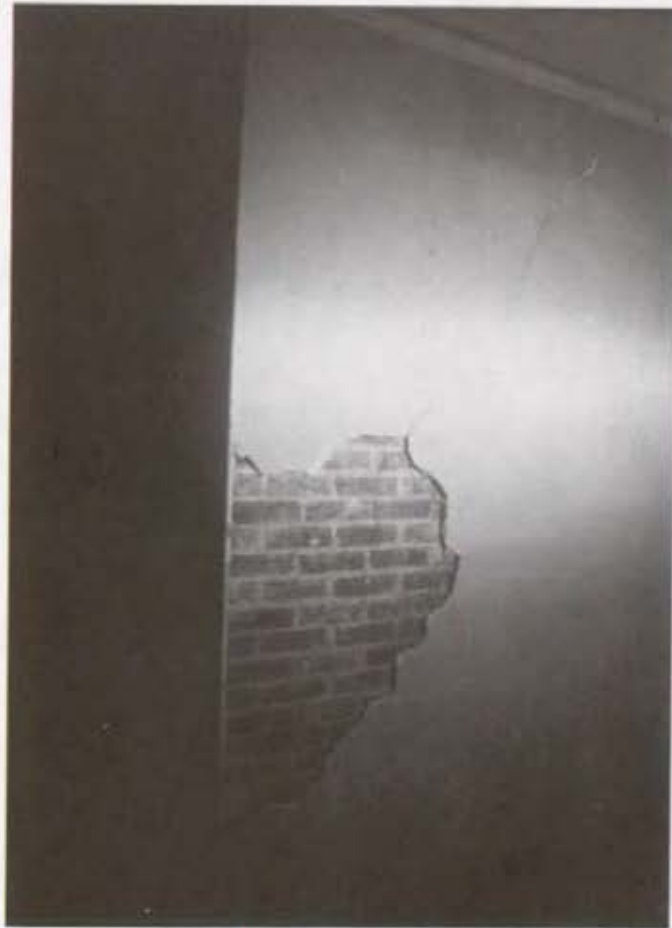
Alice's Room: Plaster Damage

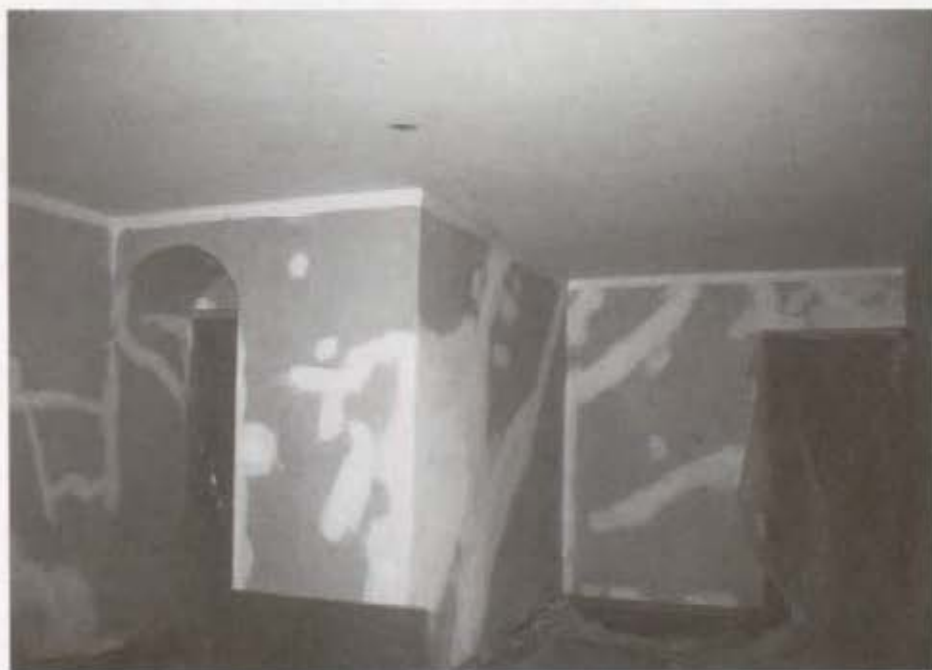
Alice's Room: After Restoration (plaster repaired,  
ready for wallpapering).

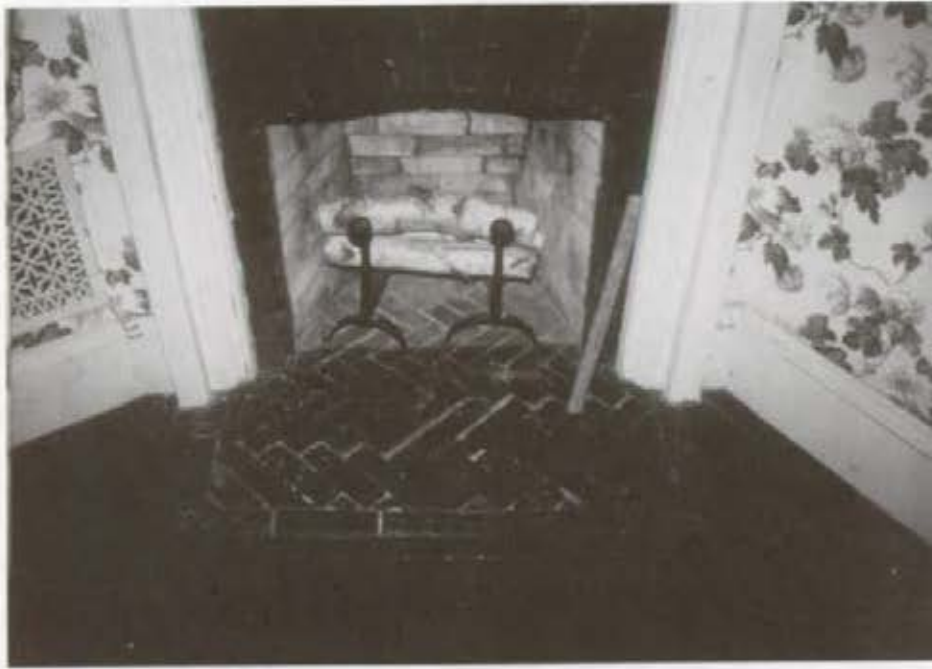
**Mother's Room: Condition of Fireplace Hearth  
Before Restoration**

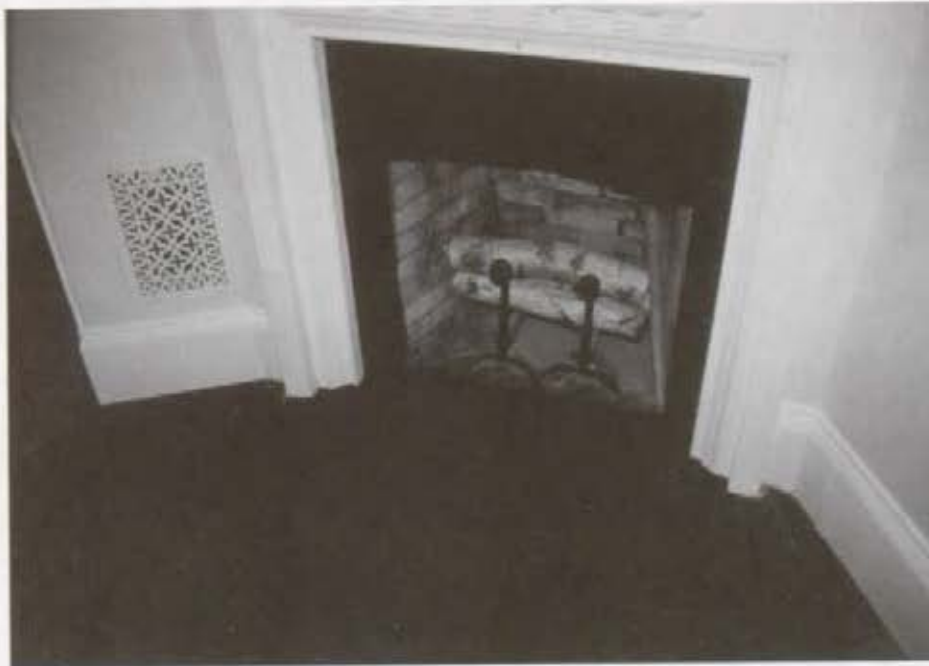
**Mother's Room: Condition of Fireplace Hearth  
After Relaying, Repointing, and Repainting**

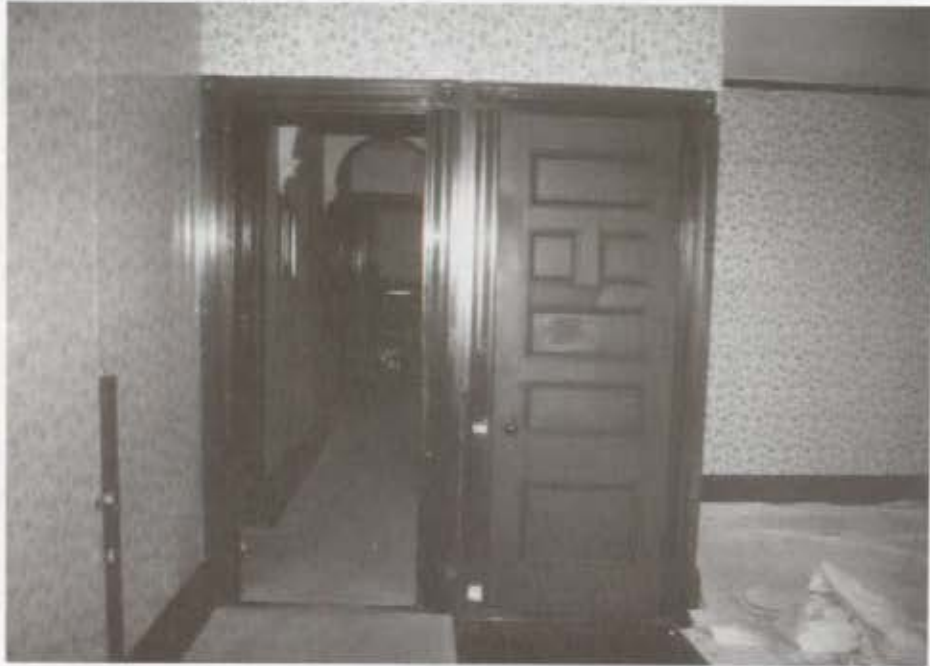
**Typical Condition of Stained Woodwork**

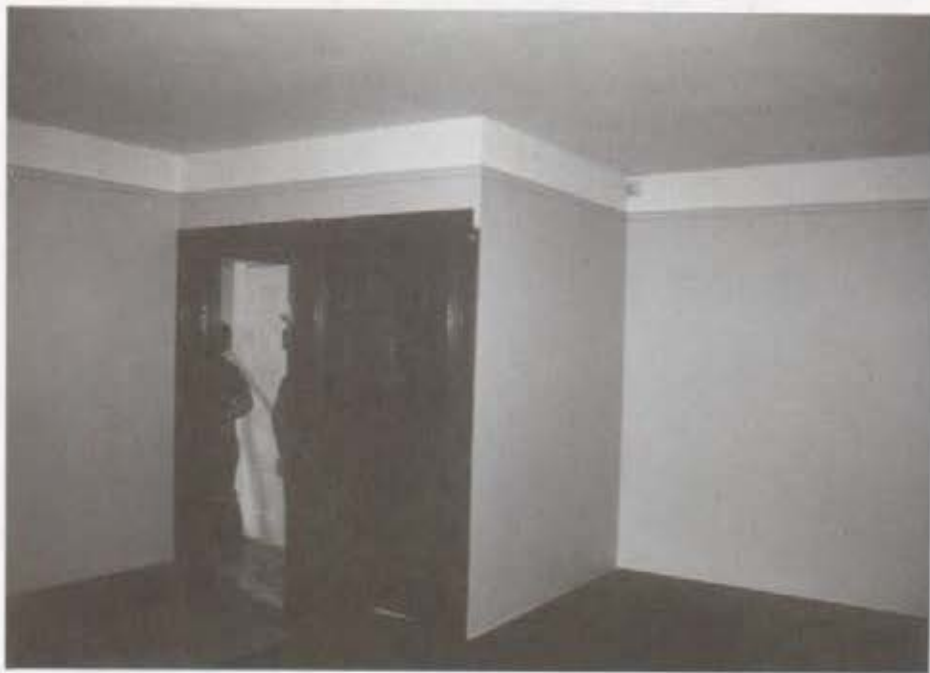
**Typical Refinishing of Stained Woodwork**

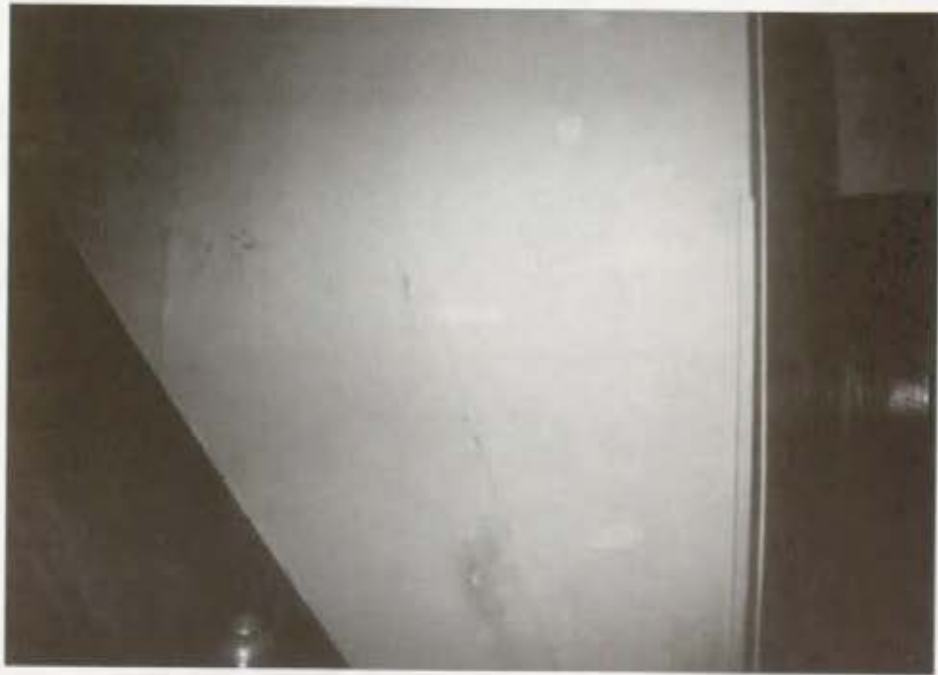
**Second Floor Rear Hall, Stairway: Before Restoration  
(plaster severely deteriorated)**

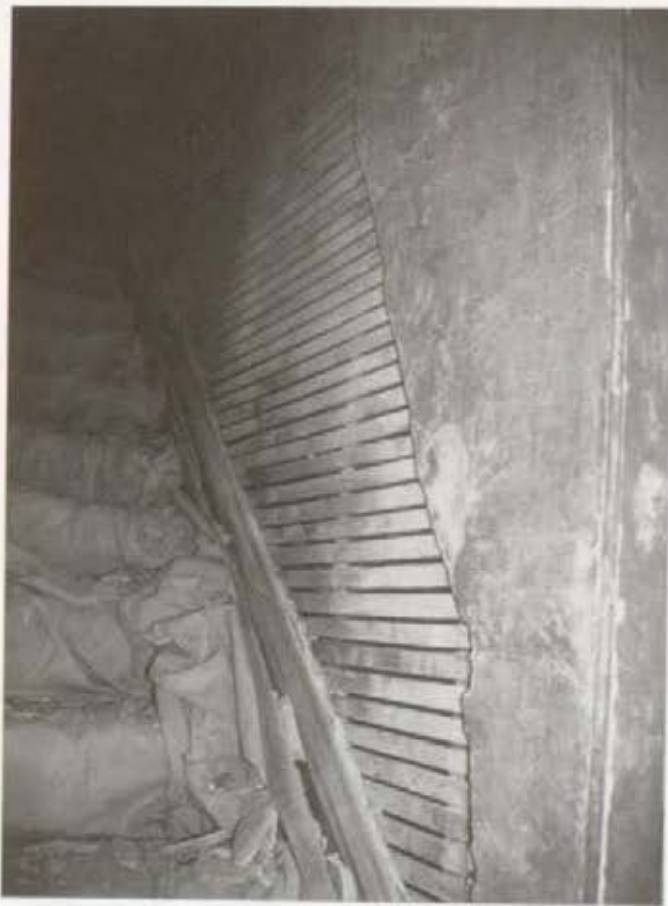
**Second Floor Rear Hall Stairway: During Restoration  
(plaster removed)**
