THE FORTIFICATIONS OF SAN JUAN NATIONAL HISTORIC SITE

HISTORIC STRUCTURE REPORT

Summaries
Conditions Survey
Recommendations
Glossary
Bibliography
Selected Historic Drawings
Appendices

1991

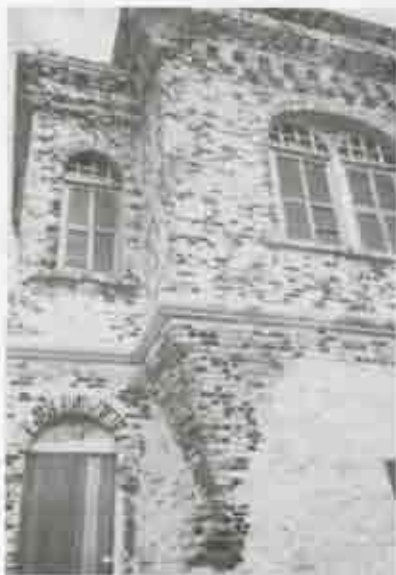
One of the most dramatic examples of differential erosion is found at the lighthouse on el Morro (fig. 9). The lighthouse was constructed in two different years; the upper (and newer) portion has deteriorated to a much greater degree than the lower. "Honey combing" is the phenomenon where brick become severely eroded and the mortar joints remain intact. (This will be discussed to a greater extent later in the text.)

Figure 9. El Morro, lighthouse. (Photo by W. Bedovic, 1989.)

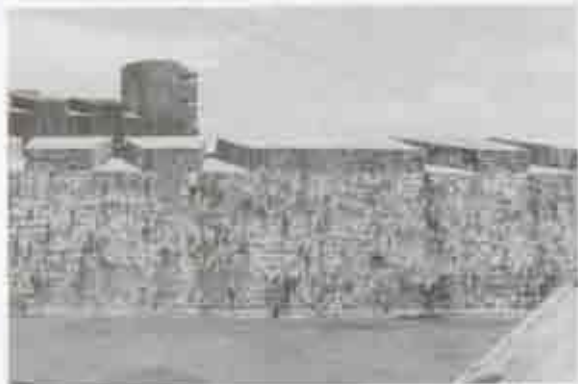
Figure 10. San Cristóbal, exterior wall of North Section.
(Photo by J. Jacob, 1989.)

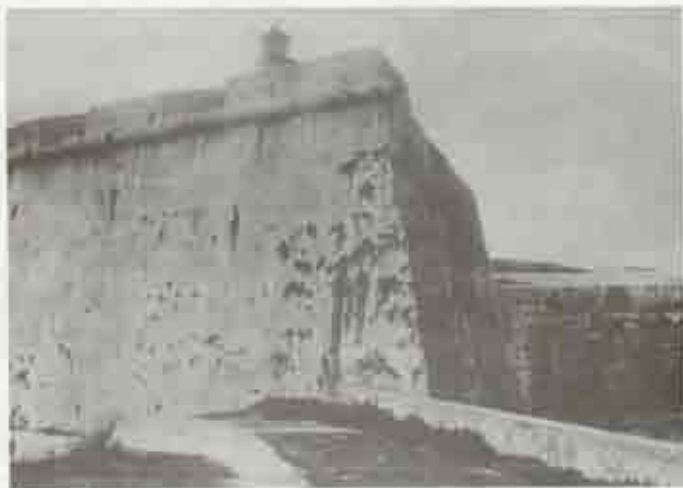
The apparent streaking of the finish may in fact be surface stains resulting from biological growth. A photograph dated 1900 shows the salient angle of Ochoa Bastion (fig. 20). The southeast wall still has most of its original surface stucco and finish. The black splotches designating deterioration and biological organisms all have, to a greater or lesser degree,

Figure 18. Cahua Bastion, salient angle. (Photographer unknown, ca. 1900. San Juan NMS Archives.)

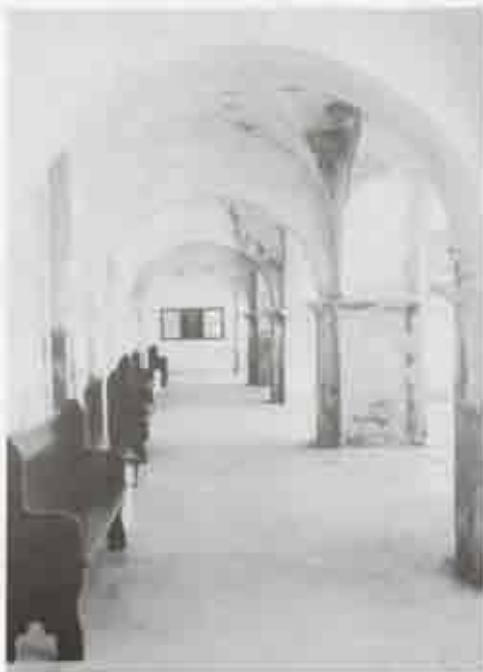
Figure 21. Officers' Quarters, San Cristóbal, arcade. (Photo by J. Berkowitz, 1986.)

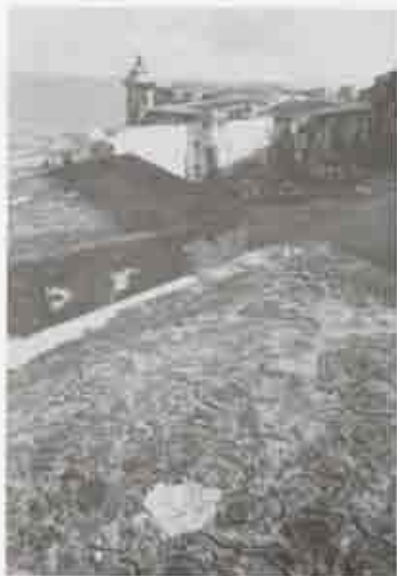
Figure 22. Santa Barbara Battery, merlons on the south side. (Photo by J. Jacob, 1989.)

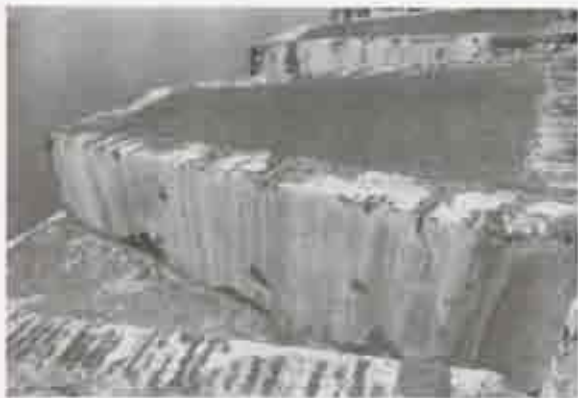
Brick dating to the Spanish tenure is primarily found edging banquettes and merlons and was originally covered with stucco (fig. 23). Where stucco has worn away on tops of merlons, brick remain in good condition with the mortar exhibiting loss. Exposed brick on banquettes is eroding due to heavy pedestrian traffic.

Figure 23. Santa Barbara Battery, sections on the south side. (Photo by J. Jacob, 1989.)

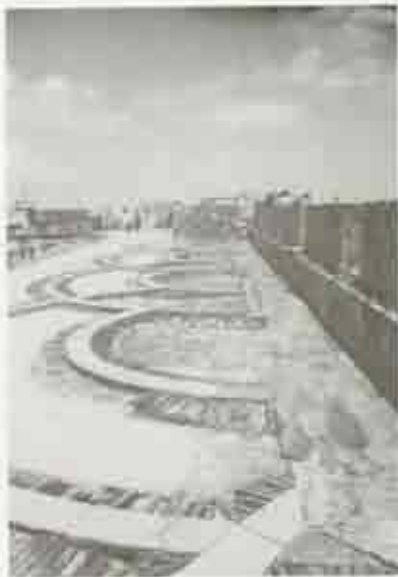
Figure 24. Santa Barbara Battery, gun tracks on the north side. (Photo by W. Sedovic, 1988.)

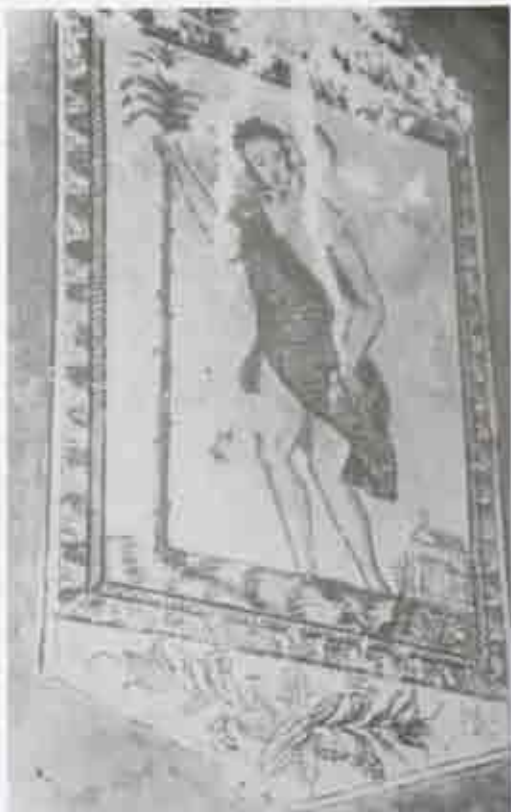
Figure 27. San Cristóbal, painted figure in cistern.
(Photo by T. T. Waterman, ca. 1910. SAN JUAN NMH
Archives.)
