HISTORIC STRUCTURES REPORT

ARCHITECTURAL DATA SECTION

THE SCALE HOUSE

Salem Maritime National Historic Site

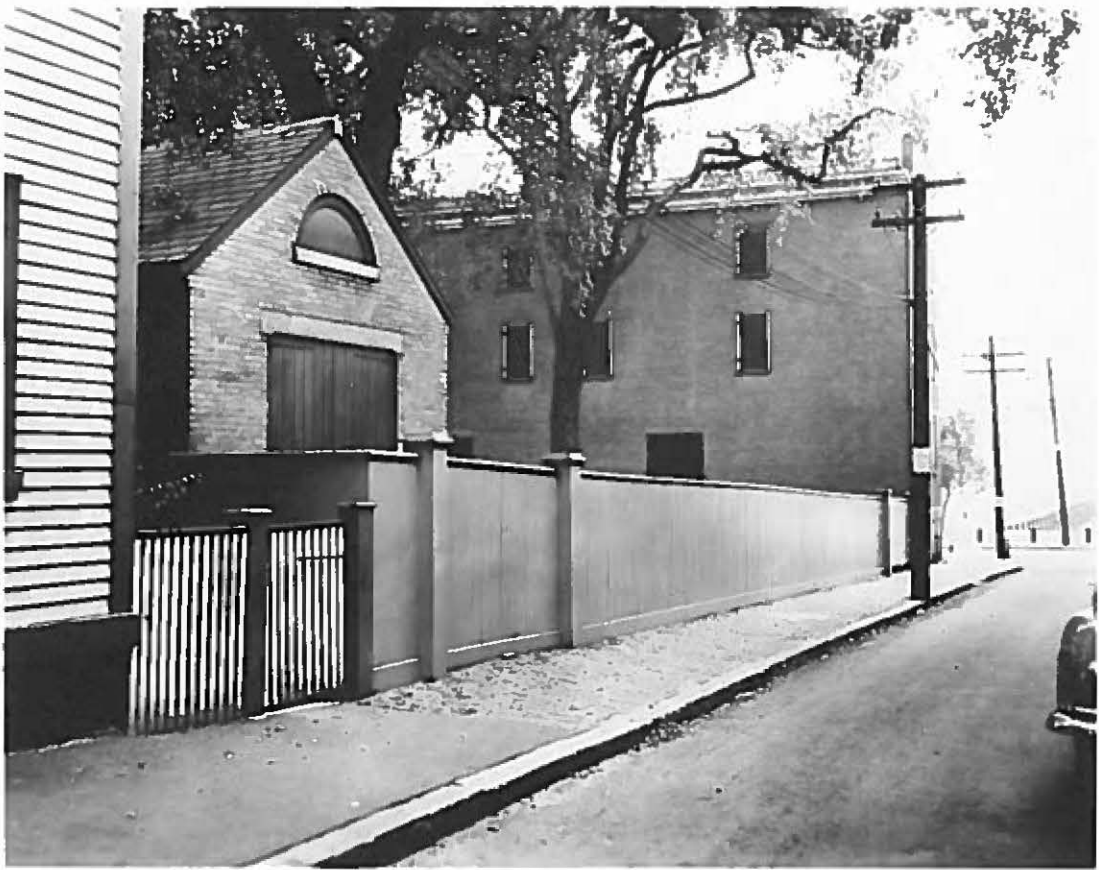
ILLUSTRATION NO. 1

View of the west front of the Scale House which is partially obscured by the Orange Street fence. The fence is a recent restoration but very little has been done to alter the original appearance of the building.

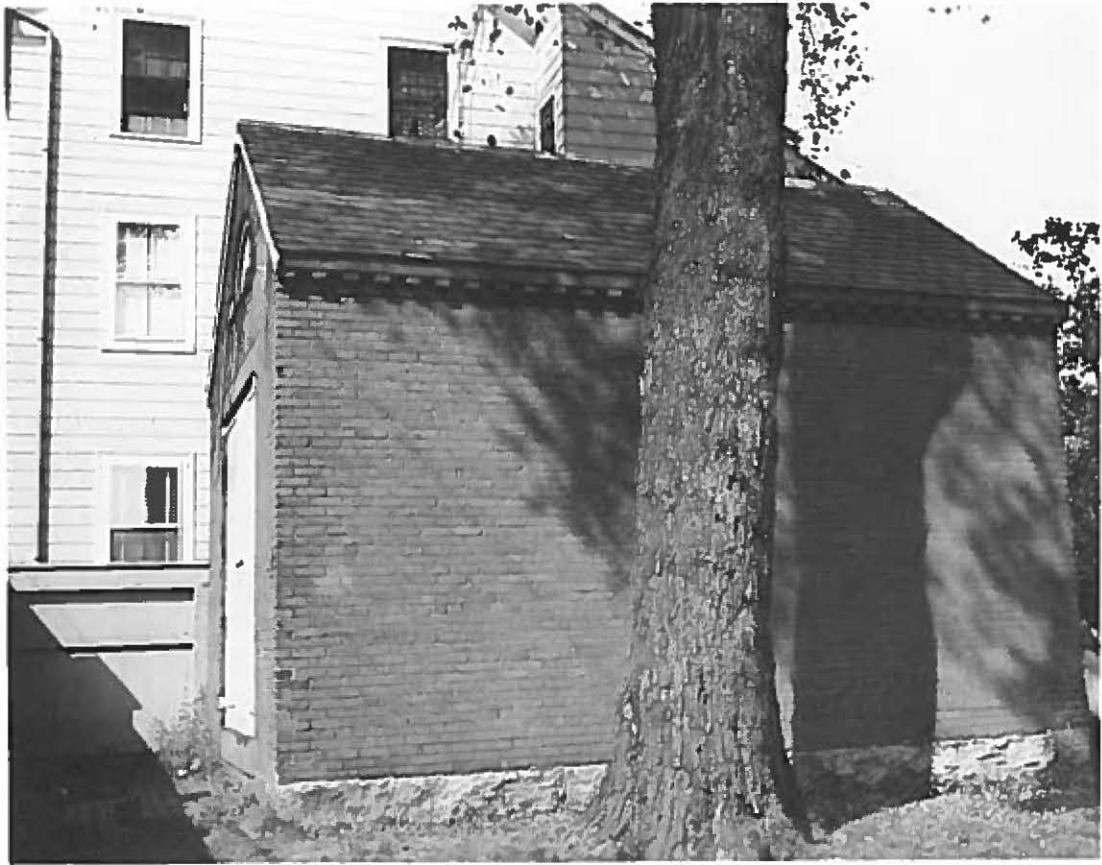
ILLUSTRATION NO. 2

View of south side of the Scale House, the brick modillion cornice being one of the most interesting features. The double doors and the arched gable opening can be seen on the west front. Also notice the remains of the right hand door stops which is about 3 feet above the floor line and 8 inches from the southwest corner of the building.

Wooden door stops, one of which still exists, should be restored, as the doors will be opened to exhibit the interior of the building. The stop is a 2-1/2" x 2-1/2" x 6" wood block.

The top and bottom are beveled 45 degrees toward the front and the 6" flat side is nailed to the brick wall. There is to be a new stop at each side of the door opening and it should be placed about 3'-4" above the floor line and 8" from the corner of the building. Although there is no evidence of a device with which to keep the doors open against the walls, they should be provided at this time if found necessary.
