historic structures report
january 1980

STATUE OF LIBERTY
ELLIS ISLAND / U.S. IMMIGRATION STATION

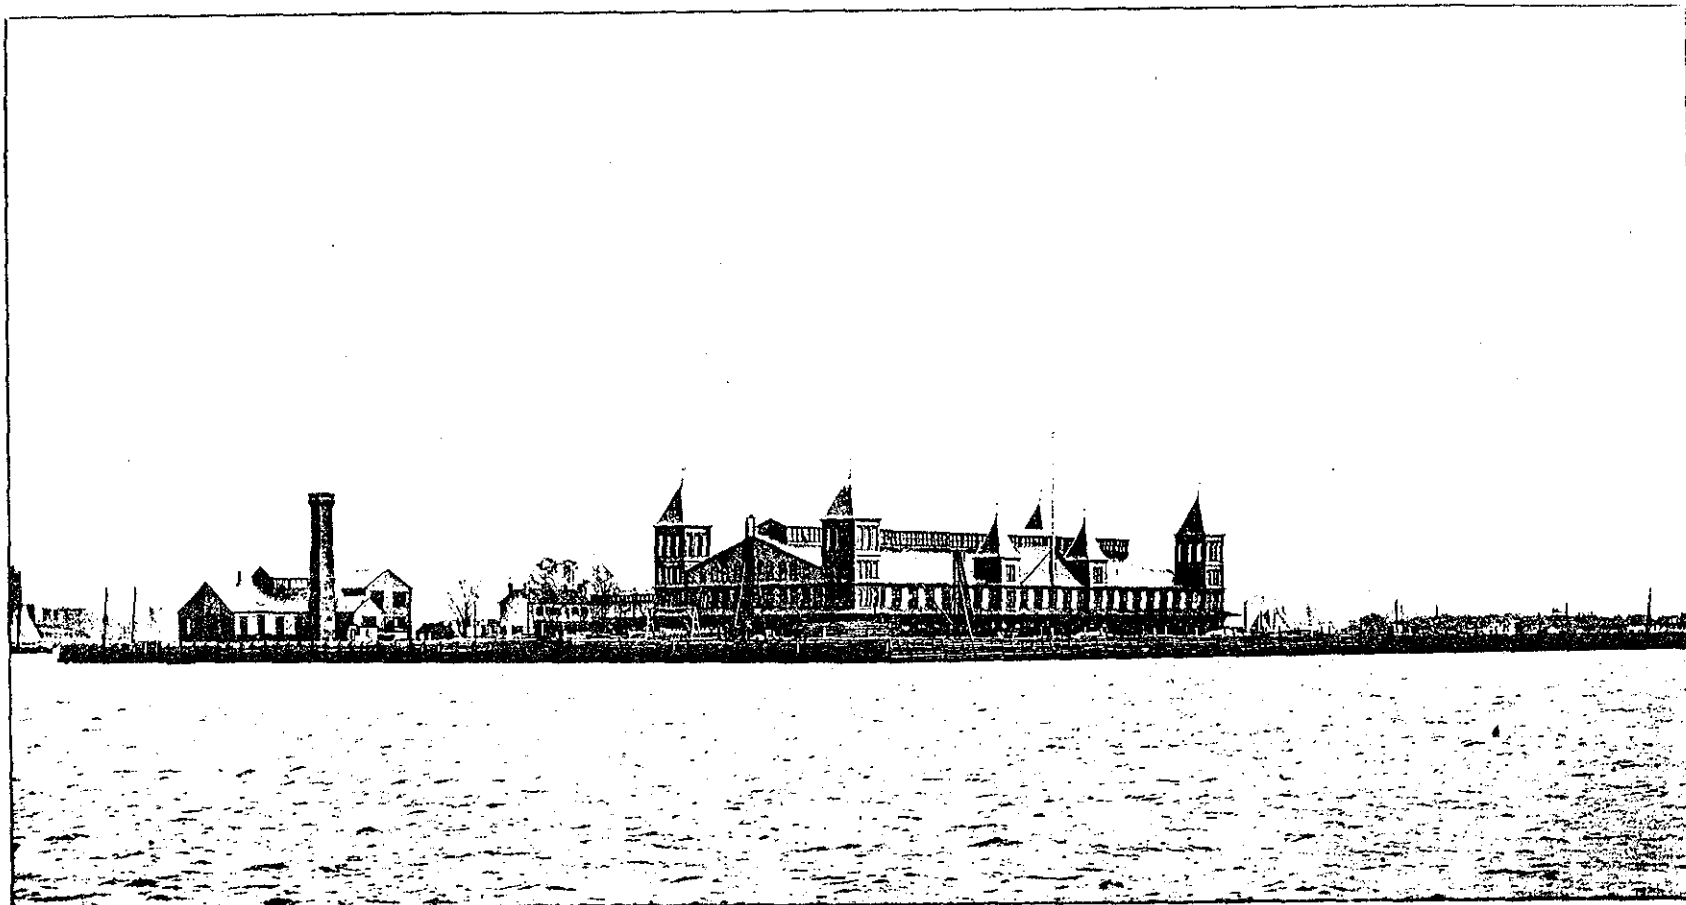
J. GOREKOWSKI, PRINT.

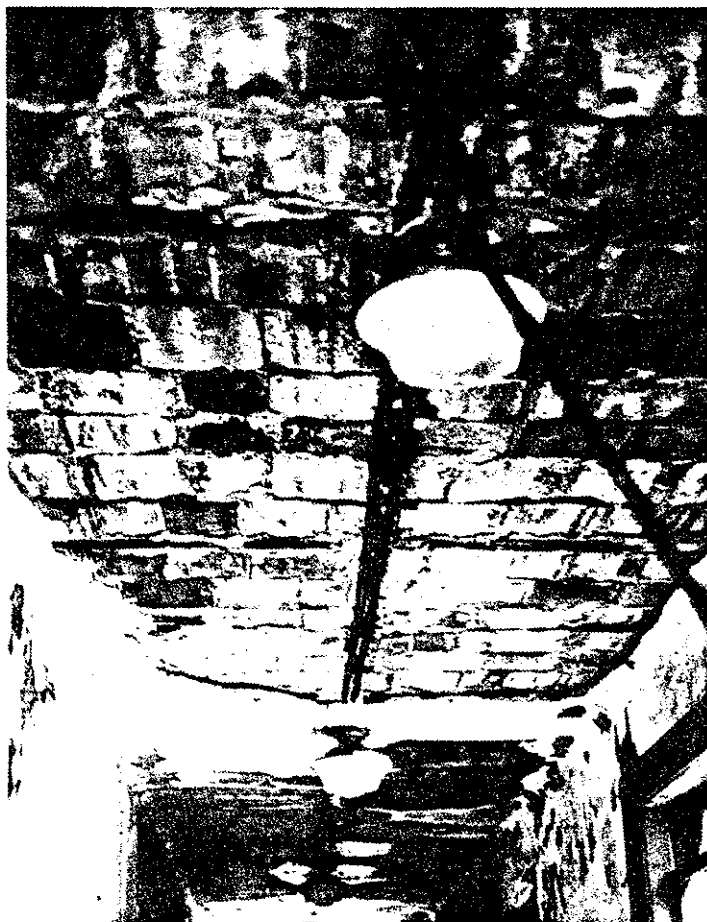
Structural clay tile fireproofing.

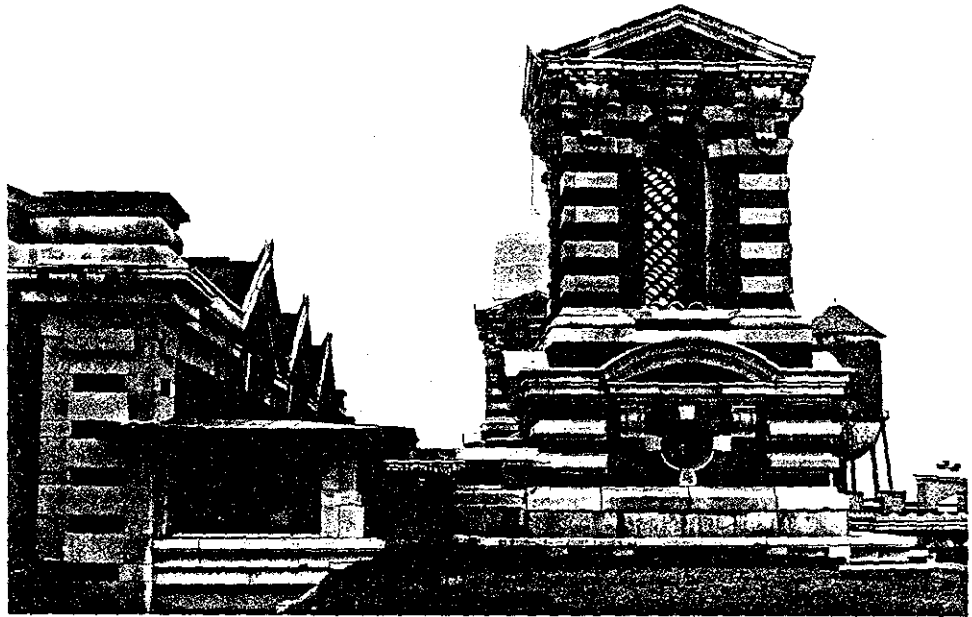
The ventilation system was upgraded in 1908 to provide air change within the rooms every five minutes. The normal rate was three to five air changes per hour.⁵¹ Only a small portion of the brick-walled duct system remains in the east end of the basement. All other walls, the fans, motors, heating coils and dampers have been removed. Many of the metal ducts can be located in the ceiling of the basement but have been blocked on the upper floors. The main supply and exhaust shafts still exist, but they, too, have been blocked off; three at the basement ceiling and all at the upper floor levels. The large exhaust fans are extant but are severely corroded and inoperable.

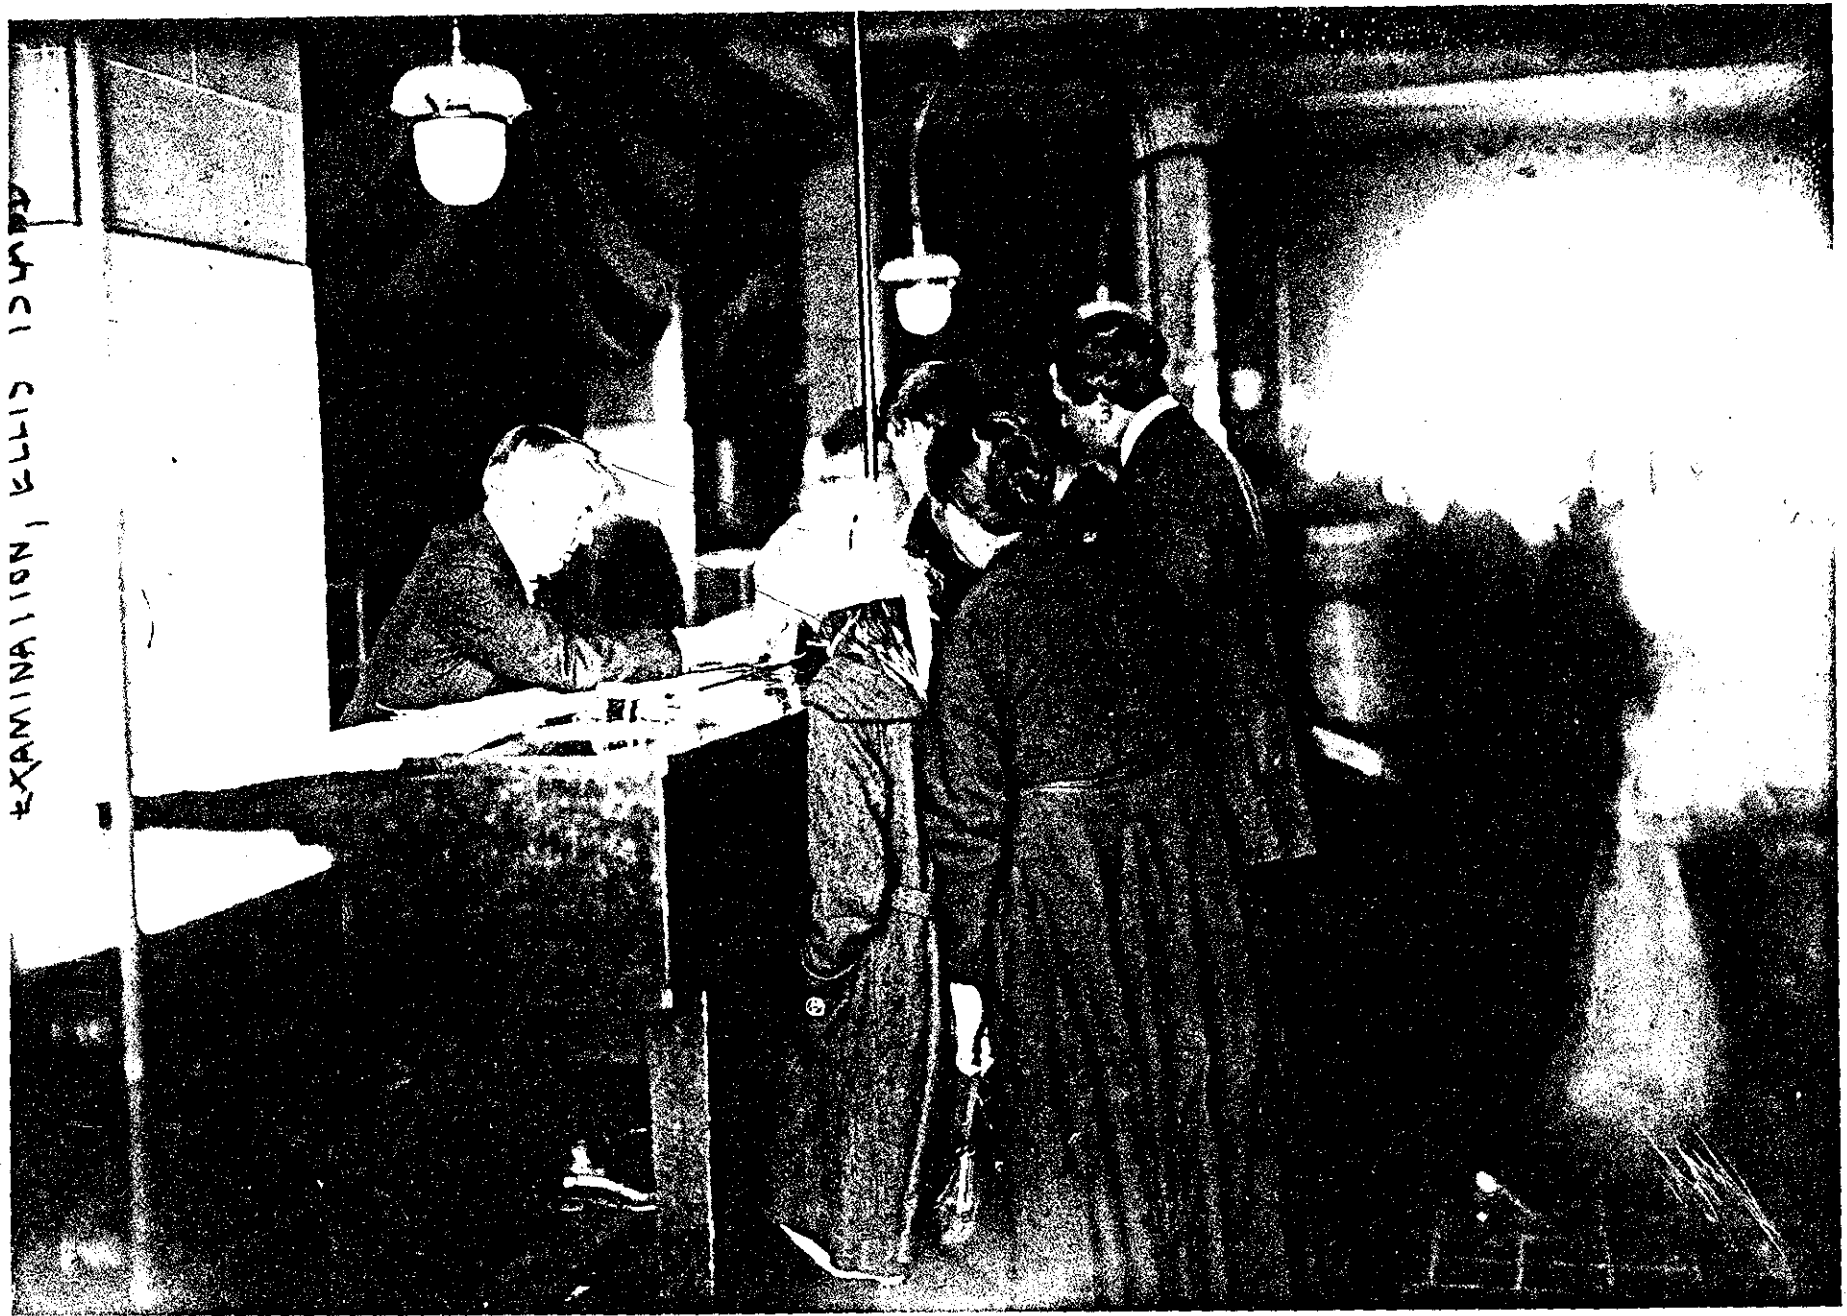
Early photograph of the Registry Hall taken sometime after 1918, showing desk mounted light fixtures. (Library of Congress, Prints and Photographs Division, Washington, D.C.).

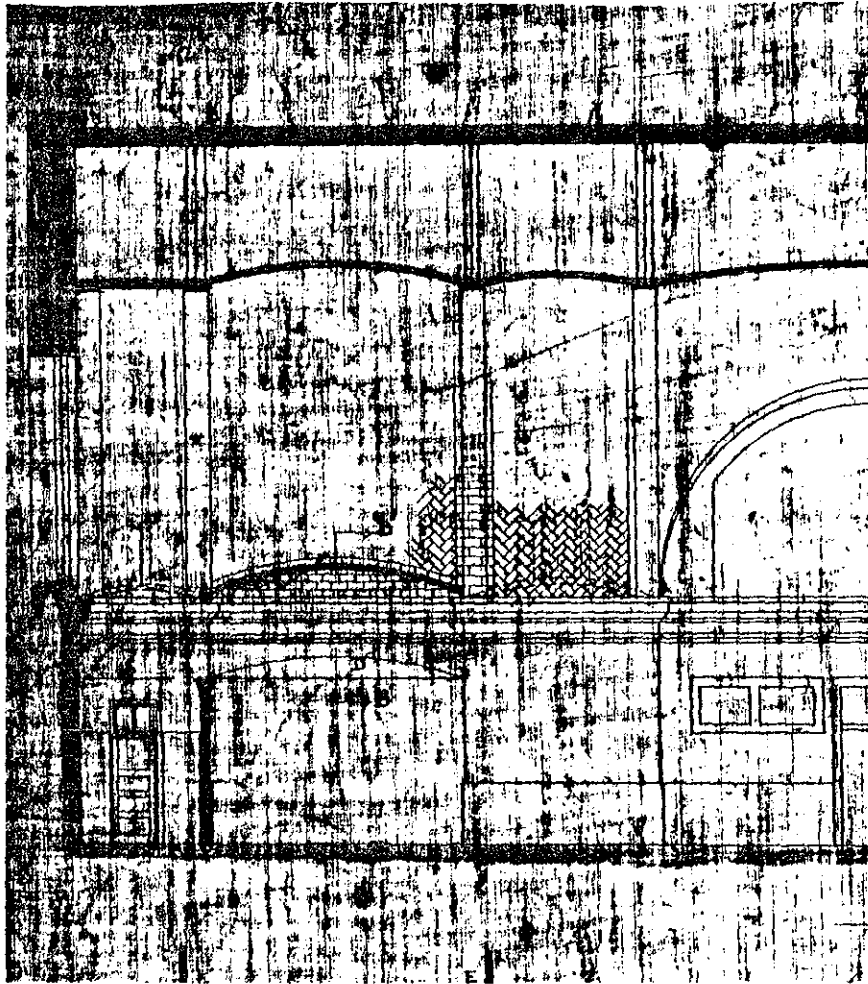
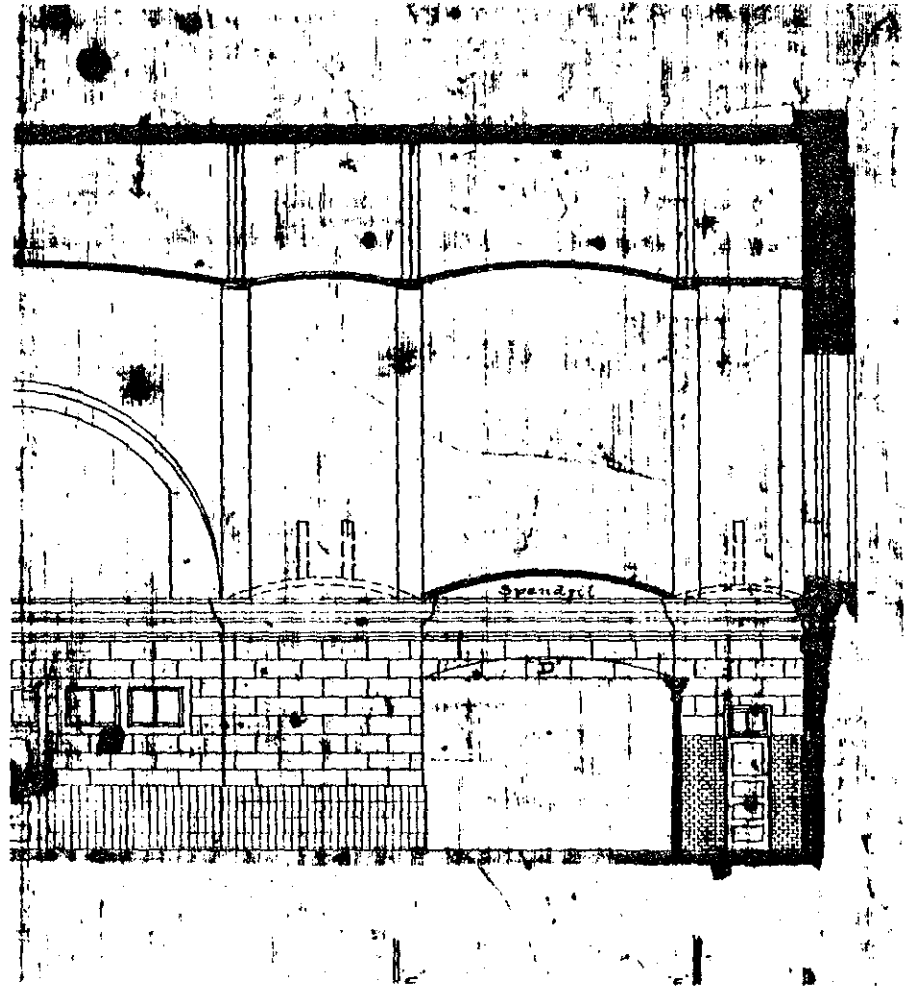
Longitudinal Section, Guastavino Vaulting. (NPS, Denver Service Center).

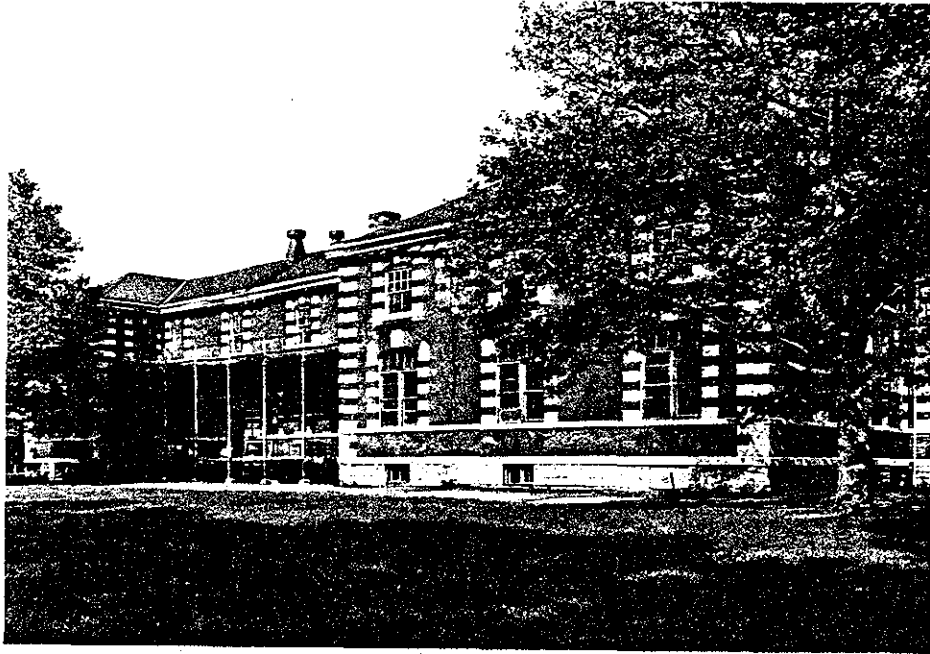
4.1 Kitchen and
Laundry
Building,
South
Elevation

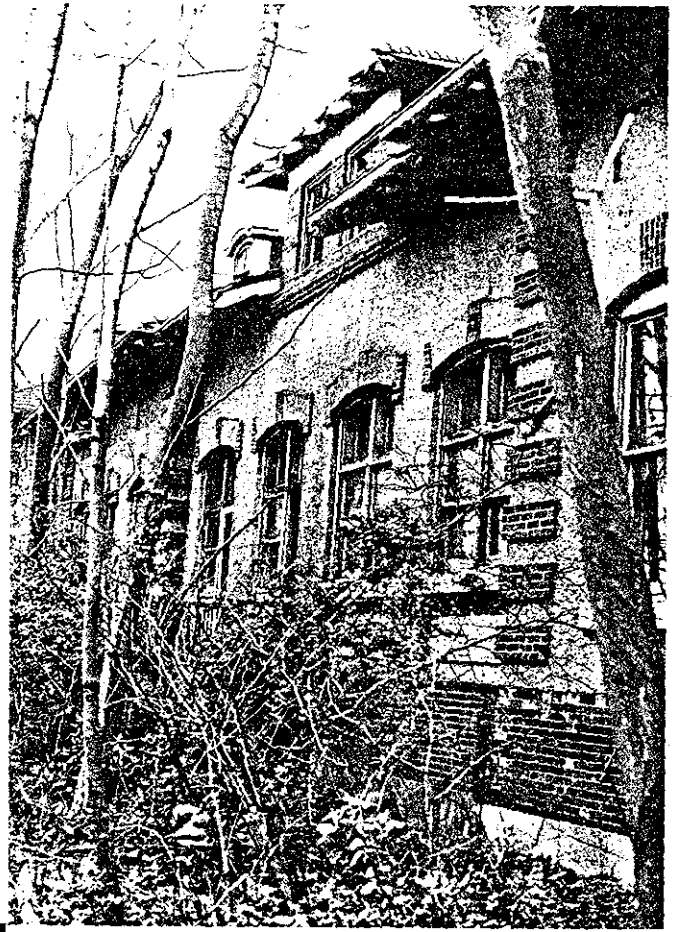
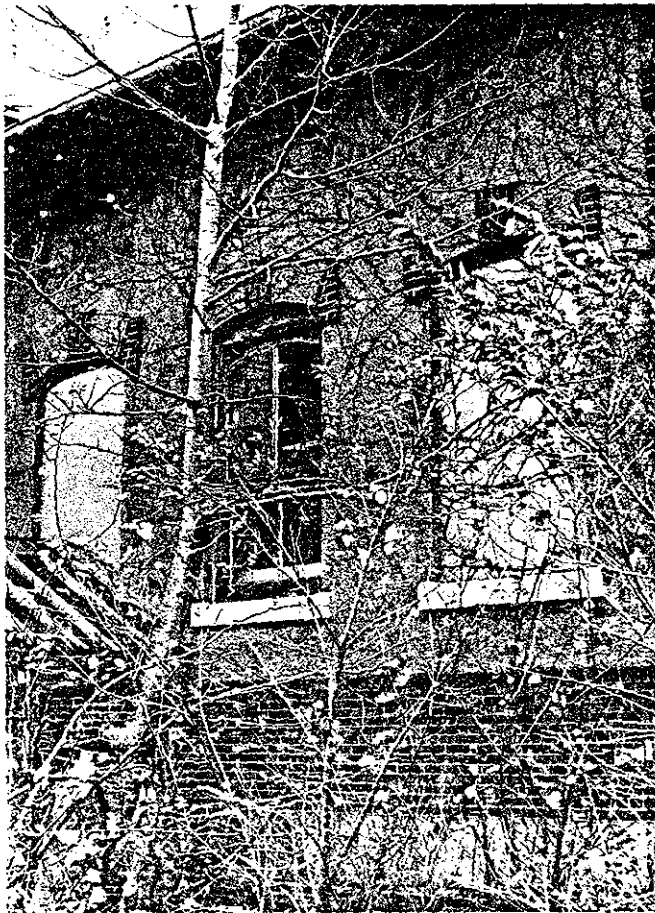
40.2 Wards 31/32, Southeast Corner

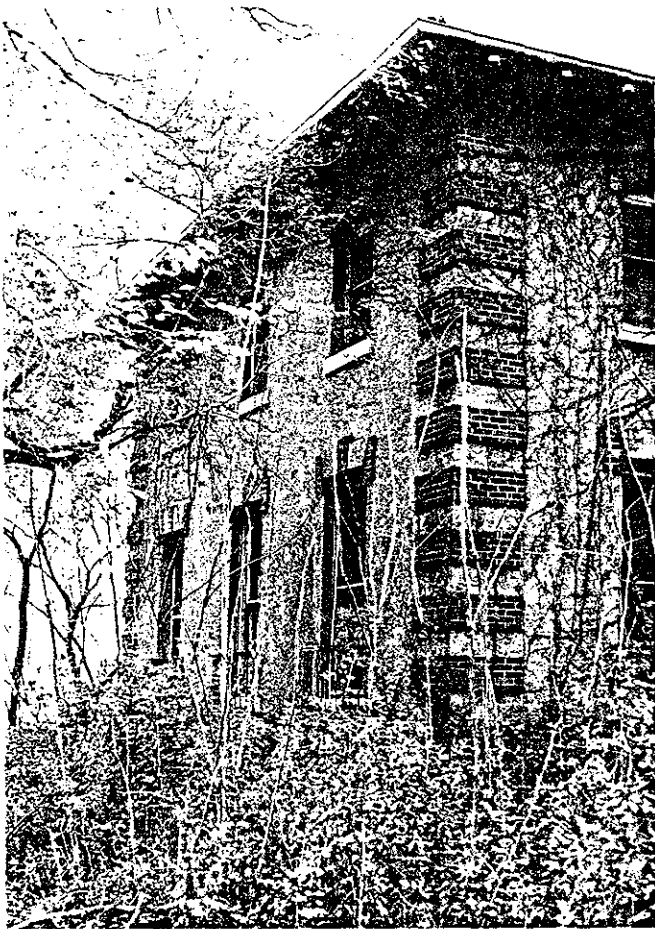
41.1 Staff Headquarters,
North Elevation

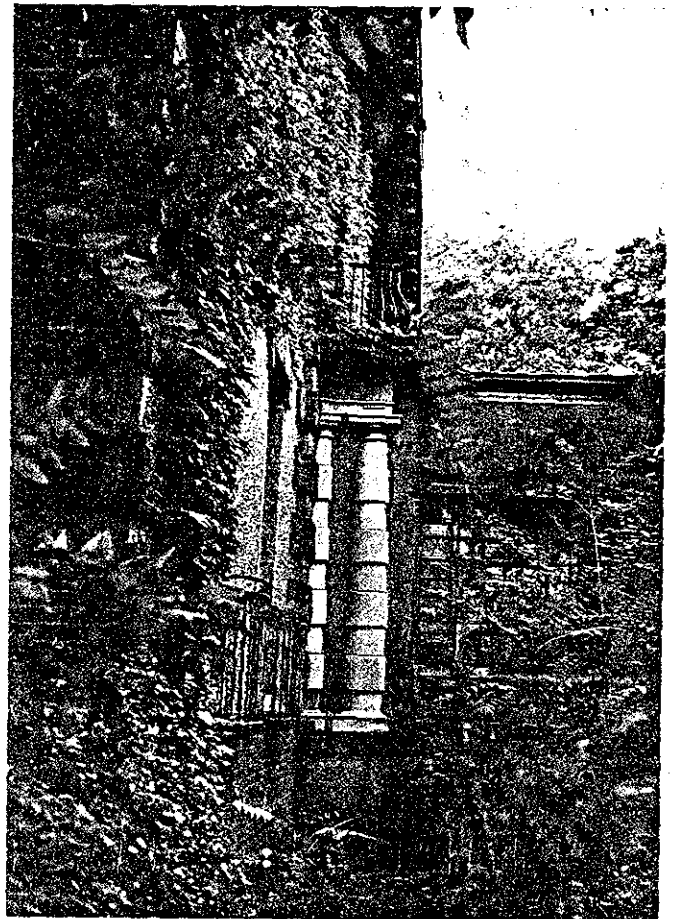
41.5 (right) Staff Headquarters, West
Porch

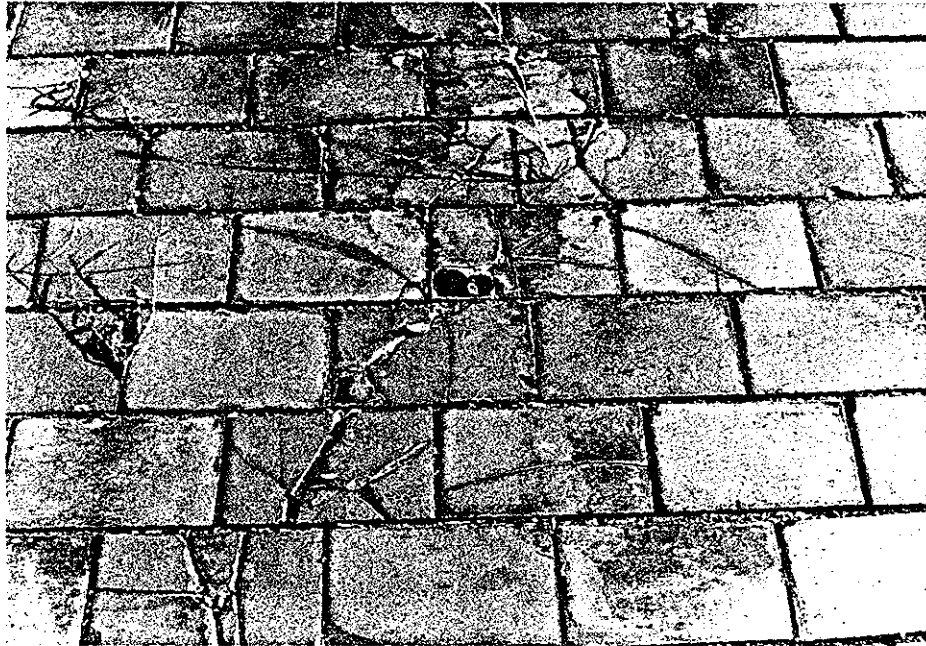
2.1 Passageway. Loose and cracked roof tiles on Section A.

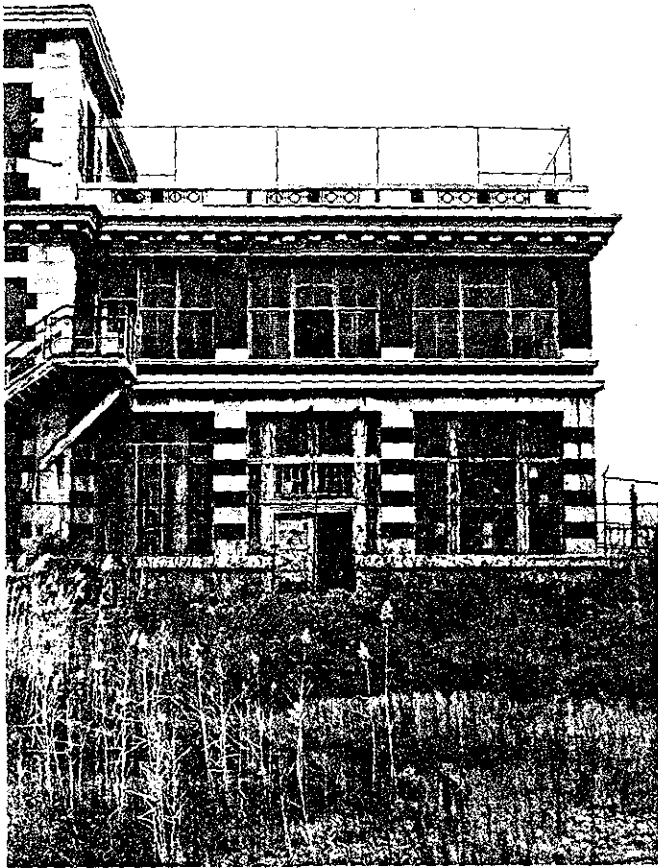
3.1 Baggage and Dormitory Building, North Wing. Note missing sash units and damaged stonework above doorway.

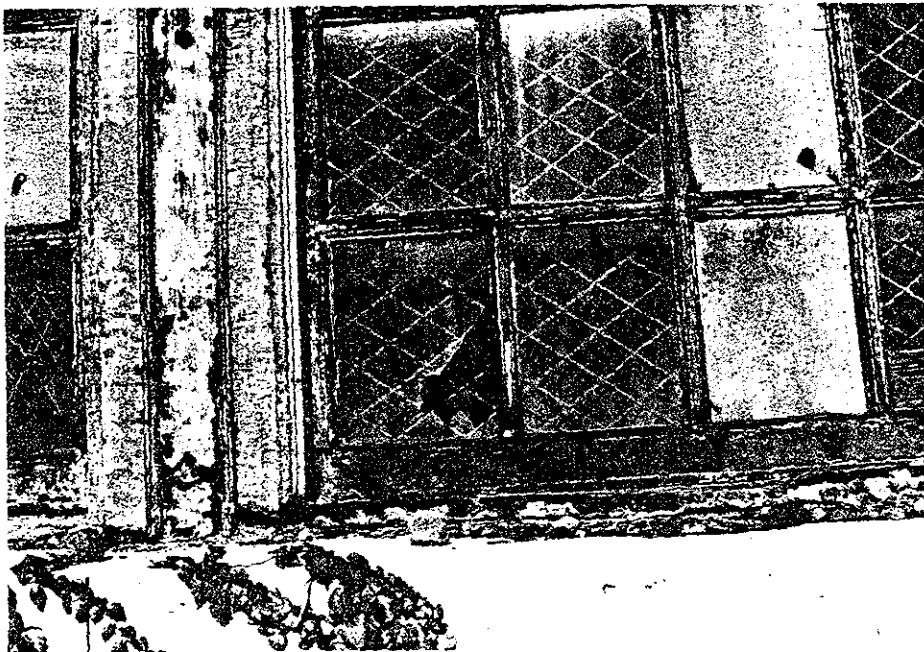
3.2 Baggage and Dormitory Building, North Wing. Corrosion of window sill and muntins.

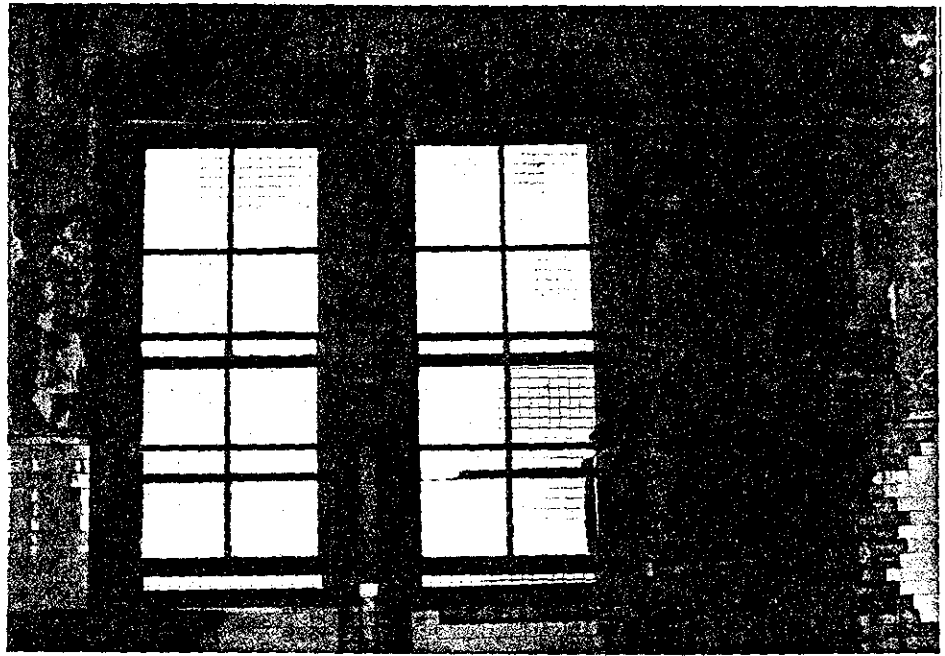
3.3 Baggage and Dormitory Building, Light Court. Damage to leader at right of windows has caused deterioration of finishes and sash.

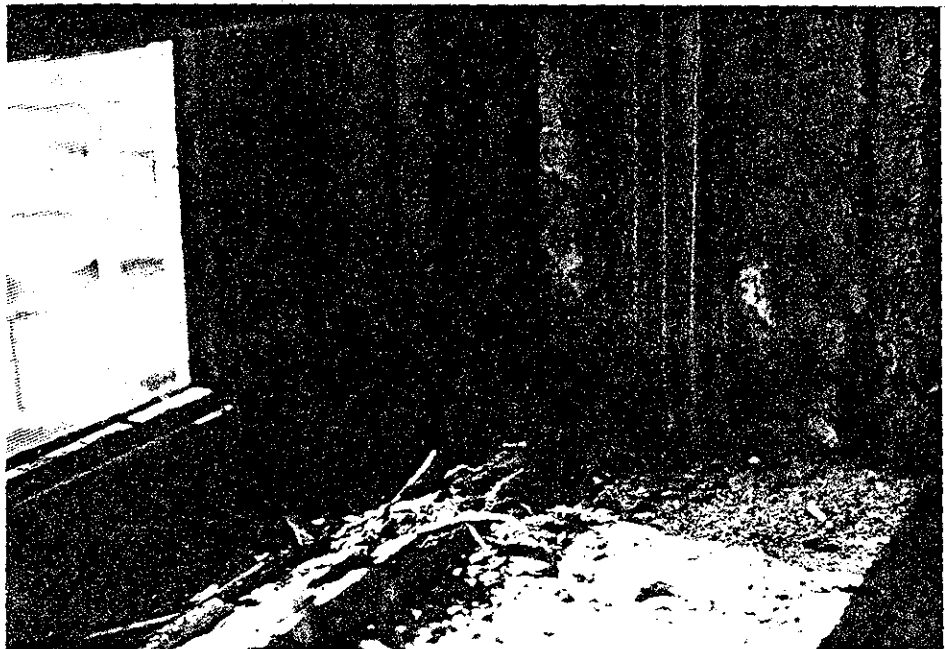
3.4 Baggage and Dormitory Building, Light Court Window. Corrosion on lower parts of window frame.

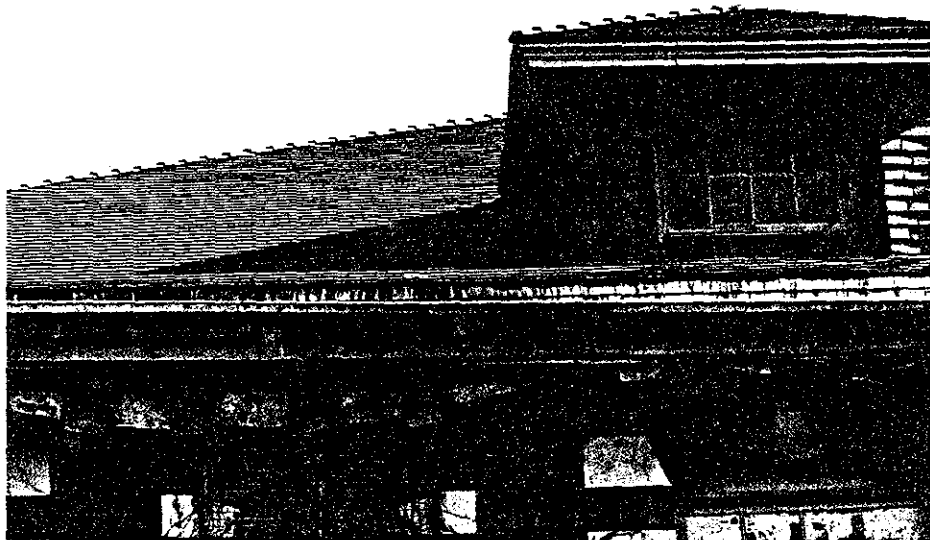
4.1 Kitchen and
Laundry
Building.
Damaged gutter
at southeast
corner.

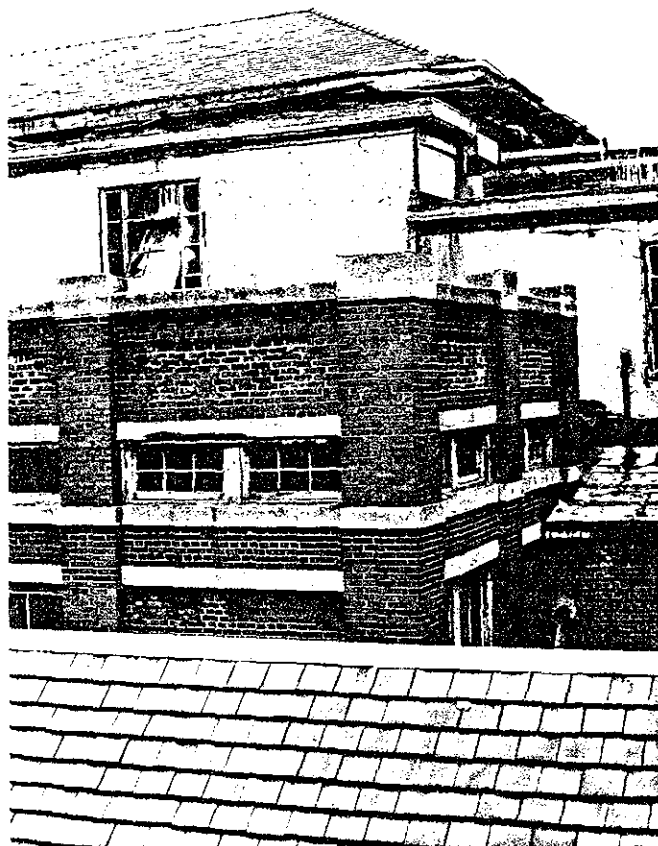
4.2 Kitchen and Laundry Building.
Torn gutter on northwest
corner. Note also spalling
concrete on cornice of
Passageway D.

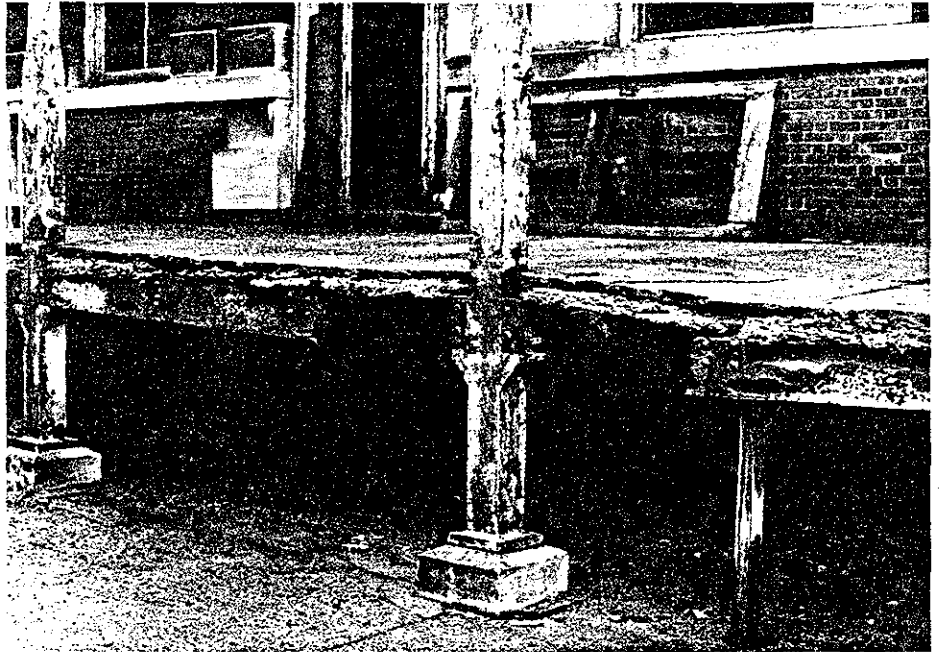
4.3 Kitchen and Laundry Building. Corroded plate and beam ends on south porch.

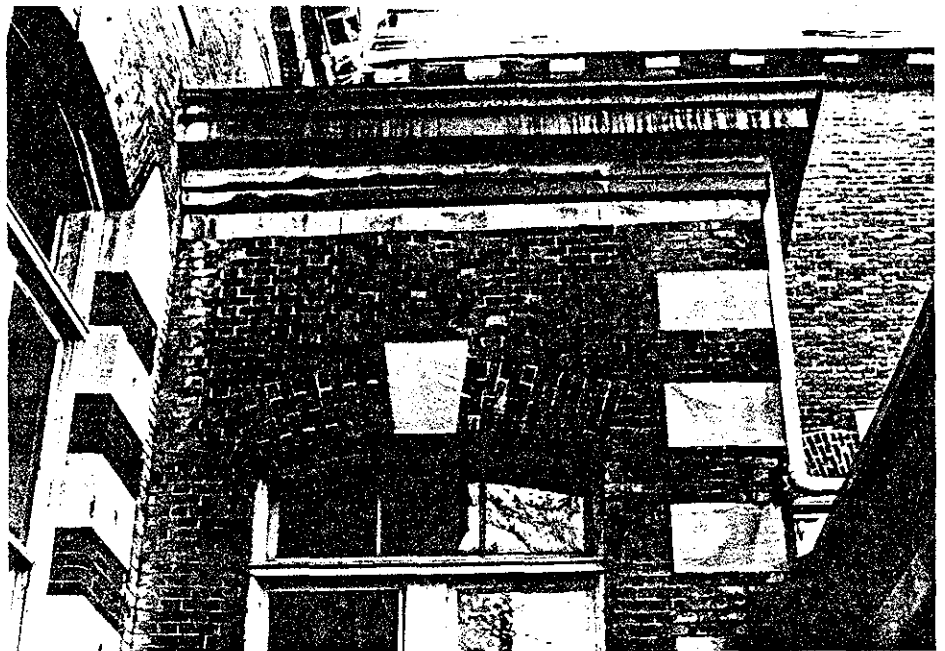
4.4 Kitchen and Laundry Building. Loose and missing brickwork on northwest wall above cellar door resulting from missing drainpipe.

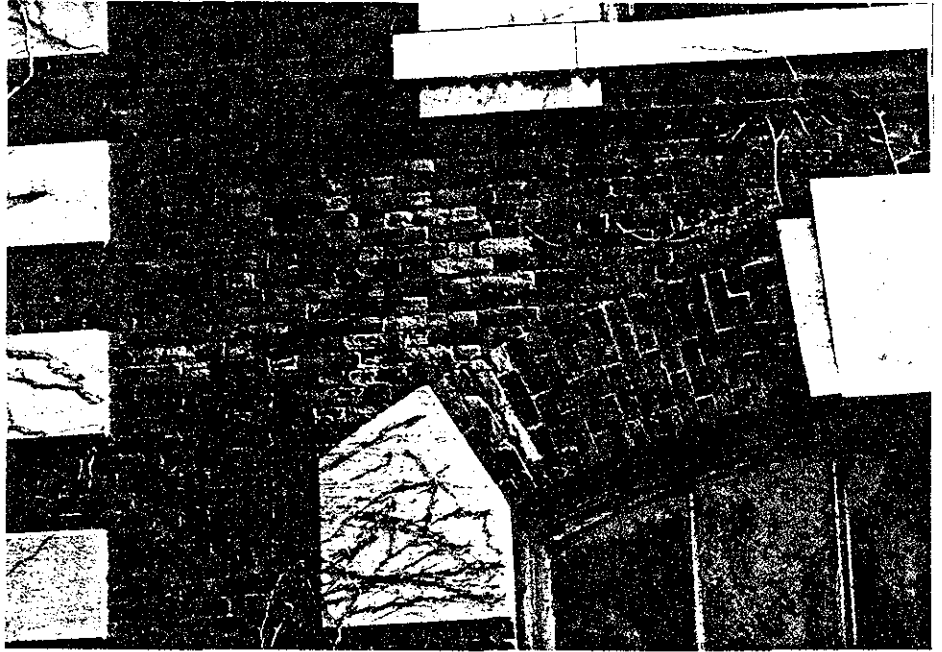
4.5 Kitchen and Laundry Building. Spalling brick on south elevation.

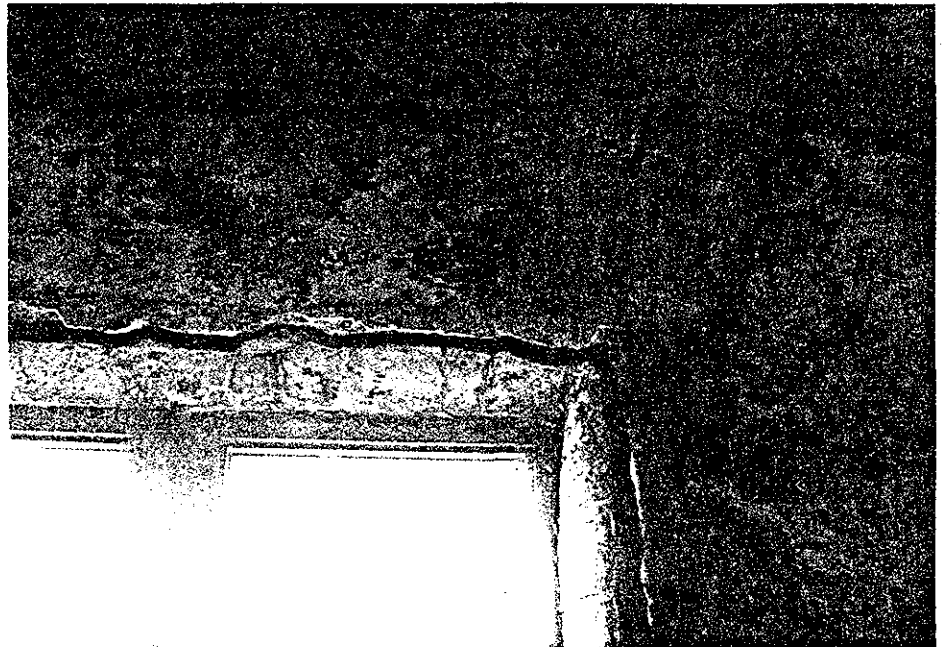
4.6 Kitchen and Laundry Building. Lintel condition on interior of Passageway D.

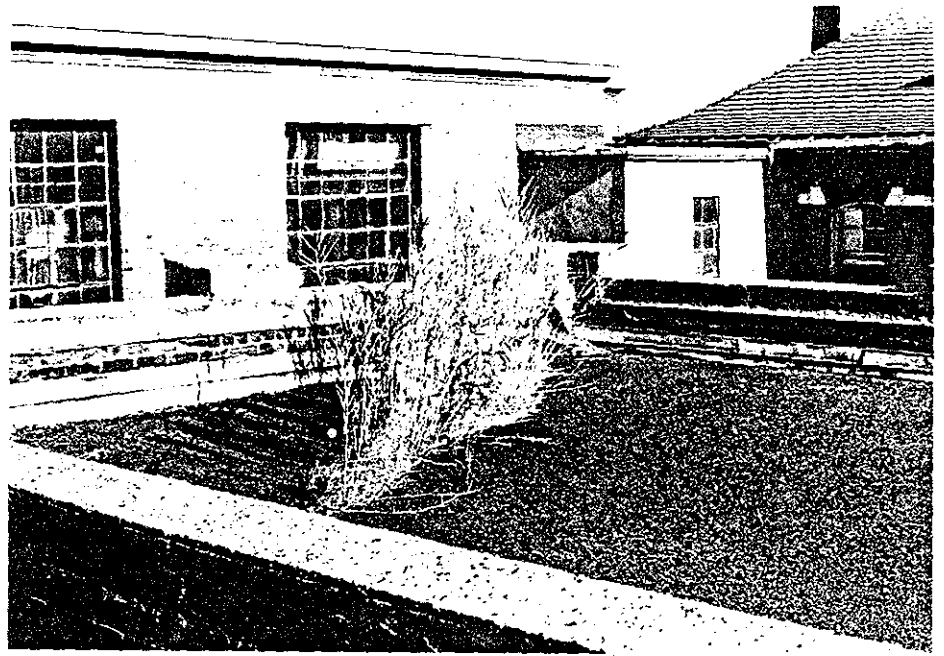
4.7 Kitchen and Laundry Building. Vegetation on roof of north wing.

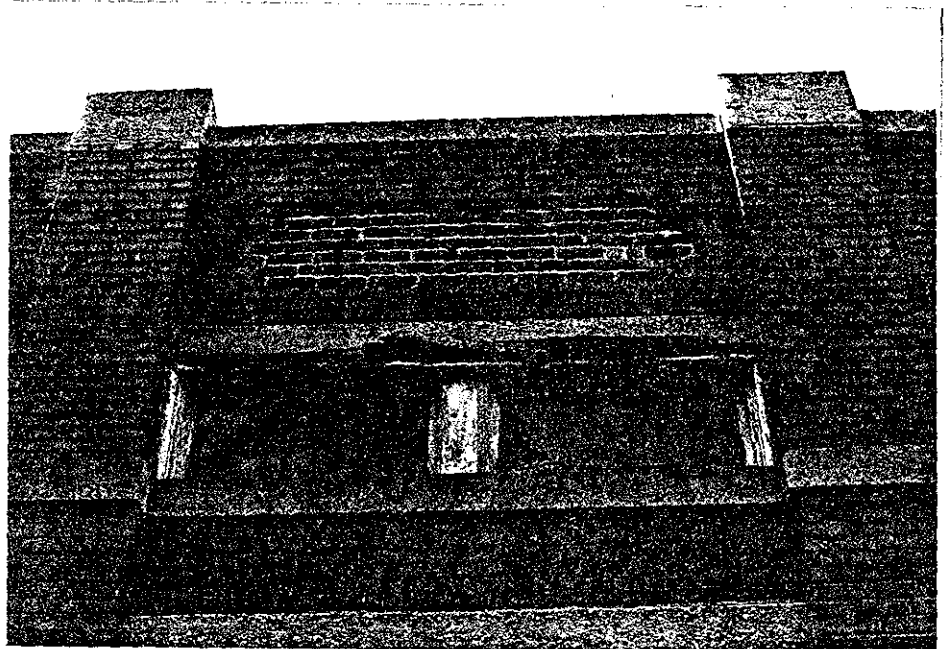
4.8 Kitchen and Laundry Building. Corroding steel and spalled concrete in lintels of north wing.

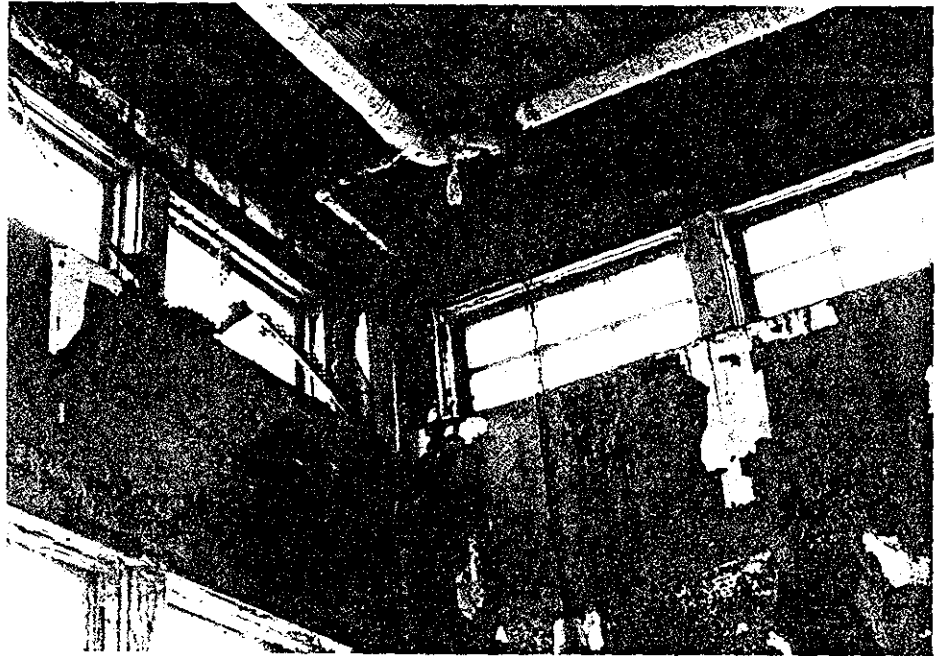
4.9 Kitchen and Laundry Building. Exposed and corroded steel framing on interior of north wing.

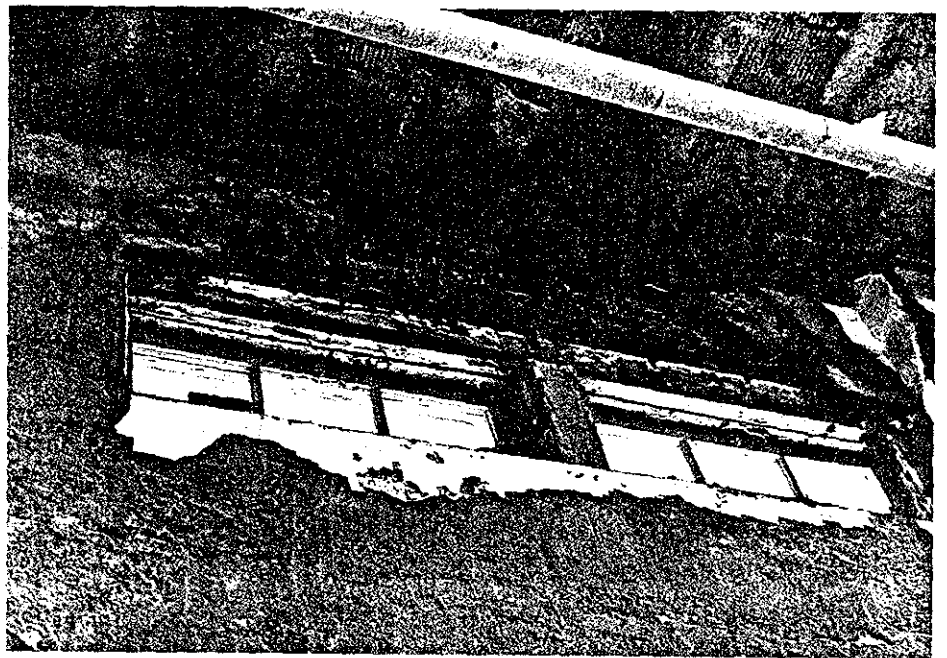
4.10 Kitchen and Laundry Building. Deteriorated finishes on interior of north wing.

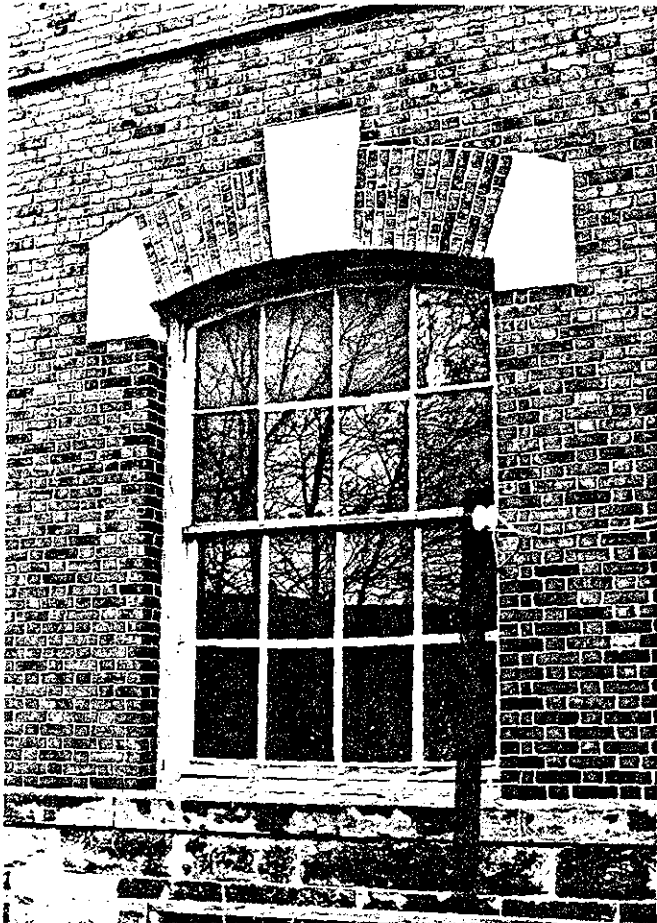
5.1 Powerhouse. Typical first floor window. Note warped bottom rail and spalling granite and bluestone.

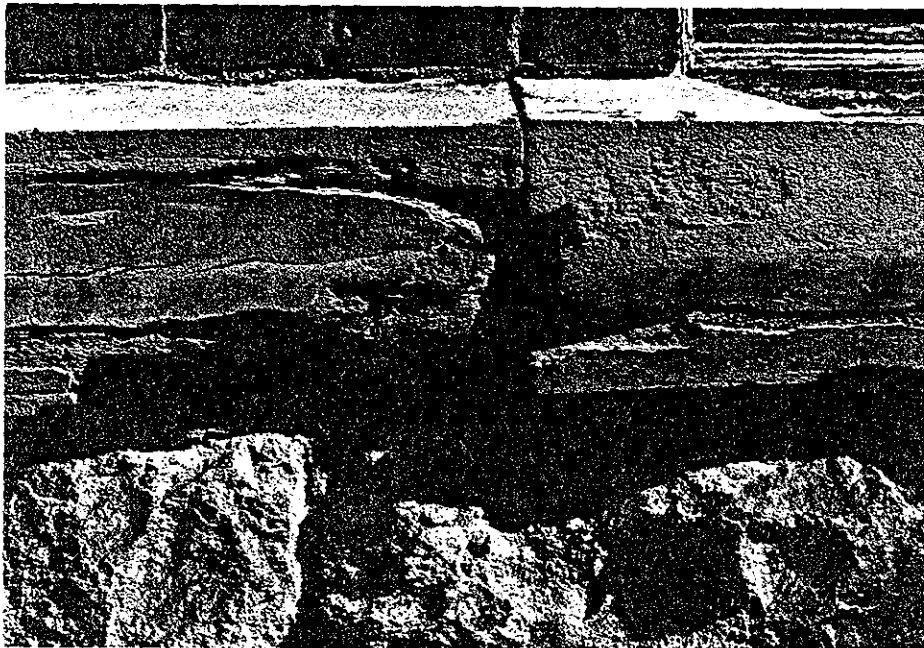
5.2 Powerhouse. Delaminated bluestone sill.

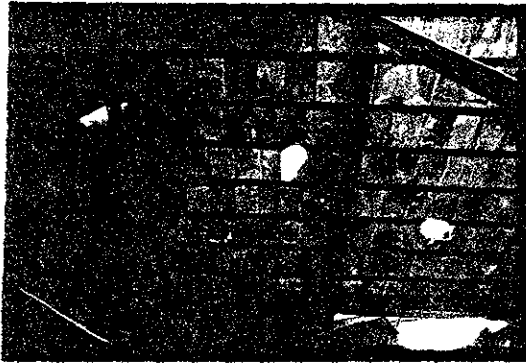
5.3 Powerhouse. Spalled terra cotta roof sheathing.

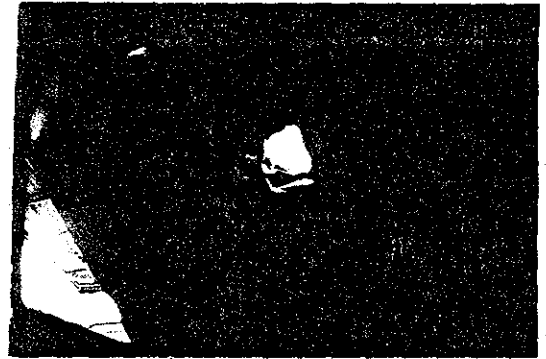
5.4 Powerhouse. Detail of hole in terra cotta sheathing.

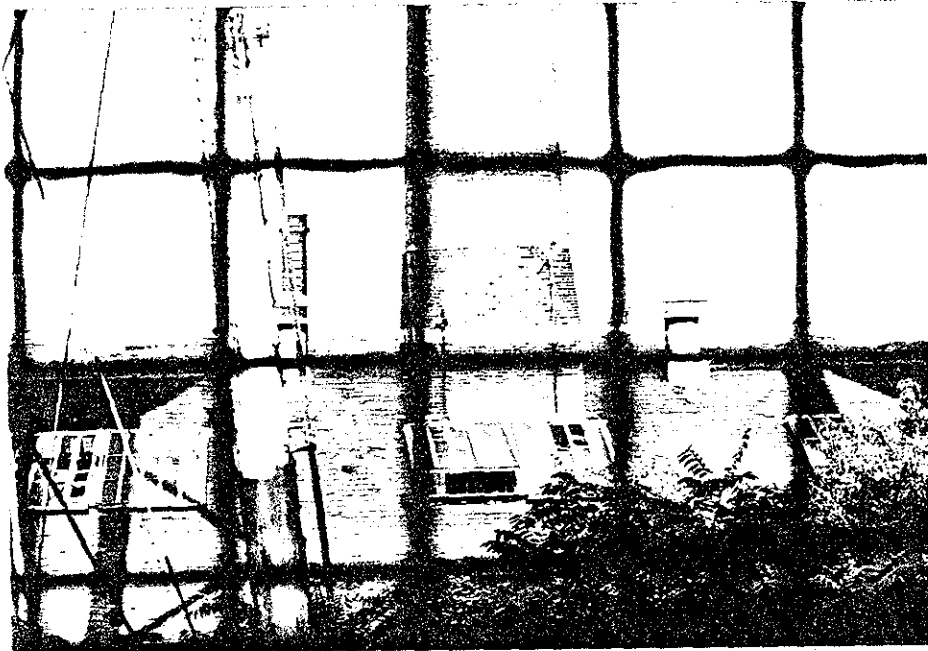
5.5 Powerhouse. East side of roof. Note cracked and missing tiles, damaged skylights and three holes in roof in left and center of photograph.

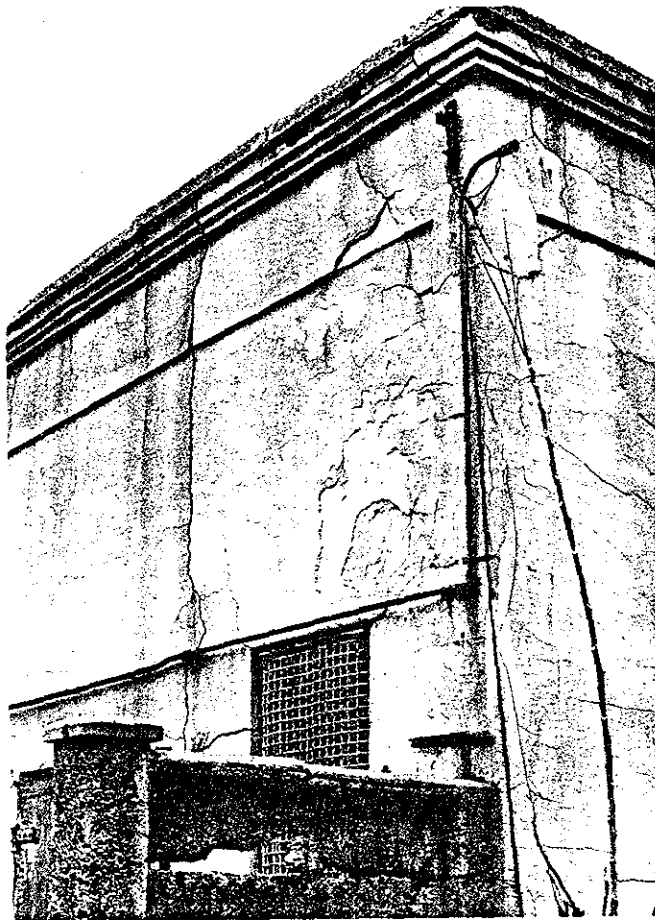
9.1 Incinerator. Concrete surface is cracking, bulging and spalling.

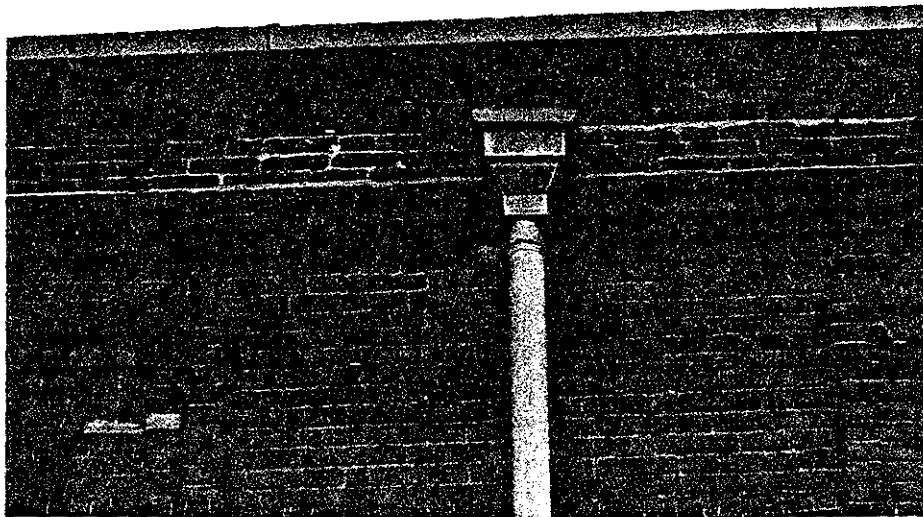
10.1 Bakery and Carpentry Building. Exposed steel angle adjacent to gutter box.
