historic structures report
january 1980

STATUE OF LIBERTY
ELLIS ISLAND / U.S. IMMIGRATION STATION

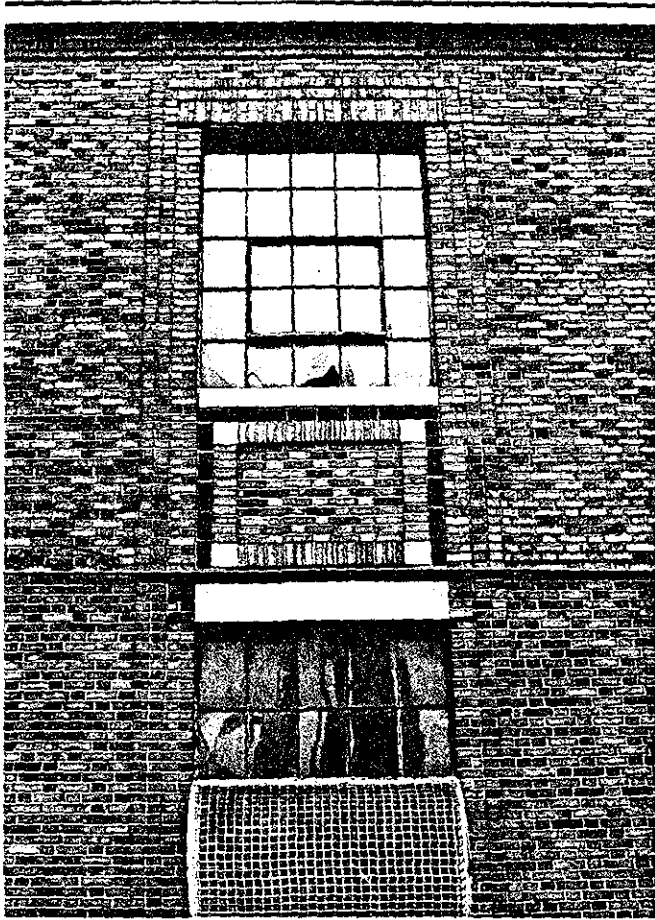
10.2 Bakery and Carpentry Building.
Typical window bay showing cracked
brickwork around lintels.

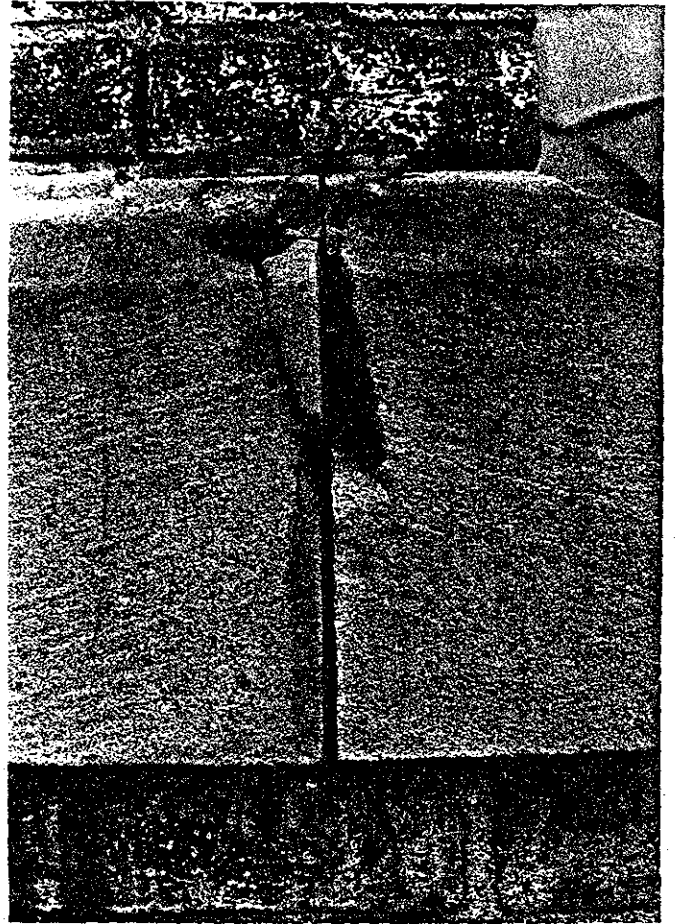
10.3 Bakery and Carpentry Building.
Damage to limestone sill caused
by corroding grill anchors.

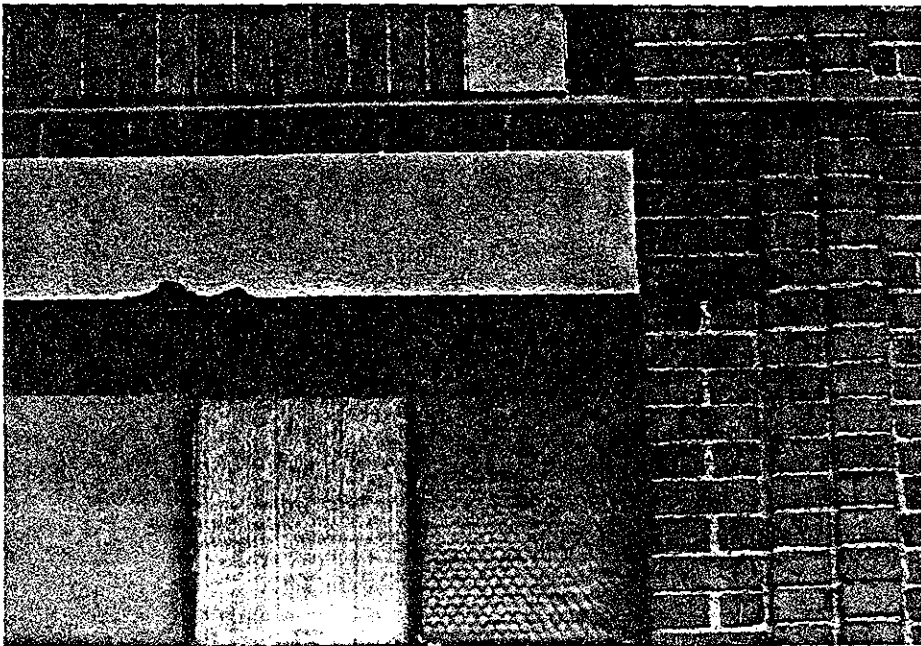
10.4 Bakery and
Carpentry
Building.
Detail of
stone and
brick damage
on lintels.

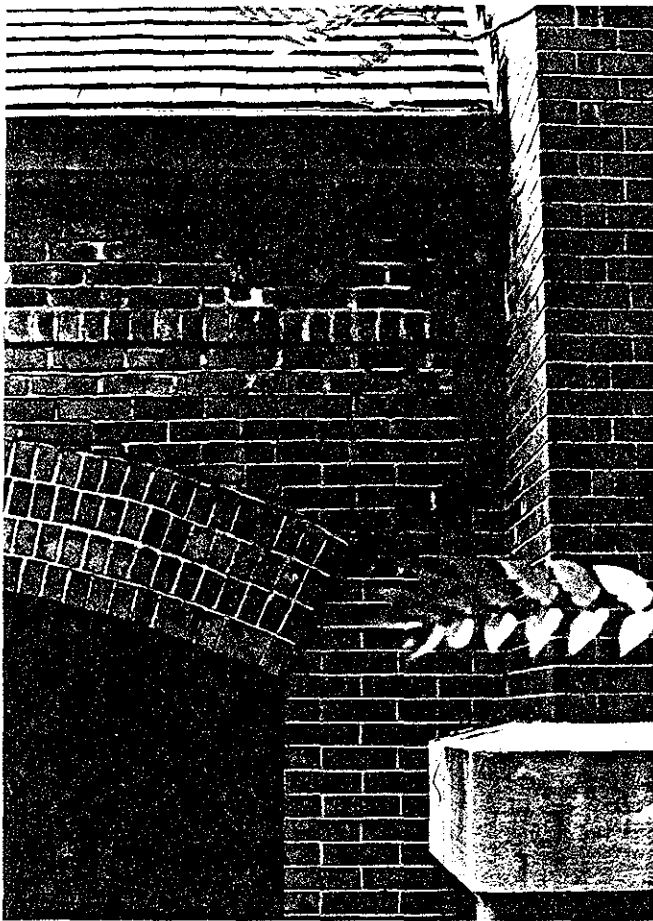
12.1 Passageway. Cracked and shifting brick wall at north end of Section A. Note also the 1 inch gap between the flashing and adjacent wall.

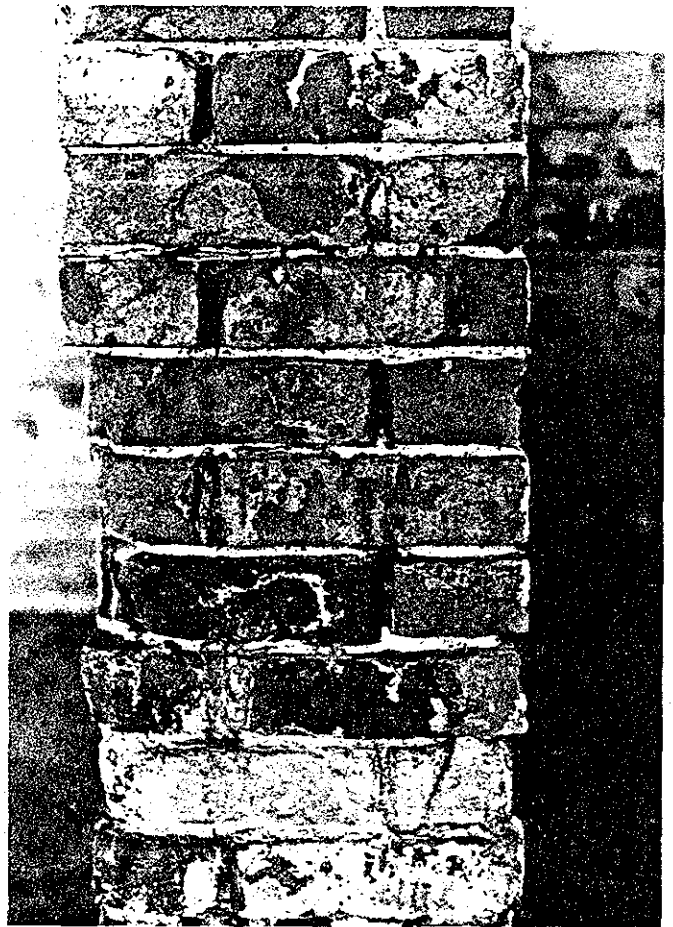
12.2 Passageway. Condition of interior wall where section D meets Passageway #13.

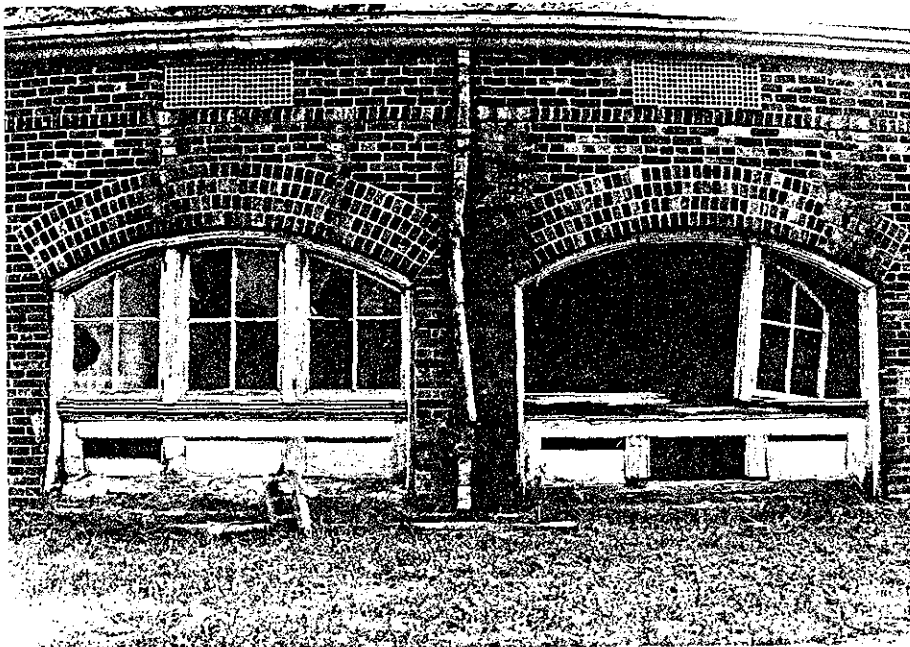
12.3 Passageway. Typical wood sash units, west elevation of section D, showing loose, warped or missing panels and sash. Note also bent and corroded downspout.

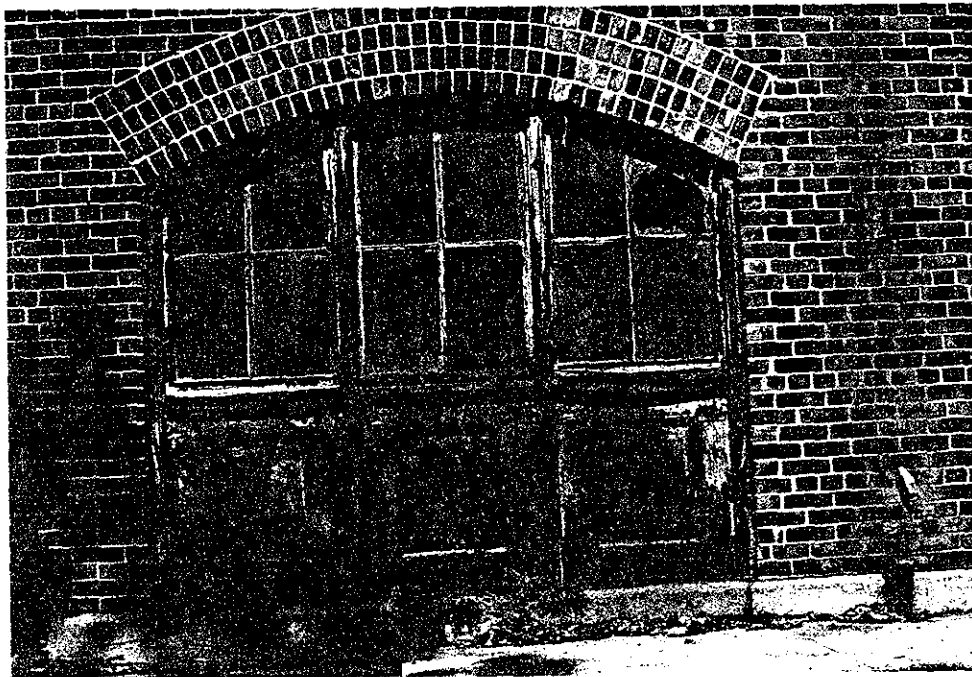
13.1 Passageway. Typical window unit, showing corroded sills and panels. Downspout to the right is missing.

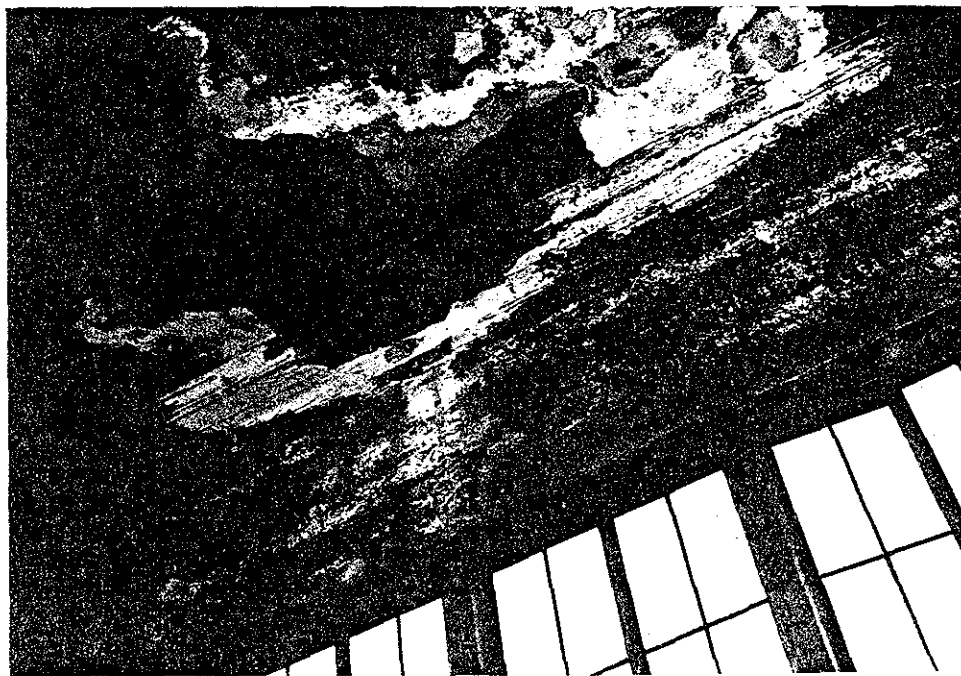
14.1 Ferry Building. Deterioration of interior finishes in central tower.

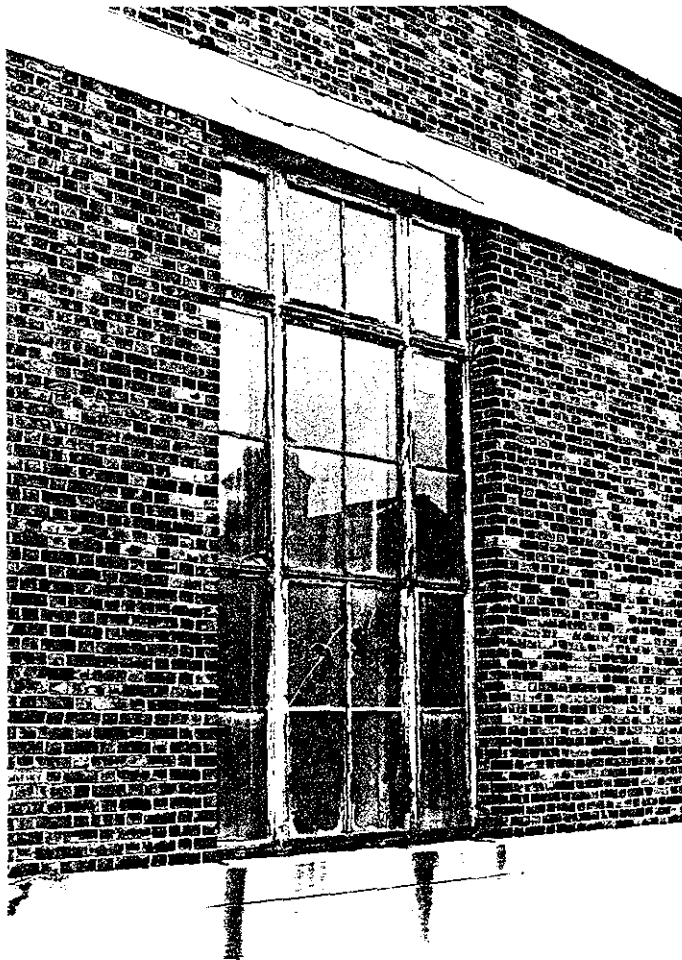
14.2 Ferry Building. Cracked terra cotta lintel.

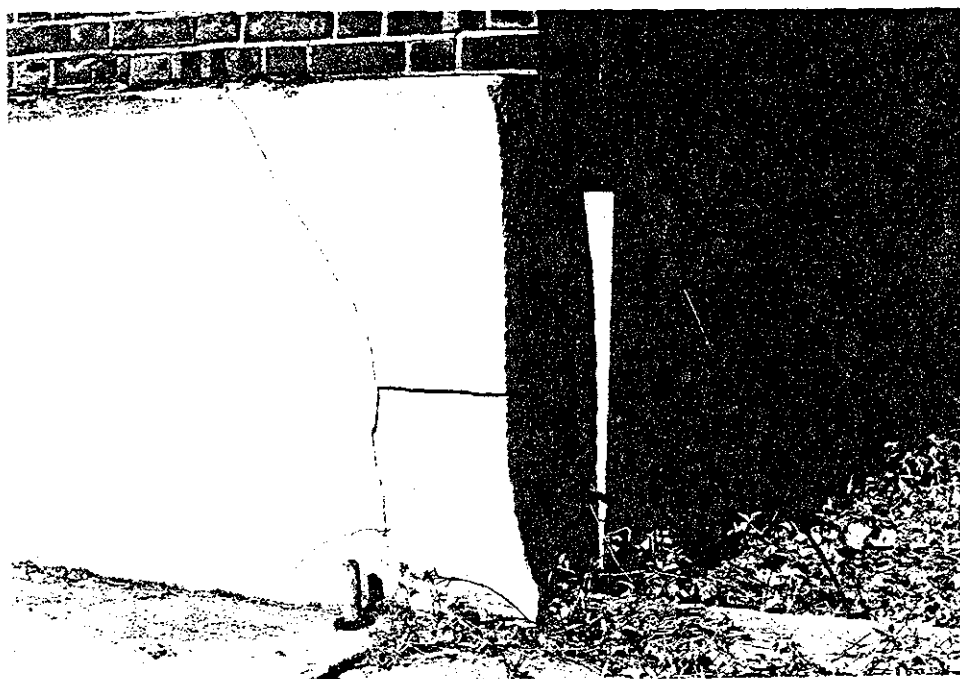
14.3 Ferry Building. Cracked and missing limestone foundation at northeast corner.

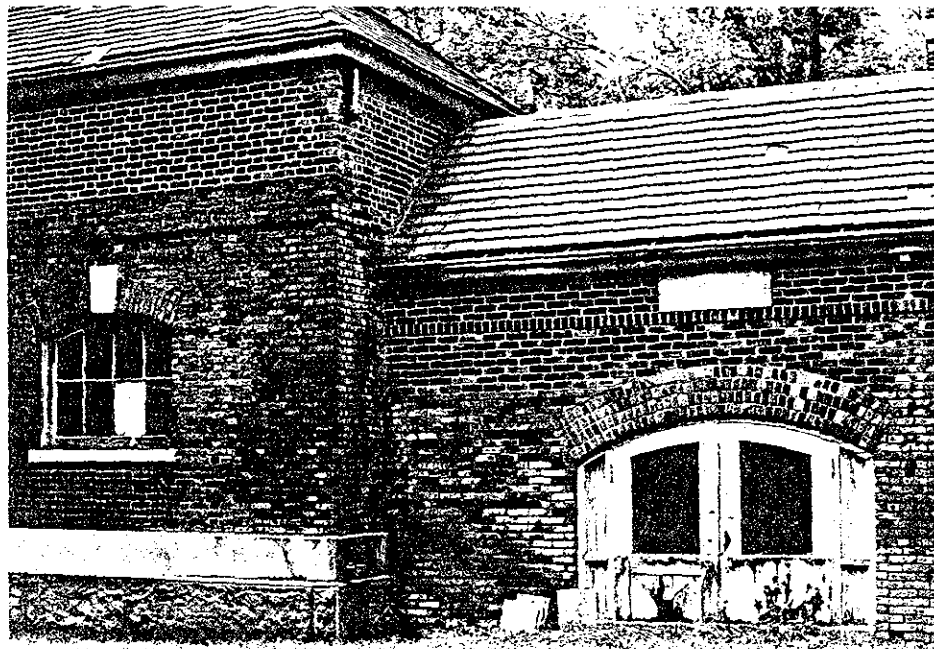
16.1 Passageway. Section A of Passageway at point where it joins Hospital #1. Note lost pointing, spalled brickwork, efflorescence and deteriorated window sash.

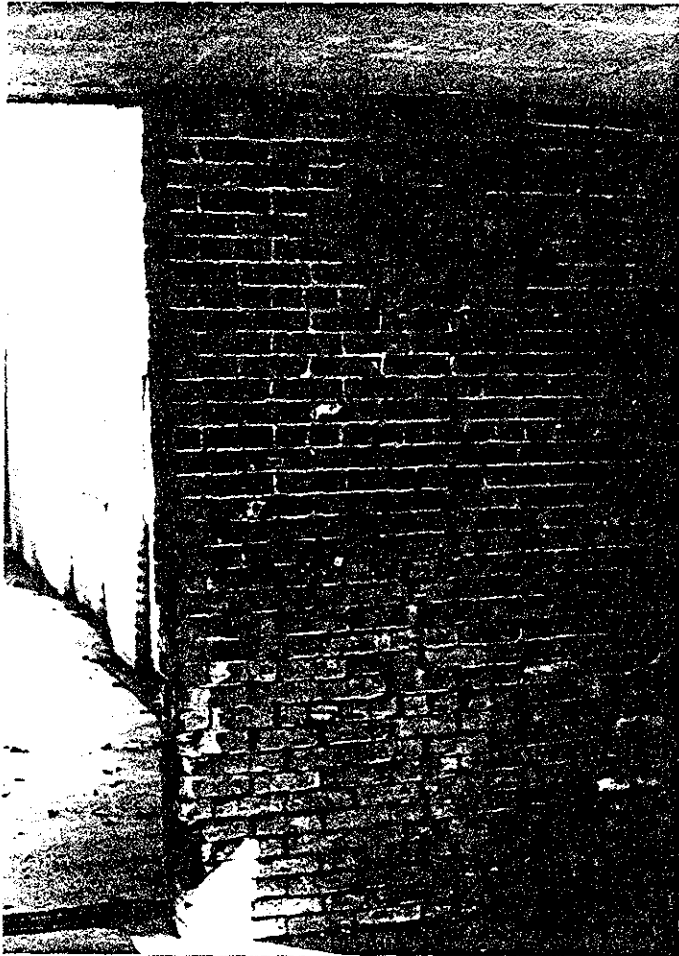
16.2 Passageway.
Cracked and dislodged
brickwork on interior
wall of north pavillion
of section A.

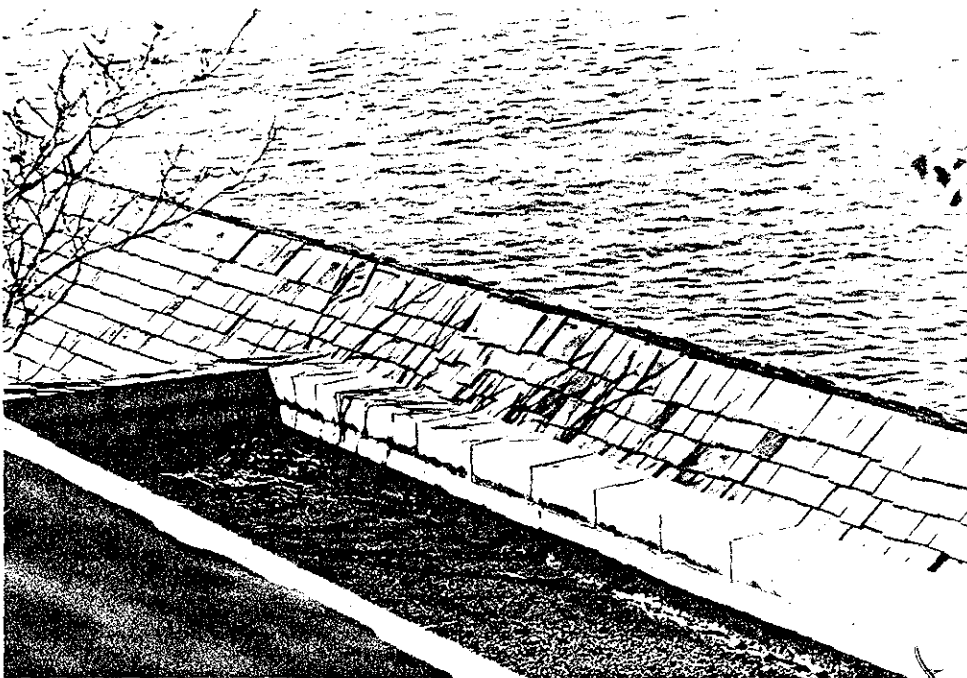
16.3 Passageway.
Fifty percent
of the ridge
tiles on
sections B-D
are missing.

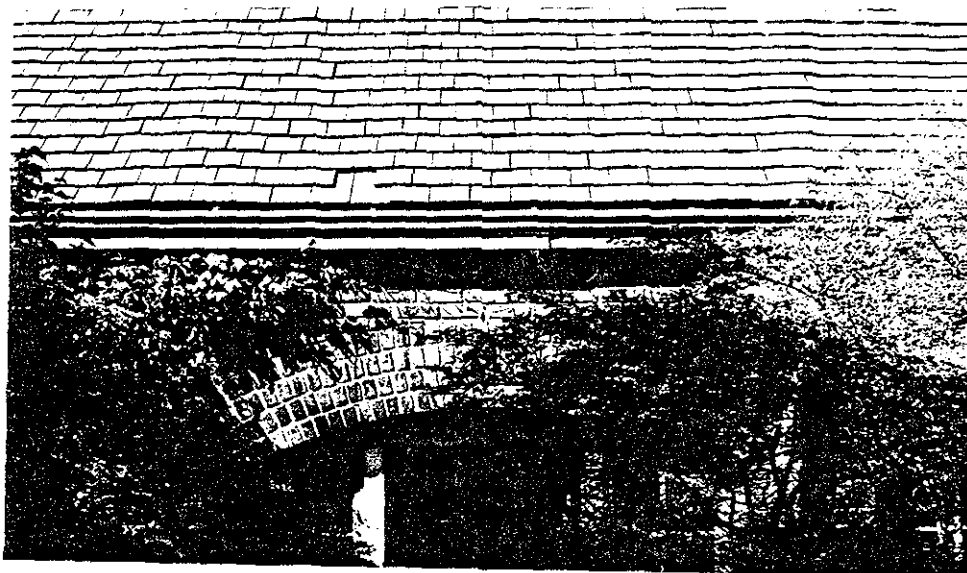
16.4 Passageway.
Rippling in
roof tiles
caused by
rotted roof
sheathing.

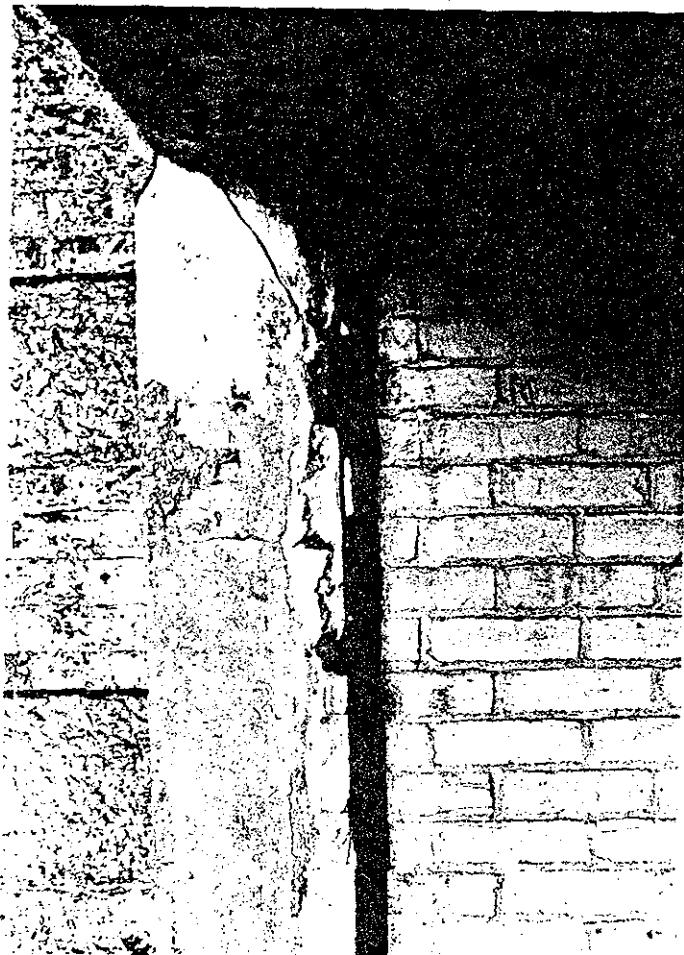
16.5 Passageway. Seven inch
wide joint open between
south end of Passageway
\$16 and Passageway #27.

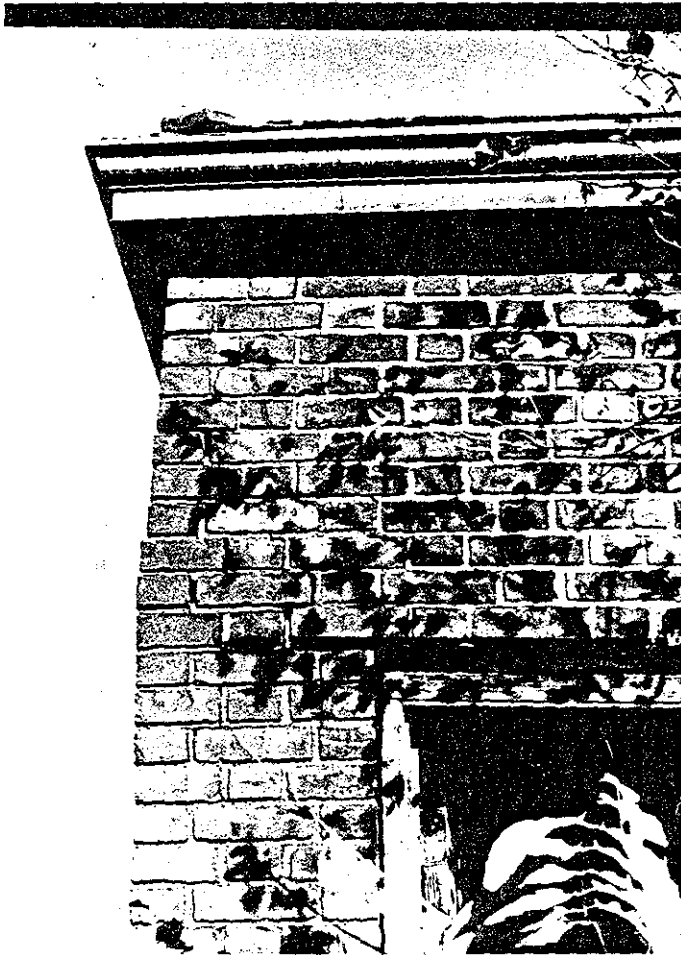
16.6 Passageway. Cracked and bulging wall at southwest corner of passageway.

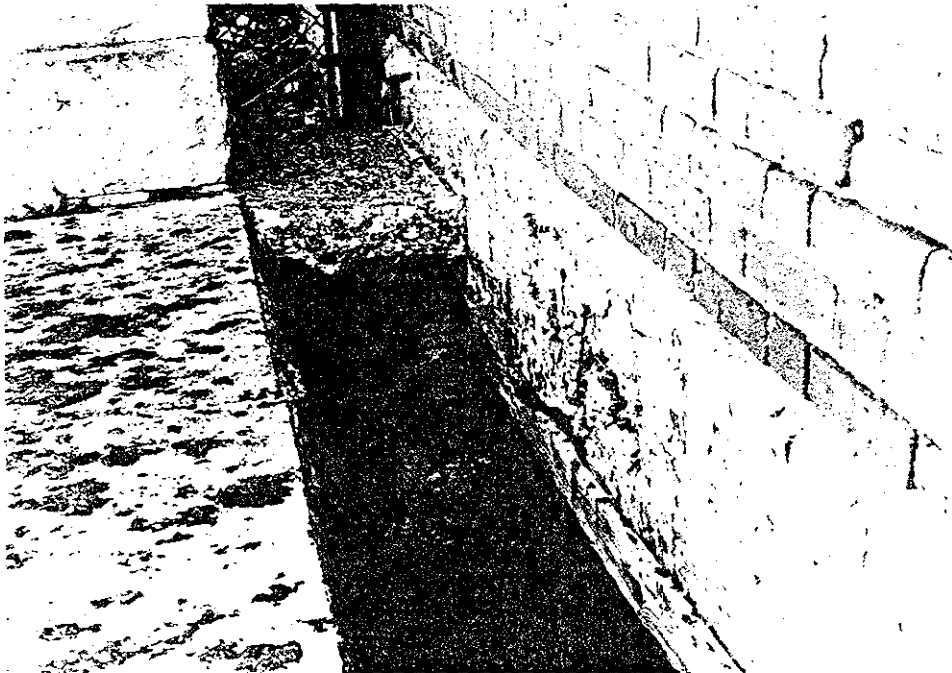
16.7 Passageway. West foundation wall of section D. Fill has been washed away, cribbing is rotted and steel reinforcement is corroded.

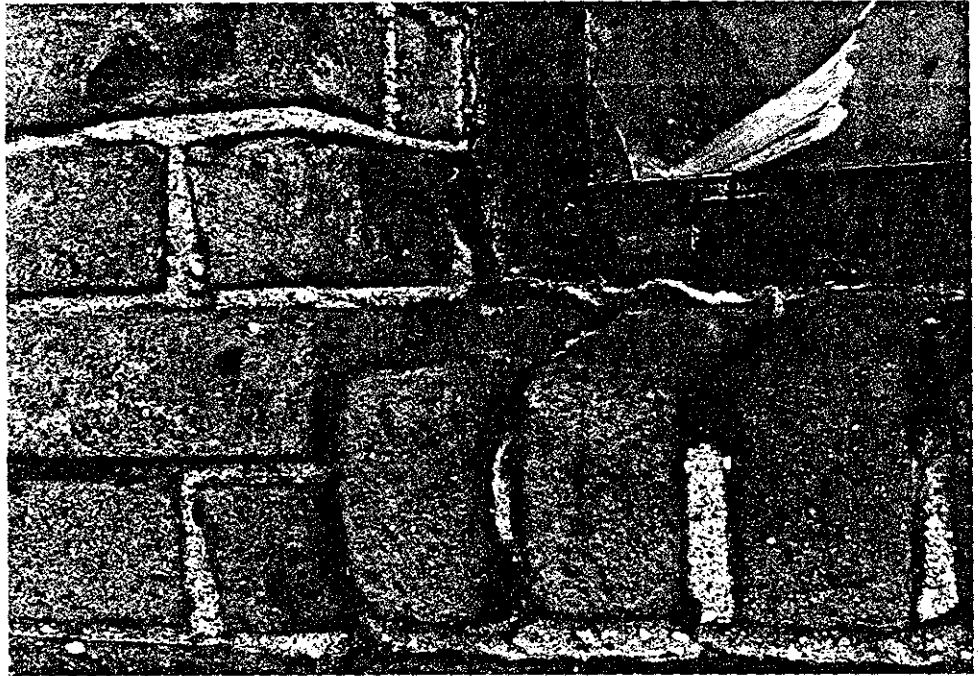
16.8 Passageway. Deteriorated brickwork on west side of section D.

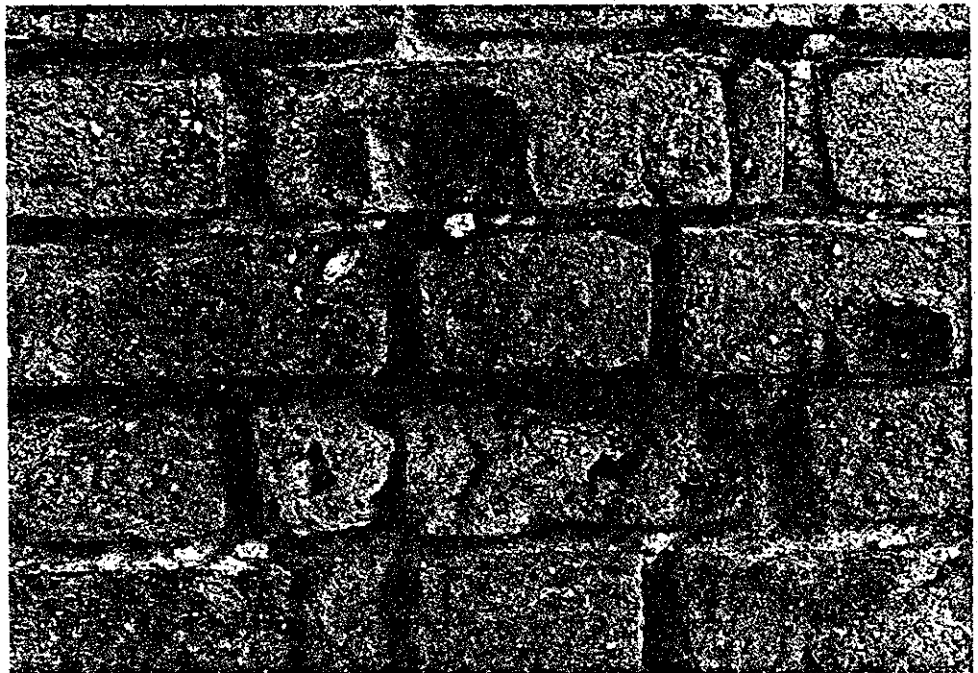
16.9 Passageway. Open joints on west side of section D.

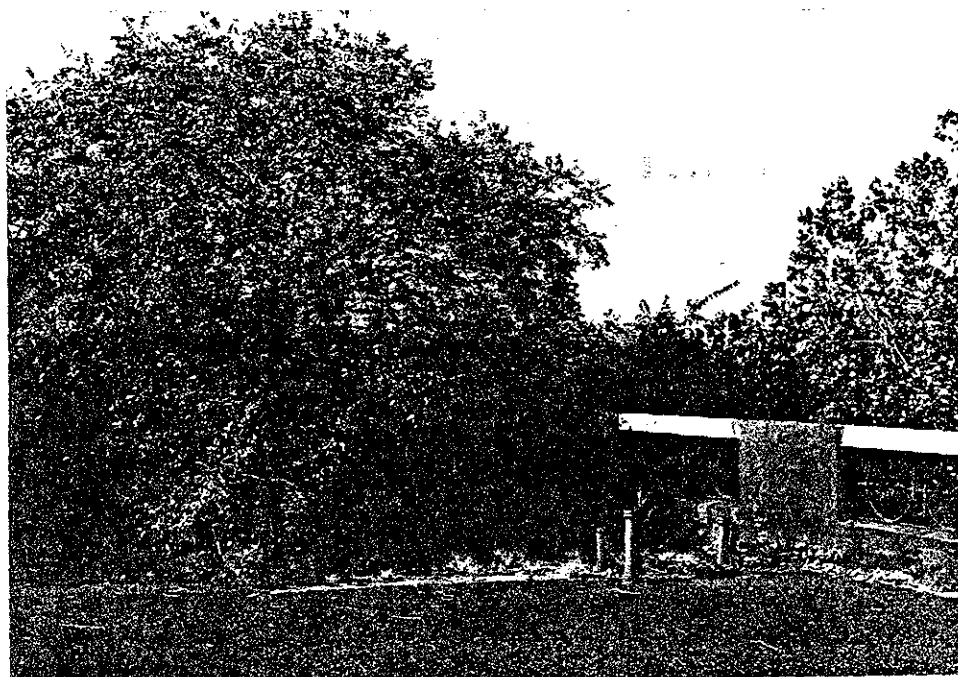
18.1 Psychiatric Ward. Shrubbery growing over drains on the south end of the roof.

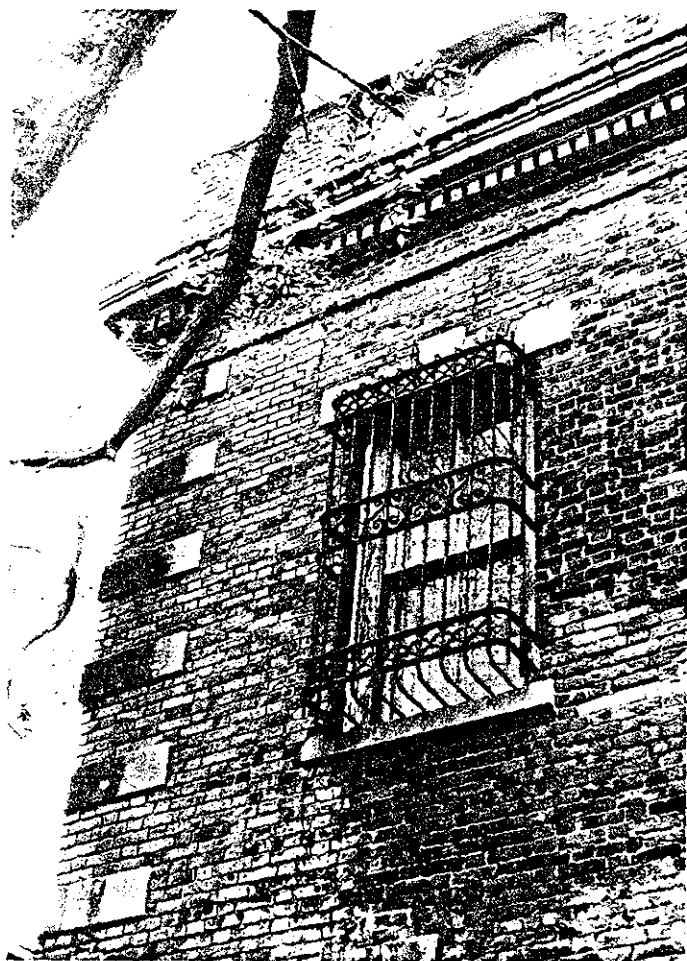
18.2 Psychiatric Ward.
South elevation showing
open joints, efflores-
cence and spalled bricks.

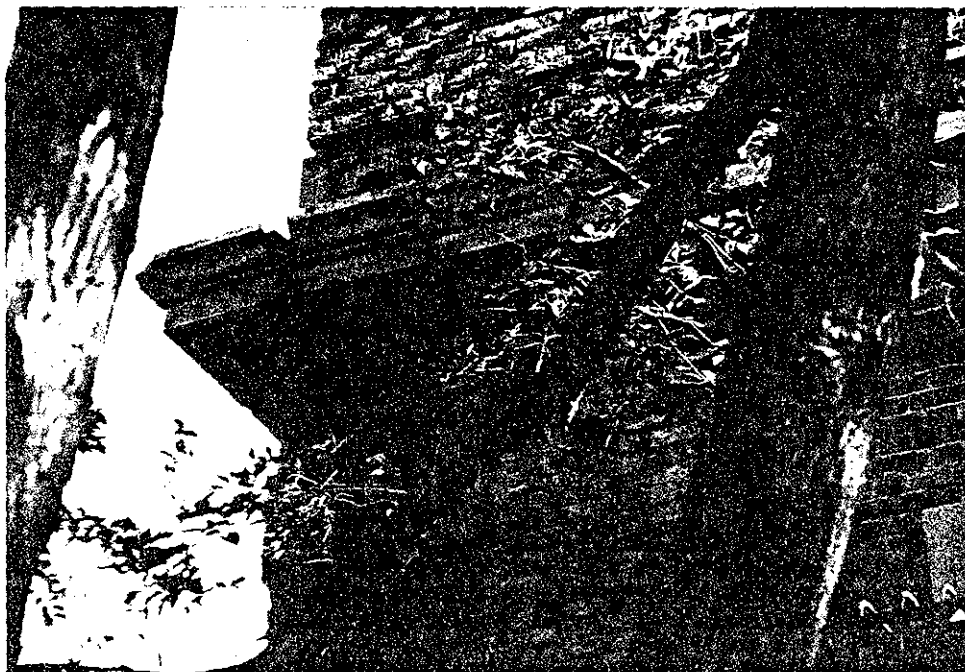
18.3 Psychiatric Ward.
Loose terra
cotta cor-
nice block
on southwest
corner.

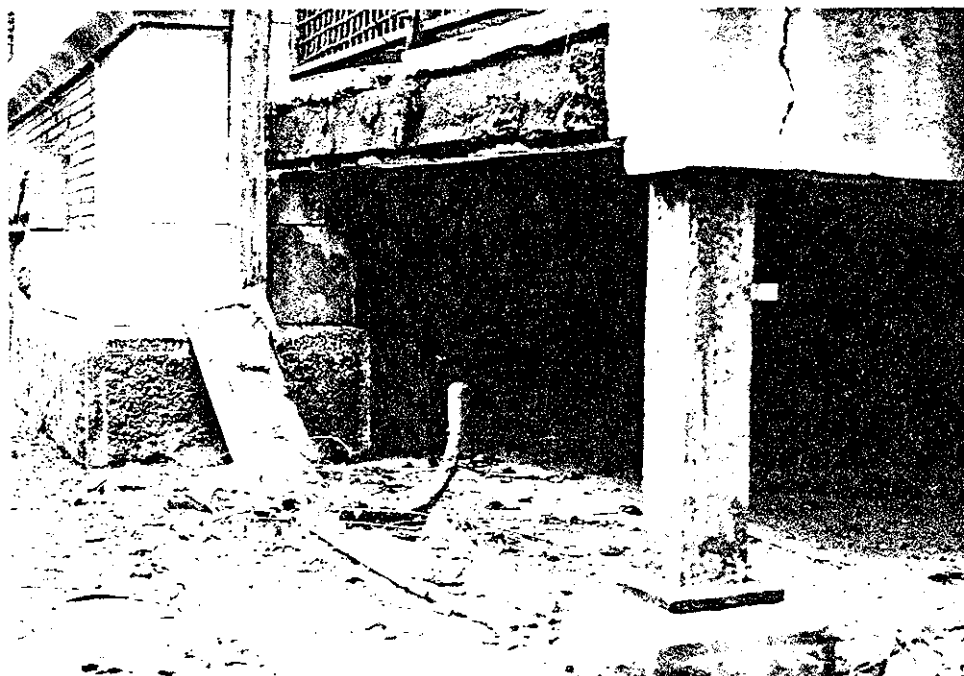
19.1 Hospital #1. Spalled concrete and corroded floor beams on south porch.

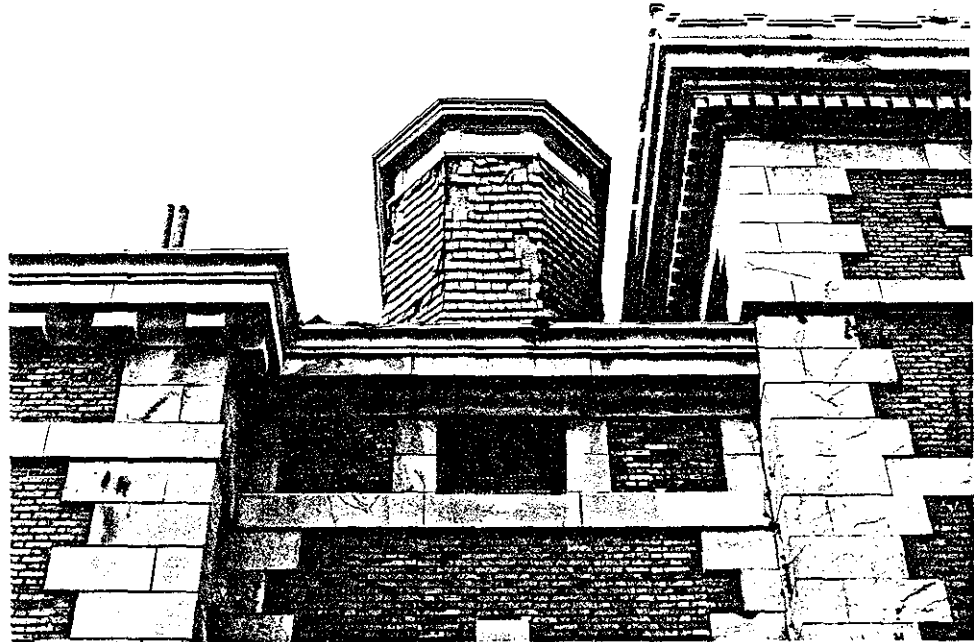
19.2 Hospital #1. Loose and missing tiles on skylights.

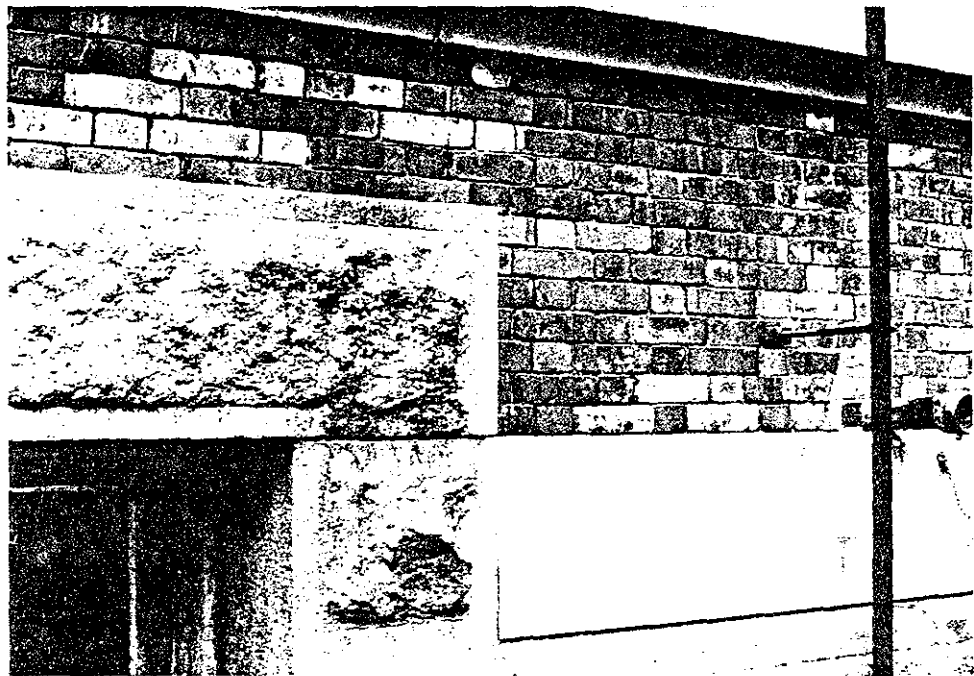
19.3 Hospital #1. Efflorescence and open joints above water table.

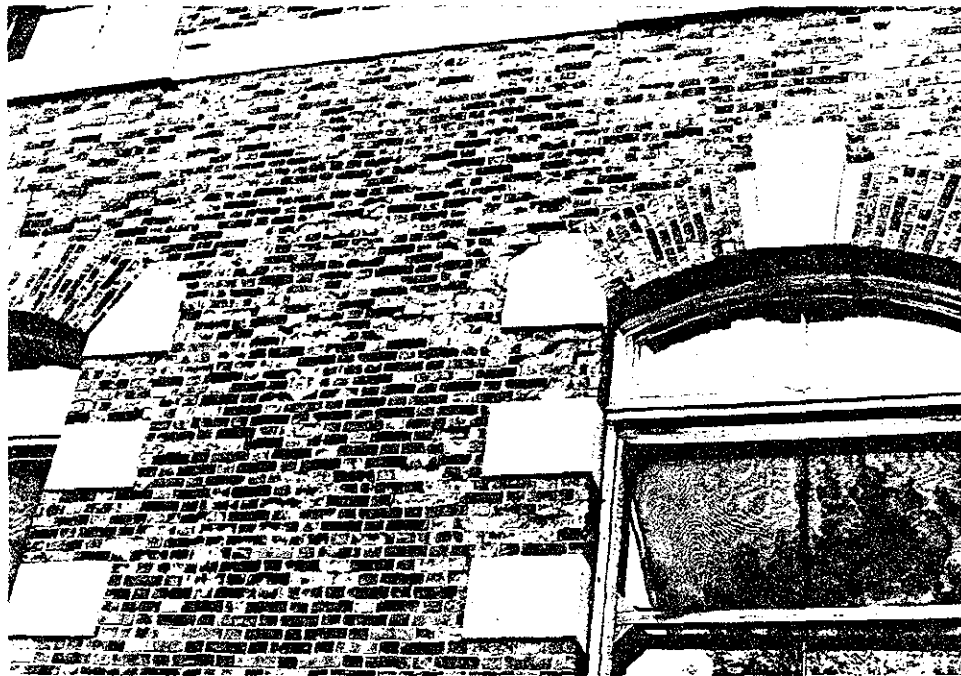
20.1 Administration Building. Spalled and efflorescing brick on north facade.

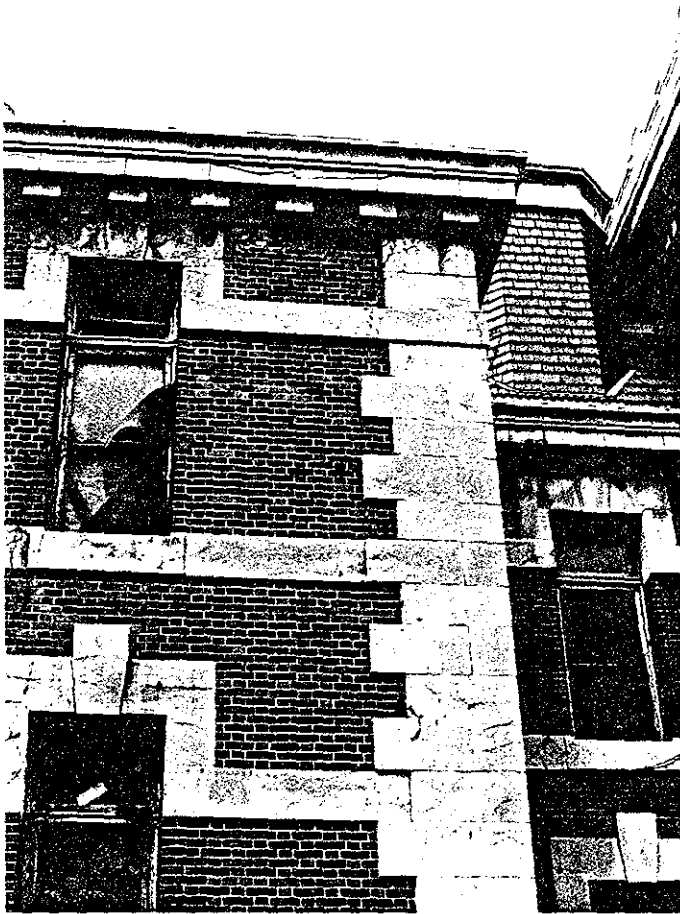
21.1 Hospital #2. Cracked
terra cotta cornice
blocks.

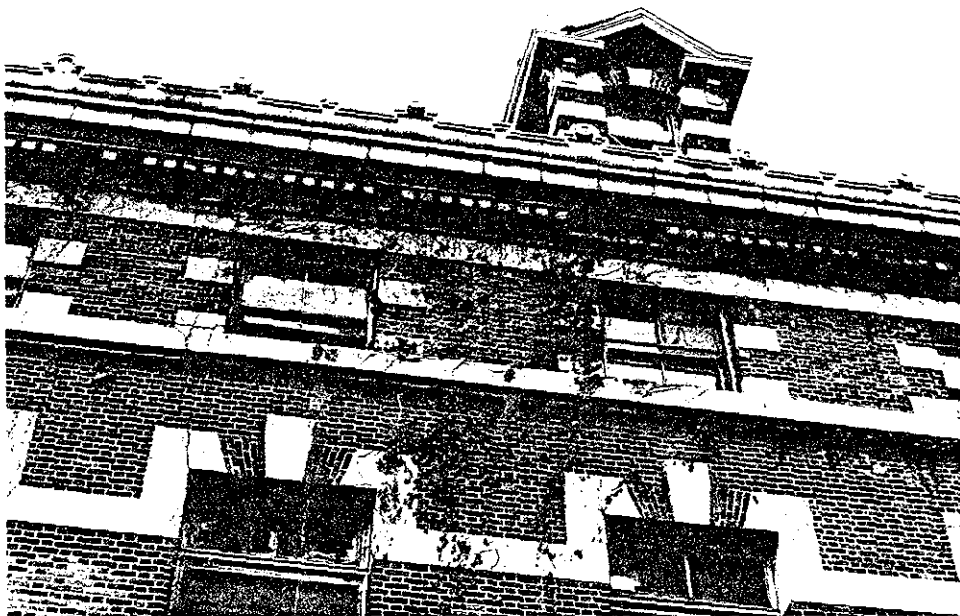
21.2 Hospital #2.
Spalled dentils
in terra cotta
cornice.

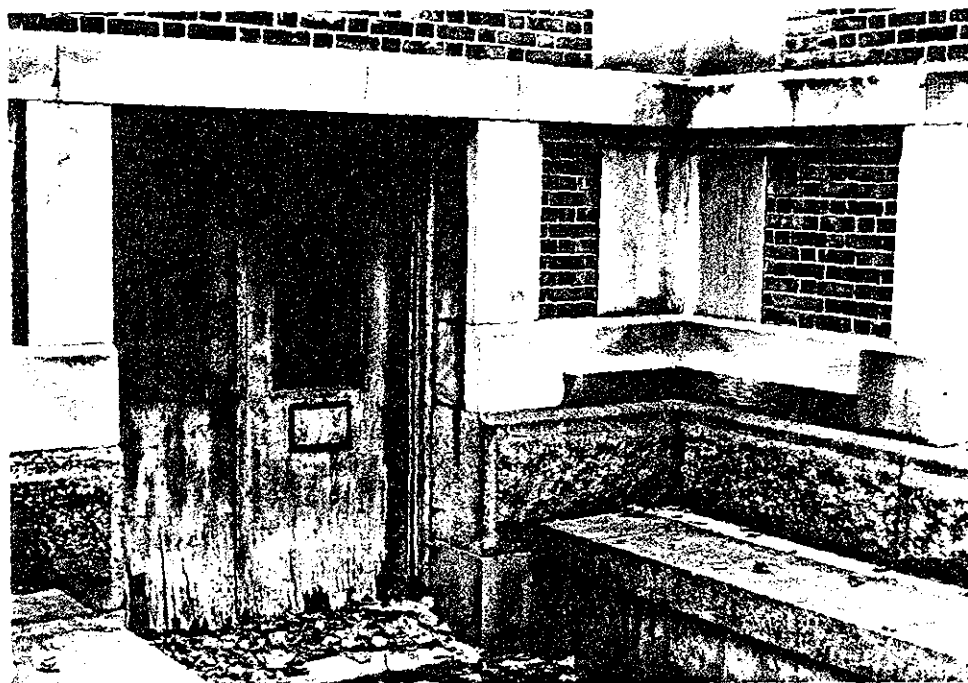
21.3 Hospital #2. Split and warped cellar doors.

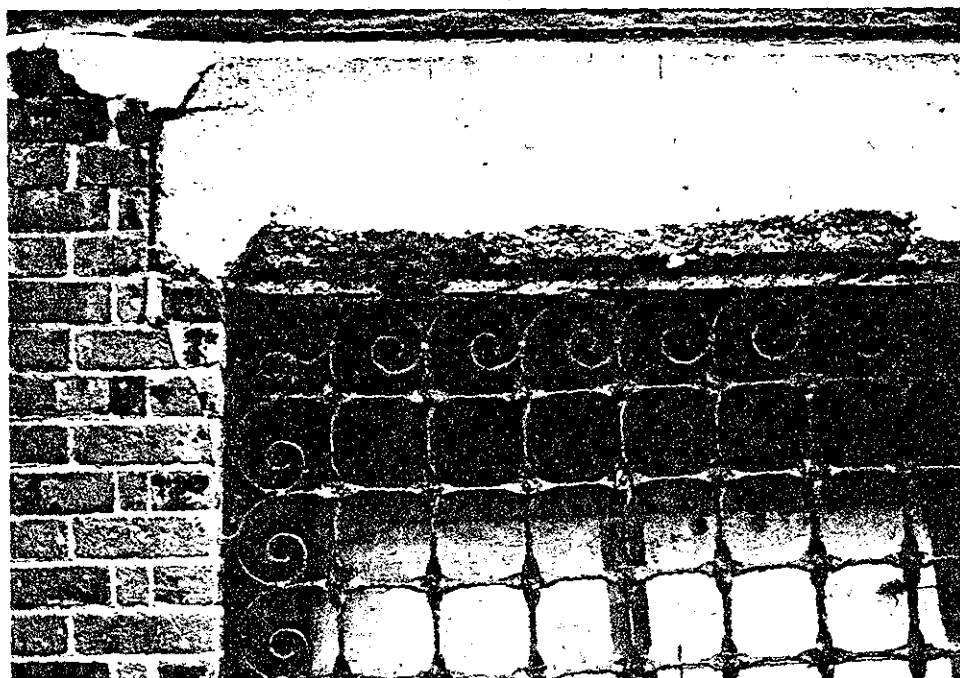
21.4 Hospital #2. Corroded ironwork and lintels on south porches.

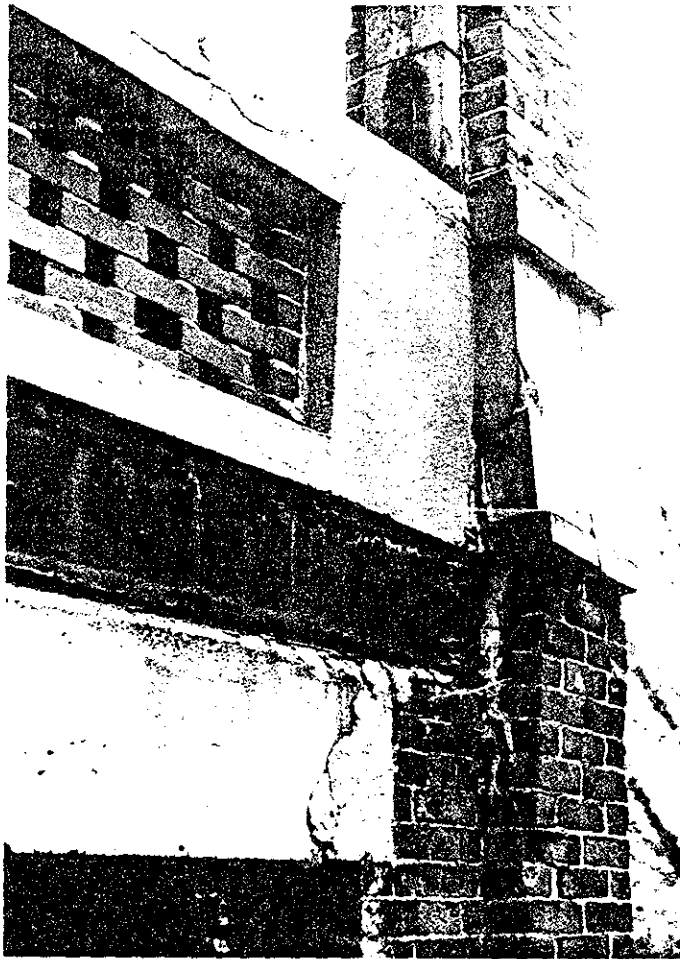
21.5 Hospital #2. Spalling brick, terra cotta and concrete on rear porch.

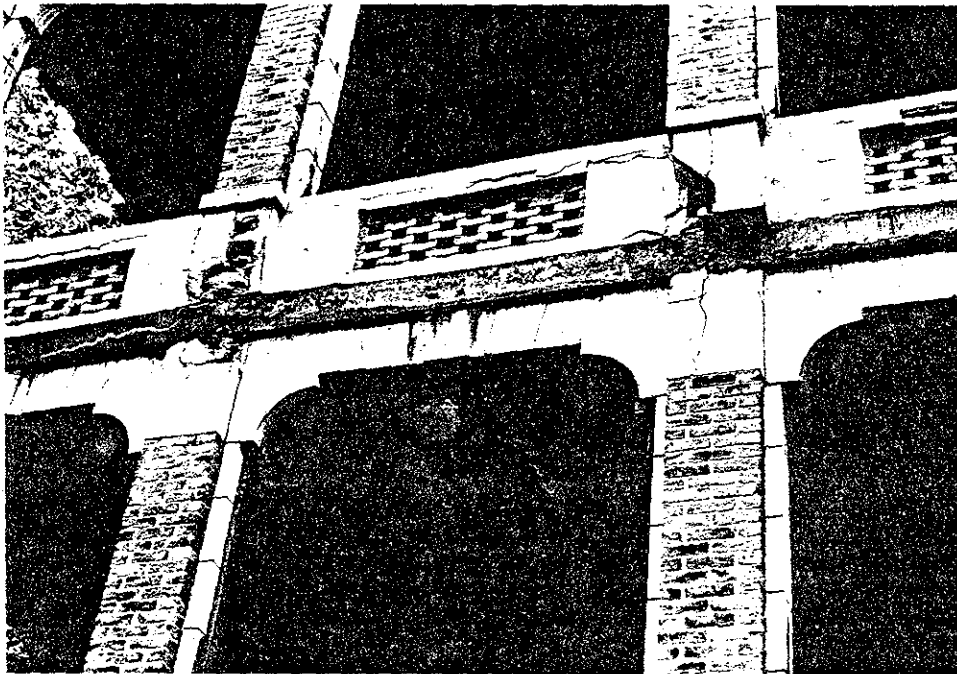
21.6 Hospital #2. Exposed and corroding second floor beams on rear porch.

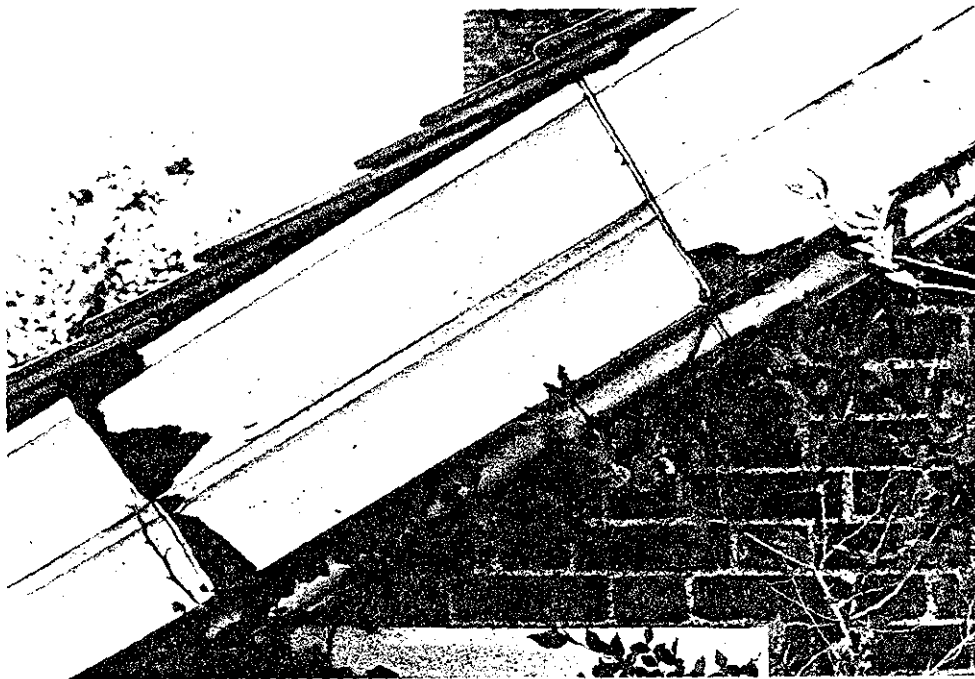
22.1 Recreation Hall. Spalled terra cotta eave blocks.

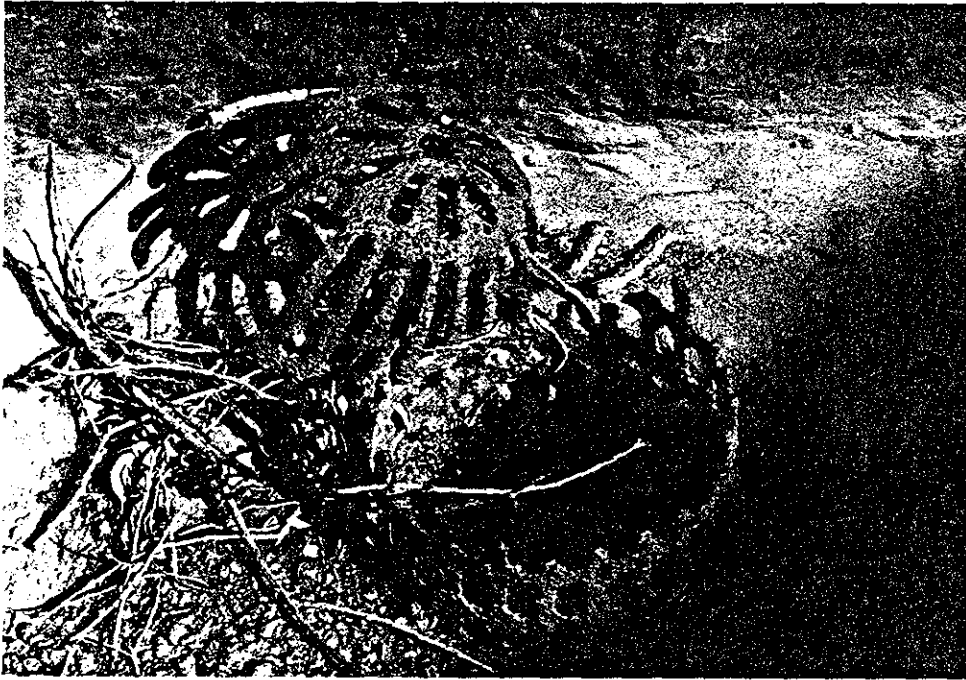
22.2 Recreation Hall.
Corroded drain
on north roof.

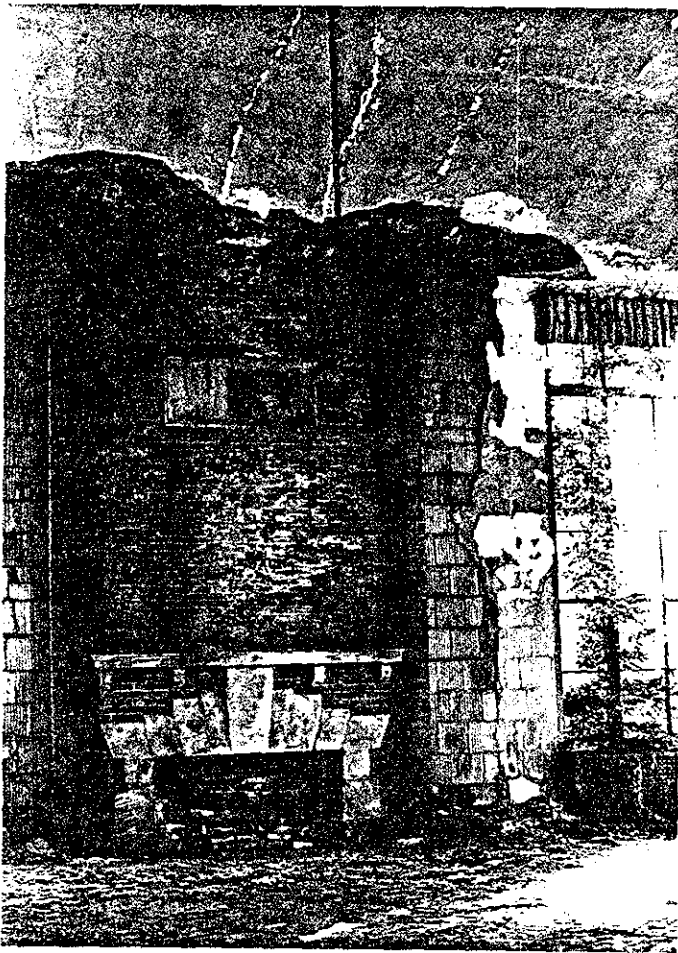
22.3 Recreation Hall.
Damage to interior
finishes around
central chimney.
