historic structures report
january 1980

STATUE OF LIBERTY
ELLIS ISLAND / U.S. IMMIGRATION STATION

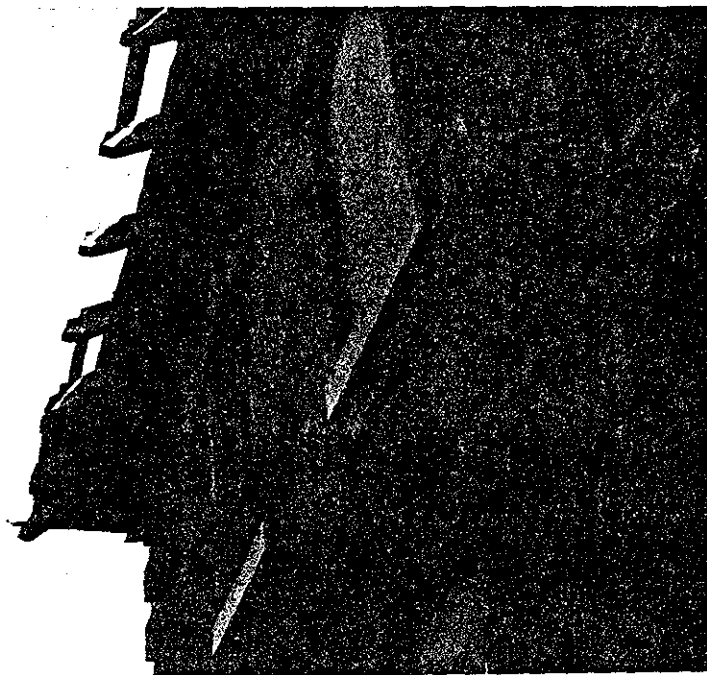
26.1 Laboratory. West eave has fallen off.

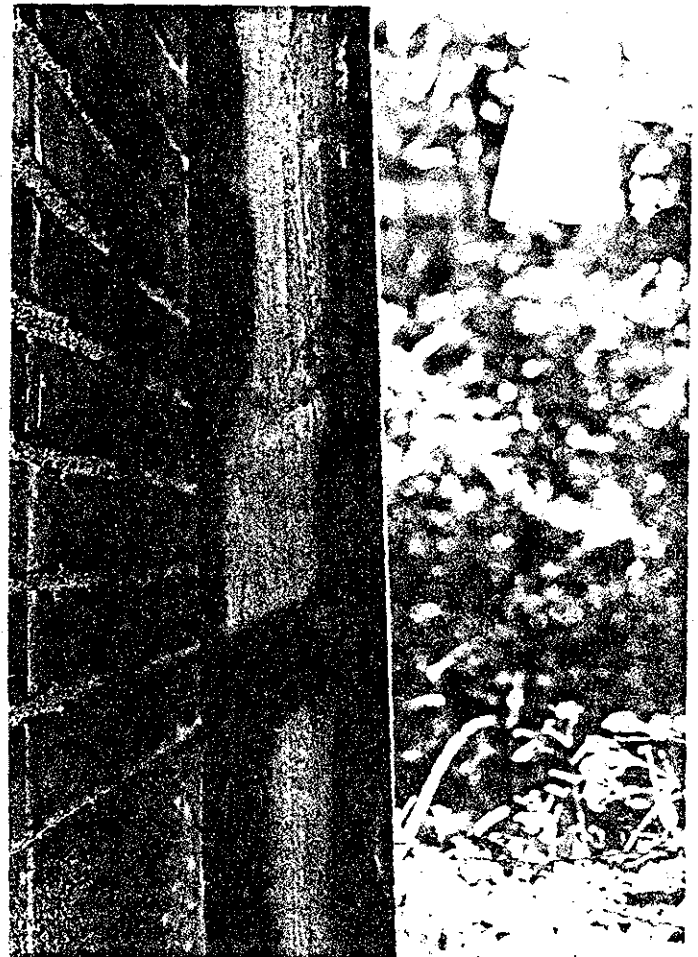
26.2 Laboratory. Cracked cast iron ground drain. This condition is typical for all similar drains on the island.

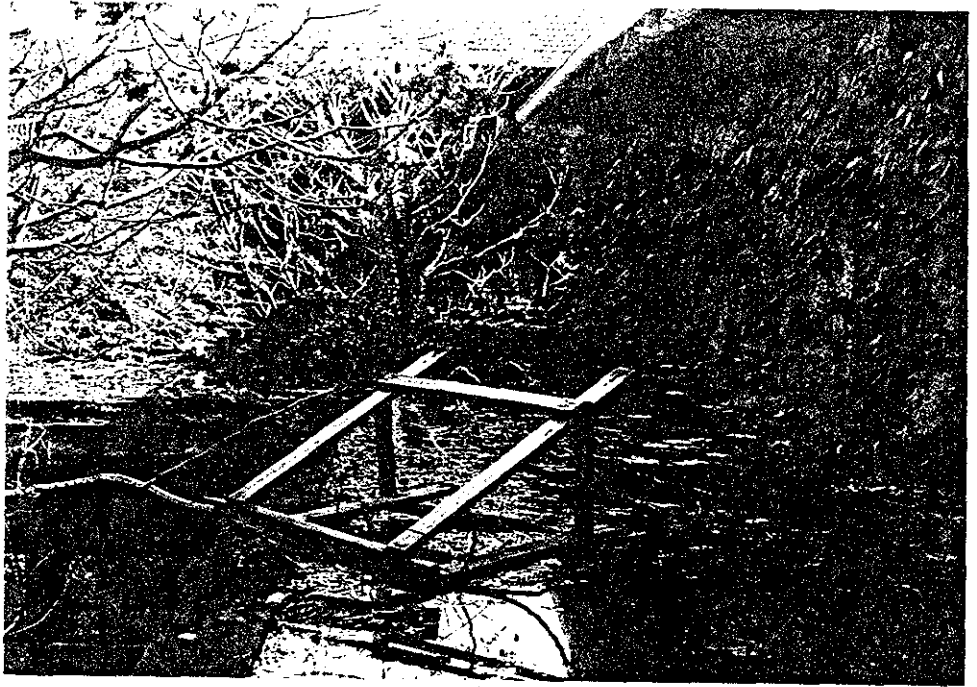
27.1 Passageway. Standing water on roof adjacent to Powerhouse and Storage Building (#24).

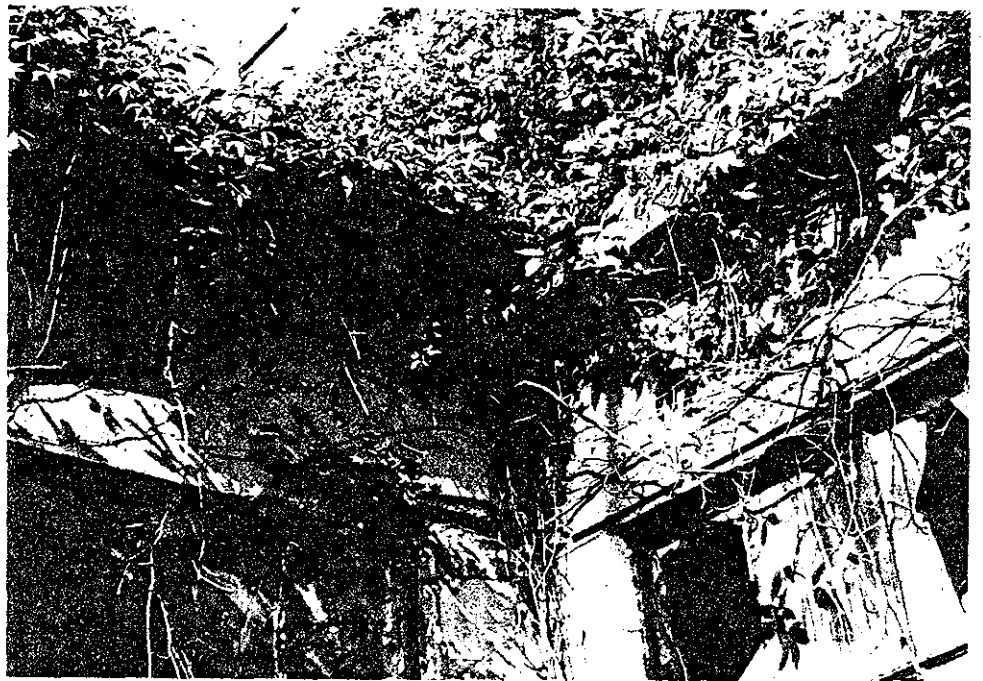
27.2 Passageway. Spalled concrete and corroding lintel on section 27A.

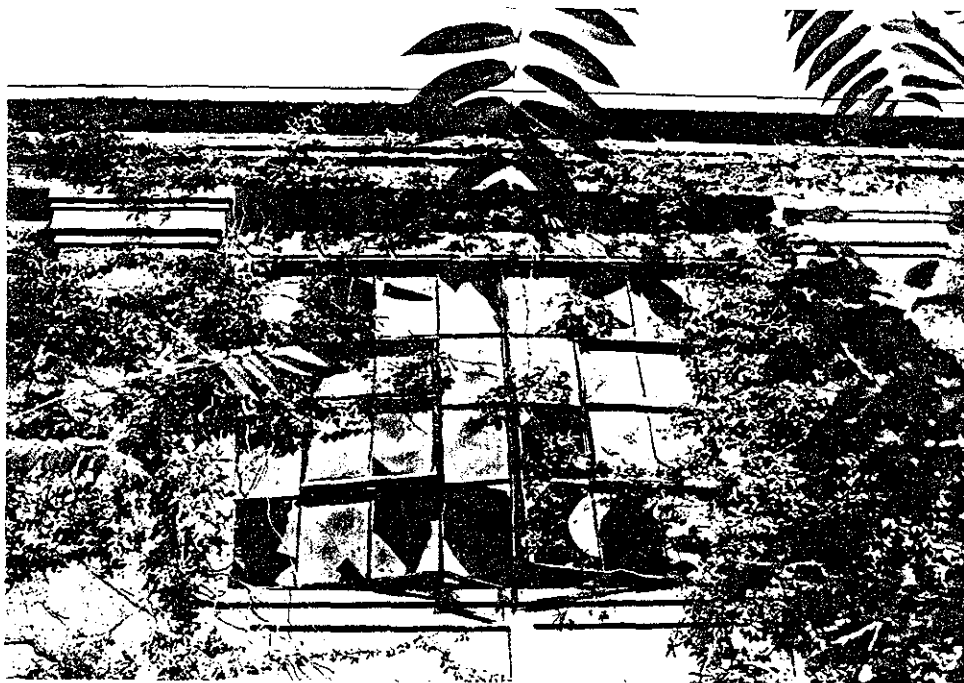
27.3 Passageway. Typical condition of metal sash.

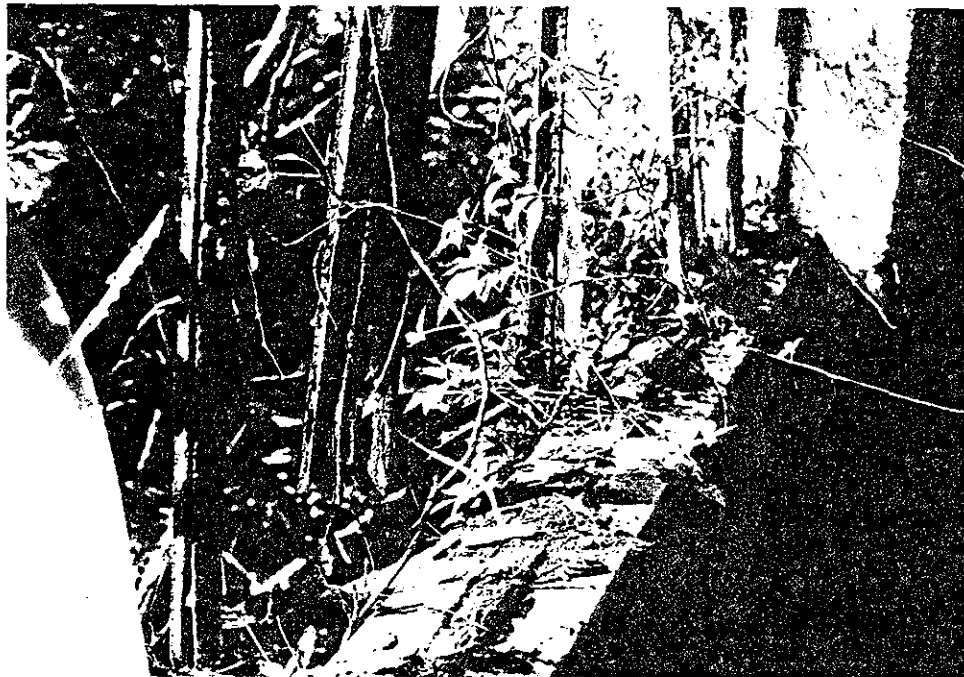
27.4 Passageway. Detail of typical sash showing corroded muntins and frames.

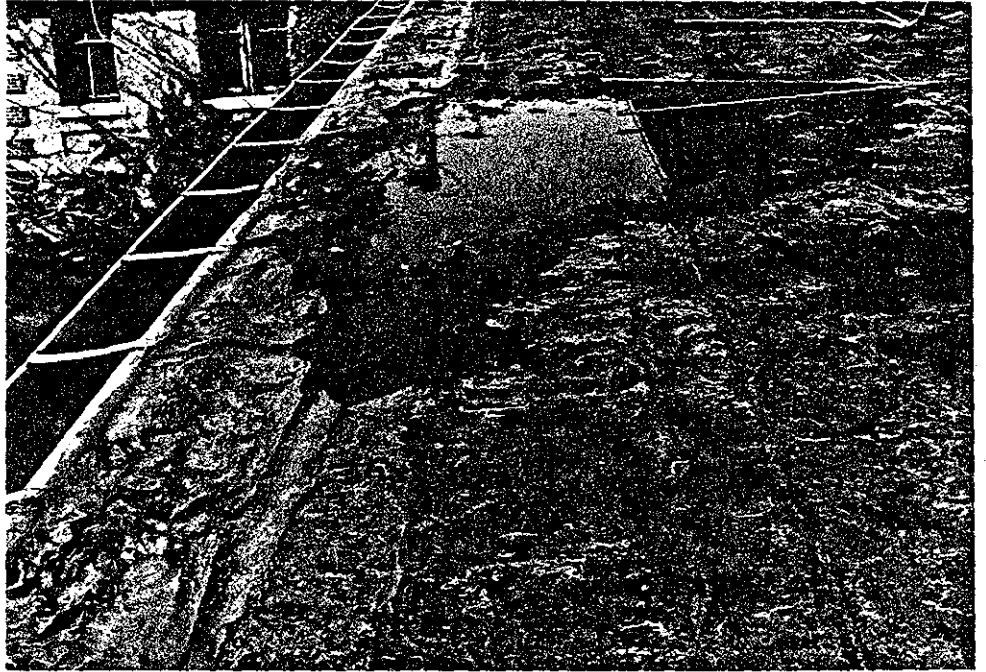
27.5 Passageway. Cracked and bubbled roof over Section 27C.

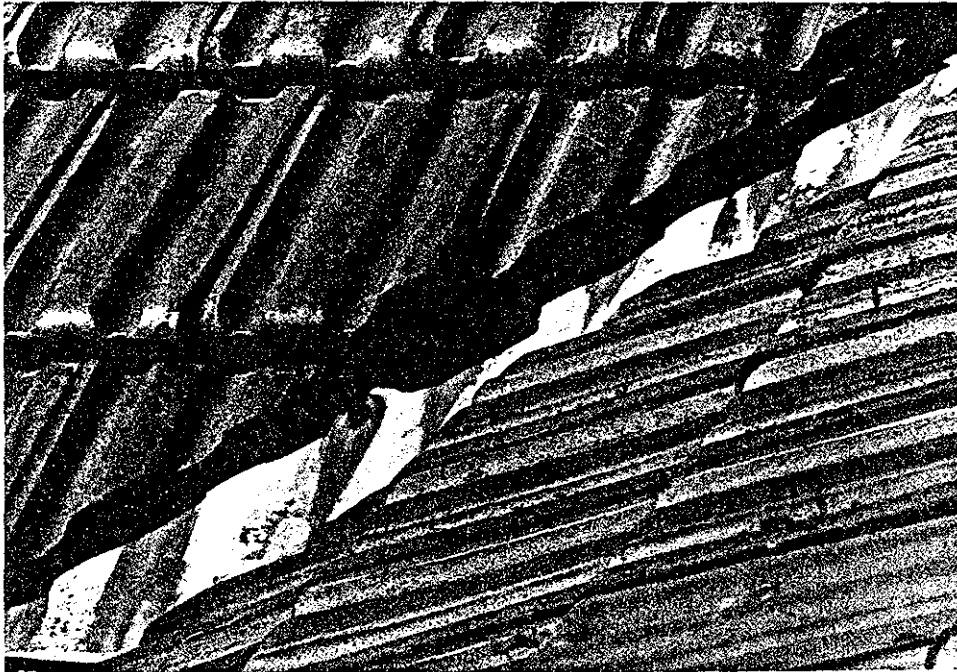
31.1 Wards 17/18.
Valley flashing
typical of all
buildings on
Island 3,
showing worn
spots where
water drains
off roof tiles.

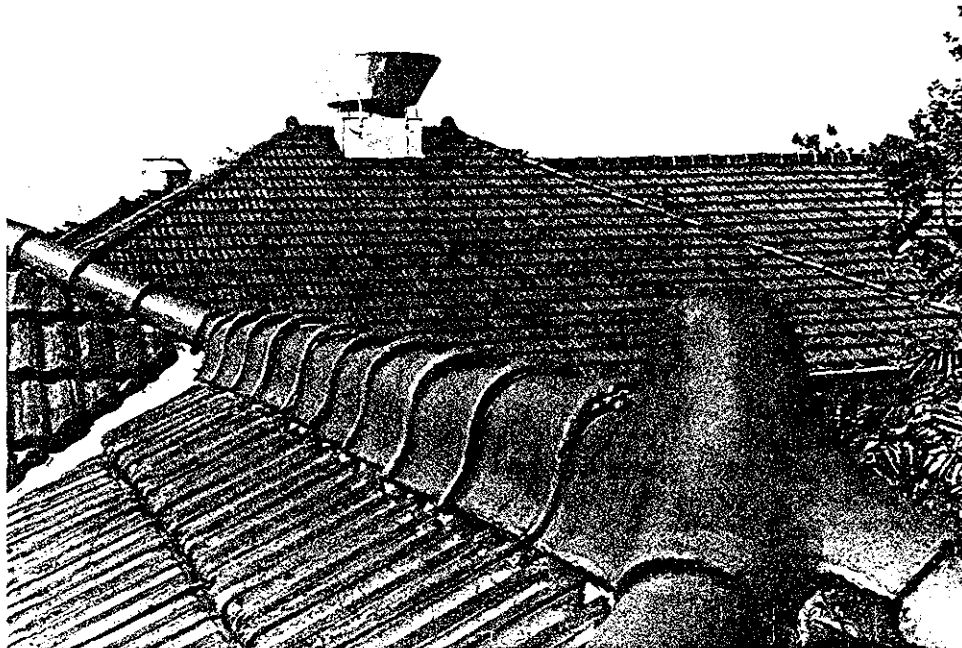
31.2 Wards 17/18.
Ridge tiles.

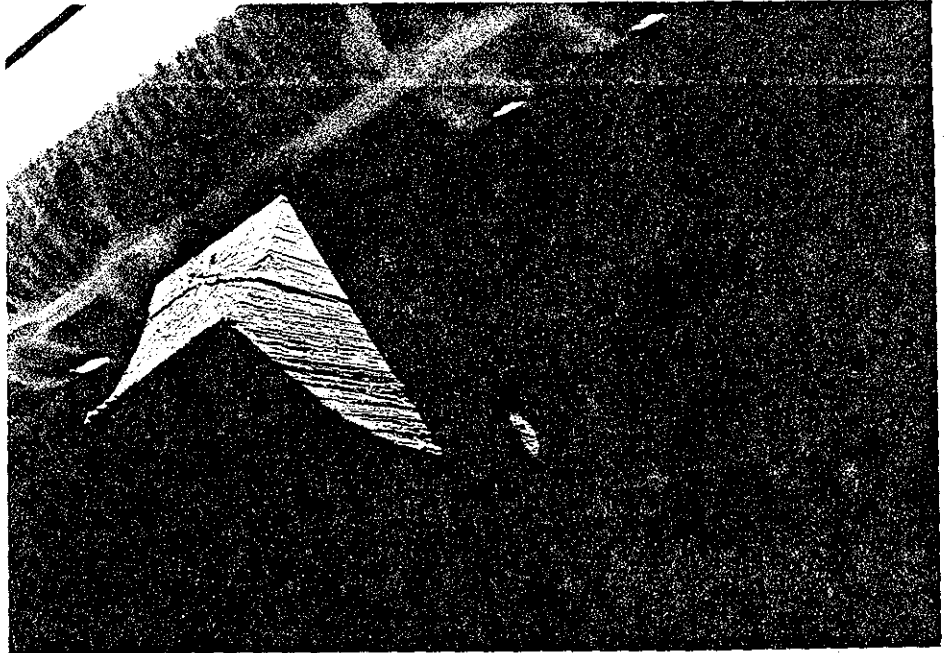
32.1 Nurses Quarters. End of wood bracket supporting eaves, showing splitting and checking found on all buildings of this construction.

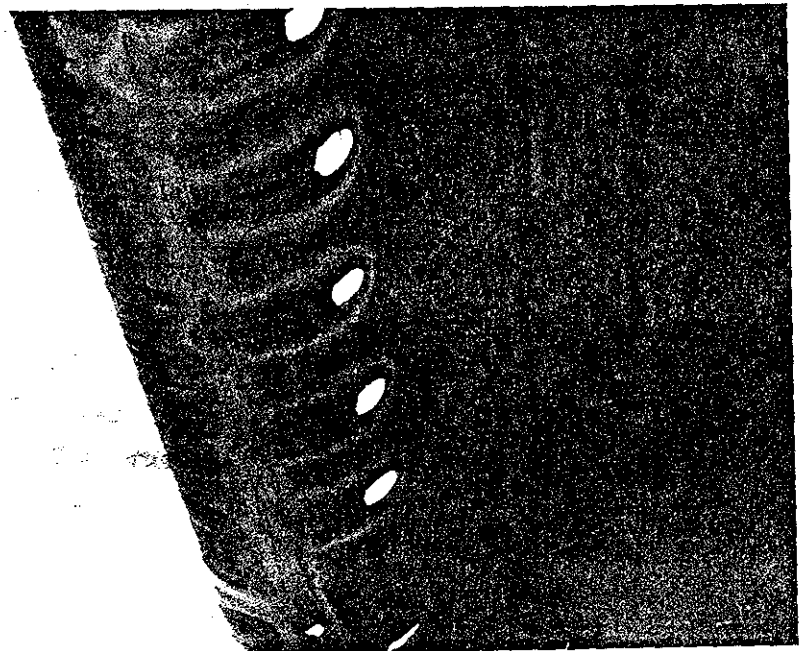
32.2 Nurses Quarters. Perforations in copper gutter caused by rainwater draining off tiles. Found on all buildings of similar construction.

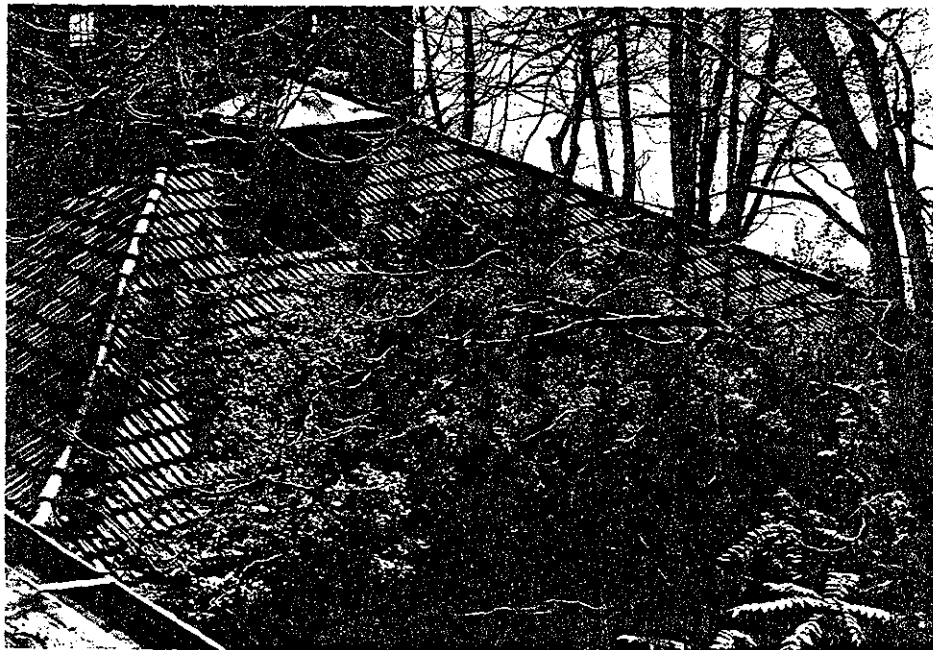
33.1 Kitchen. Roof covered with vegetation.

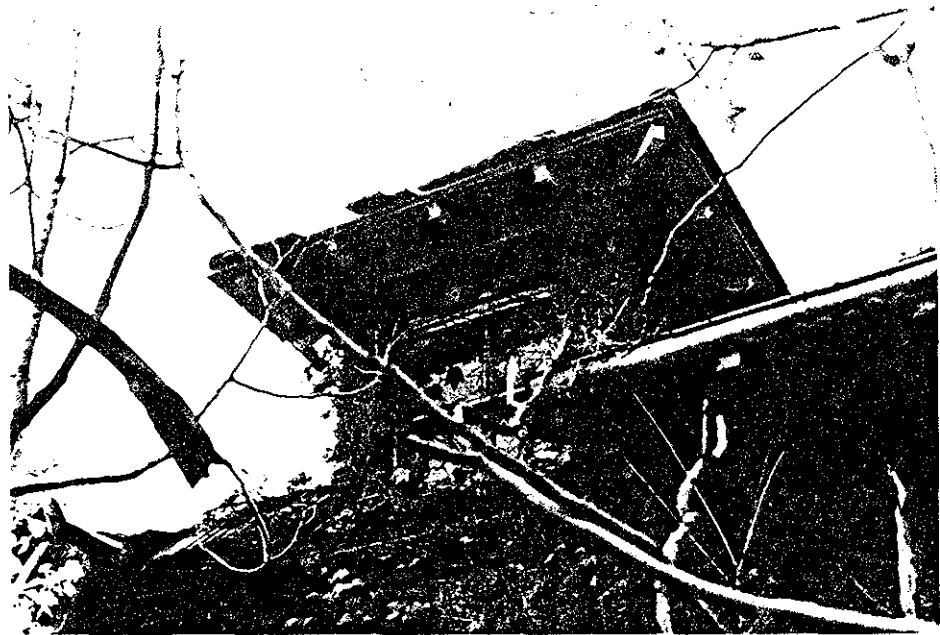
38.1 Wards 27/28. Dormers on north side. Note missing roof tiles, damage to eaves to left of dormer and vegetation growing in gutters.

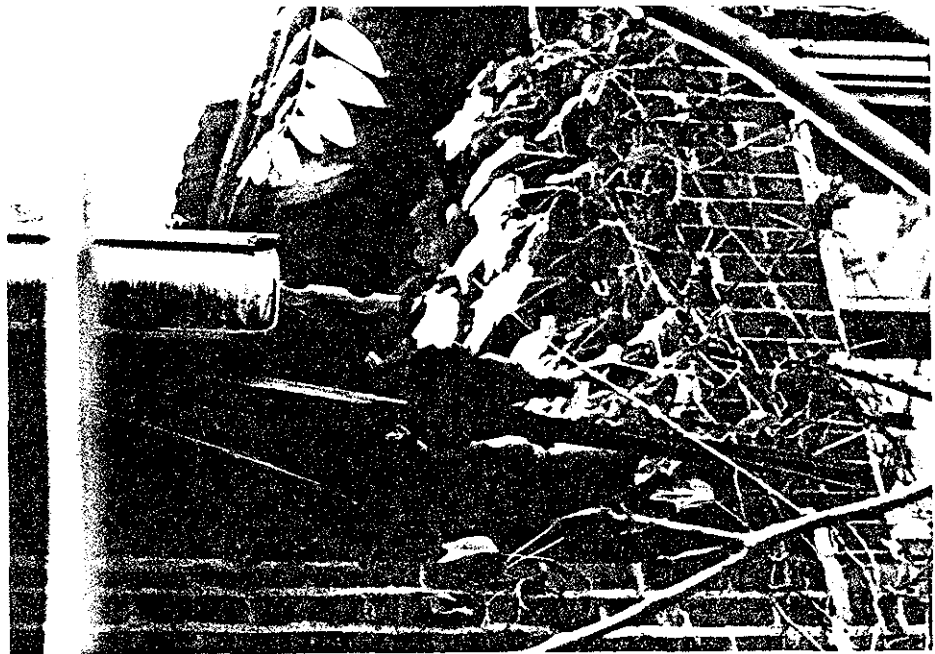
38.2 Wards 27/28. Detail of damage to north dormer.

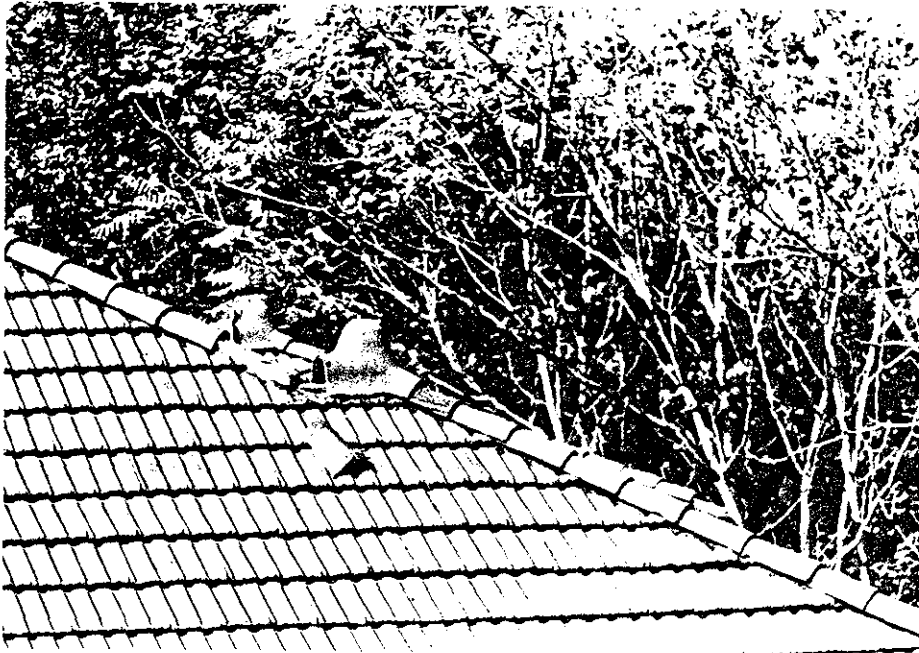
39.1 Wards 29/30.
Missing tiles
or open joints
at ridge cap
allow water to
flow in along
ridge battens.

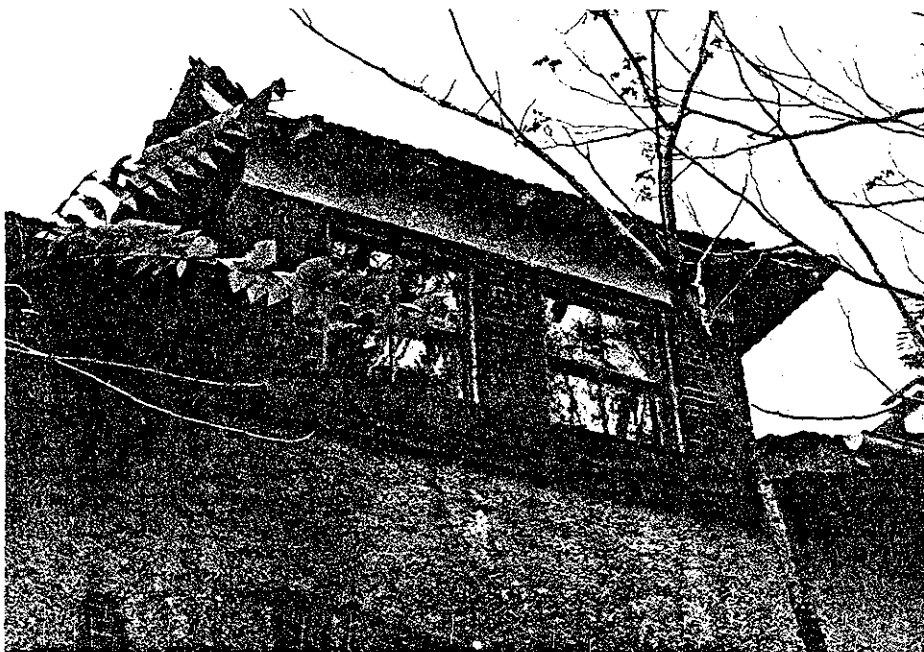
39.2 Wards 29/30.
Damaged eaves
in north
dormer.

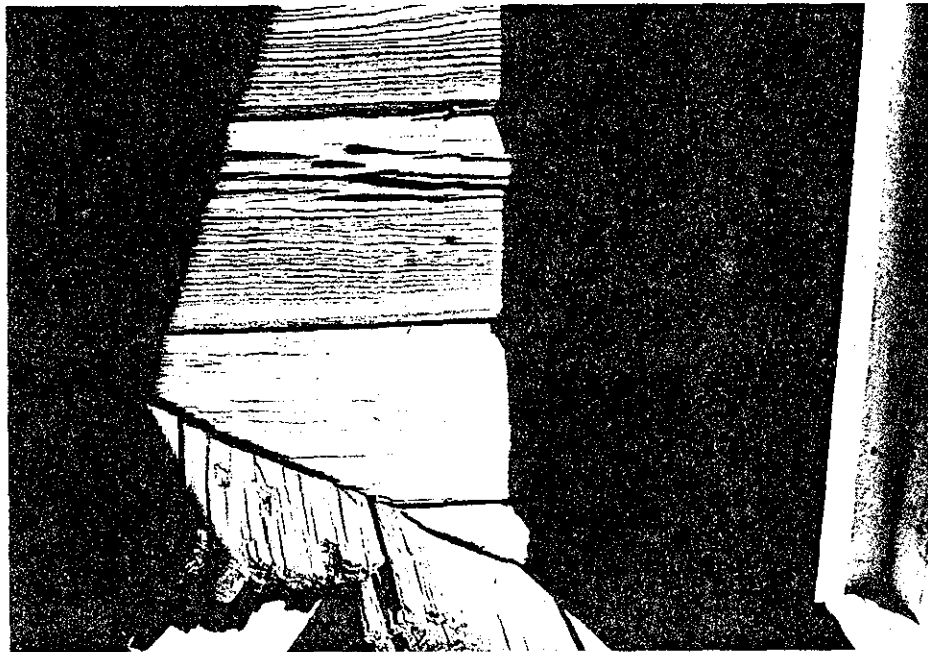
41.1 Staff Headquarters. Split and checked wood dormer sheathing. Caused by exposure through open windows, this condition is similar to that found in Buildings #26 and #32.

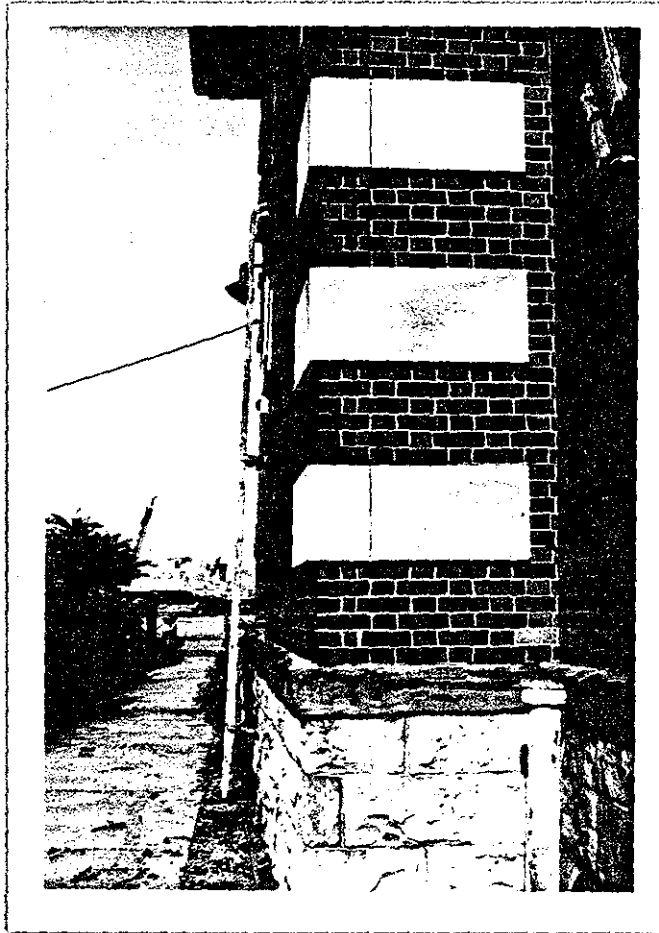
West Wall looking
North from Line 10

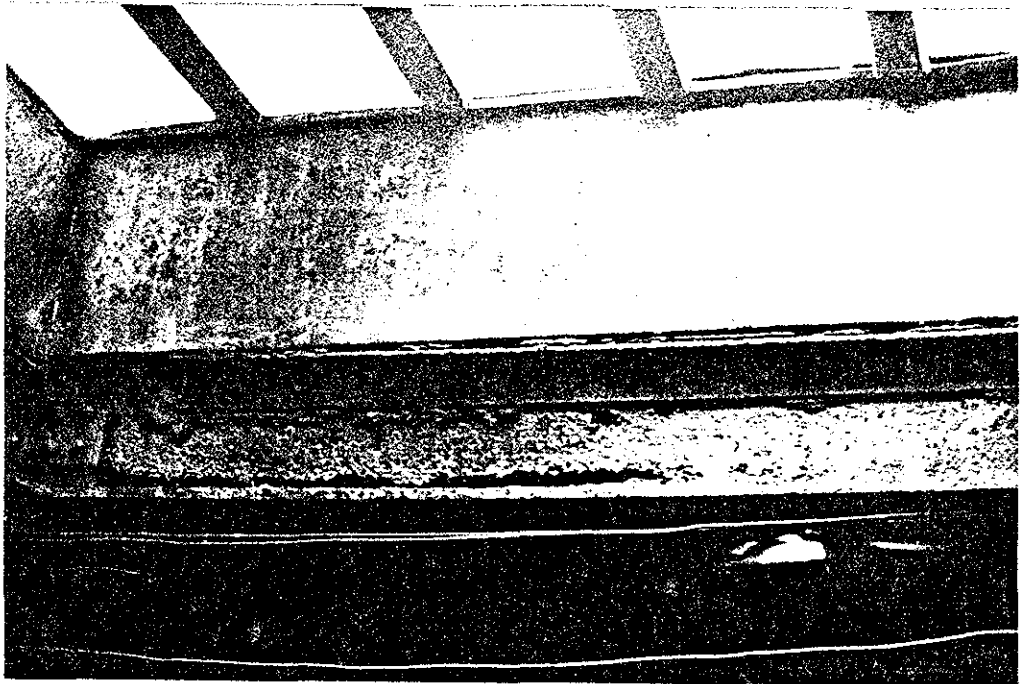
Corroded Skylight
Purlin

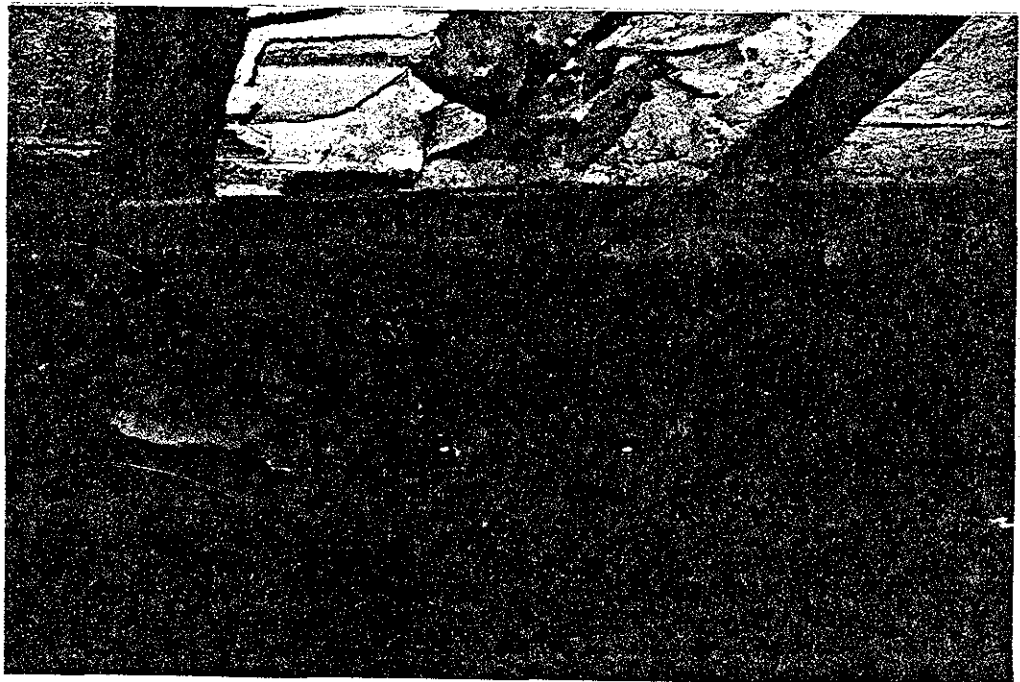
Corroded Roof Purlin

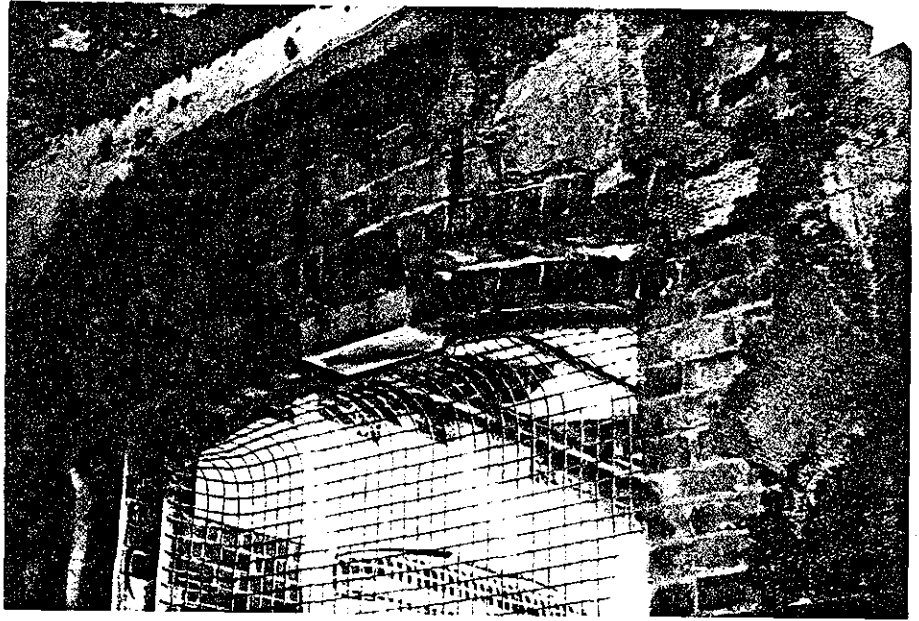
Partially Collapsed
2nd Floor Arch over
Window

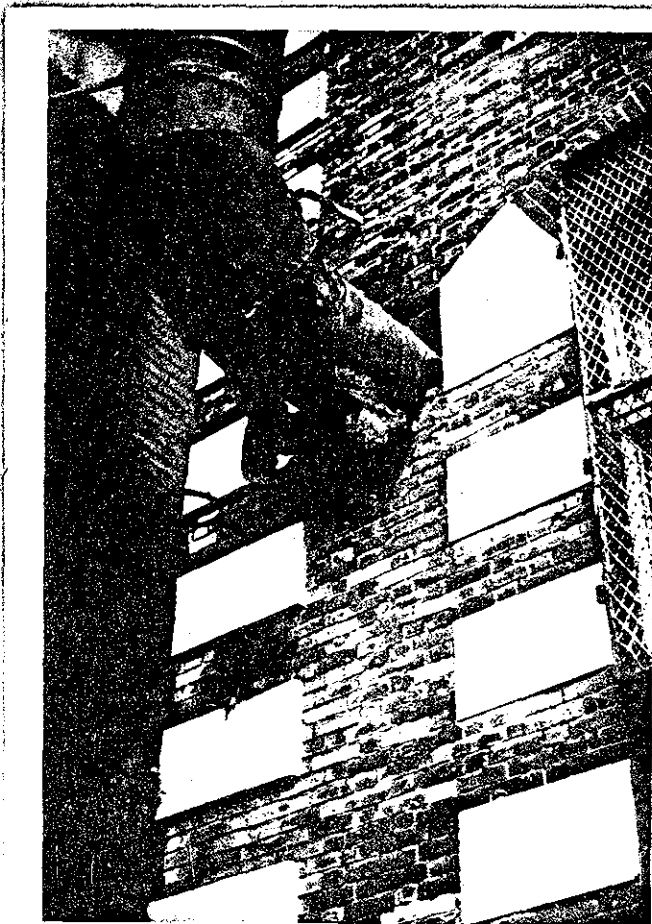
Damaged Wall and
Steel Stack

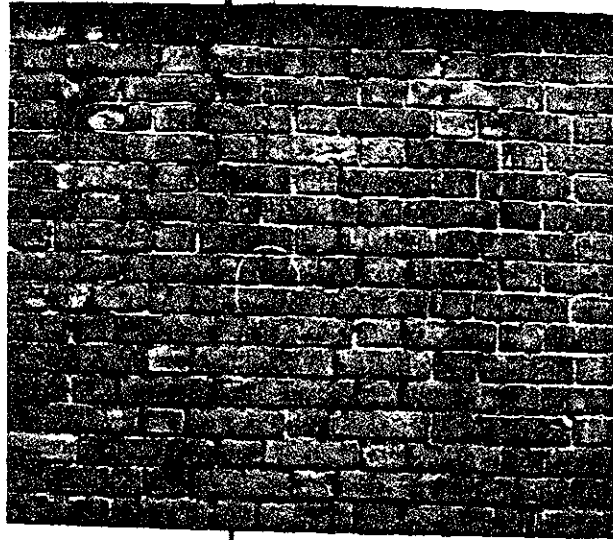
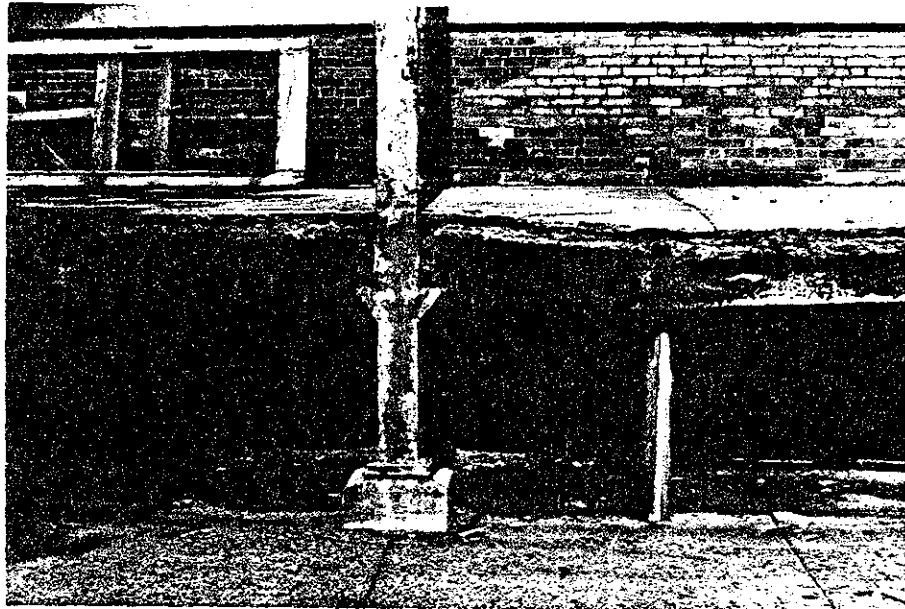
Completely Corroded
Porch Spandrel Beam

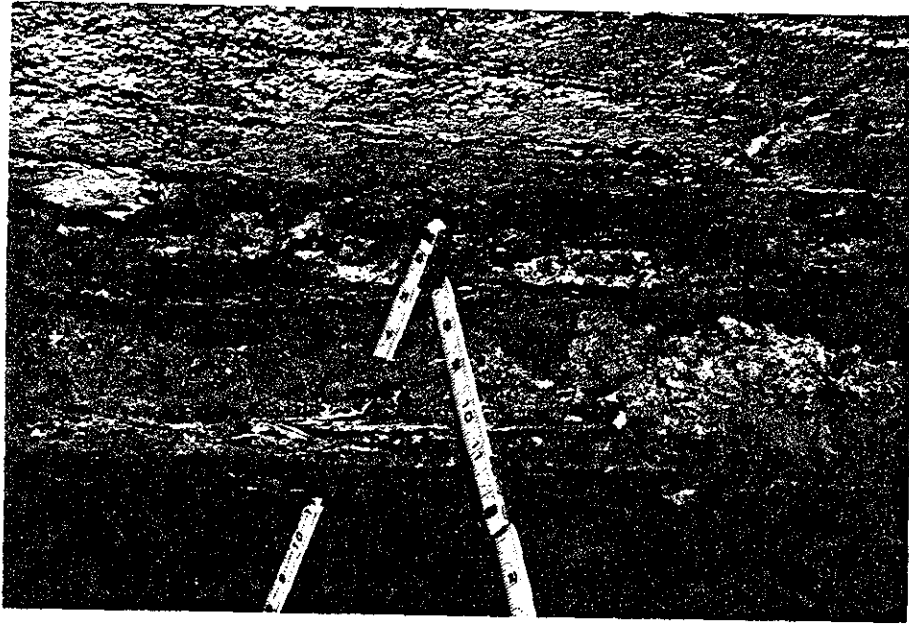
Corroded Porch Floor
Beam

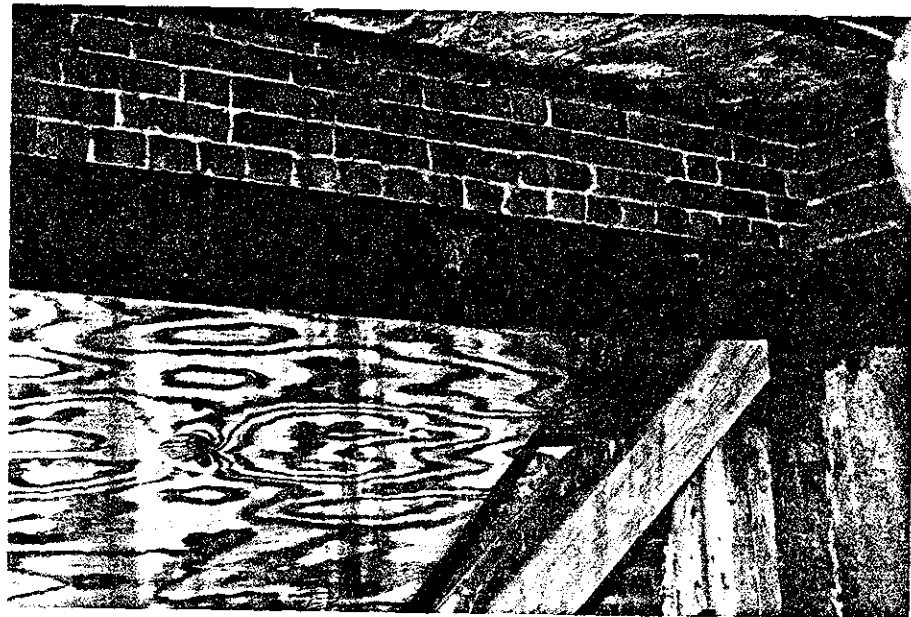
Wood Supporting Second
Floor Beam

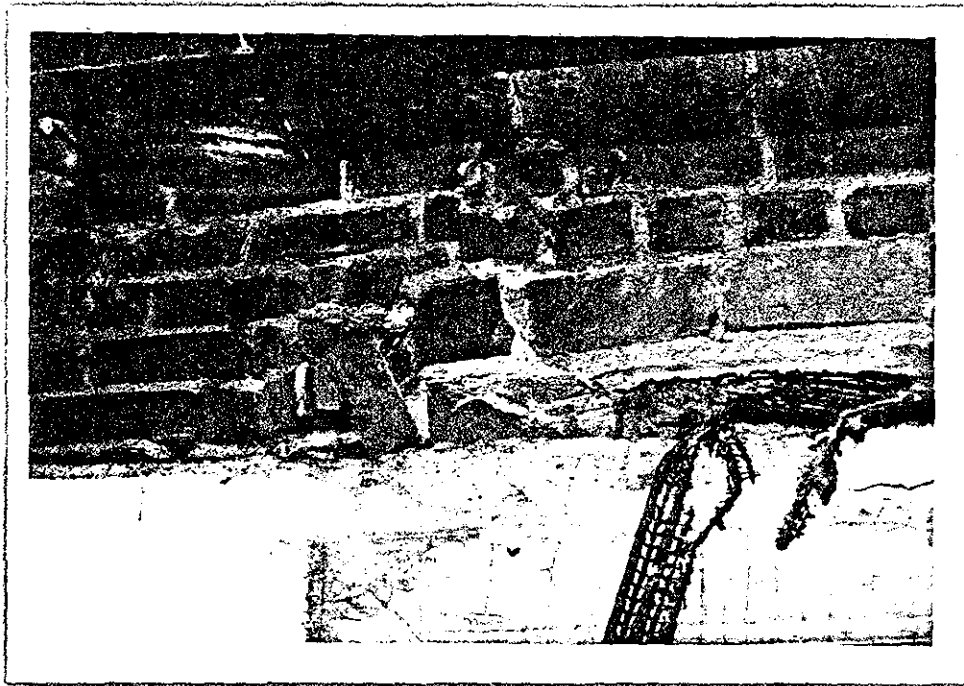
Cracked Wall at
Covered Walkway Roof

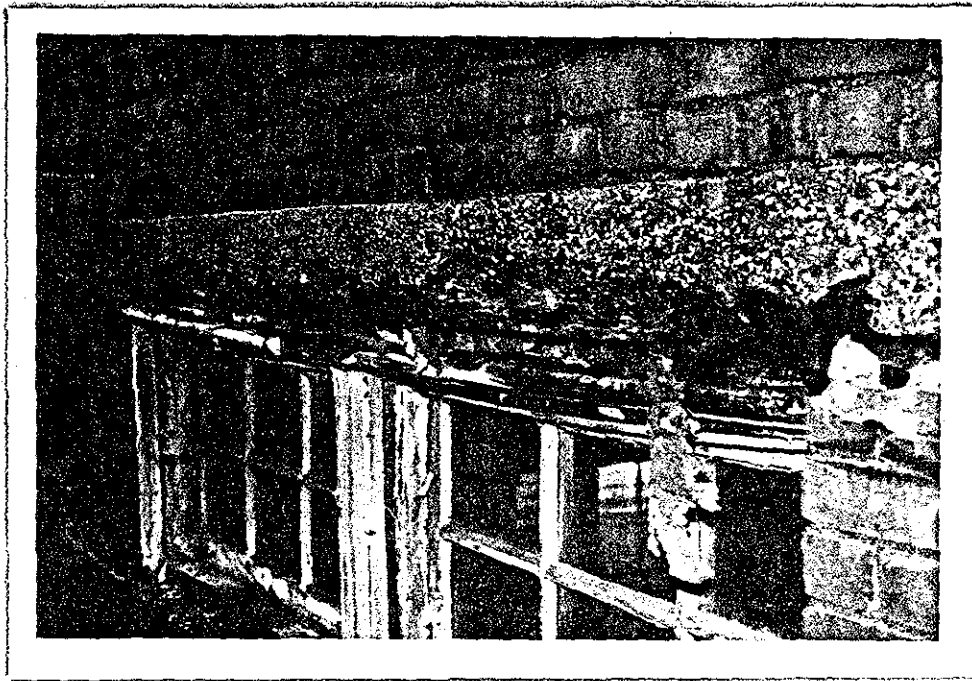
Addition #1 - Typical
Damaged Lintel

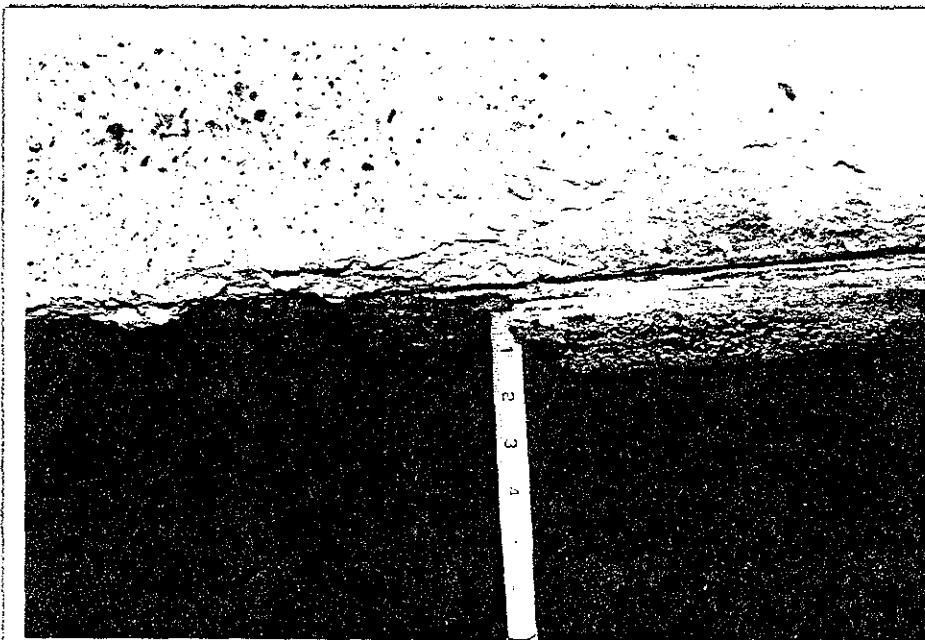
Addition #2 - Corroded
Floor Beam

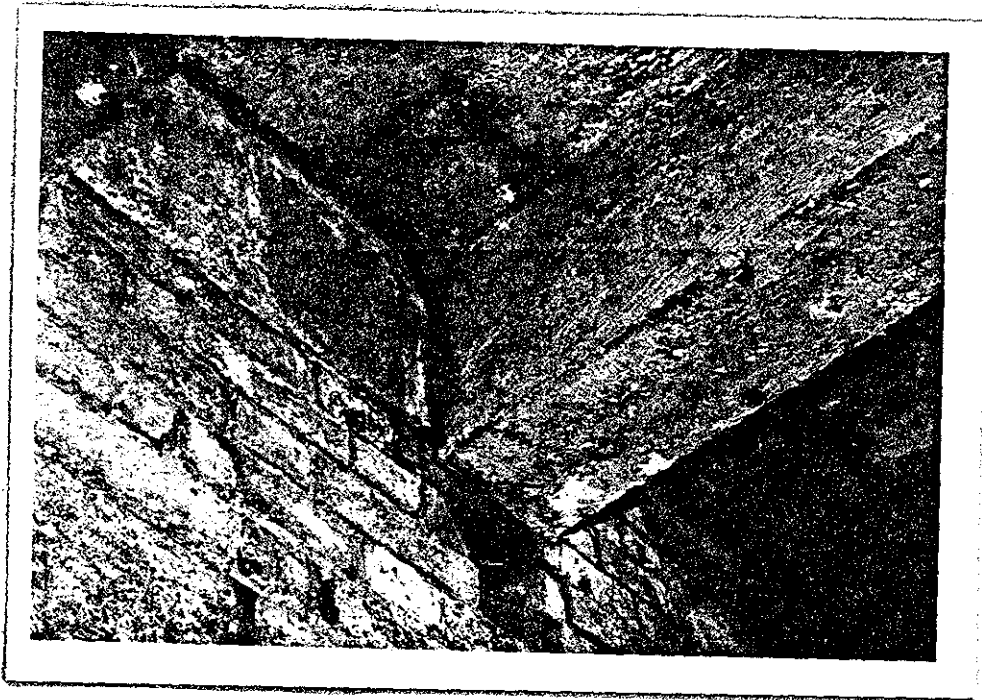
Addition #2 - Separated
Roof Slab

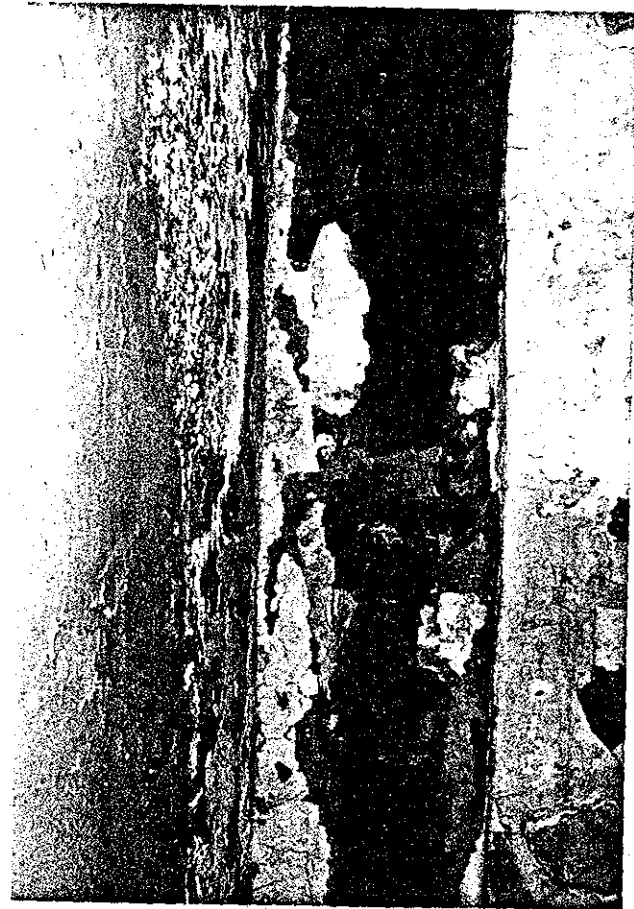
Typical Water Damage -
3rd Floor Leader

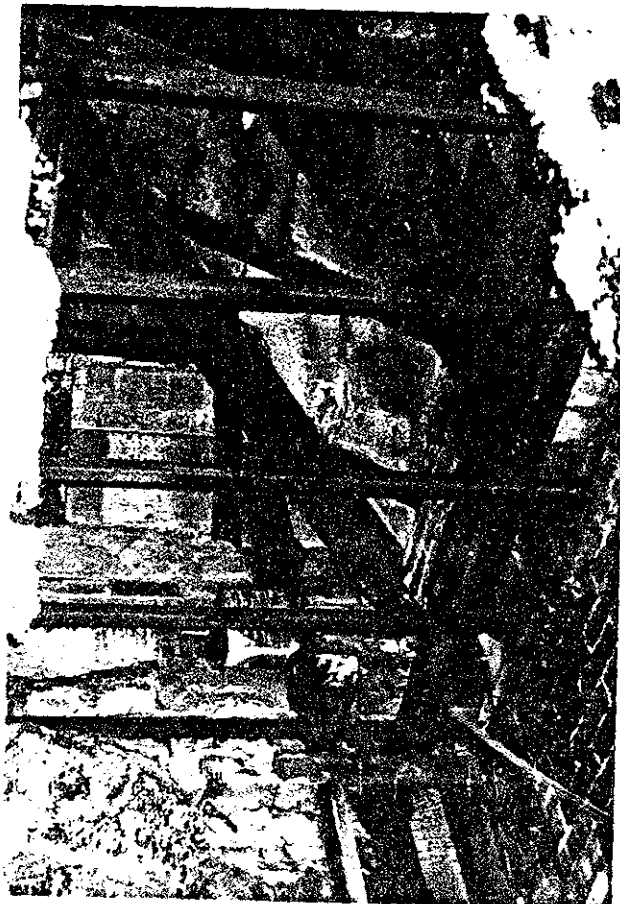
Collapsed Ceiling and
Plaster - 3rd Floor

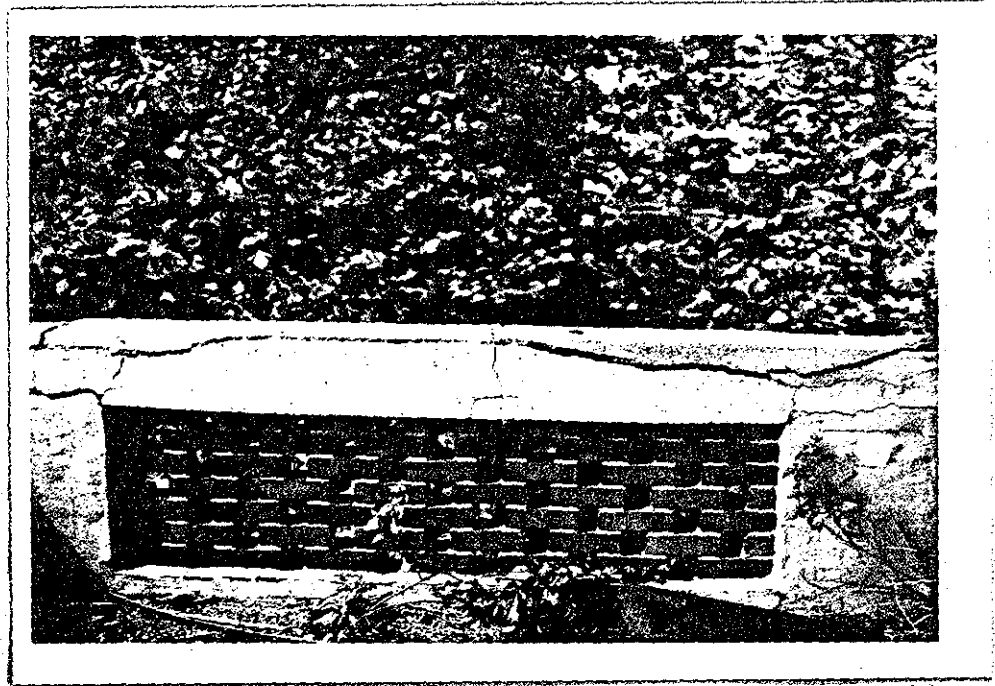
Cracked 2nd Floor
Balcony Parapet

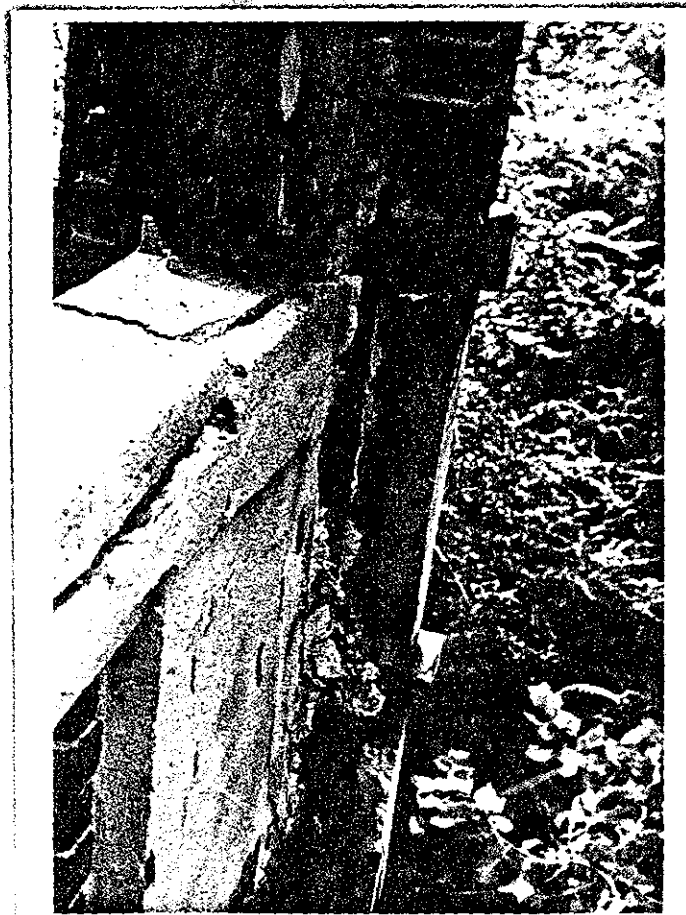
Damaged Column at 2nd
Floor Balcony

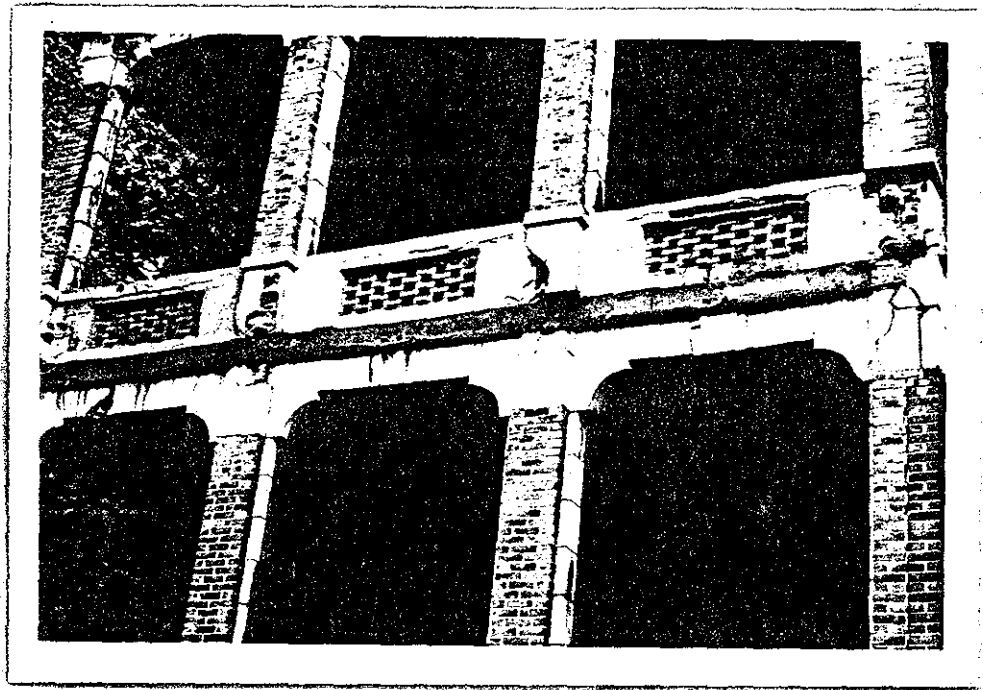
Damaged 2nd Floor
Balcony

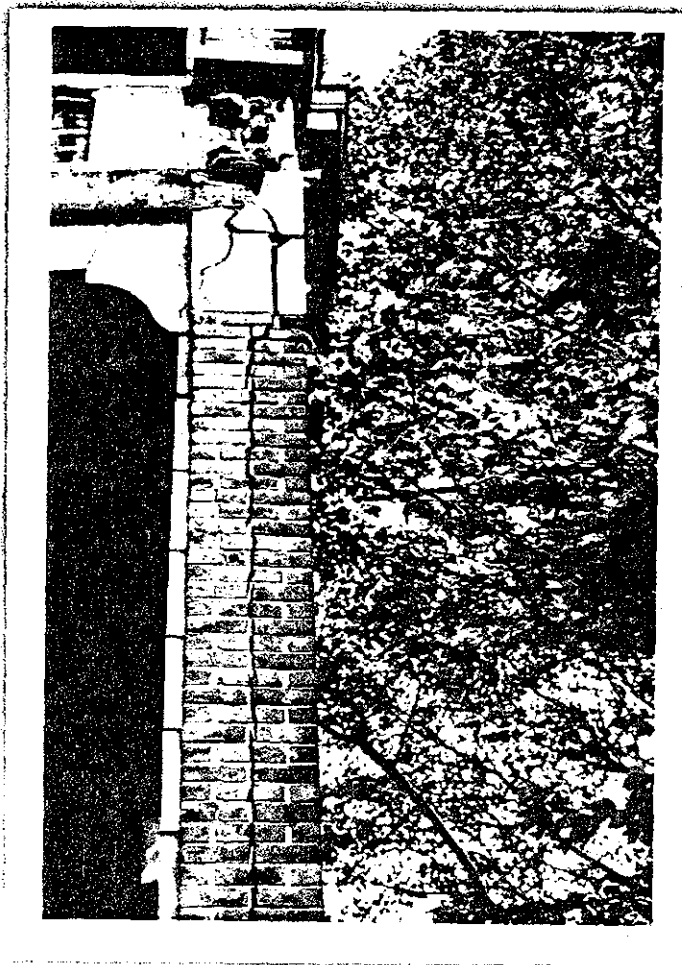
Damaged 1st Floor
Balcony Column
