historic structures report
january 1980

STATUE OF LIBERTY
ELLIS ISLAND / U.S. IMMIGRATION STATION

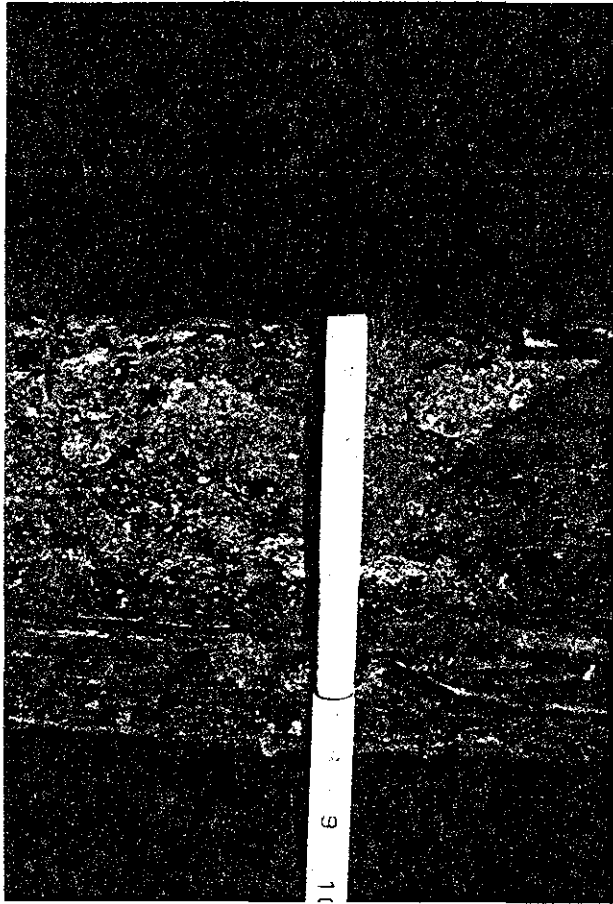
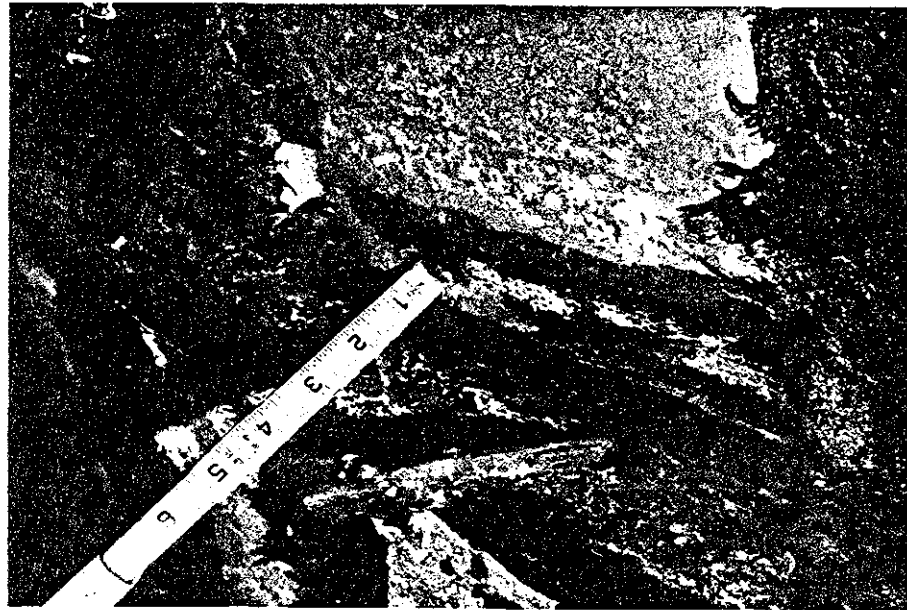
Corroded "T" Purlins
Supporting Roof Tiles

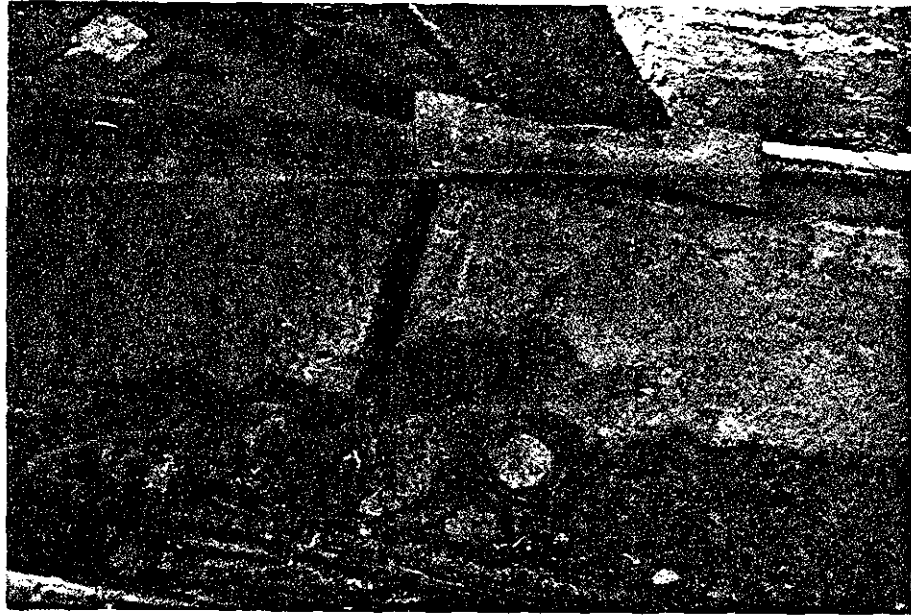
Corroded Horizontal
Purlins at Truss Top
Chord

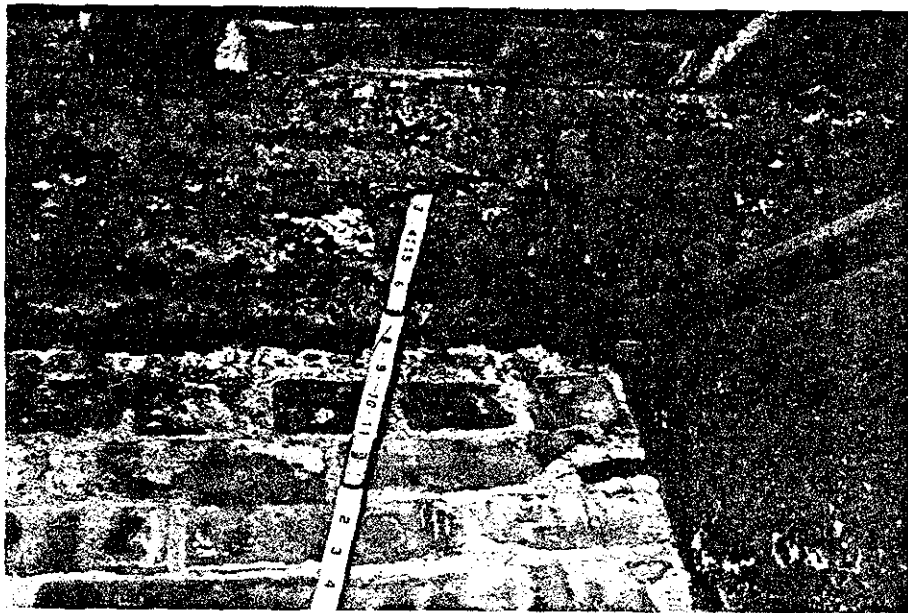
Corroded Stack Purlin

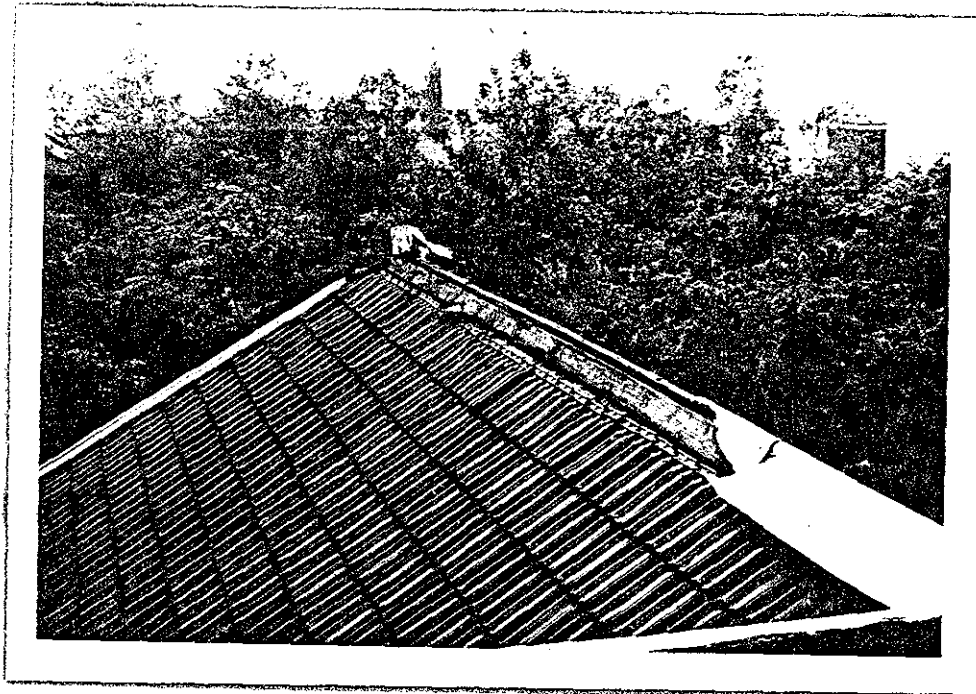
Missing Ridge Capping
