National Park Service
Cultural Landscapes Inventory
1996

Liberty Island
Statue of Liberty National Monument

Inventory Summary

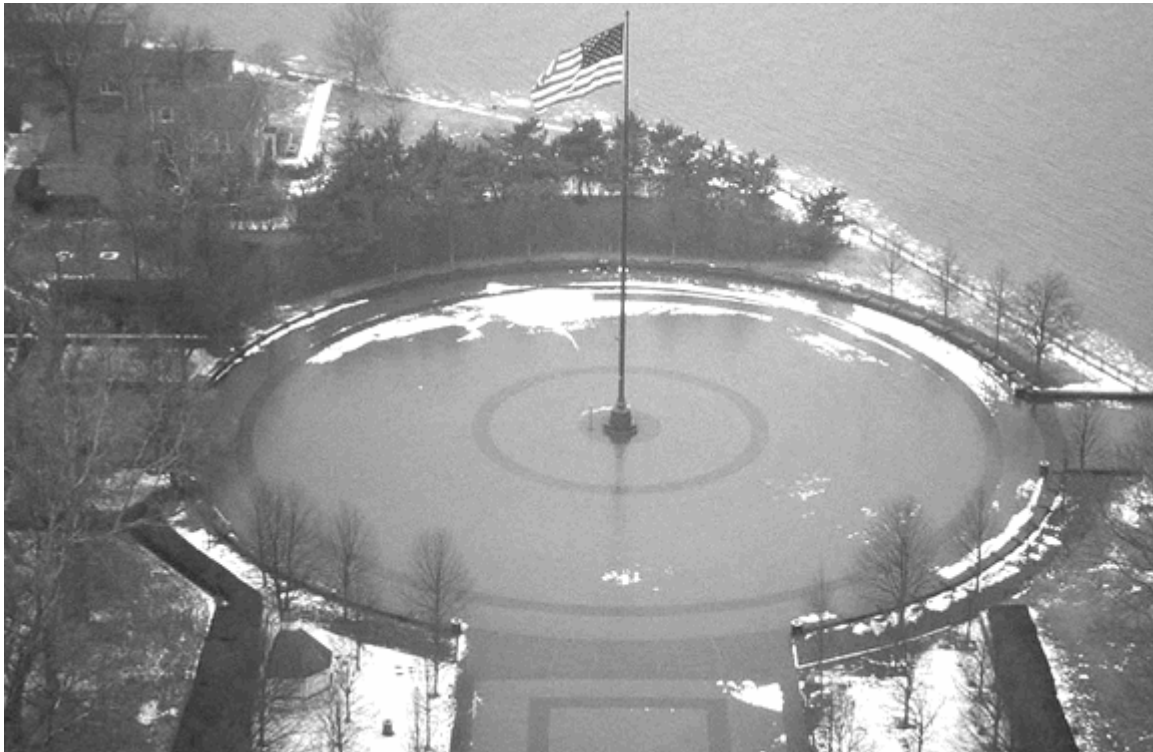
In 1986, the flag plaza was completely redesigned. The circular form, red brick paving and scale of the space are not in keeping with the historic character of the space (2003).

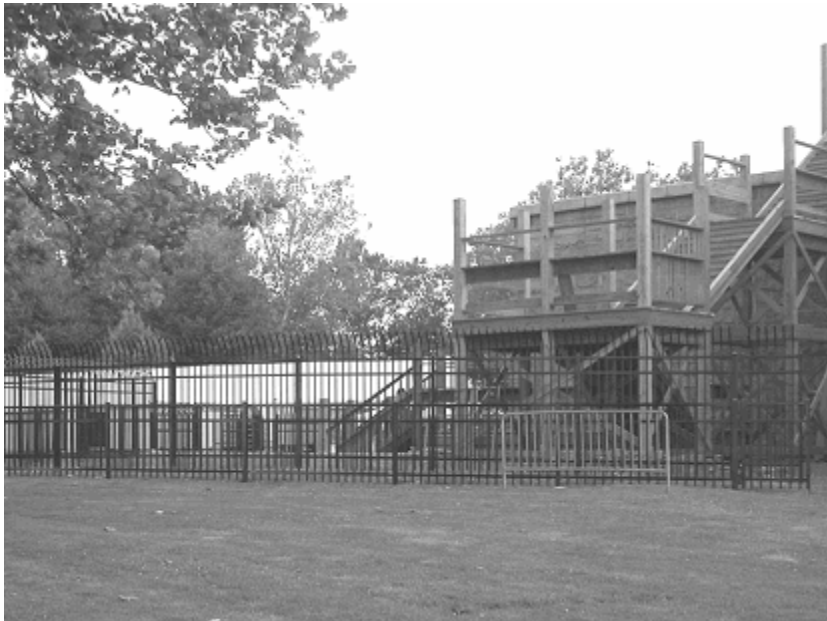
Small-scale structures such as the concession/security tent, temporary Fort Wood stairs and security fencing detract from the historic appearance of the landscape (2004).
