# Historic Housing Area Historic Structures Report

## HS-05 Quarters

Wind Cave National Park

January 27, 2016  
NPS PMIS # 158029

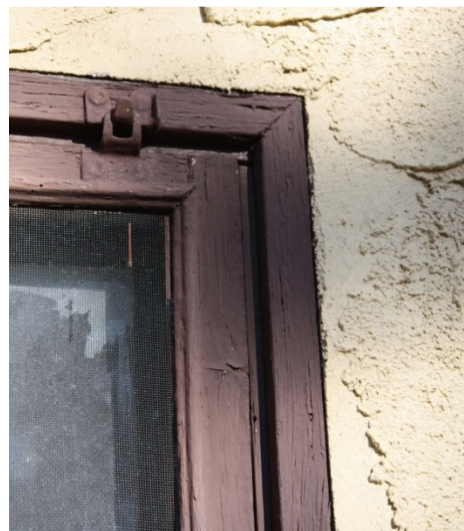
Figure W4. Detail of typical window trim deterioration where the historic trim is exposed. This shows signs of many peeling paint layers and wood rot at Window 103. (SRJA 2015)

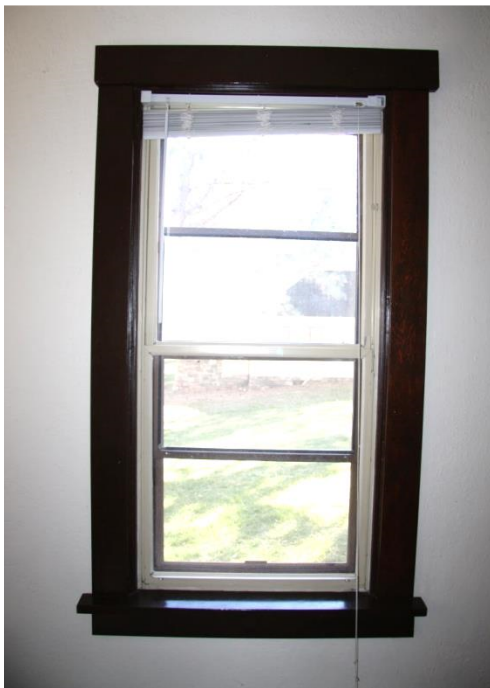
Figure W7. Detail of inappropriate aluminum interior replacement Window 103. (SRJA 2014)

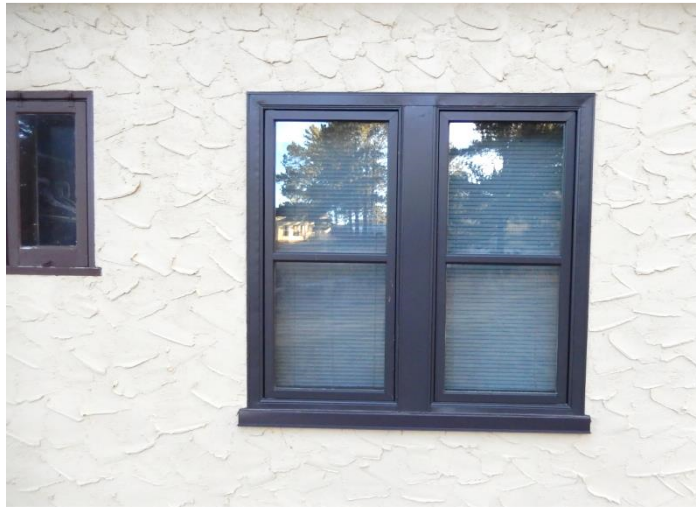
Figure W9. Detail of historic wood Window 114 on the left adjacent to replacement aluminum casement Window 113 with metal panning over the trim. Note the metal trim is much thicker at the side and at the sill. (SRJA 2015)

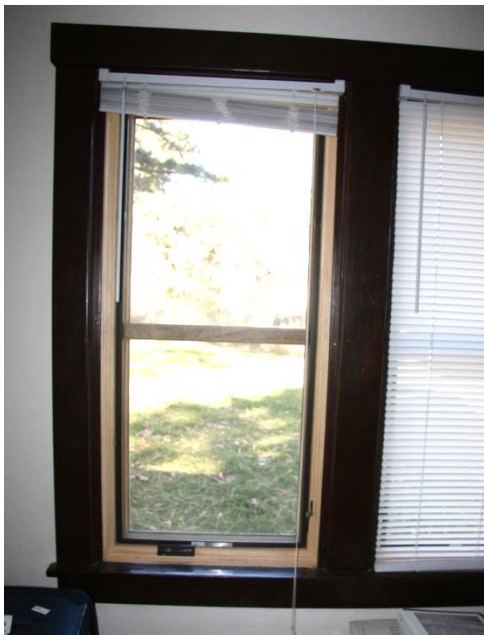
Figure W11. Detail of inappropriate aluminum interior replacement Window 113. (SRJA 2014)

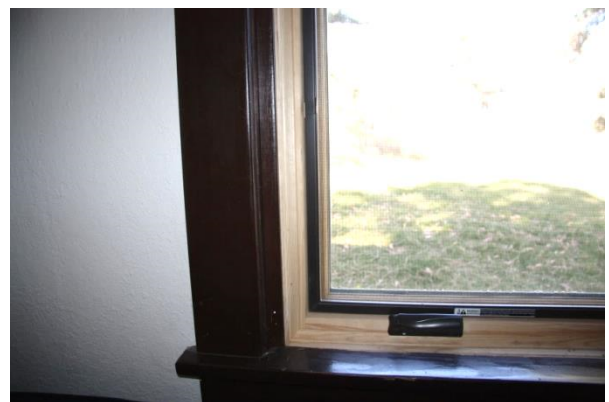
Figure W12. Detail of inappropriate aluminum interior replacement Window 113. (SRJA 2014)

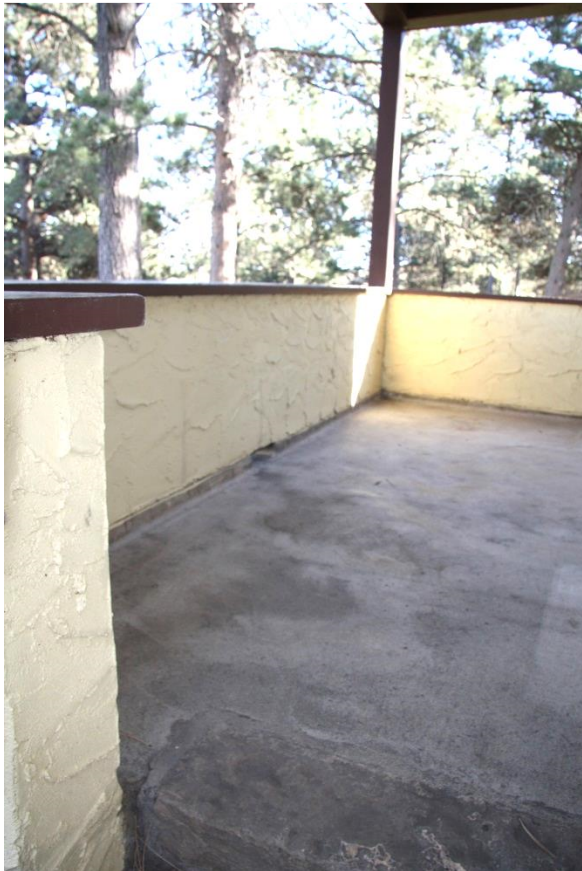
Figure X7. Front porch floor detail. Note the integral concrete curbing at the perimeter and drainage hole through the east porch wall. (SRJA 2014)

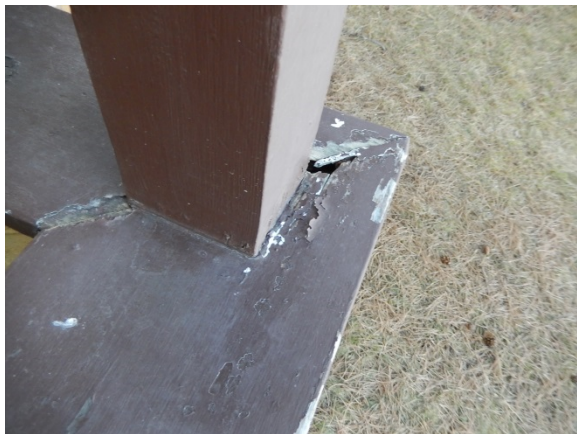
Figure X8. Porch northeast column and wall cap deterioration. (SRJA 2015)

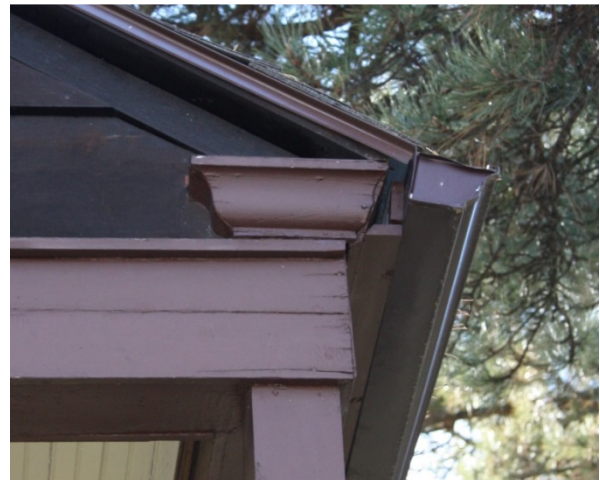
Figure X10. Northeast corner of porch gable. From this angle, the wood cornice on the north side of the house appears to have been replaced with a flat trim board. This detail is not very noticeable. (SRJA 2014)

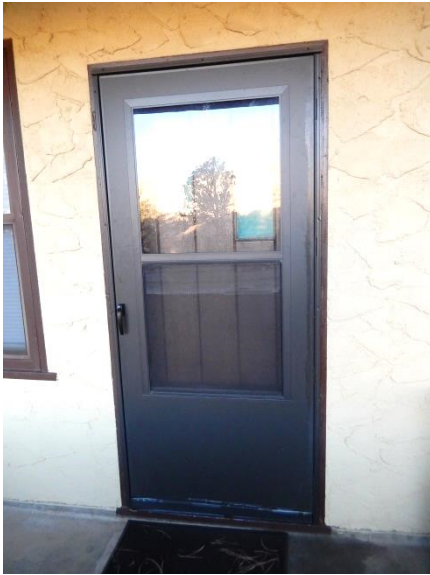
Figure X11. Door 100/1 Aluminum storm door. Note the weatherstripping at the base has become detached and requires repair or replacement. (SRJA 2014)

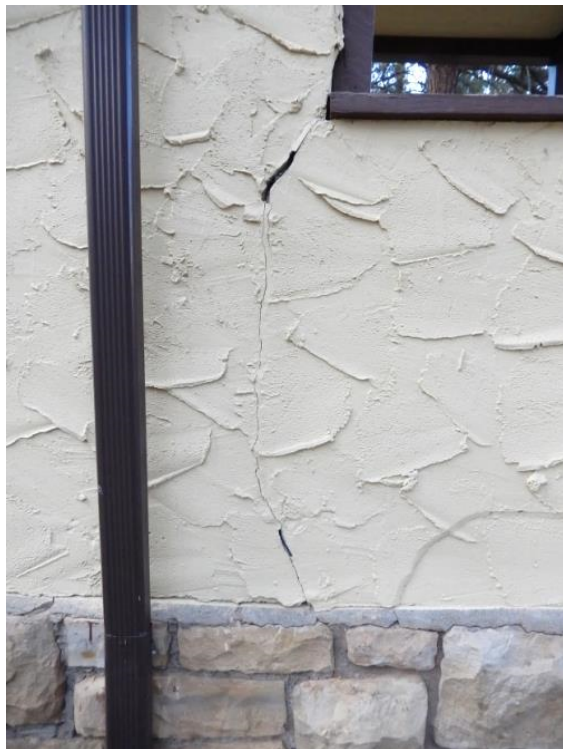
Figure X15. South Elevation crack detail at porch. (SRJA 2015)

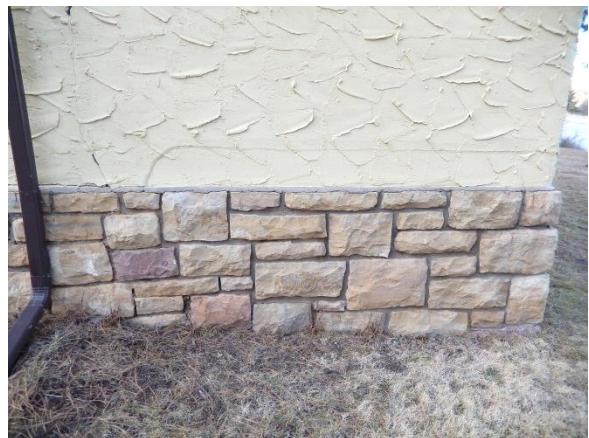
Figure X16. South Elevation horizontal crack detail at porch floor. (SRJA 2015)

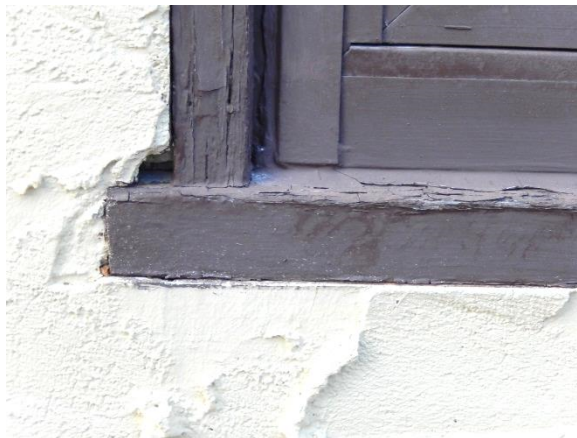
Figure X17. South Elevation detail of deteriorating wood trim at window and missing stucco at Window 106. (SRJA 2015)

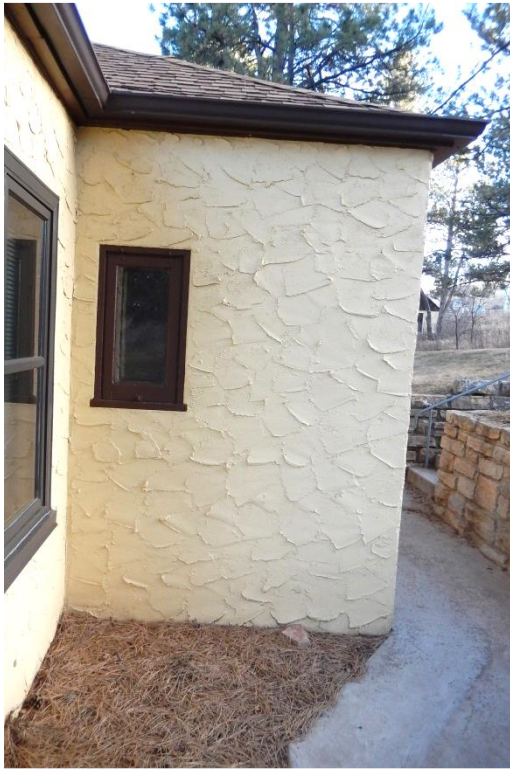
Figure X32. North Elevation Window 108. Note the grade is above the top of the stone foundation wall (SRJA 2015)

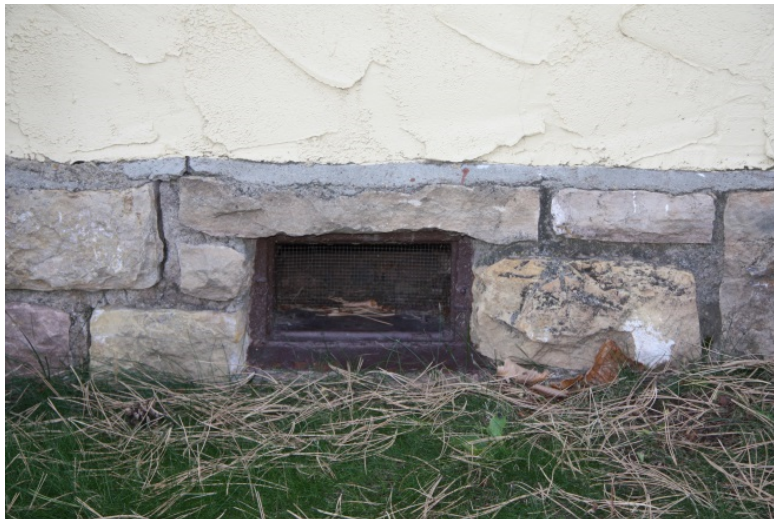
Figure X34. North Elevation crack detail east of foundation vent. (SRJA 2015)

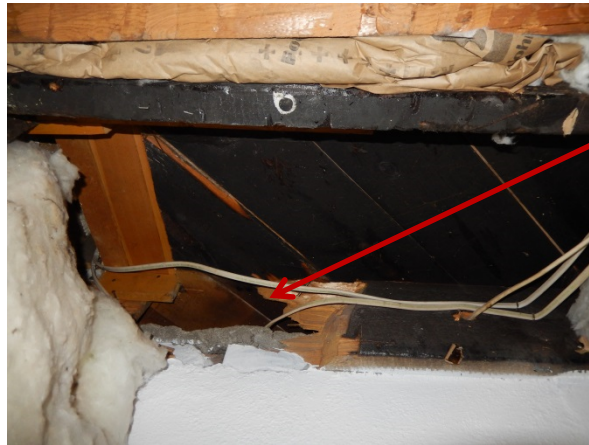
The red arrow points to the small access hole in the floor framing above the east basement foundation wall.

The wood in this area is charred from a previous fire but is structurally sound.

Figure B-7. Basement 001 east foundation wall looking at access hole to Crawl Space 002. (SRJA 2014)

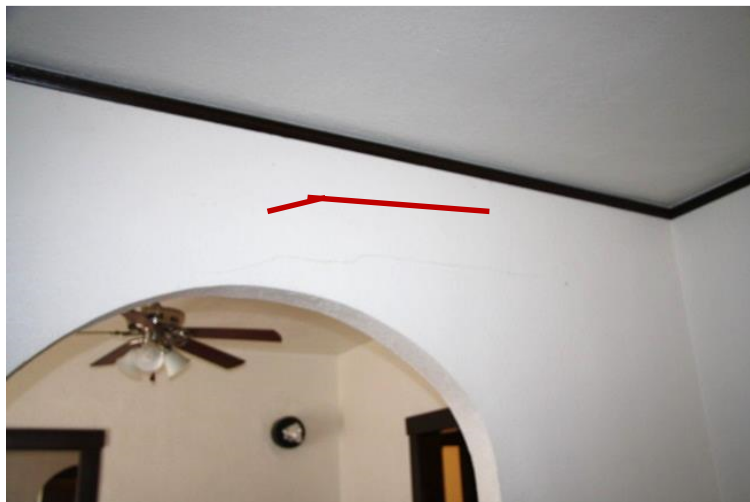
Figure 1-9. Living Room 100 looking at crack in wall above Door 100/2. (SRJA 2014)

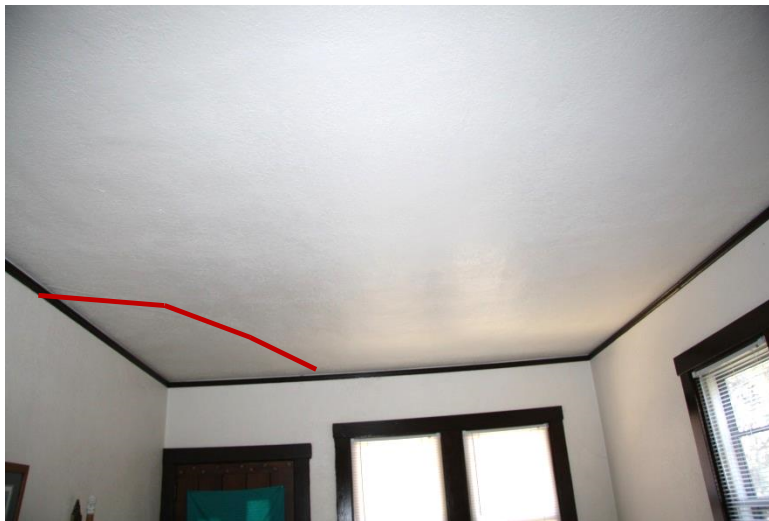
Figure 1-10. Living Room 100 looking at cracks in ceiling. (SRJA 2014)

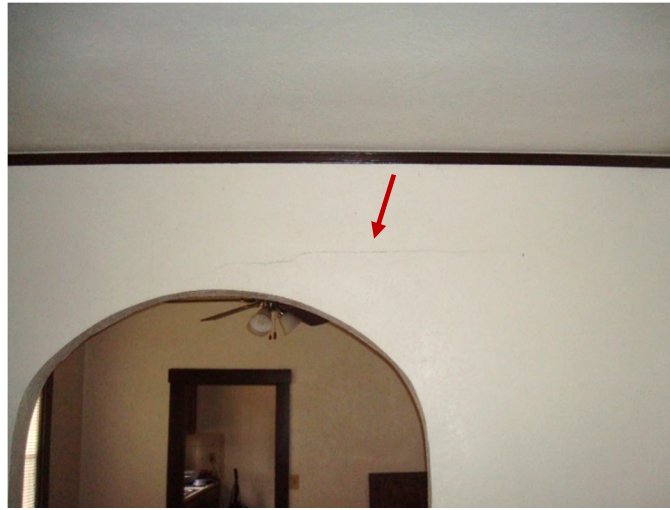
Figure S5. Crack over Door 100/2. (SEA 2015)

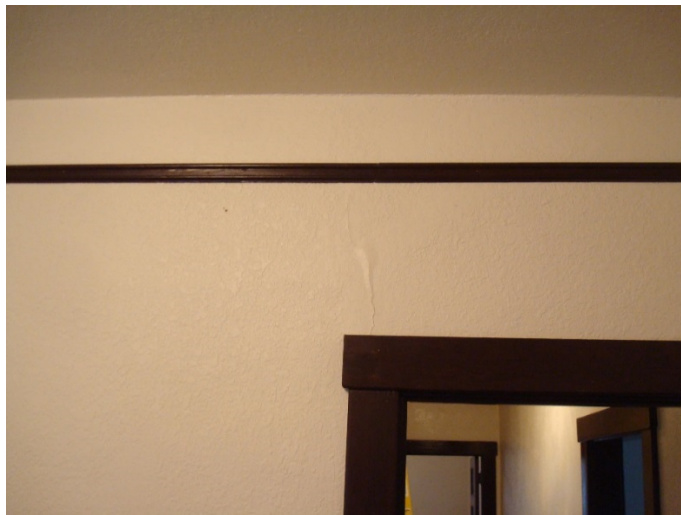
There is a crack over Door 109/1 (Figure S6). Cracks are present in the ceiling of Living Room 100 (Figure S7).

Figure S6. Crack over Door 109/1. (SEA 2015)

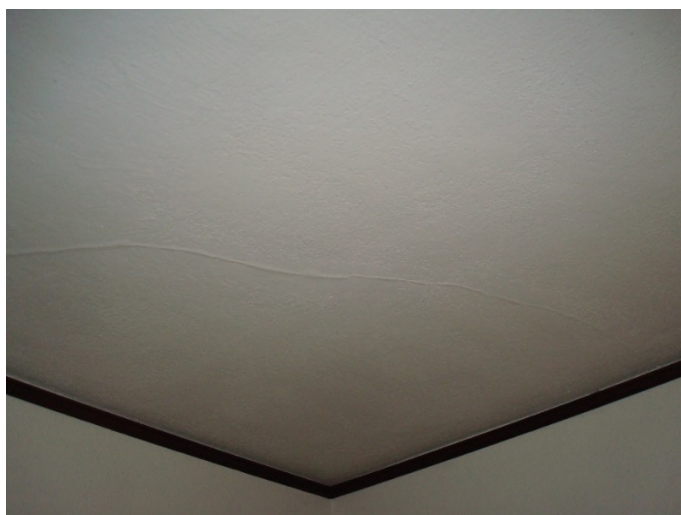
Figure S7. Crack in ceiling of room 100. (SEA 2015)

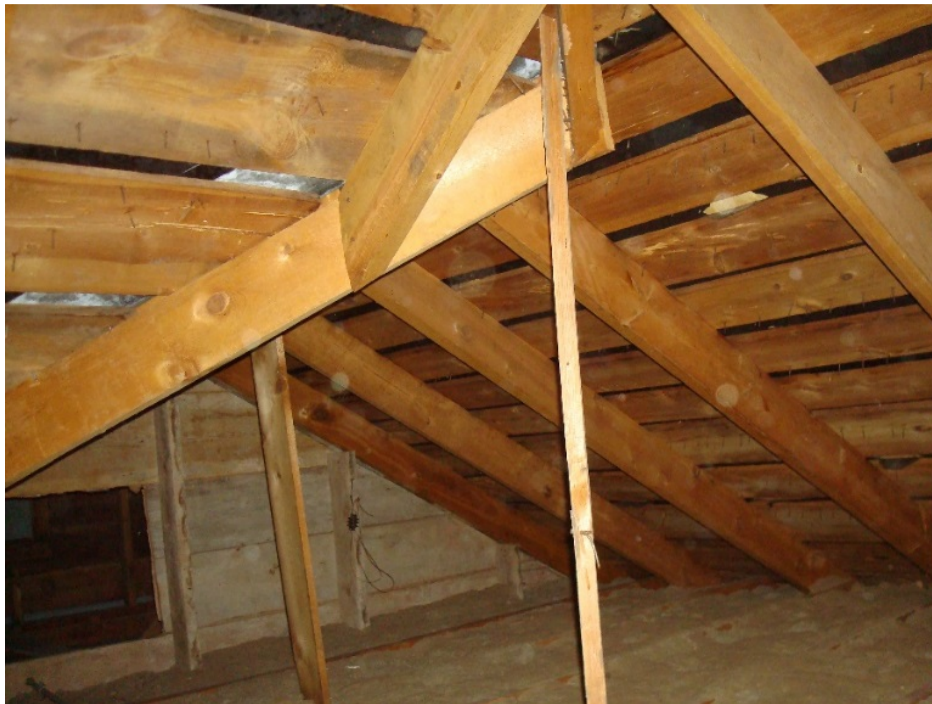
Over Room 100 there are two 1x members that support the end of a hip rafter (Figure S8). The 1x member bears on the ceiling joists of Room 100. These 1x members are adding load to the ceiling joists resulting in the joist deflecting and cracking the ceiling plaster.

Figure S8. 1x members supporting hip rafter. (SEA 2015)

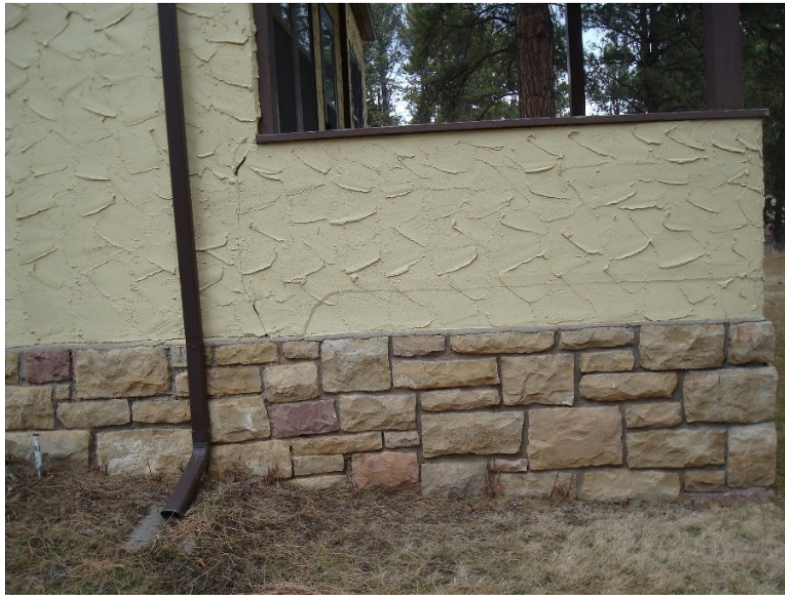
Figure S9. Crack in south wall. (SEA 2015)

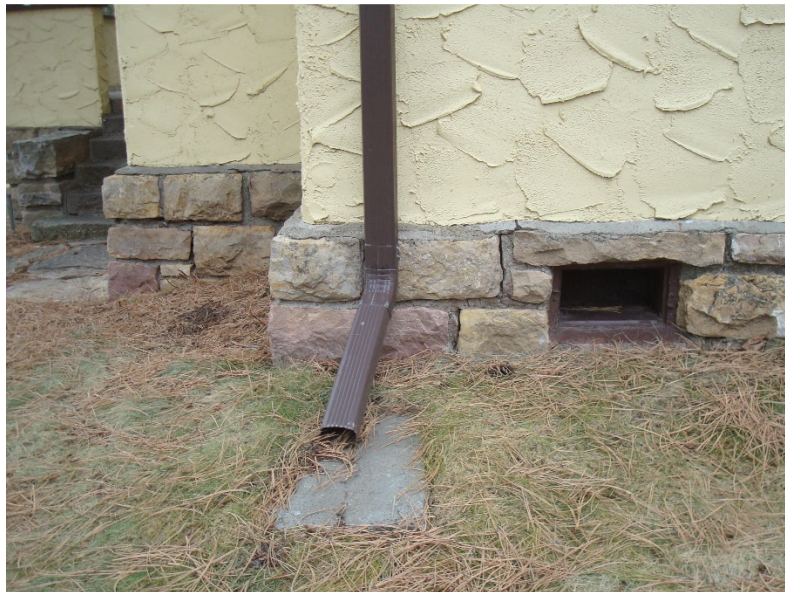
A second crack is present on the north elevation outside of Closet 106A (Figure S10). This is in the north addition area. This crack is present in the stone but does not migrate up into the stucco finish.

Figure S10. Crack in foundation, north elevation. (SEA 2015)

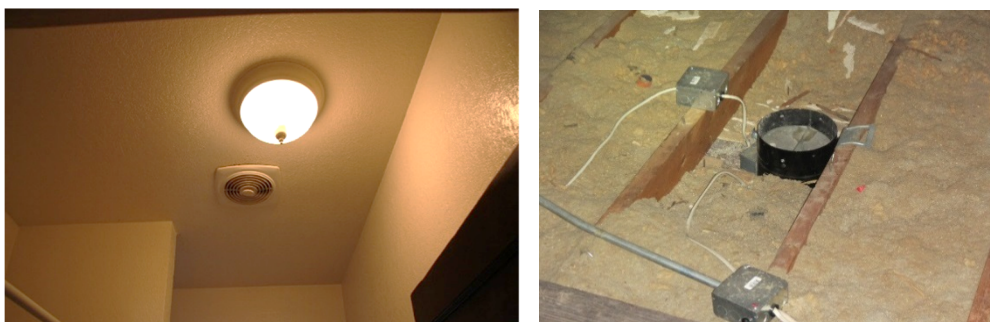
Bathroom 108 has an existing ceiling mounted exhaust fan. It discharges exhaust air into the attic space (Figure M08). Per International Mechanical Code section 501.3, air shall not be exhausted into an attic space. Moisture can potentially build up in the attic creating deterioration and mold problems.

Figure M08. Bathroom – 108, Exhaust fan and termination. (HEI 2015)
