# Historic Housing Area Historic Structures Report

## HS-07 Quarters

Wind Cave National Park

January 27, 2016  
NPS PMIS # 158029

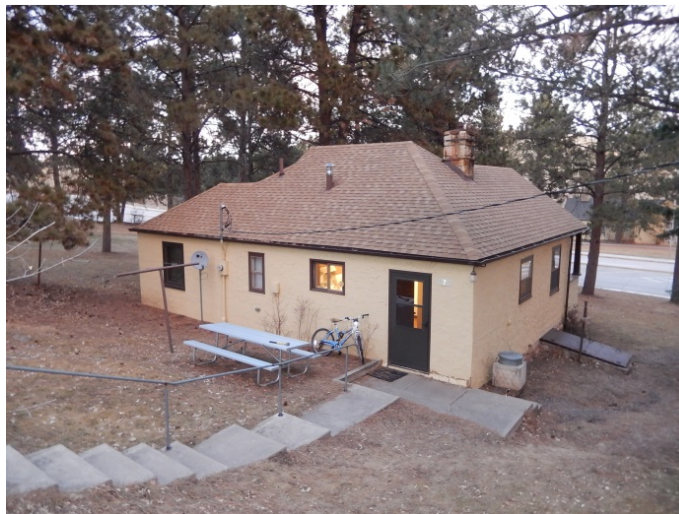
Figure R1. West-facing roof. (SRJA 2015)

The original wood shingle roof was replaced with asphalt shingles for the first time in 1982. The existing asphalt shingle roof dates to 2002 and appears to be in good overall condition. The roof is a Heritage 40 Laminated asphalt shingle, manufactured by Tamko Roofing in the Rustic Cedar color.<sup>6</sup> The K-style aluminum gutters and downspouts were also installed at that time. Aside from the stone chimney, two roof penetrations include a vent for the kitchen sink and a vent for the bathroom – both on the west-facing roof. Also, there is no cricket visible behind the stone chimney to shed water. The original 1931 construction drawings do not indicate to

construct one; this should be confirmed. The original 1931 construction drawings call for 24-inch shingles with a 10-inch exposure. The existing roof and gutters are in good condition. The gutters require cleaning and may benefit from gutter covers.

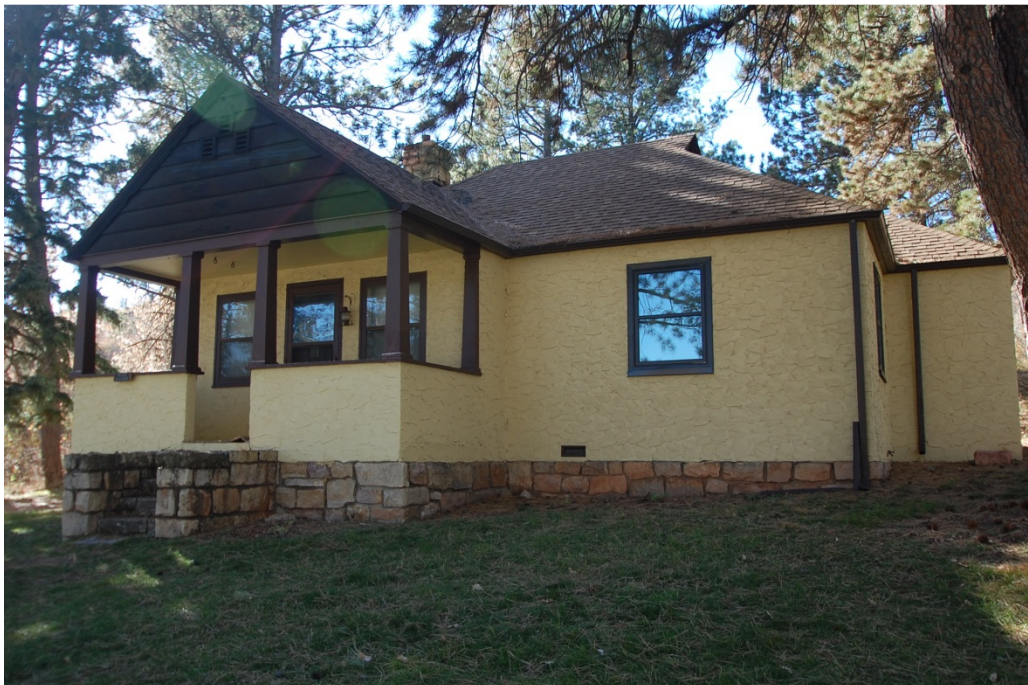
Figure X1. East Elevation. Note at the north section, the grade is above the top of the stone foundation.  
(SRJA 2014)

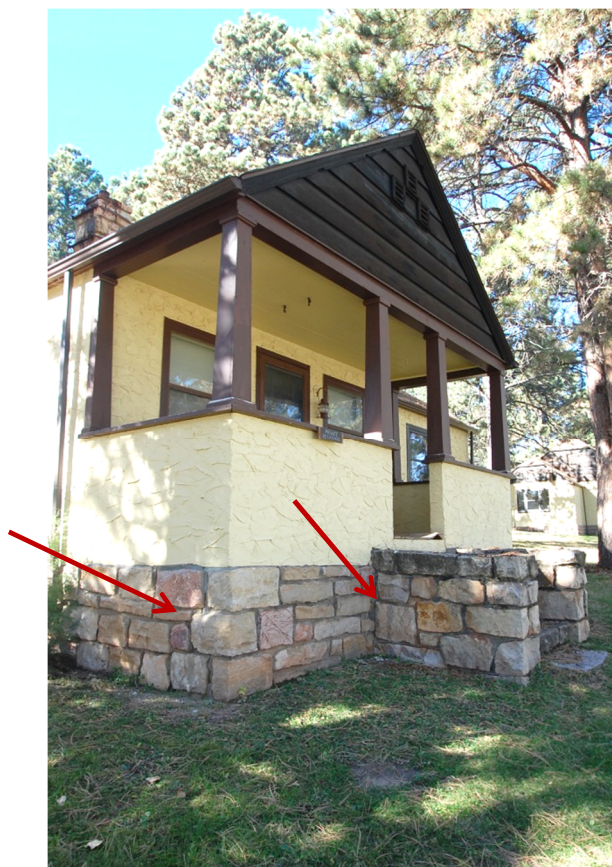
The wood trim and horizontal wood siding in the east-facing porch gable appear to be in good overall condition, requiring only touch-up painting (Figures X1 and X2). It was not apparent if the wood louvers in the gable contain screens. These should be verified to be in place and in good condition. The south cornice is missing large sections from previous animal activity, but appears to be stable.

Figure X2. East porch. The red arrows identify cracks. (SRJA 2014)

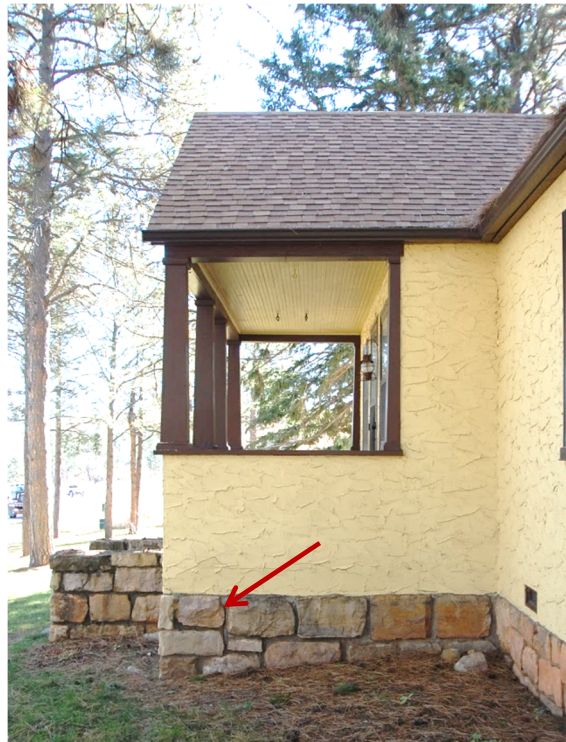
Figure X3. Porch - North Elevation. The red arrow identifies a crack. (SRJA 2014)

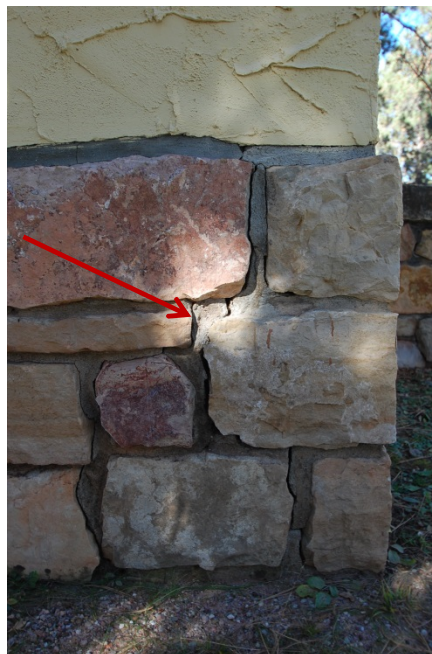
Figure X11. Porch - South Elevation crack detail. (SRJA 2014)

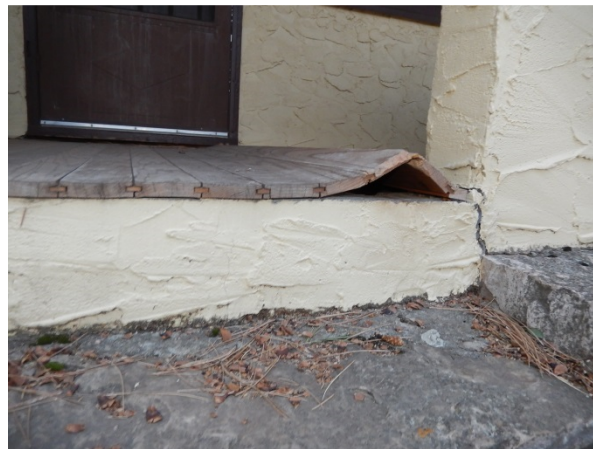
Figure X14. Porch – flooring detail. (SRJA 2014)

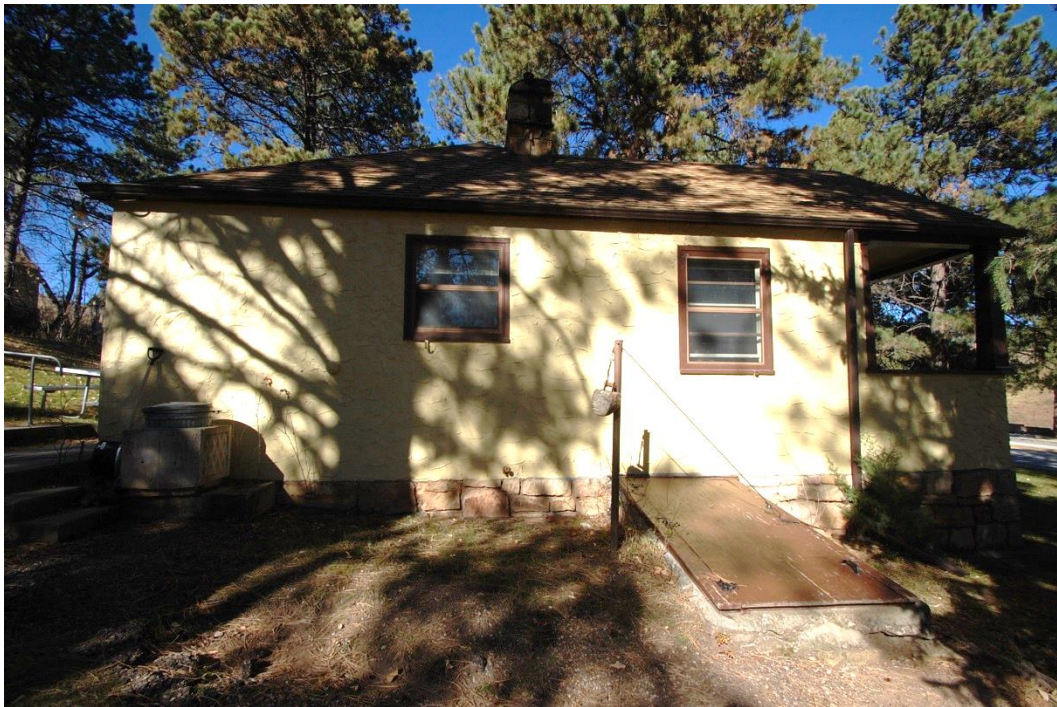
Figure X22. South Elevation. (SRJA 2014)

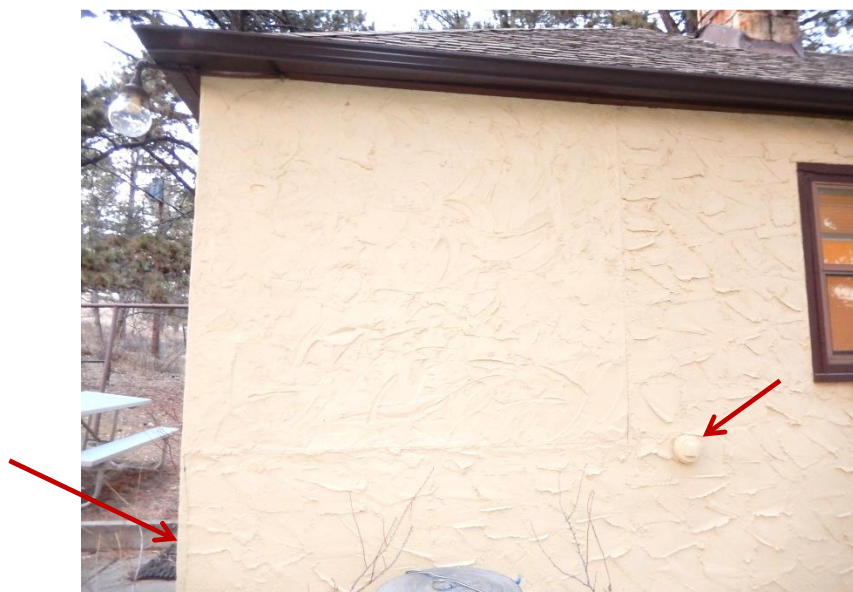
Figure X23. South Elevation at west side. Outline of infilled screen porch can be seen. The right red arrow points to a clean-out installed in the wall. The left arrow points to a large vertical crack at the corner.  
(SRJA 2015)

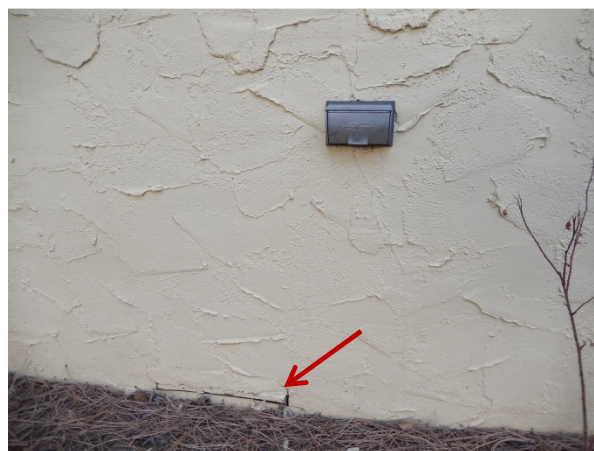
Figure X31. West Elevation covered foundation vent detail.  
The gray box above is a GFCI. (SRJA 2015)

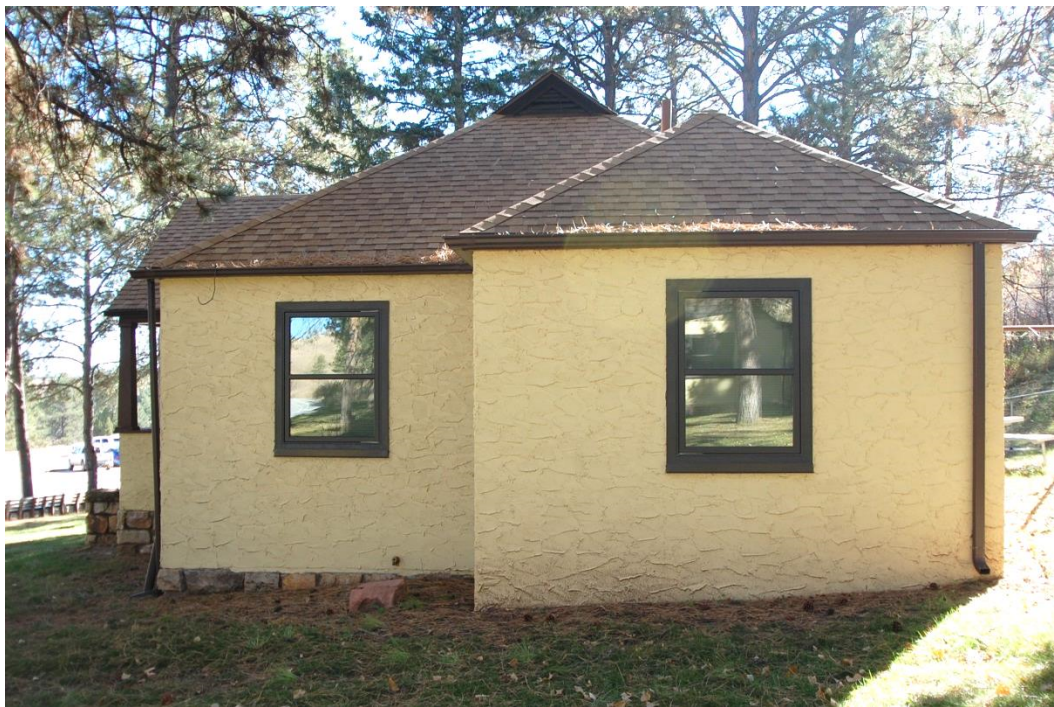
Figure X36. North Elevation. Note the grade is very high at the west side. The downspout extension is missing. (SRJA 2014)

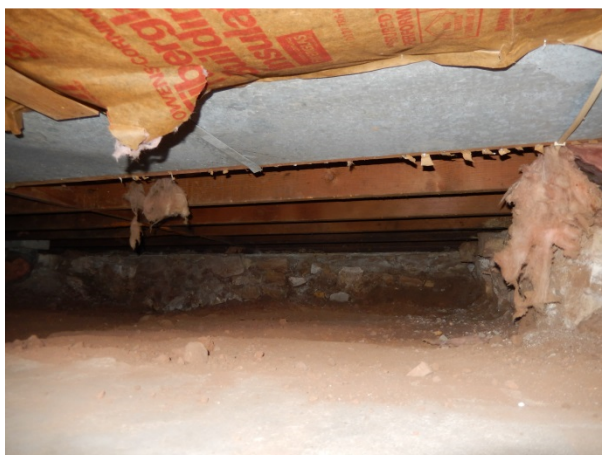
Figure B-14. Basement Room 001 Looking into north crawl space.  
Note the insulation is missing here. (SRJA 2014)

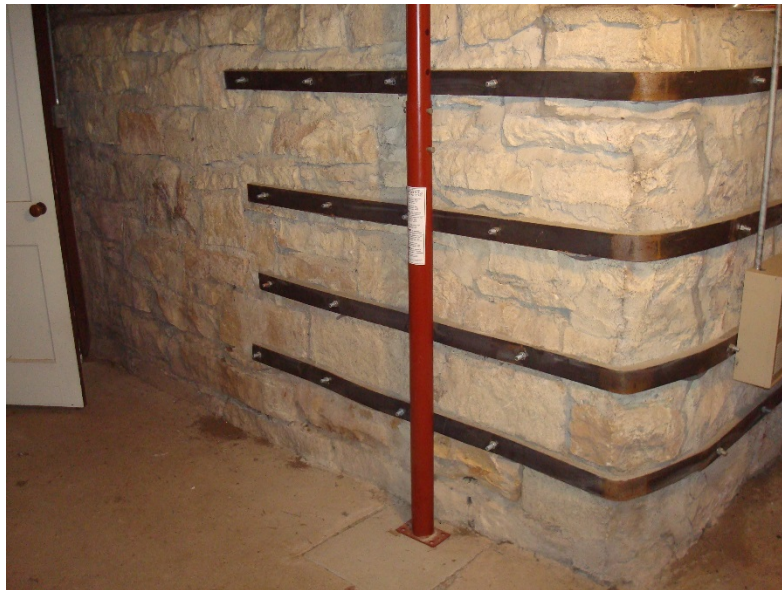
walls of the corner together. Post-installed anchors connect the straps to the retaining walls. A crack has been repointed as part of that repair. The repairs are consistent with the stone retaining wall moving outward at this corner.

Figure S2. Repair to existing stone retaining wall looking southwest. (SEA 2015)

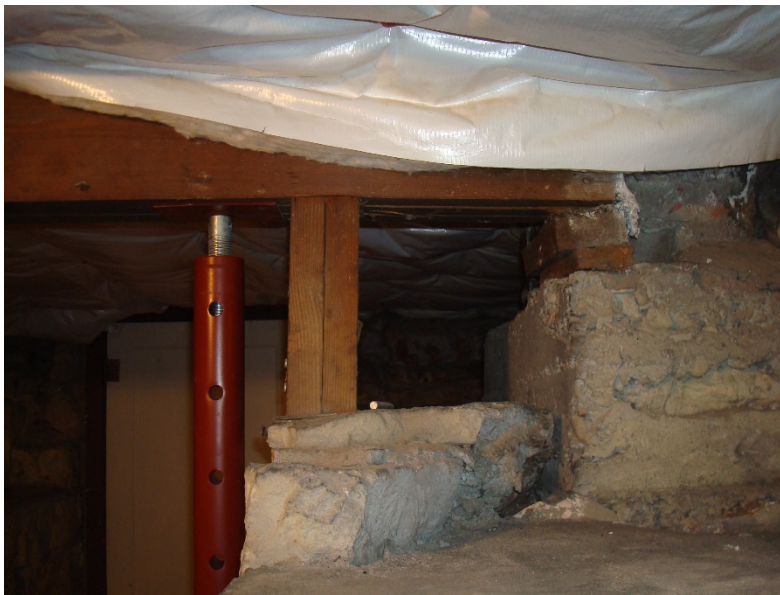
On the west end of the southern-most girder, the interior end of the post is supported by the original haunch on the chimney with wood blocking between the chimney haunch and the girder, wood blocking from a stone support on top of the stone retaining wall and a 2 ½-inch diameter steel post (Figure S3). While they appear to be performing adequately at this time, none of these appear to be permanent repairs.

Figure S3. Room 001 girder support, east side of chimney looking south. (SEA 2015)

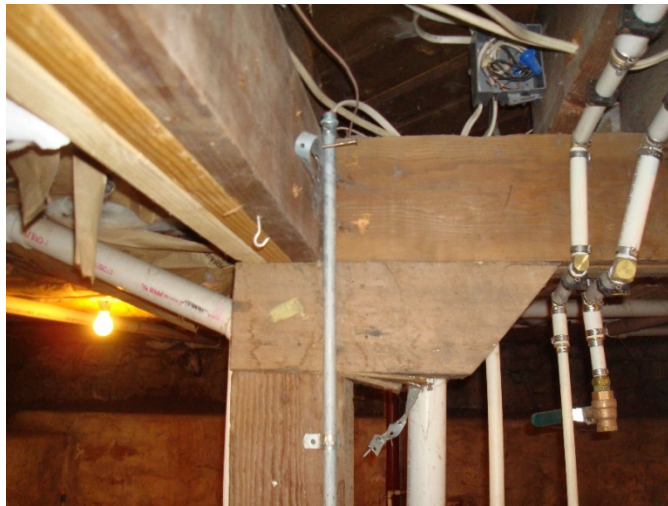
At the center of the basement there is a wood post supporting wood girders from three directions. The north-south girder is supported at this location by a wood corbel (Figure S7). While this appears to be functioning adequately at this time, the eccentric loading could lead to corbel rotation, compromising the support of the north-south girder.

Figure S7. Corbel support of wood girder looking west. (SEA 2014)

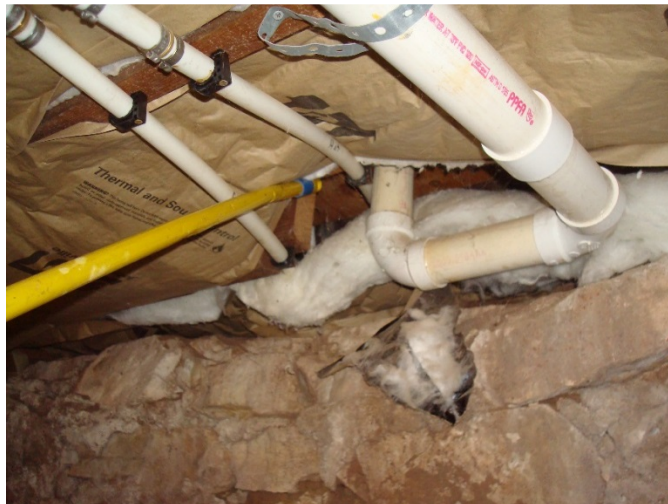
At the west side of the basement adjacent to the west foundation wall, a floor joist has been cut/notched to installed drain lines (Figure S10). The cut/notch is located approximately 3'-1" north of the south girder under the kitchen sink cabinet.

Figure S10. Notch in girder for drain installation. (SEA 2015)

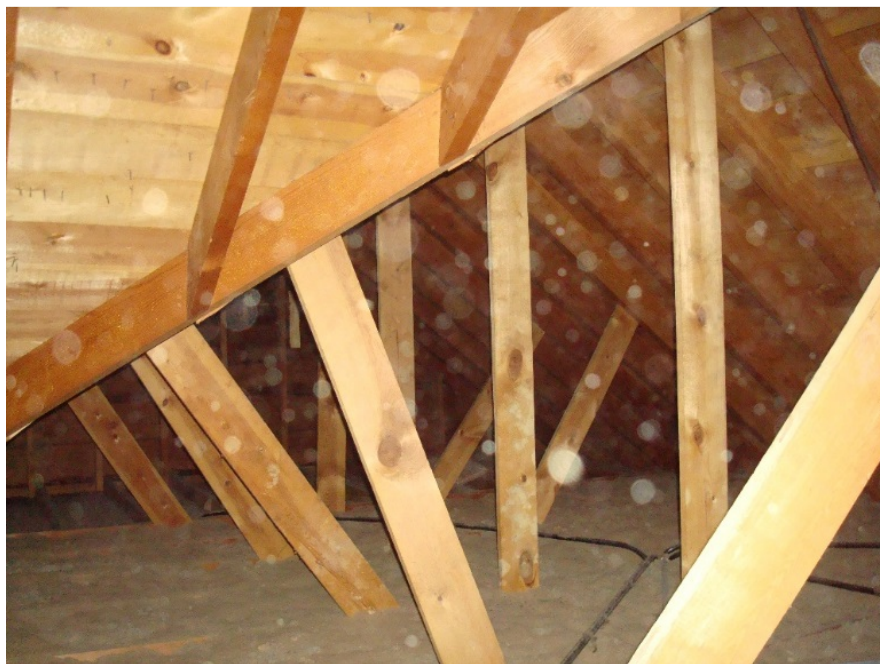
Roof framing consists of 2x6 (nominal) roof rafters at 16-inches on center and 2x6 hip rafters. 1x6 braces are present to brace the roof rafters. The 1x6 bracing members extend down to the ceiling joists (Figure S11). Over Rooms 100 and 106 this additional load to the ceiling joists is increasing the deflection in the joists and resulting in cracking in the ceiling.

Figure S11. Roof framing, 1x6 bracing bearing on ceiling joists. (SEA 2015)

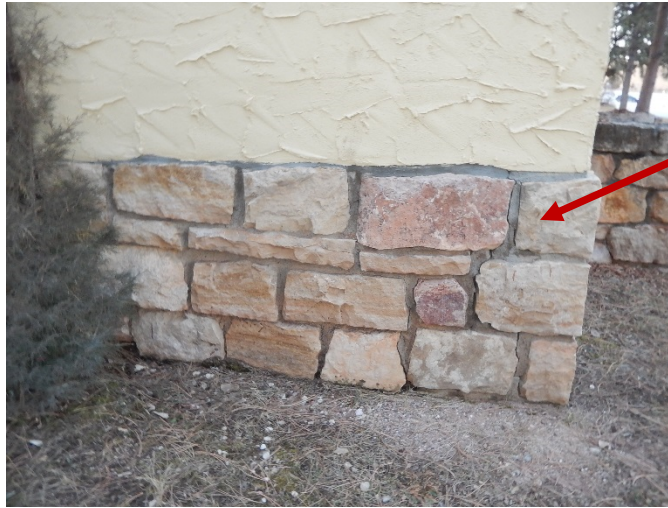
Cracks are present in the stone foundation wall. The cracks are located on the south elevation near the southeast corner, the south face near the northeast corner and the north face near the northeast corner. The cracks are consistent with settlement of this portion of the building (Figures S12, S13, and S14).

Figure S12. Crack in south foundation wall. (SRJA 2015)

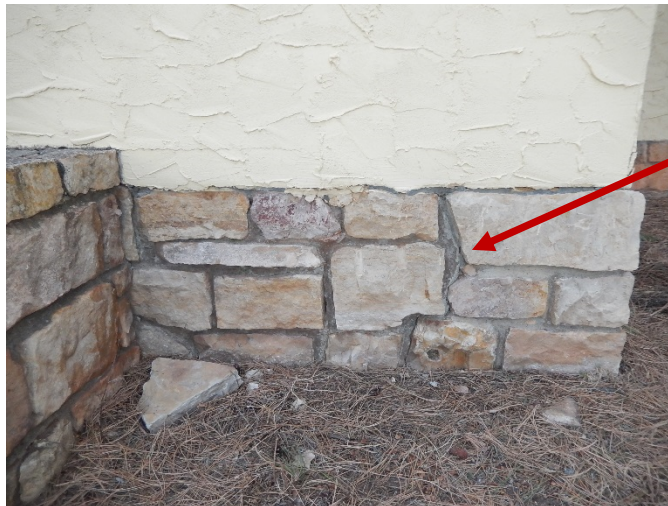
Figure S13. Crack in east foundation wall. (SRJA 2015)

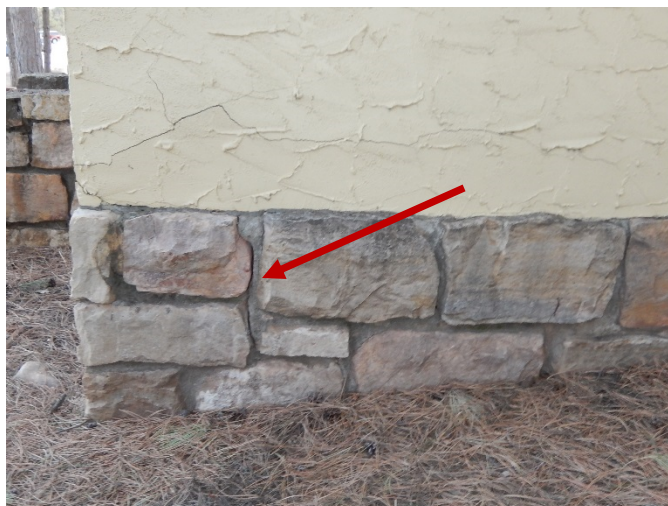
Figure S14. Crack in north foundation wall. (SRJA 2015)

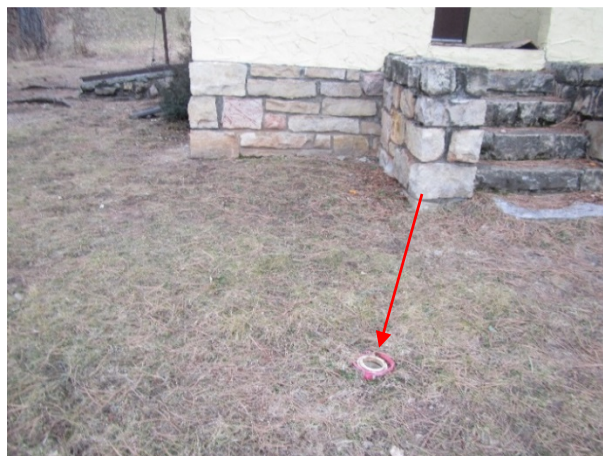
Figure P05. Damage exterior sanitary sewer cleanout. (HEI 2015)

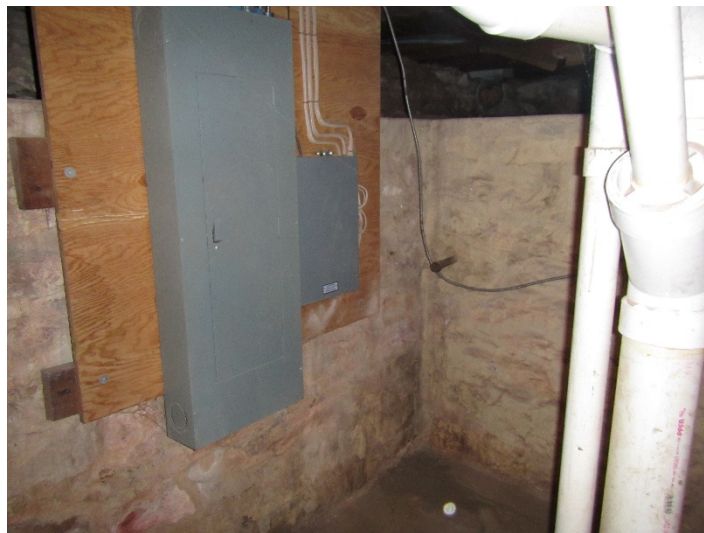
The electrical service panelboard is located on the west wall of Basement 001 (Figure E04). It is a 225A, 42-pole, 240/120V single phase, 3-wire panelboard with a 225A main circuit breaker (Figure E05). This panelboard serves all of the power loads in the building including lighting, HVAC, kitchen equipment and general purpose receptacles. The panelboard is manufactured by Westinghouse and appears to be in good condition. It does not meet the minimum clearance required by NEC Table 110.26(A)(1). The existing PVC piping in front of the panelboard is located 35  $\frac{3}{4}$ -inches from the face of the panel, 36-inches is required. The date of installation could not be confirmed. There are currently no arc fault circuit interrupter (AFCI) circuit breakers in the panelboard which are required in residential construction by the NEC. Overall the existing electrical system appears to be in good working order.

Figure E04. Electrical service panelboard located in Basement 001. (HEI 2015)
