# Historic Housing Area Historic Structures Report

## HS-11 Upper Garage

Wind Cave National Park

January 27, 2016  
NPS PMIS # 158029

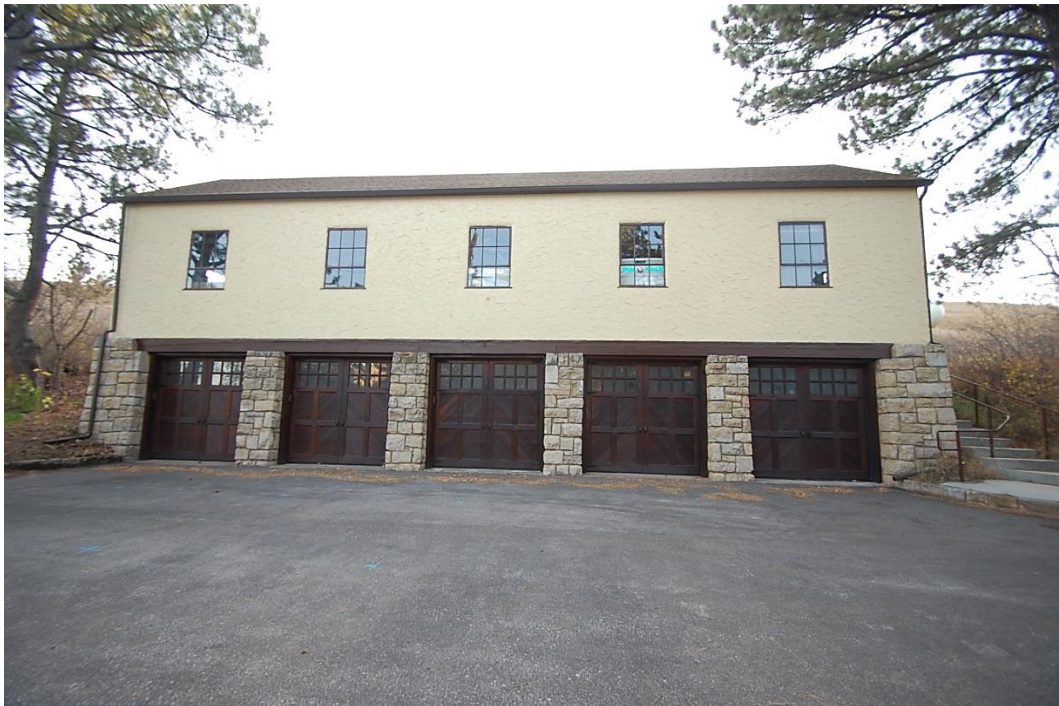
Figure X1. East Elevation. (SRJA 2014)

The two-story east elevation is visible from the public right of way (Figures X1- X5). The lower level is exposed native stone laid in a random ashlar pattern. There are a total of five garage bays. A large three-piece wood girder spans these openings. The stone masonry is in very good overall condition, requiring only spot repointing, cleaning, paint removal and repairs to the mortar wash at the top of the wall. A few stones near the concrete are fractured due to the lack of a soft joint between the stone and the poured concrete drive. This is due to expansion and contraction of the concrete. A metal threshold is embedded in the concrete of the north bay. This is the only door with this type of threshold. This installation may have been done to block

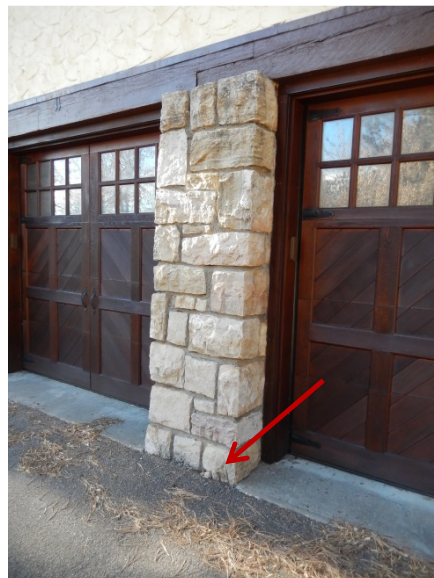
Figure X2. East Elevation detail at stone pier. Note the girder splicing above this pier. The bottom right stone is fractured from the expansion and contraction of the driveway poured directly against the stone. (SRJA 2015)

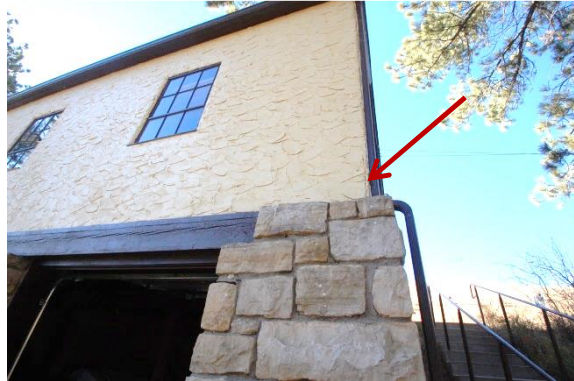
Figure X3. East Elevation detail at northeast corner. Note the stucco crack at the corner. (SRJA 2015)

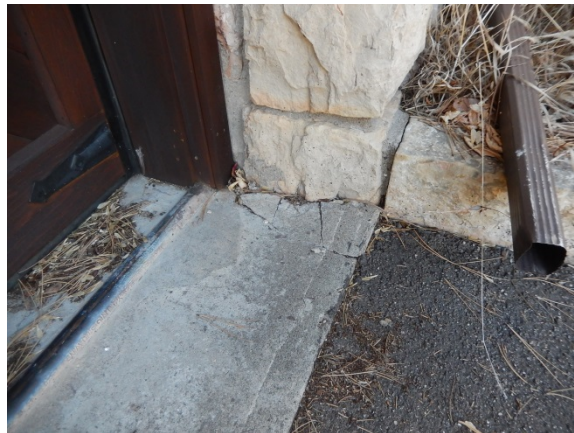
Figure X4. East Elevation detail at the north bay threshold. Note the cracked concrete threshold, the embedded steel threshold and downspout. (SRJA 2015)

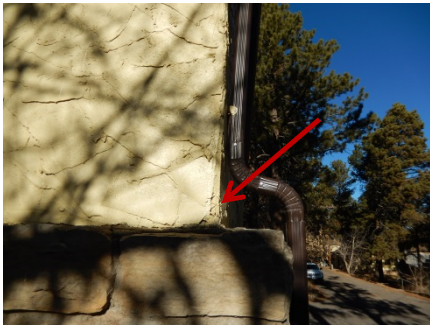
Figure X7. South Elevation detail at southeast corner where missing stucco has exposed metal lath. (SRJA 2015)

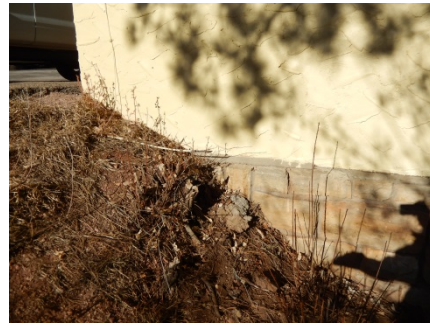
The south elevation has a steep grade change which is evident by the exposed stone foundation. The foundation is nearly full height at the east side and the grade is well above the top of the stone foundation wall at the west side. The stone foundation along this elevation is in good condition, requiring only spot repointing, cleaning and mortar wash repair/replacement at the top of the foundation wall. There are some minor stucco cracks on this elevation with some missing stucco at the southeast corner near the foundation. In this location, the wire lath has been exposed and is painted. The grade being in contact with the stucco walls is not ideal near the southwest corner of the building.

Figure X8. South Elevation detail with grade above the foundation wall in contact with the stucco cladding. (SRJA 2015)

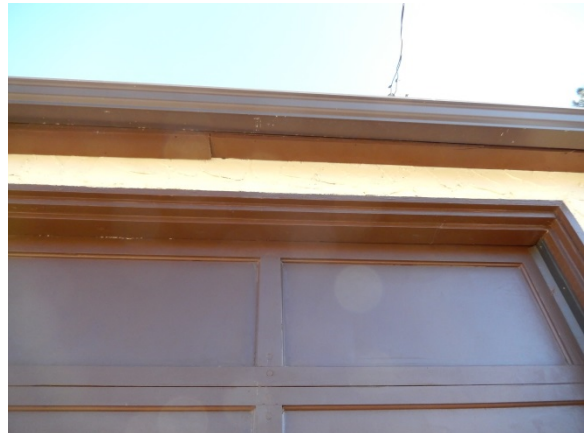
A soffit board is loose above the first garage door from the south (Figure X14). There were bees flying in and out of this area during the November 2014 site visit. The remainder of the wood trim is in good condition, requiring only touch-up painting.

Figure X14. West Elevation detail of loose soffit.  
(SRJA 2015)

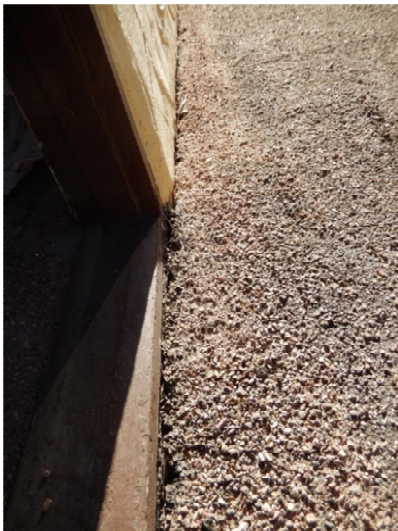
Figure X12. West Elevation detail of joint  
between asphalt drive and building. There is no  
soft joint installed. (SRJA 2015)

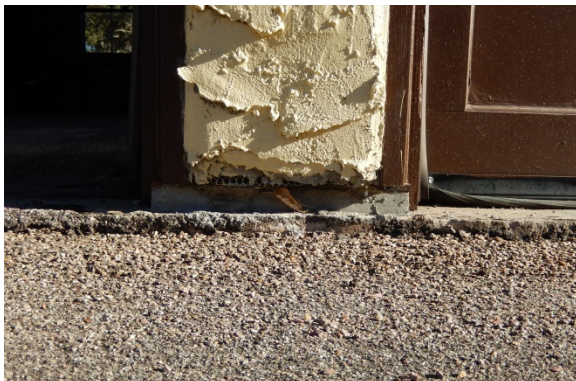
Figure X13. West Elevation detail of missing  
stucco at base of pier and exposed wire lath.  
(SRJA 2015)

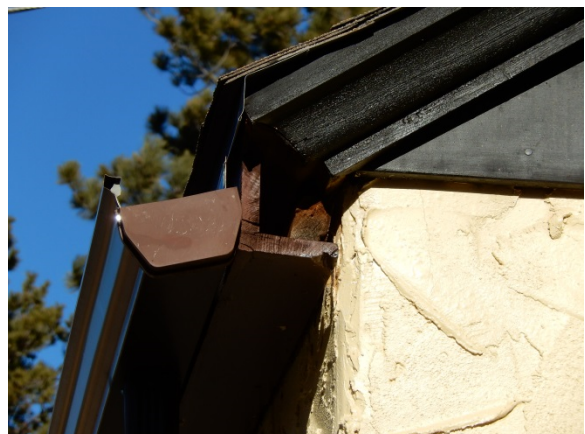
Figure X16. West Elevation detail of the south  
side of the gutter that is run short of the roof,  
photograph taken looking north. (SRJA 2015)

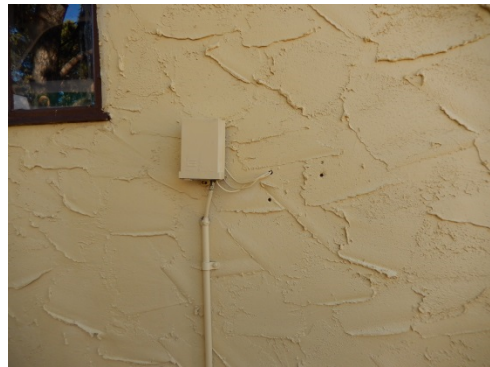
The north elevation has a steep grade change which is evident in the exposed stone foundation (Figures X17 – X21). The foundation is nearly full height at the east side and flush with the top of the stone foundation wall at the west side. The stone foundation along this elevation is in good condition, requiring only spot repointing, cleaning, spotty paint removal and mortar wash repair/replacement at the top of the foundation wall. There is one stone near grade that has fractured and requires replacement (Figure X19). There are some minor stucco cracks on this elevation with some small holes in the plaster located near the utility box that require patching (Figure X20).

Figure X20. North Elevation stucco detail.  
(SRJA 2014)

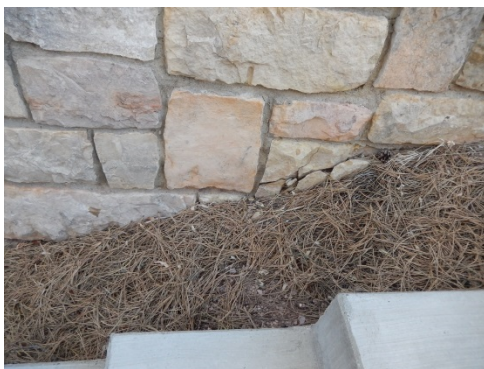
Figure X19. North Elevation stone foundation  
deterioration detail. (SRJA 2014)

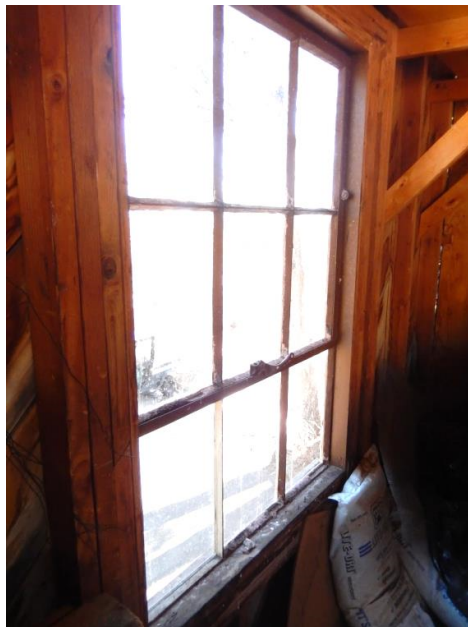
Figure W1. Interior window detail. Note the missing glazing putty. (SRJA 2015)

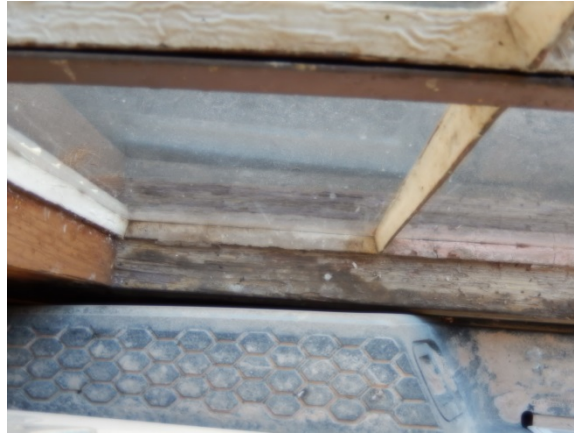
The stucco walls on the second level of the east elevation are in overall good condition. Some minor diagonal cracking is visible at the corners of the second level windows. Window 103 in the fourth bay from the north has broken glass and the frame and stucco wall is slightly bowed. At the time of this report, the vehicle parked in the garage was backed against the wall and was touching the exposed wood studs below the window. The broken glass and bowed wall are likely from repetitive contact with this wall from vehicles. The wood trim appears to be in good condition requiring only touch-up painting.

Figure W2. Window 103 Detail with truck bumper against window frame. Note the deteriorated wood sill on the exterior of the window. (SRJA 2015)

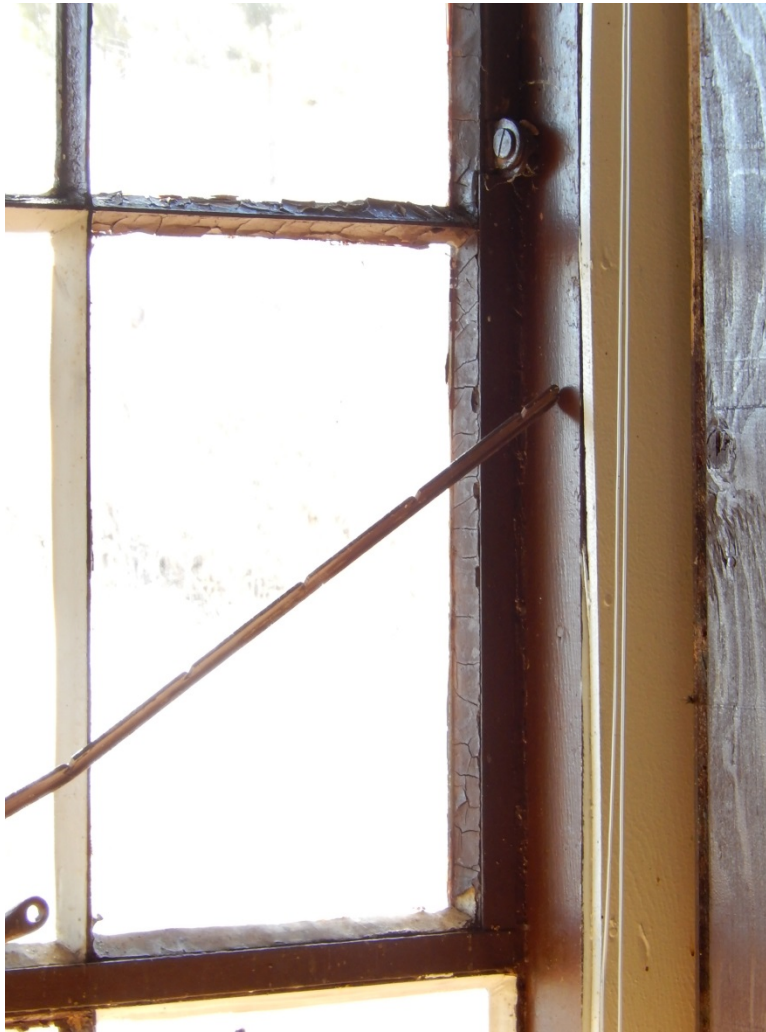
Figure W3. Interior Window 106 detail. Note the deteriorated glazing putty. (SRJA 2015)

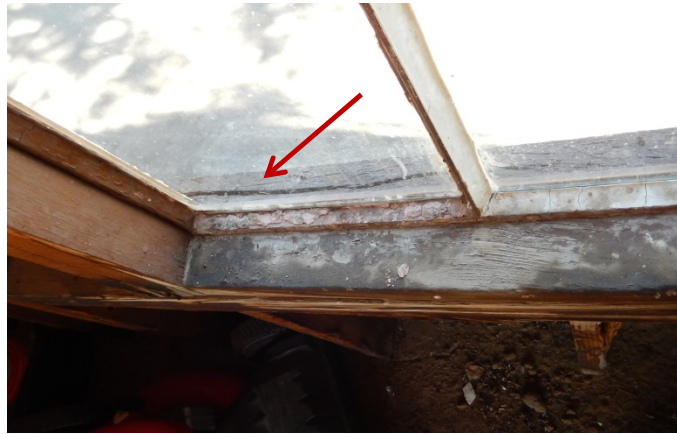
Figure W4. Interior Window 104 detail. Note the missing glazing putty and deteriorated exterior sill. (SRJA 2015)

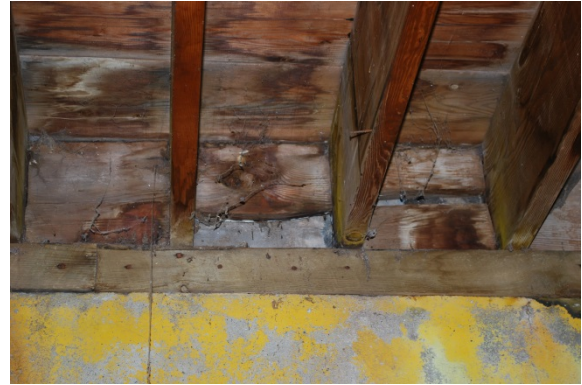
Figure 1-5. Garage 100 Detail of west wall. Note the deteriorated blocking between the joists. (SRJA 2014)

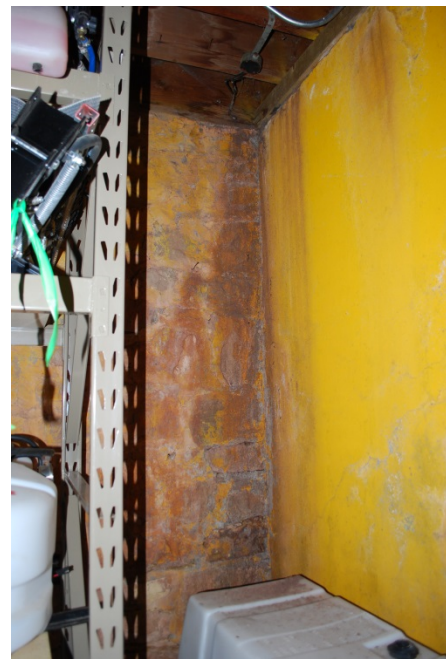
Figure 1-6. Garage 100 Water infiltration in the southwest corner where the south stone foundation wall intersects with the west concrete wall. (SRJA 2014)

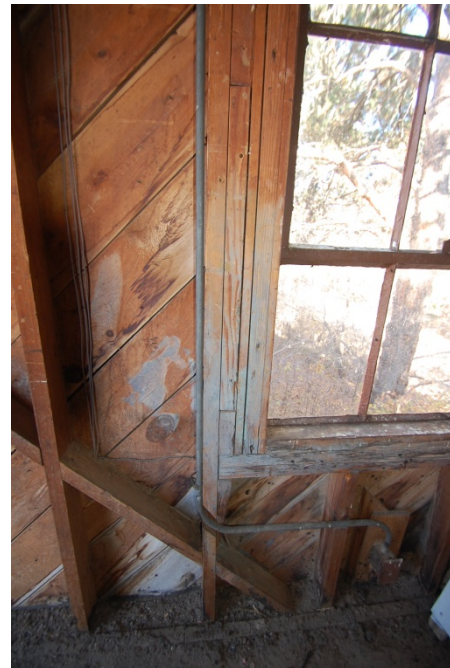
Figure 2-7. Garage 200 Looking at detail of north wall. Note the moisture staining on the interior wood framing and sheathing surfaces. (SRJA 2015)

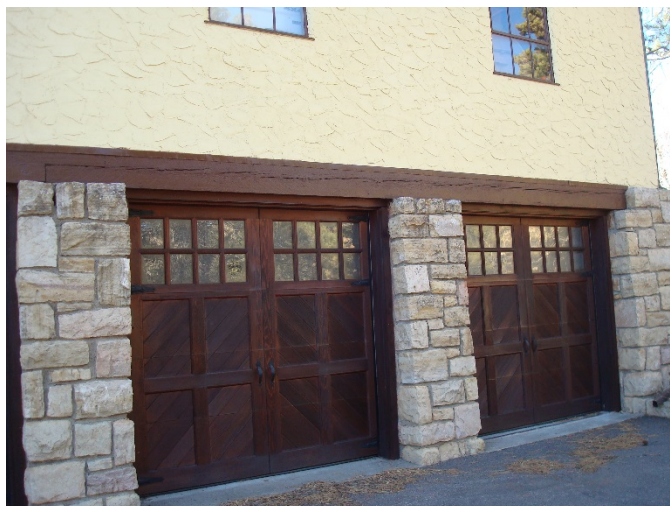
Level one is a garage level and is currently being used to park and store yard and maintenance equipment (Figure S1). The west foundation wall is constructed of cast in place concrete. The north, south and east foundation walls are constructed of unreinforced stone. The north, south and west elevations are in contact with grade. The east face has stone pilasters with timber girders over the door openings (Figure S2). The floor is a concrete slab-on-grade. Wood girder timbers span over the door openings and support the floor framing and wall framing above. The girders are spliced over the two center pilasters (Figure S3). The girders over the door openings display some splitting, but it does not appear to be affecting their performance (Figure S4). No excessive deflection was noted.

Figure S4. Splitting in north girder. (SEA 2015)

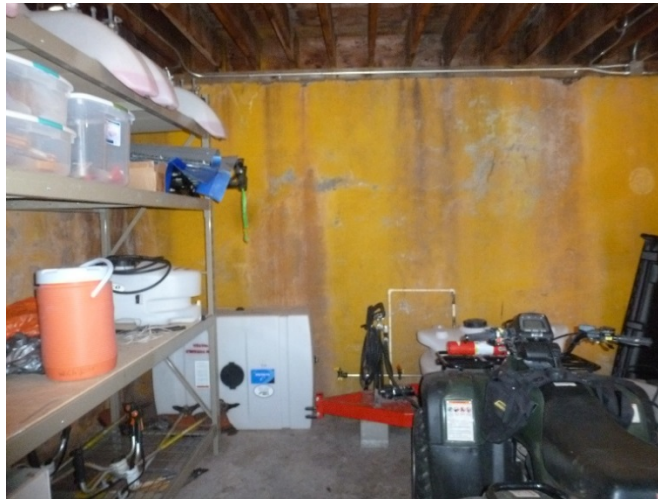
Figure S5. West foundation wall. (SEA 2015)

Some cracking is present in the west concrete foundation wall but it is minor and does not pose a structural concern at this time. Water staining from the top of the west foundation wall is present from water entering over the top of the wall. This makes it difficult to determine if the minor cracks in the west foundation wall are leaking, but they appear to be dry (Figure S5).

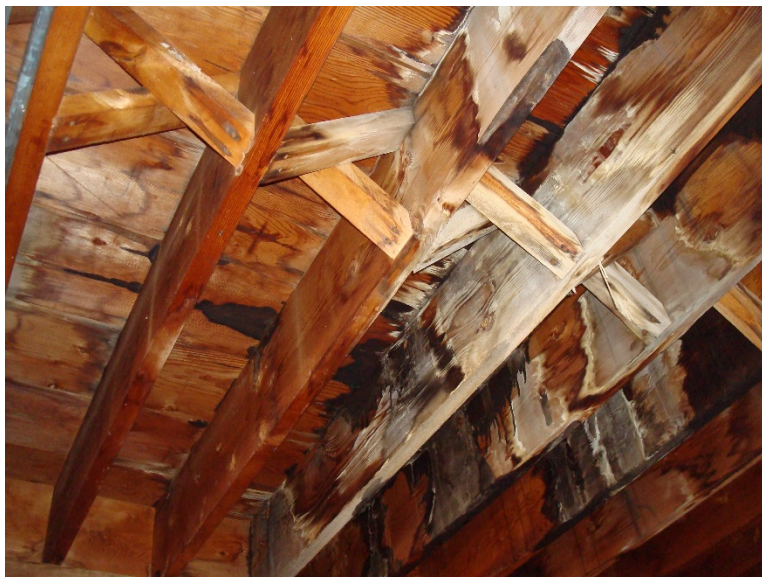
The floor joists are stained extensively at some locations, but the staining appears to be consistent with an asphaltic product such as bitumen that may have been used on the deck as a bonding agent for the asphalt (Figure S10). Deterioration in the wood joists is not visibly evident with the exception of the bearing location on the west foundation wall.

Figure S10. Asphalt stained floor joists. (SEA 2015)

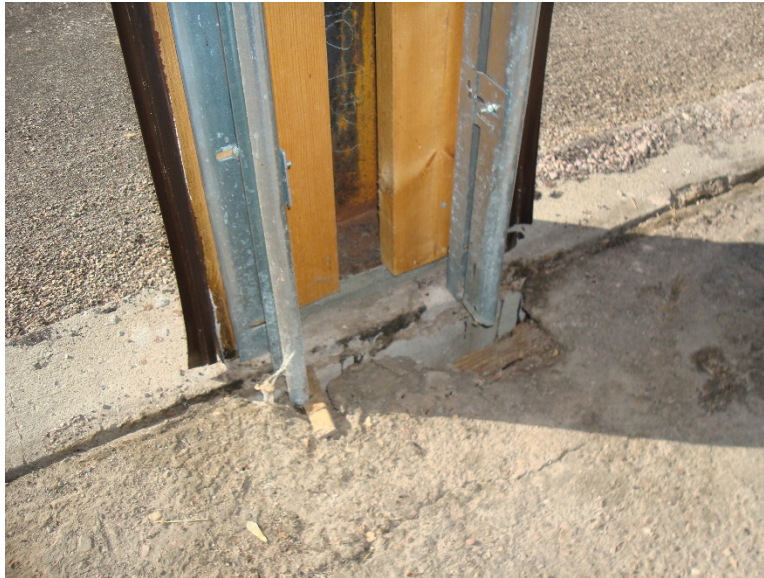
The asphalt topping is present in the four parking bays. It has deteriorated at some locations along the west foundation wall and the wood decking below is deteriorated (Figure S11). At one location observed near the east wall there is a deep depression in the asphalt similar to a pot

Figure S11. Deteriorated asphalt and wood deck. (SEA 2015)

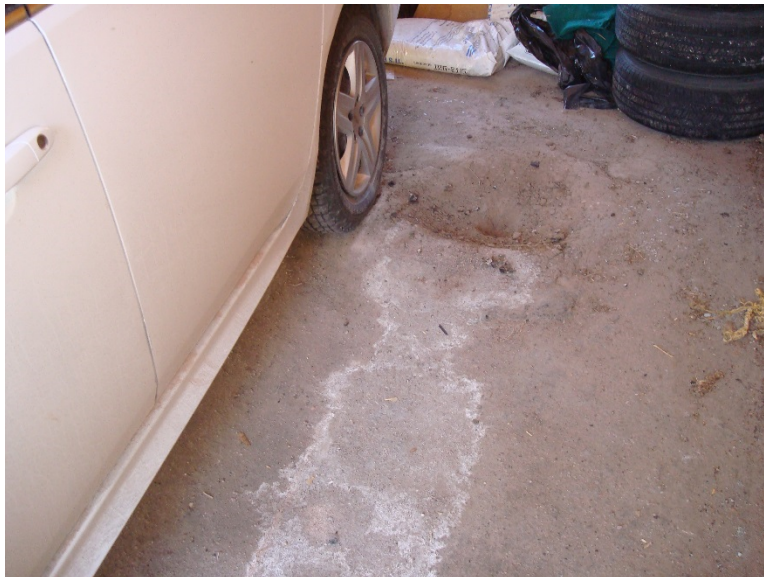
hole (Figure S12). It appears as if this is where the wheel of a vehicle has set repeatedly over time.

Figure S12. Depression in asphalt. (SEA 2015)

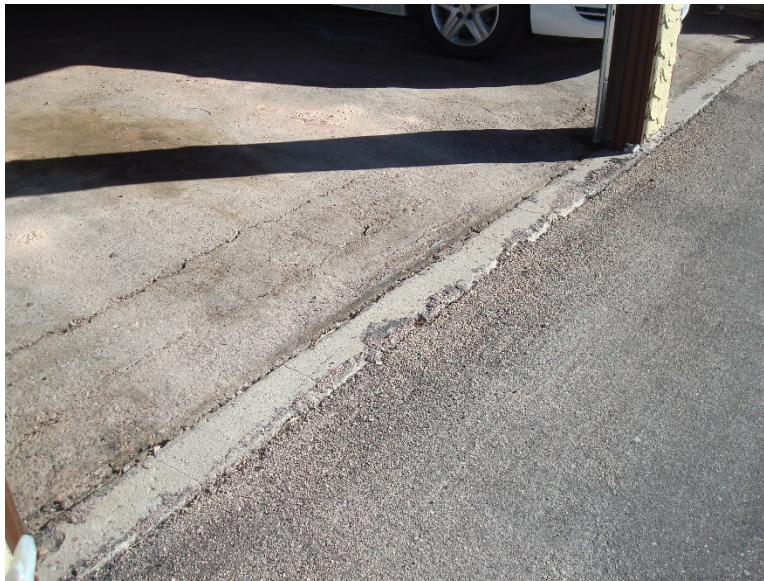
Figure S13. Detail at west foundation wall. Note: the asphalt drive is too high at the edge of the exposed concrete wall. This will not allow for the water to divert away from the building properly. There is no lip or offset at the building entry. Also, the top of the exposed wall is sloping in towards the building. (SEA 2015)

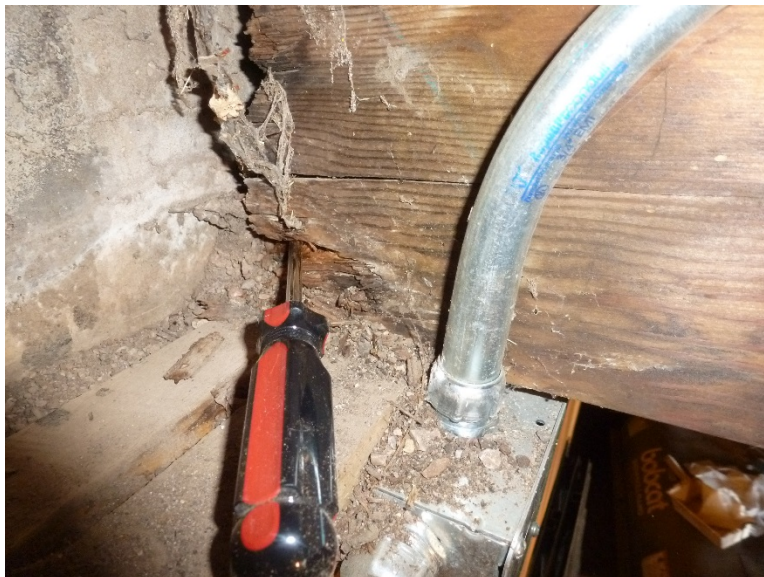
Along the west foundation wall, there is a concrete ledge. A wood sill plate is anchored onto the ledge, and the 2 x 12 (nominal) floor joists bear on the sill plate. 1x blocking is present between the floor joists and is placed against the face of the concrete foundation wall. As constructed, the top of the west foundation wall slopes inward towards the building (Figure S13). This creates a condition where rainwater or snow melt runs across the top of the west foundation wall down to the ledge and onto the west end of the floor joists. This has led to severe rot of the joists at the bearing locations. Several of the floor joists are exhibiting severe rot and are easily probed

with a flat screw driver (Figure S14). The sill plate is not exhibiting the same level of deterioration, but there is concern that the bottom sides of the sill plates could also be deteriorated. This deterioration should be addressed as it could lead to a structural failure of the floor framing along the west wall.

Figure S14. Deteriorated joist end at west foundation wall. (SEA 2015)
