THE STANTON HOUSE

Women's Rights
National Historical Park

Historic Structure Report

HISTORIC STRUCTURE REPORT

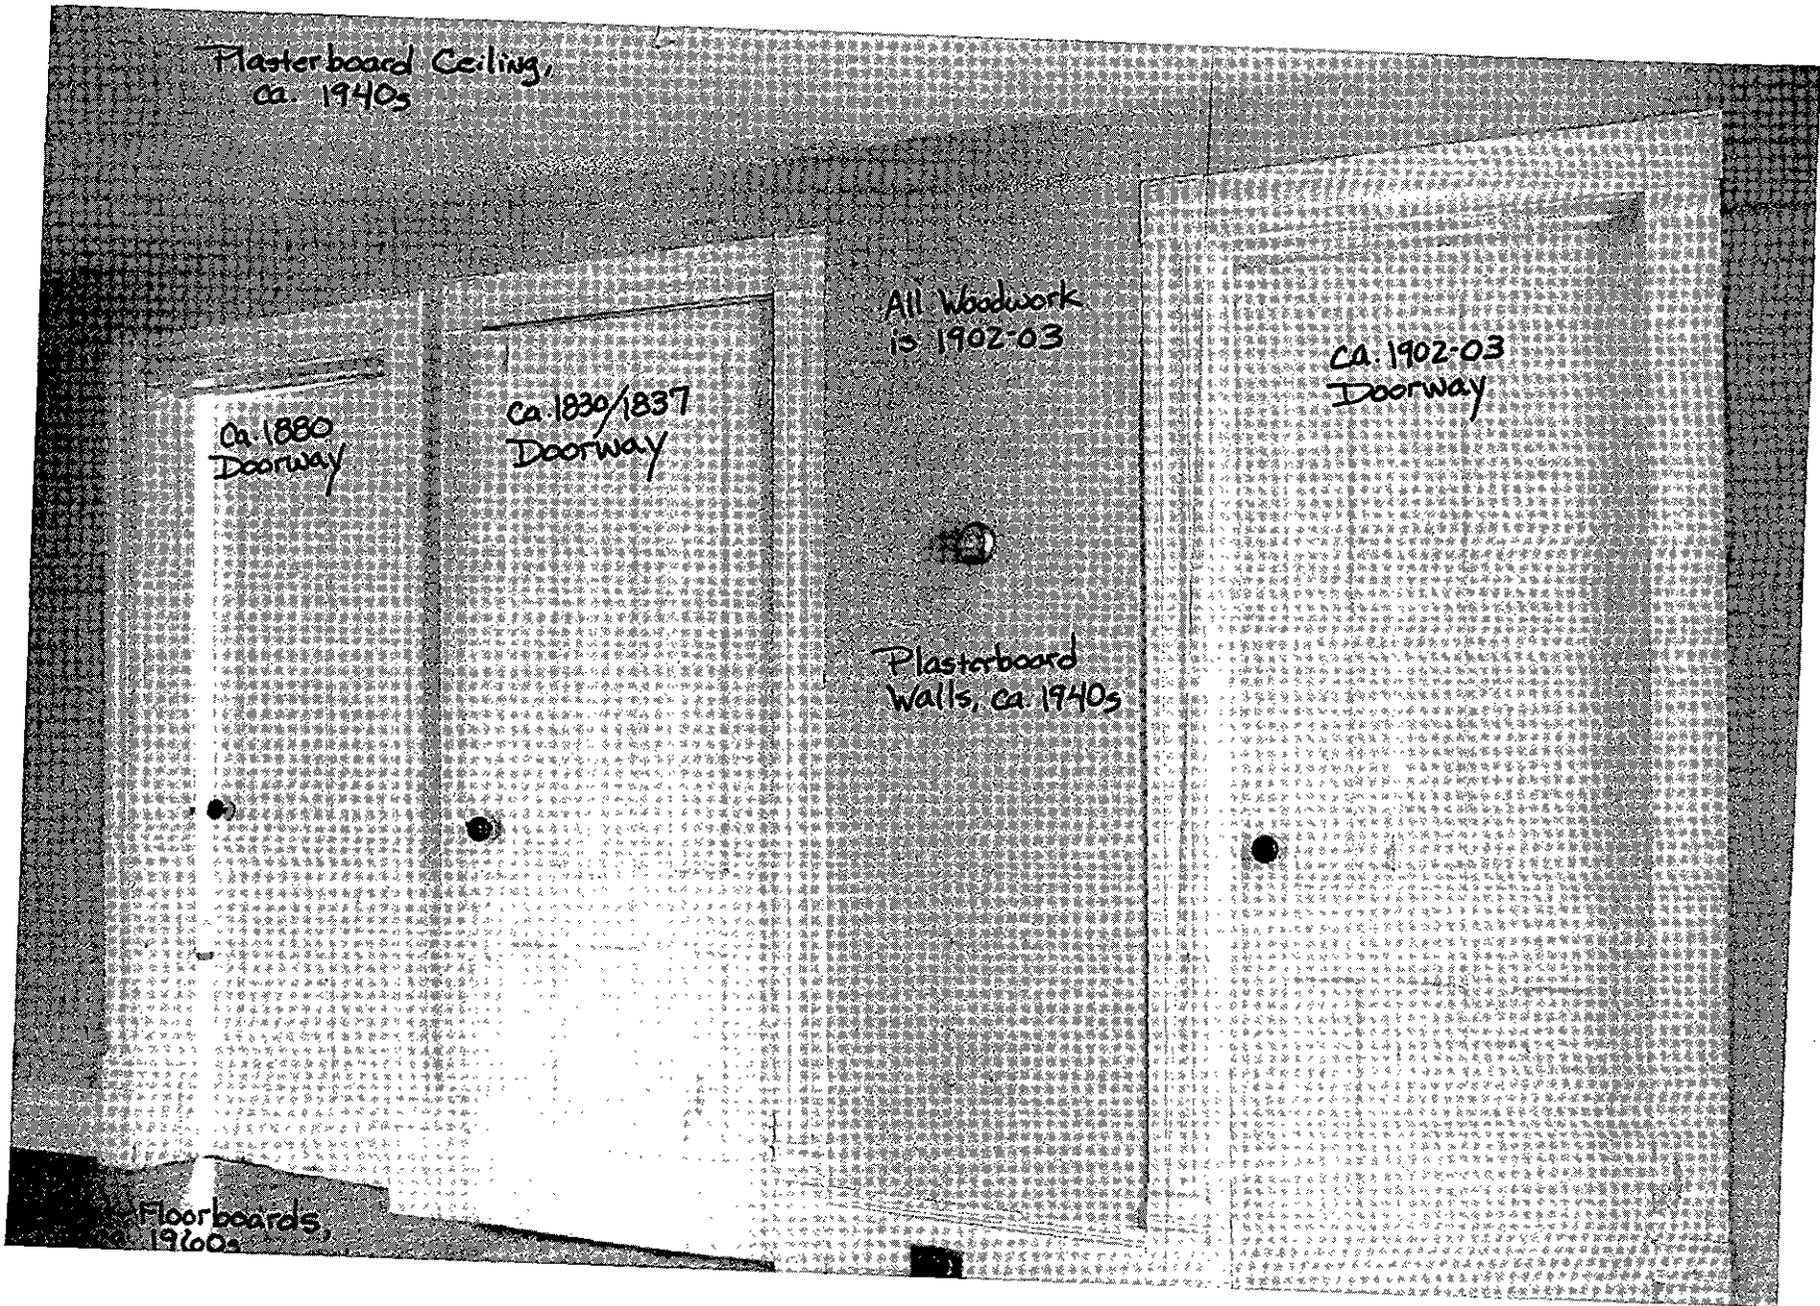
Figure 46. Stanton House: Room 103, looking north, June 1982.

Plasterboard Ceiling,
ca. 1940s

Ca. 1880
Doorway

Floorboards,
1900s

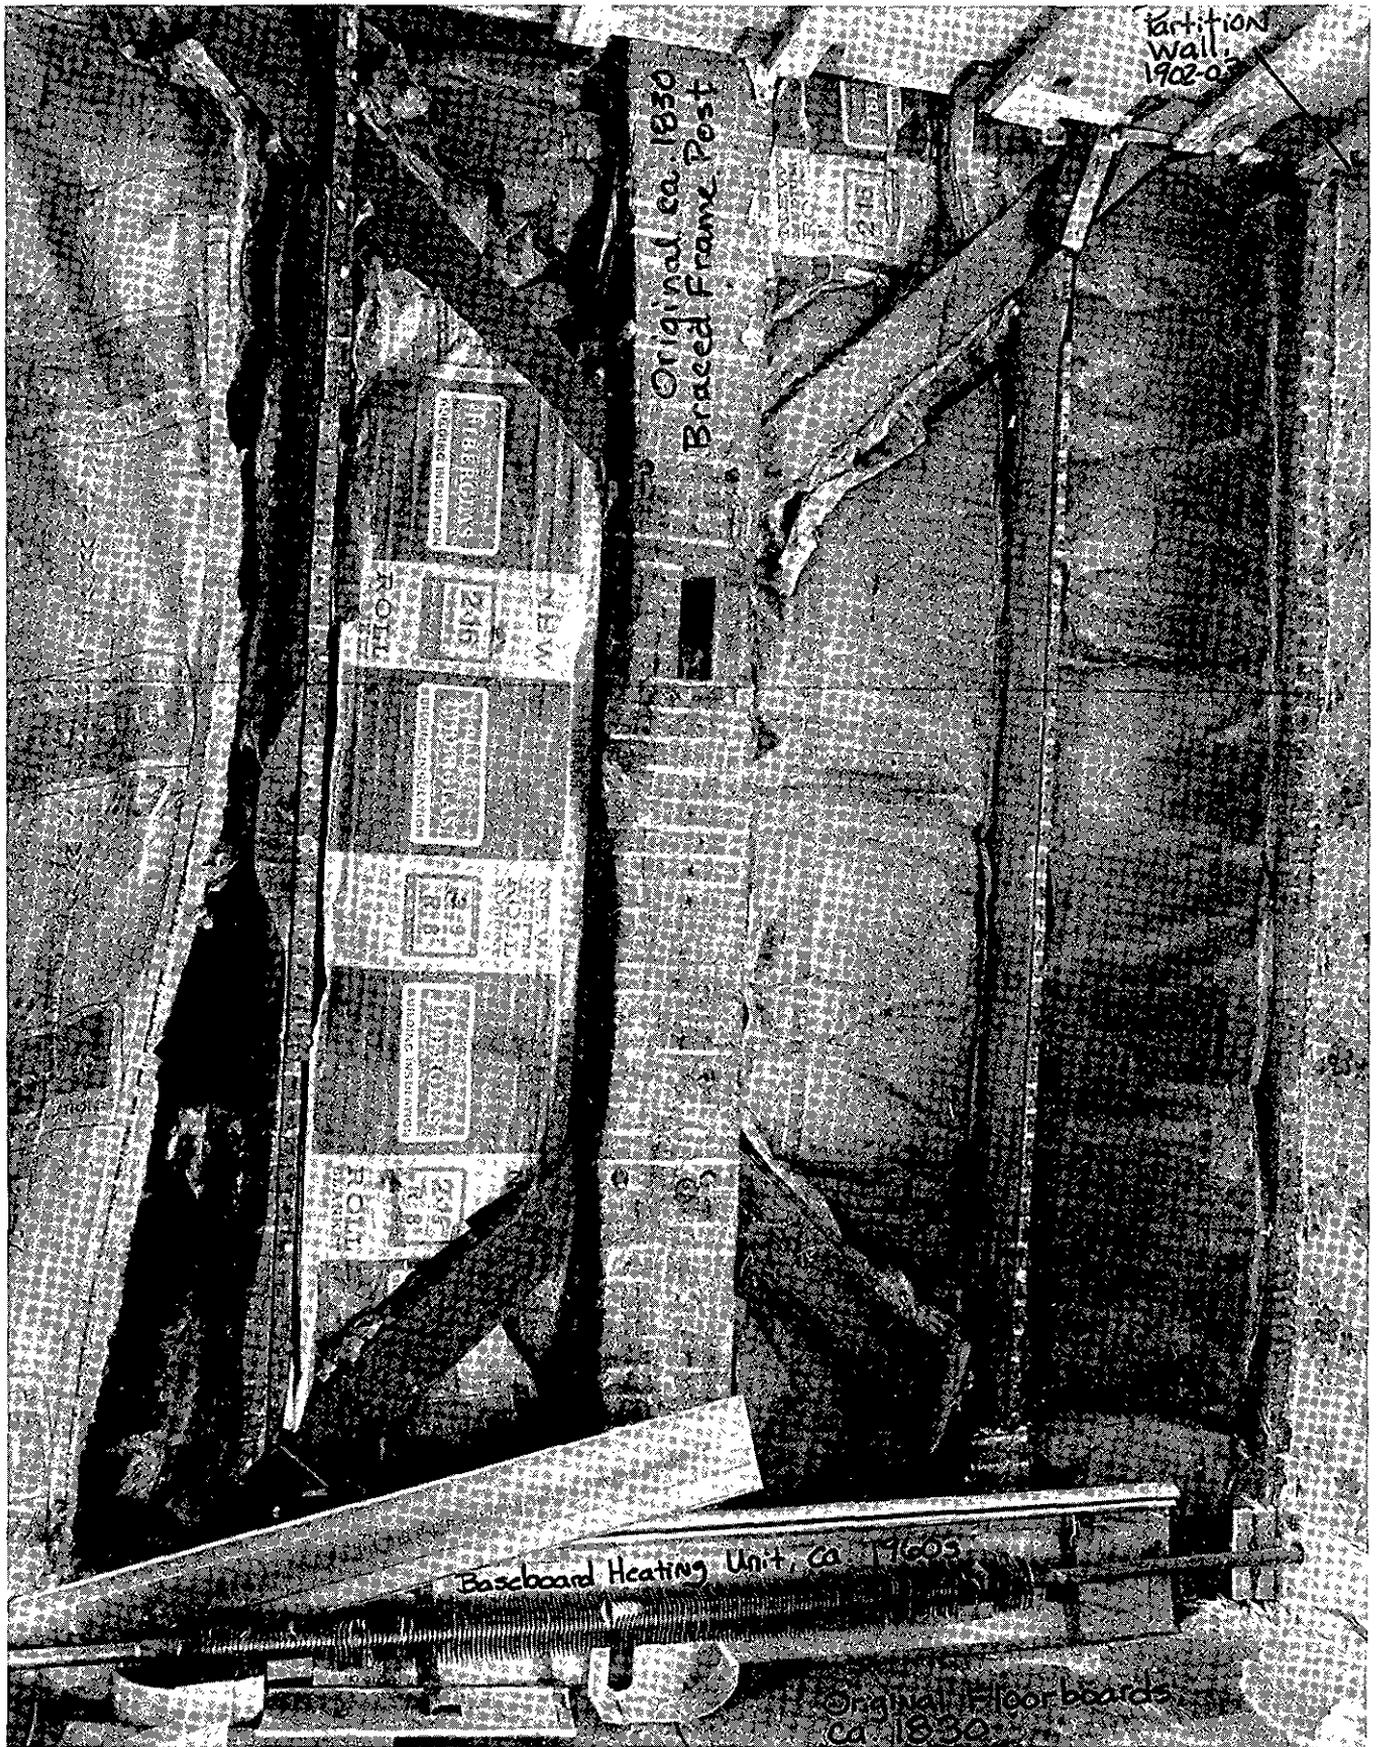
Figure 58. Stanton House: second-story hall, detail of braced-frame post at north wall, July 1982.

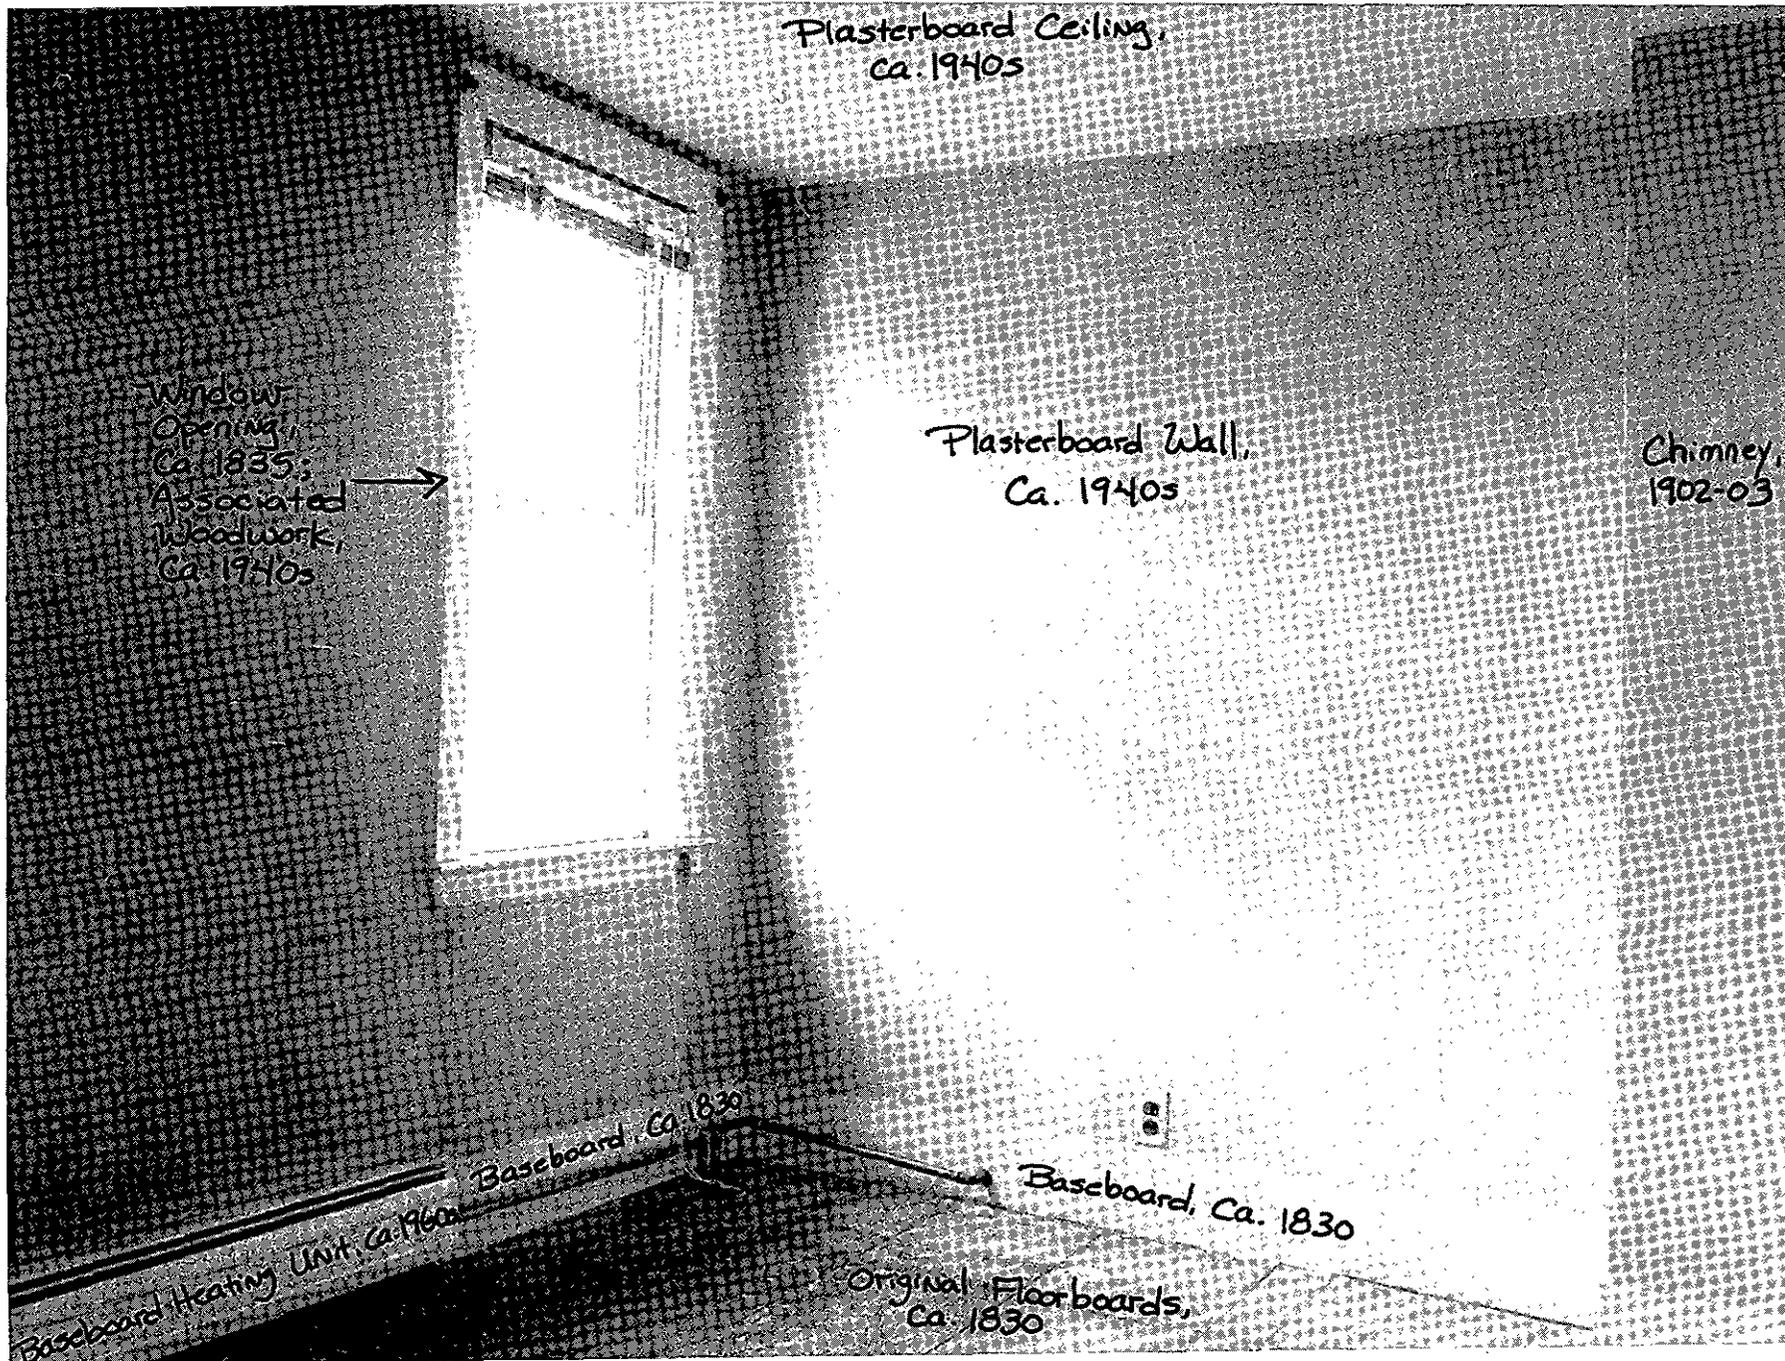
Figure 64. Stanton House: Room 202, looking southwest, June 1982.

Plasterboard Ceiling,
ca. 1940s

Floor Patch, ca. 1840,
at Former Stove Well, ca. 1830

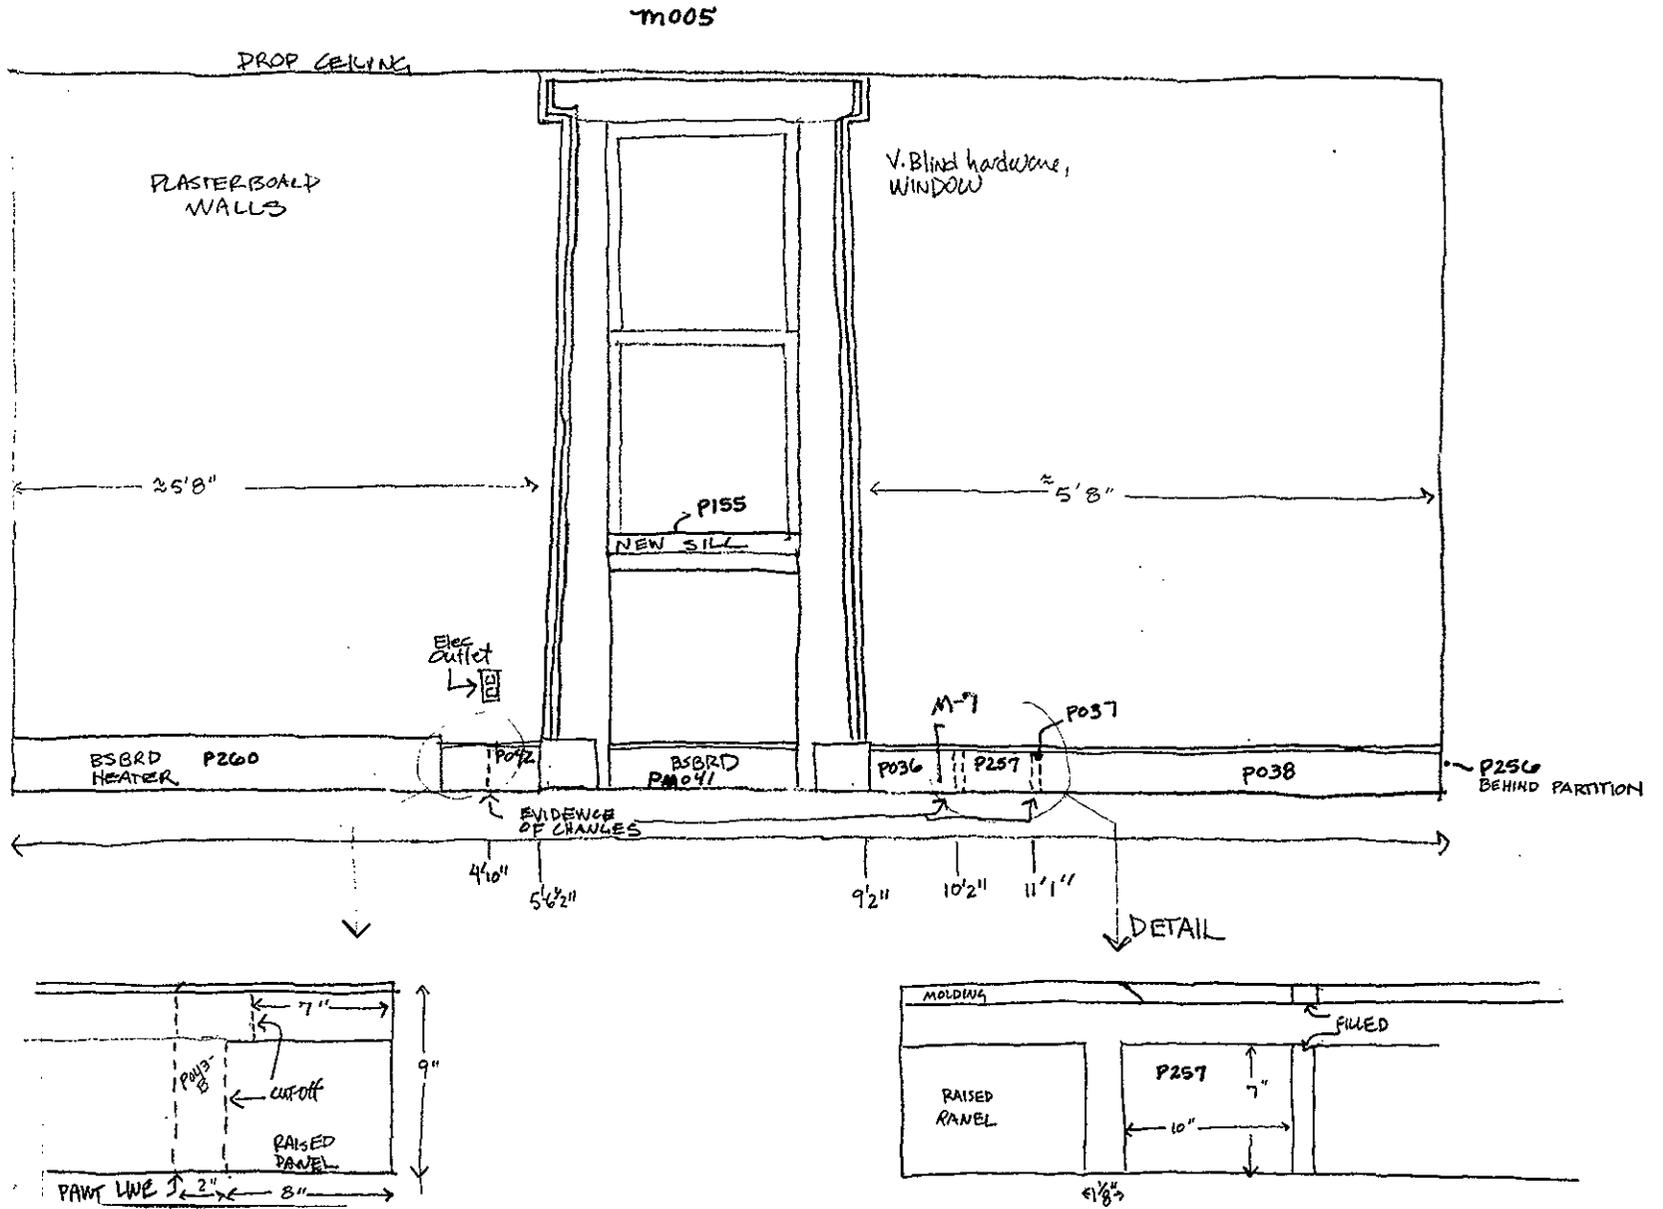
PLASTER WALL +
CEILING BENEATH
DRYWALL + DROP
CEILING

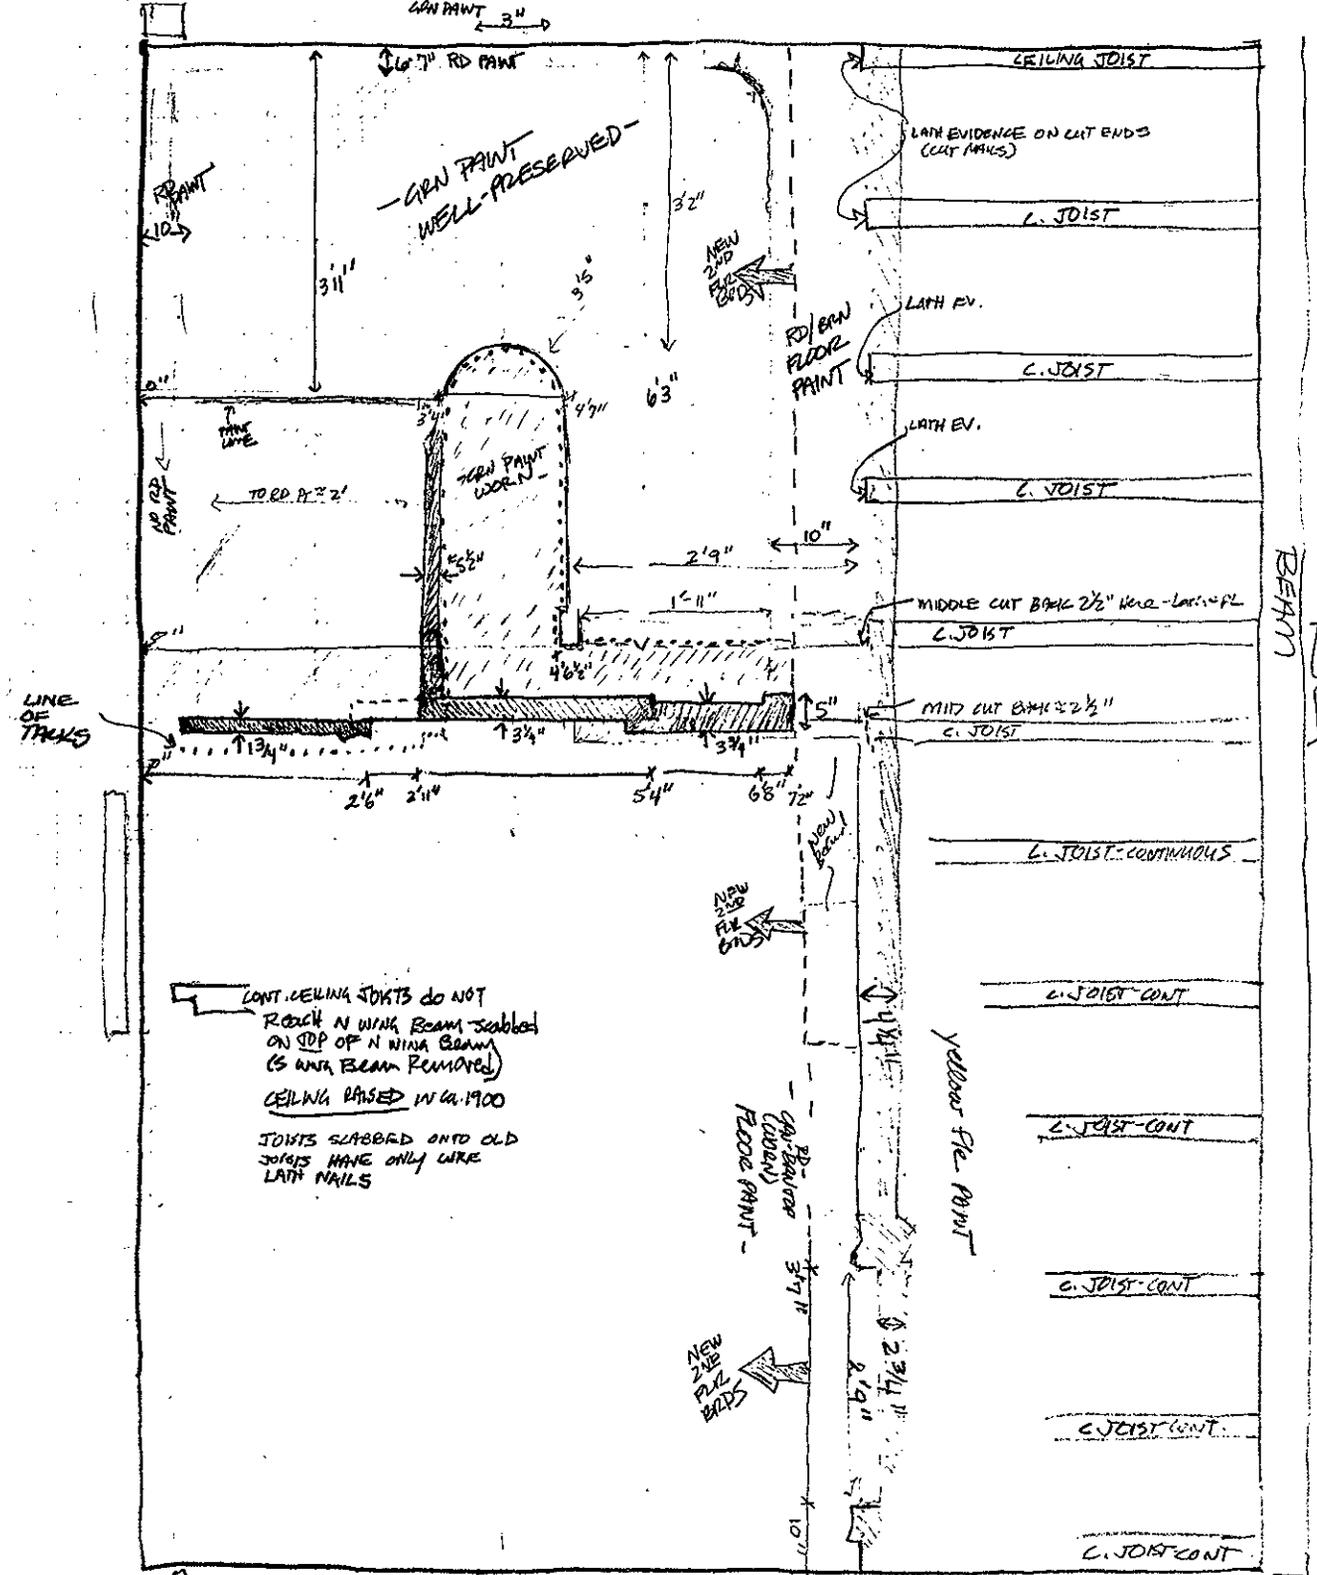
CONT. CEILING JOISTS DO NOT
 REACH N WING BEAM SCABBED
 ON TOP OF N WING BEAM
 (S WING BEAM REMOVED)
 CEILING RAISED IN CA. 1900
 JOISTS SCABBED ONTO OLD
 JOISTS HAVE ONLY WIRE
 LATH NAILS

JOISTS CUT
 OFF @ N
 NEWELL POS
 LOCATION
