# VILLAGE HALL

## Women's Rights National Historical Park

**Historic Structure Report**

VILLAGE HALL  
HISTORIC STRUCTURE REPORT  
Women's Rights National Historical Park  
Seneca Falls, New York

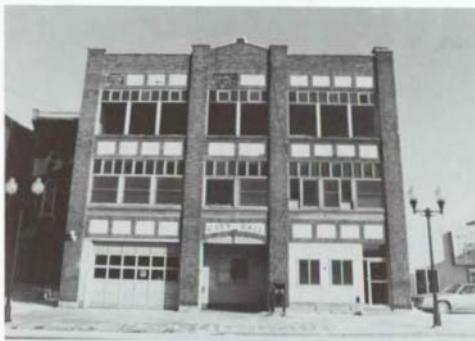
Fig. 13. Exterior South Facade [1988].

Brick Surface. The brickwork at first-story level is in good condition. It is chipped at midpoint on the east side of the garage doorway, and the east side of the central bay (which originally also was a garage doorway.) It is possible that both chipped areas are the result of vehicles passing through the doorways.

The parget on the back side of the parapet is also in poor condition. It is cracked and has spalled, exposing the underlying brick masonry to weathering.

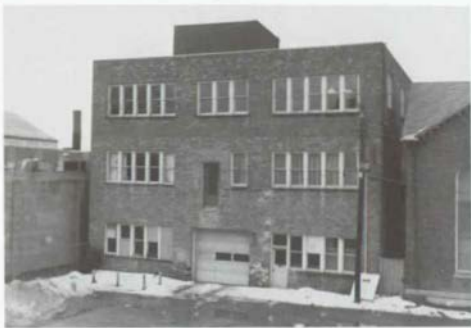
Fig. 15. Exterior North Wall [1988].

The overall condition of the north wall is poor. There are no obvious structural dangers (e.g., areas of bowing or eminent collapse). However, the surface conditions of the bricks and mortar are among those that contribute to eventual structural failure. These conditions are most severe at first-story level. For example, surface loss in the form of spalling occurs most extensively at first-story level. There are also localized areas of efflorescence, specifically on either side of the garage doorway to a height of about 4 feet. The brickwork directly below the second-story doorway is stained with a white haze. This may be the result of mortar being exposed by the deteriorated and missing brickwork below the doorway (see below).

Brick Cracks. The north wall displays three areas of extensive cracking, all located between the first- and second-story levels. The east end of the east bay contains a vertical crack that ascends, from a point about level with the first-story windows' meeting rail, to the east end of the second-story window opening's sill. The crack runs mostly along and through the mortar joints, but does traverse a few bricks (approximately 5 out of 40 courses). The crack's greatest width--approximately 1/4 inch--occurs next to the lintel of the first-story window opening. The east bay also displays a vertical crack below the middle window at

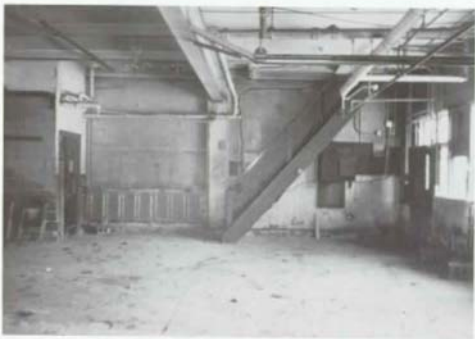
Fig. 32. Room 106 (Garage), Looking West [1988].

Walls. The west wall of the main area is an original brick exterior wall, and so is divided into bays by brick pilasters that encase structural steel columns. Its plaster and paint are orig-

inal, judging by the former's characteristically smooth texture. The plaster is in poor condition, being cracked throughout. At the north end of the wall, where a steam radiator is attached, the plaster has spalled extensively.

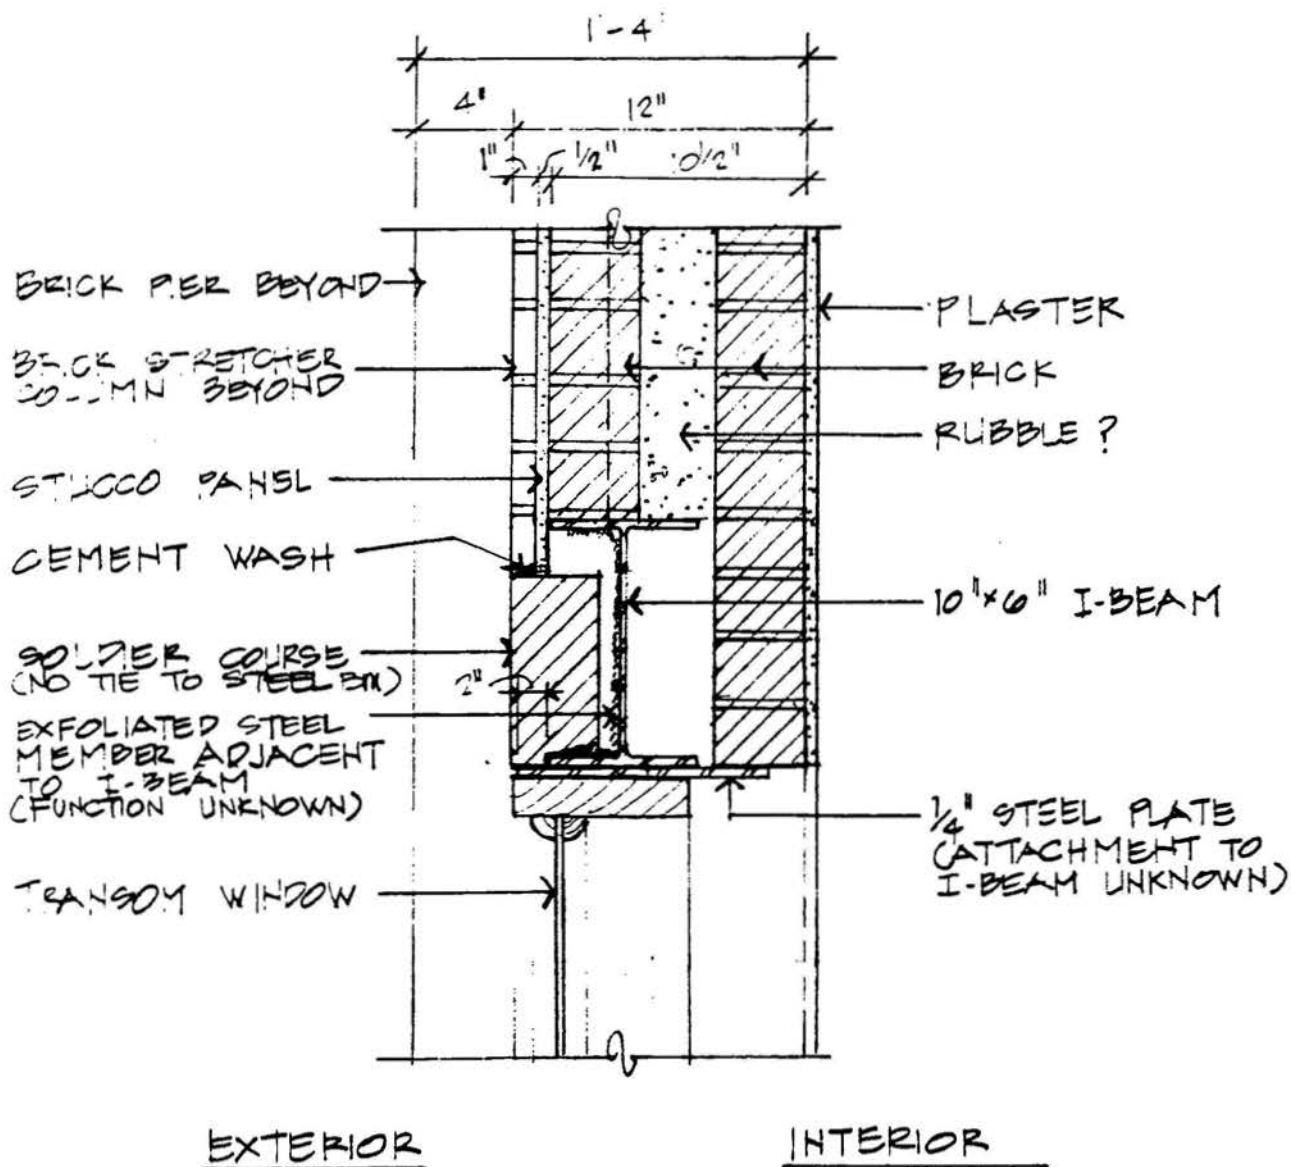
SOUTH WALL SECTION  
 SCALE:  $1\frac{1}{2}'' = 1'-0''$

NOTE: BOXED SOLDIER COURSE ABOVE 2<sup>ND</sup> STORY WINDOWS (EAST END) REMOVED & STORED. NAME ON BRICKS - "CALEDONIAN".  
 SOLDIER COURSE ABOVE 3<sup>RD</sup> STORY WINDOWS ALSO EXHIBITS MOVEMENT.
