Doughton Park and Sections 2A, B and C Blue Ridge Parkway Cultural Landscape Report

Cultural Landscape Report

Written by The Jaeger Company

2006

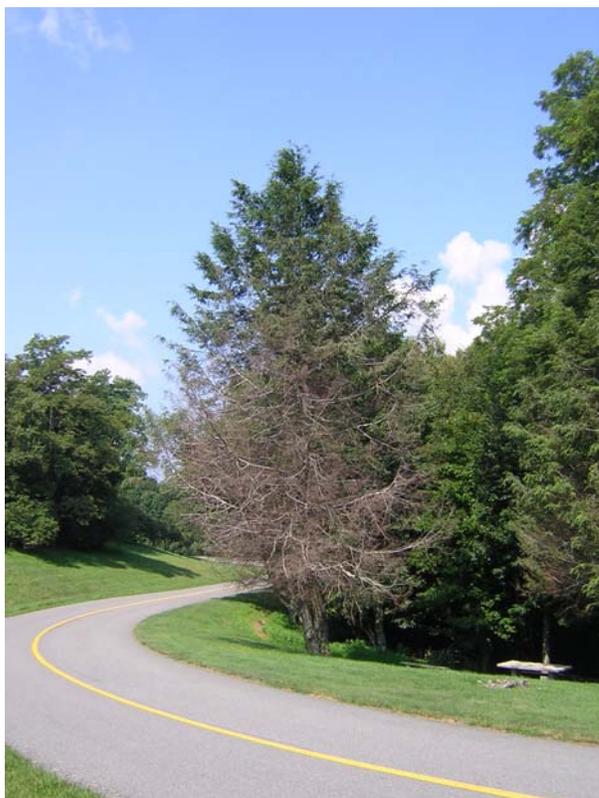
Figure 3.40: Hemlock Woolly Adelgid damage, (Photo by the Jaeger Company, 2005).

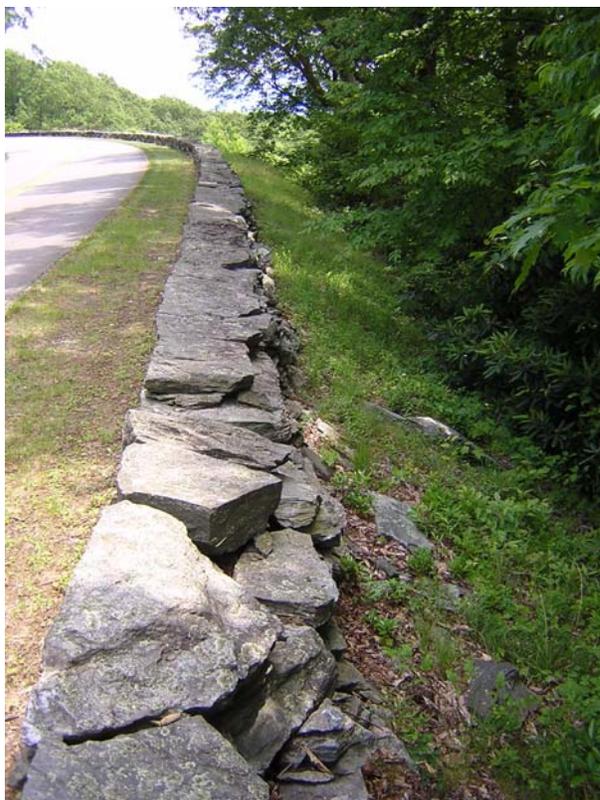
Figure 3.58: Example of guardwall, good condition, (Photo by the Jaeger Company, 2005).

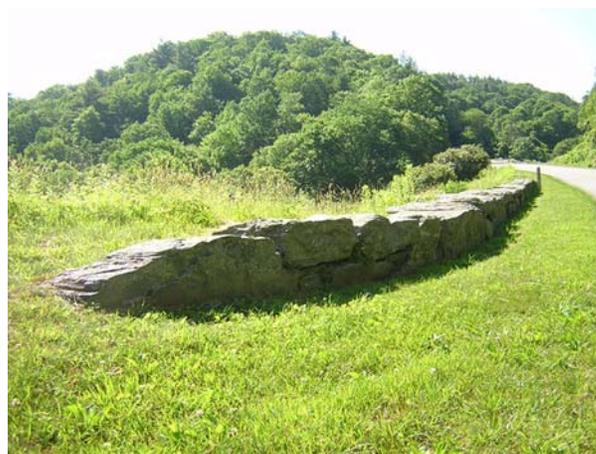
Figure 3.59: Good example of guardwall transitioning into slope, (Photo by the Jaeger Company, 2005).

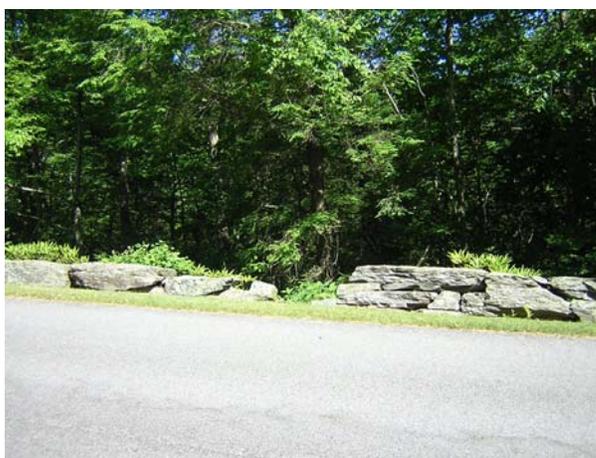
Figure 3.60: Guardwall missing capstones, (Photo by the Jaeger Company, 2006).

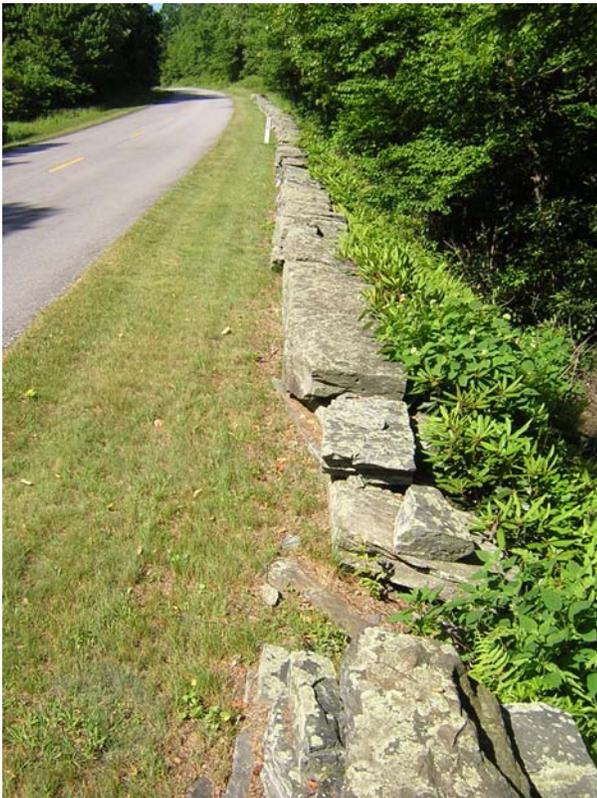
Figure 3.61: Guardwall missing stones and slanting, (Photo by the Jaeger Company, 2006).

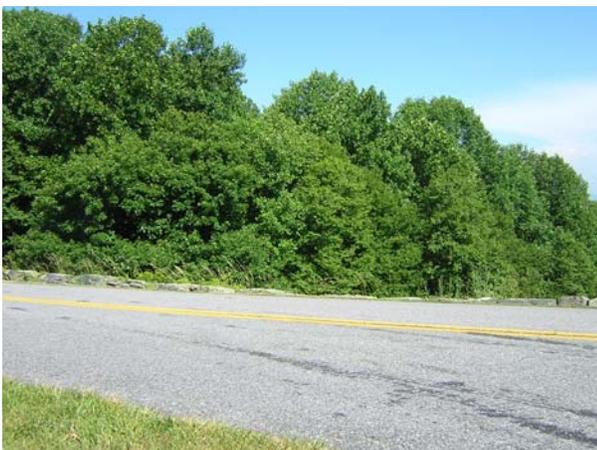
Figure 3.62: Guardwall sinking from original elevation, (Photo by the Jaeger Company, 2006).

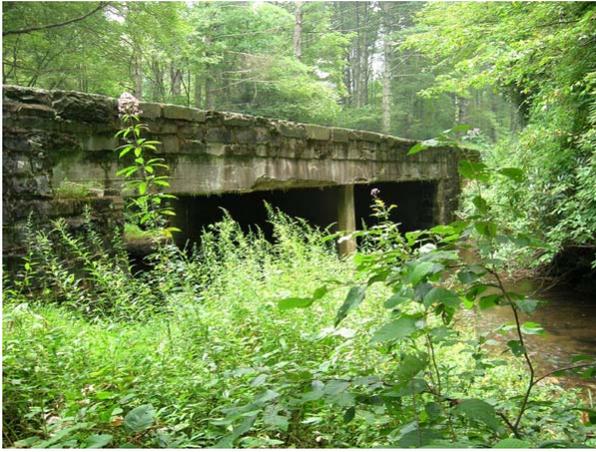
Figure 5.14: Bridge at MP 223 has vegetative growth on concrete and stonework. Concrete appears to be degrading (Photo by Ian Firth, 2005.)

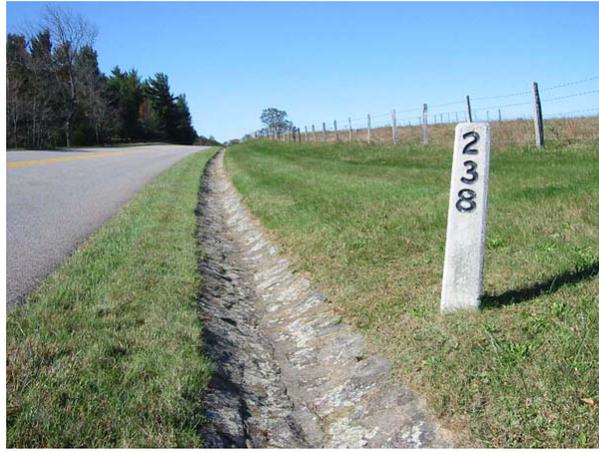
Figure 5.16: Well maintained stone lined gutter at MP 238, Parkway Right (Photo by The Jaeger Company, 2005.)
