Cape Lookout Village Cultural Landscape Report

Cape Lookout National Seashore
Carteret County, North Carolina

9 May 2005

Cultural Landscape Report

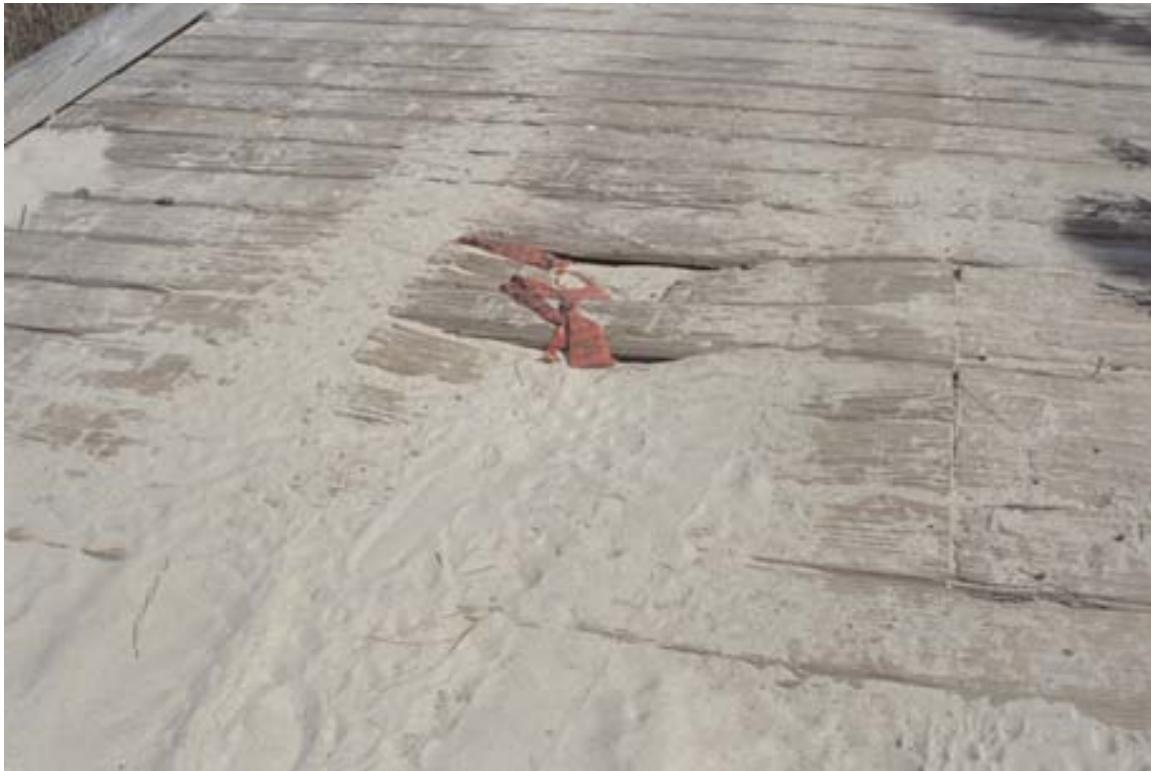
Figure 3-55. A wooden bridge crosses an intermittent drainageway as part of a road leading between Back Road and the village precinct. As seen in this photograph, the bridge is in need of repair.

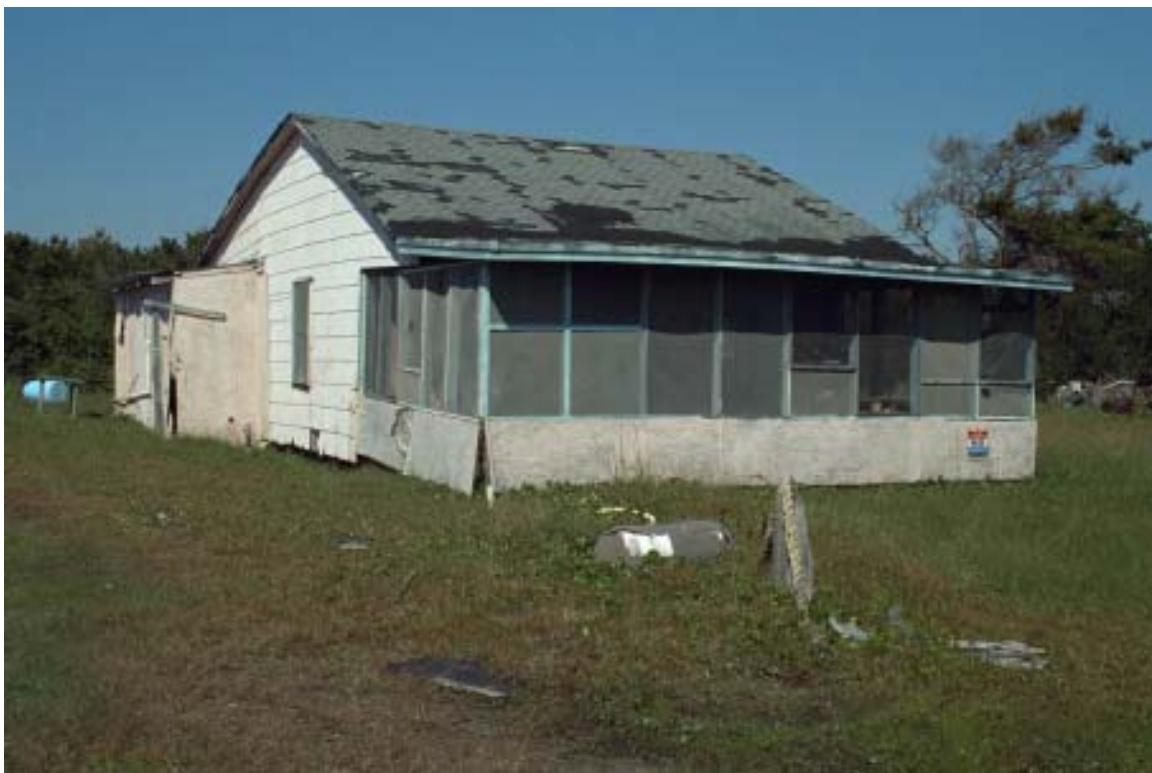
Figure 3-95. The Carrie Arendell Davis (Lewis-Davis House) is significantly deteriorated.

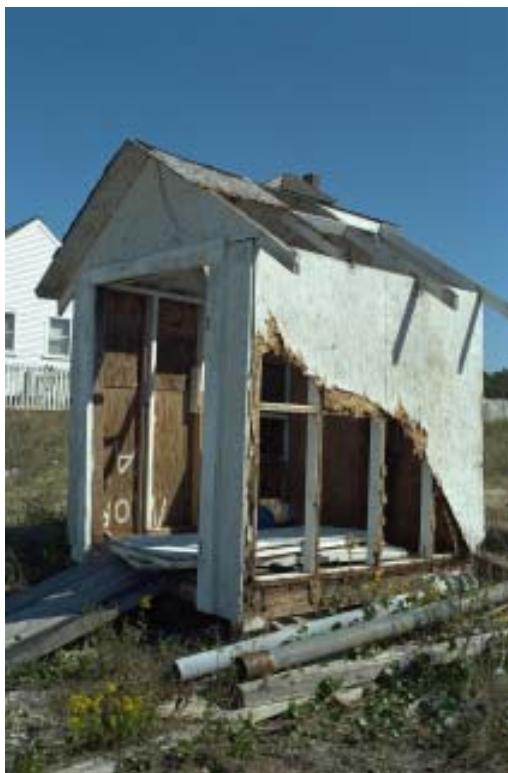
Figure 3-101. This small wood storage shed at the Coast Guard station is very deteriorated.

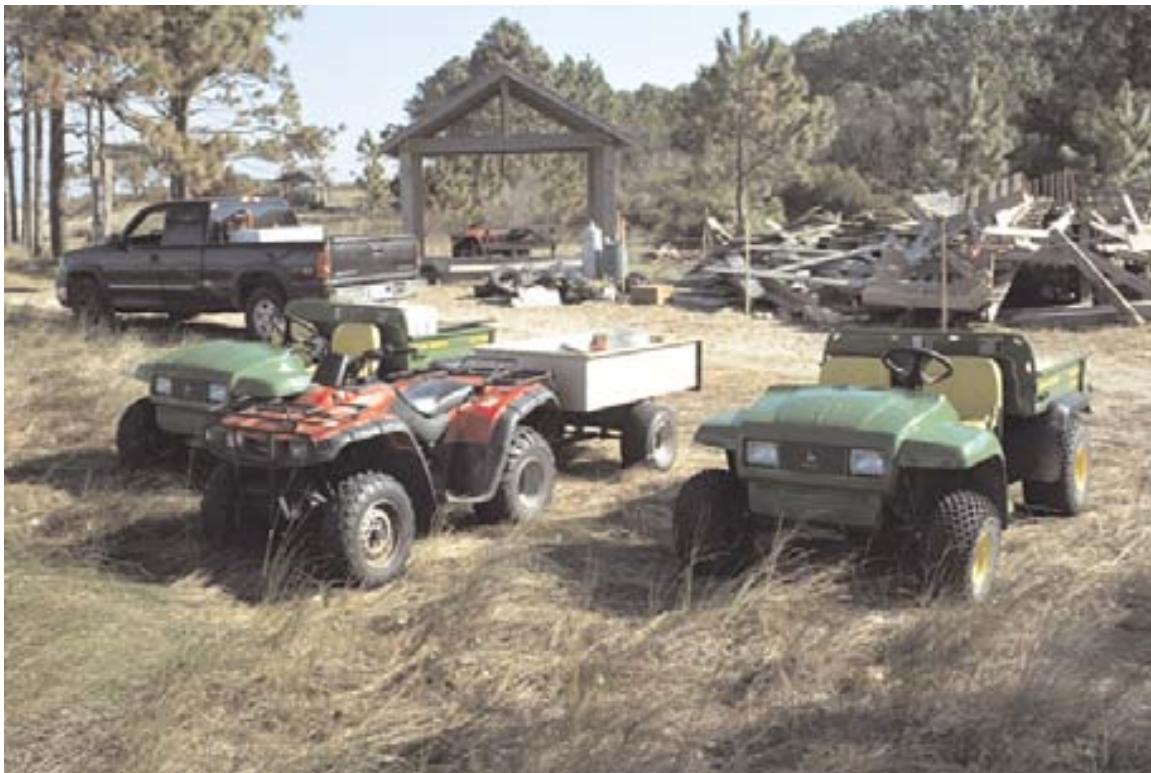
Figure 3-157. Numerous piles of debris are found in the lighthouse area from damage caused by Hurricane Isabel.

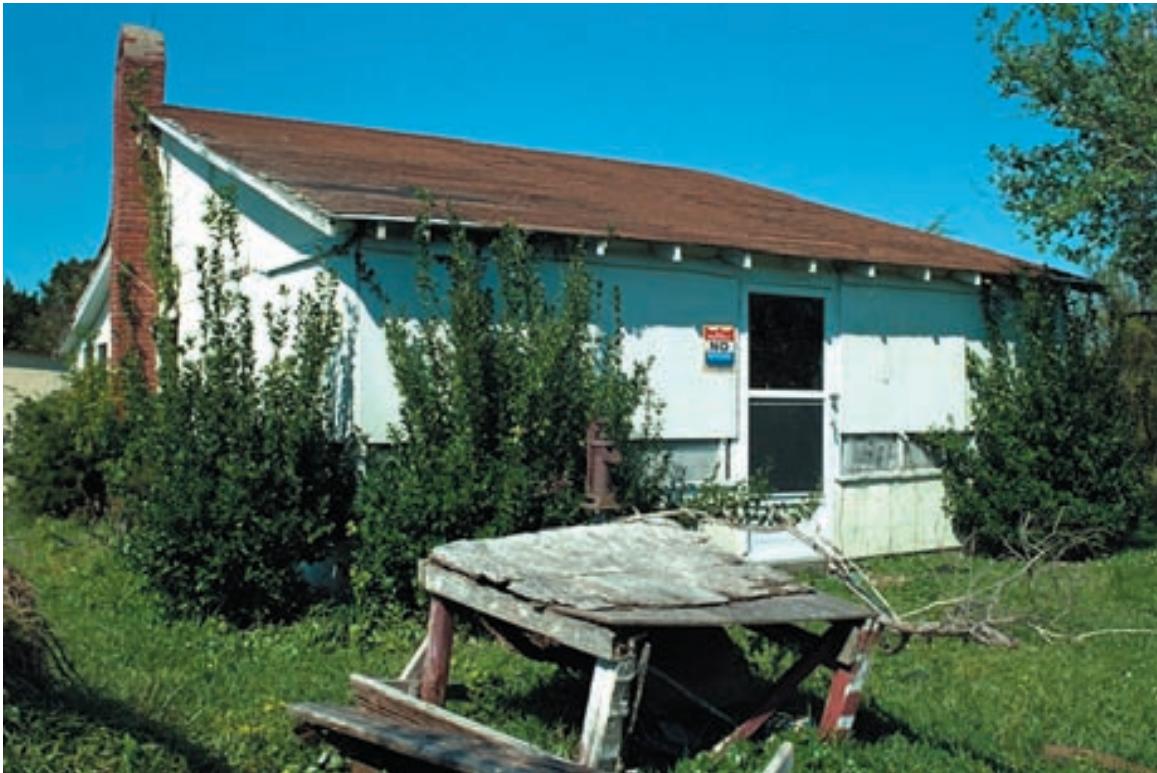
Figure 5-17. The foundation planting of privet, shown, should be removed. Privet is an invasive alien shrub that could threaten the cape's native plant communities.

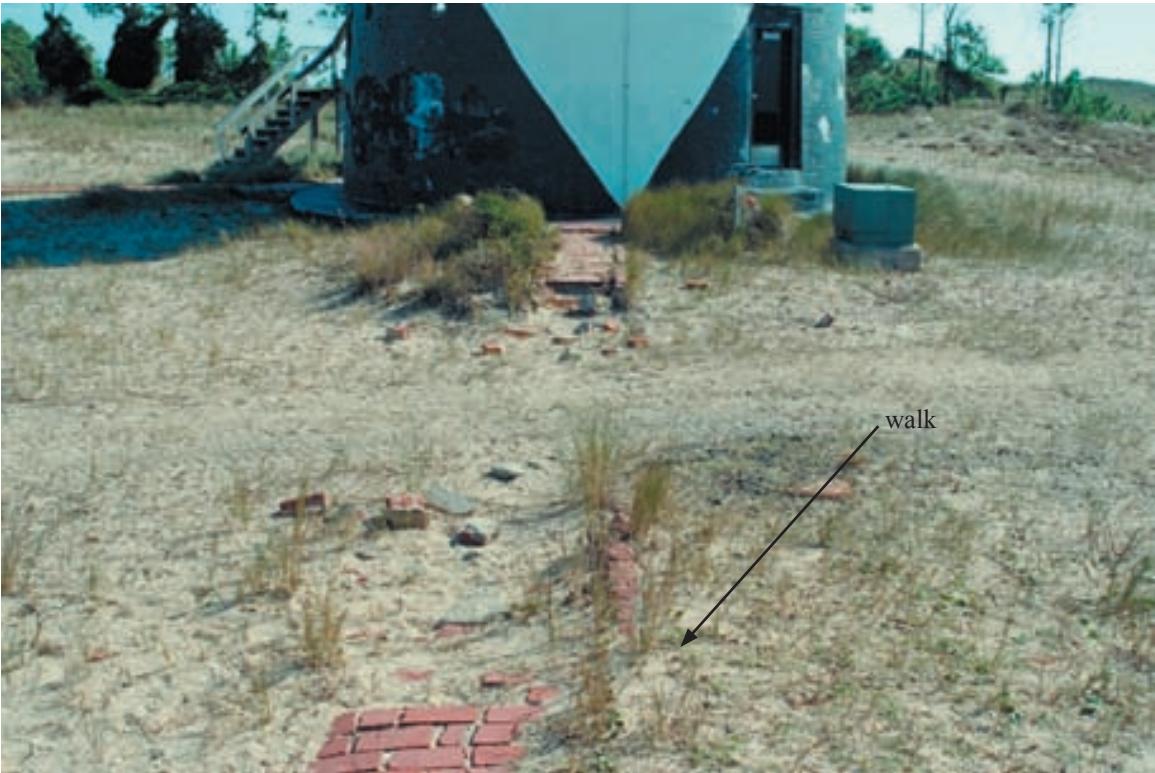
Figure 5-27. The existing historic walk between the lighthouse and the oil shed is in poor condition and is broken by a non-contributing road alignment running through walk. The historic walk should be restored and the non-contributing road removed.

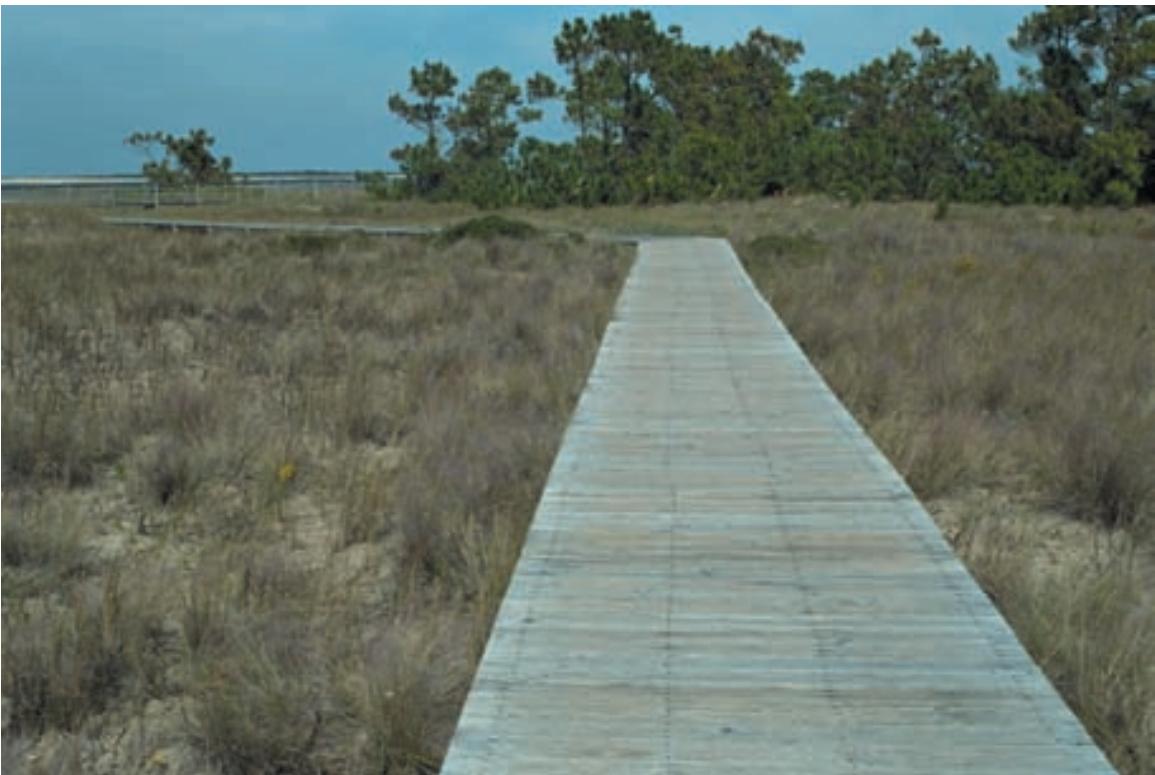
Figure 5-28. A wood boardwalk leads from the boat landing to the rear of the 1873 keeper's dwelling. The route should be altered to provide access to the historic front entrance of the dwelling.

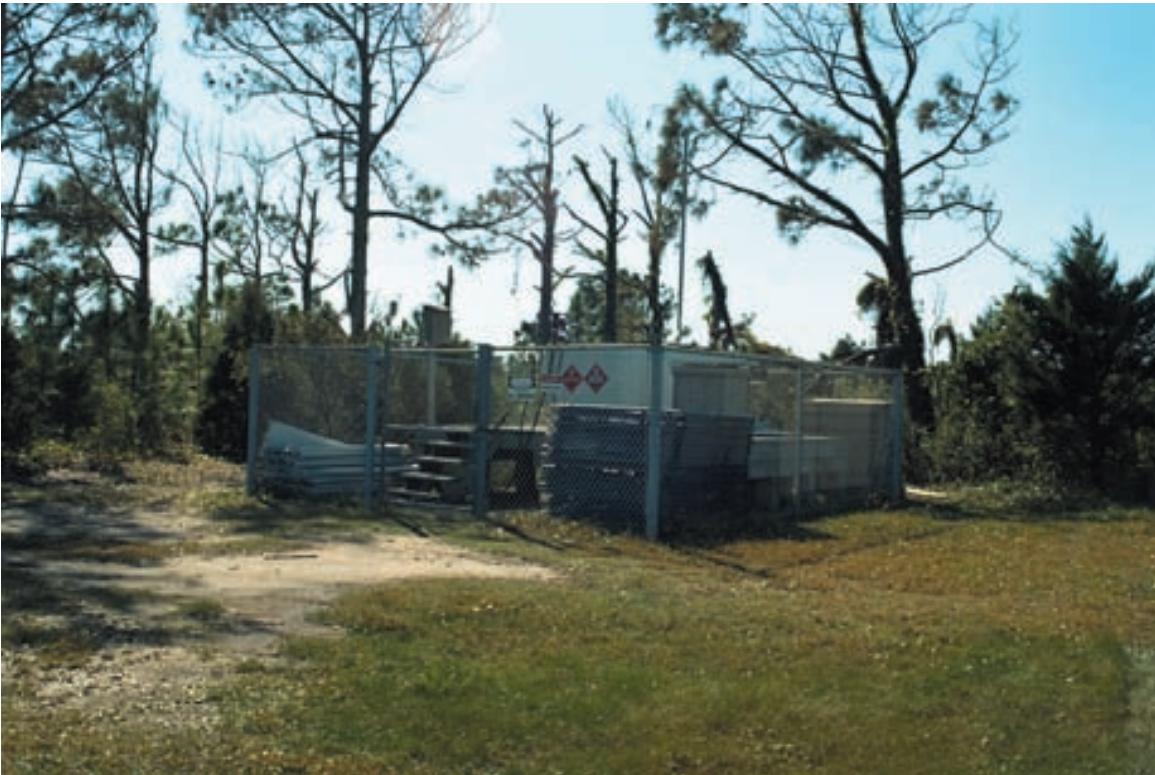
Figure 5-35. Existing condition of chain-link fence surrounding material storage.

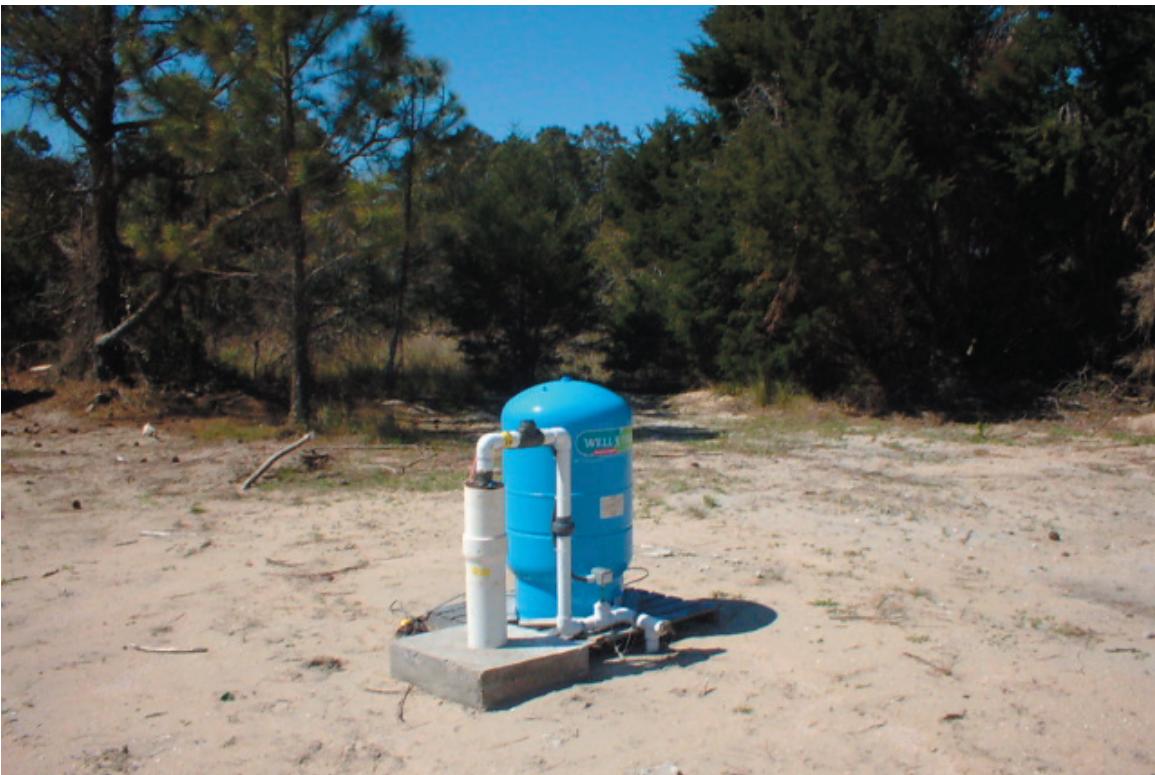
Figure 5-37. New well at lighthouse requiring screening.
