NATIONAL REGISTER OF HISTORIC PLACES
INVENTORY - NOMINATION FORM

COMMON:
C & O CANAL

CITY OR TOWN:
Washington, D.C. to Cumberland, Md. (Western Terminus)

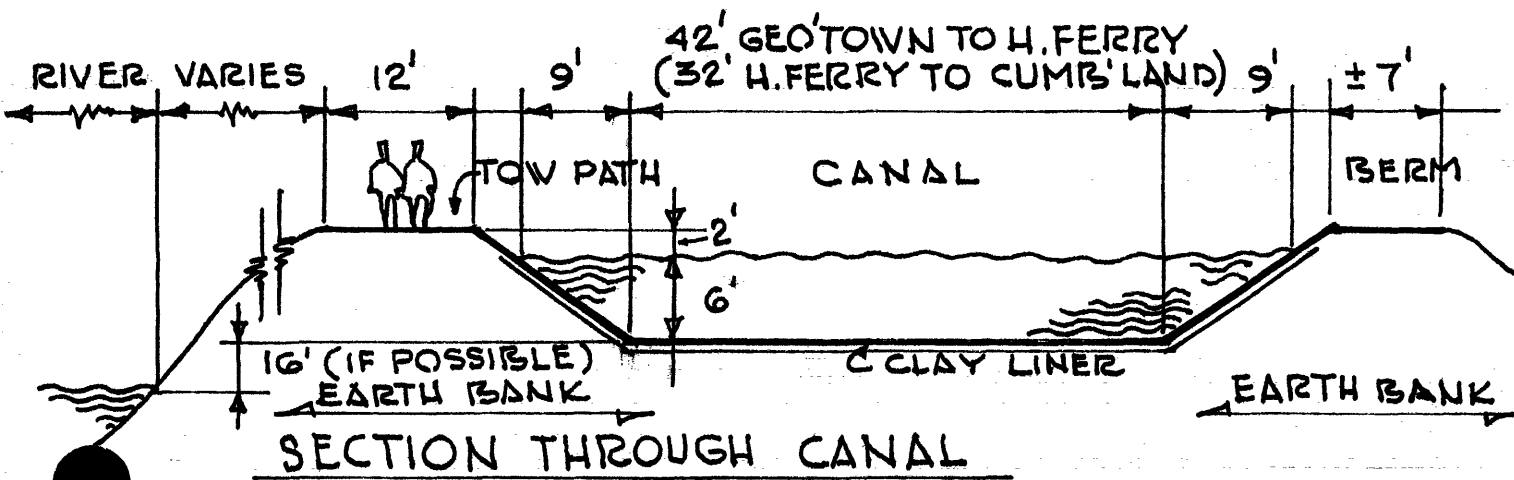
From Georgetown to Harpers Ferry: A canal cross section to carry 6' depth of water (with the exception of Little Falls to Georgetown, where 7' was maintained so that some water could be drawn off to provide water power for nearby mills and foundries), 42' wide bottom; sides on a slope of 1' vertical to 1½' horizontal giving top width of canal of 60', the sloping sides were to rise 2' above water level, and entire canal bed was waterproofed, with a clay liner. Much of the canal had earthen sides and bottom, but dry wall stone sides were used on curves, areas subject to floods, and places where unusual strain was likely to be exerted on the canal walls, and in a few restricted locations the canal was blasted out of natural rocks. From Georgetown up to the Alexandria Aqueduct a specified 12' towpath was on the berm (land side) of the canal, and at that point a bridge afforded access to the towpath on the river side of the canal for all the remaining miles. The towpath was specified to have a smooth, hard surface and surfacing was of crushed rock or whatever was available in the immediate area. For rain water drainage, the towpath sloped 1" to 1' toward the Potomac.

From Harpers Ferry to Cumberland: the canal narrows to a 50' top dimension and a 32' wide bottom. All other elements remain as above.

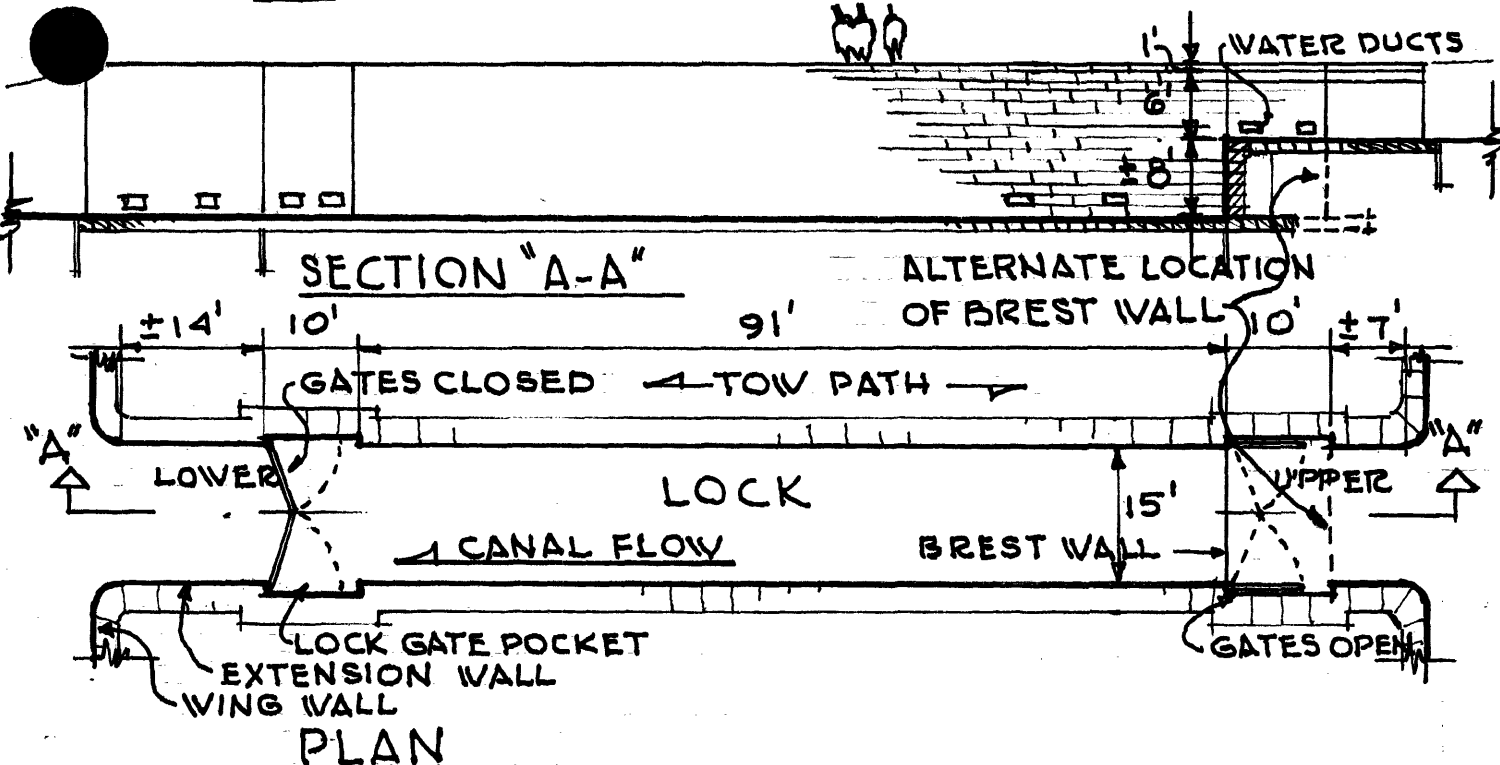
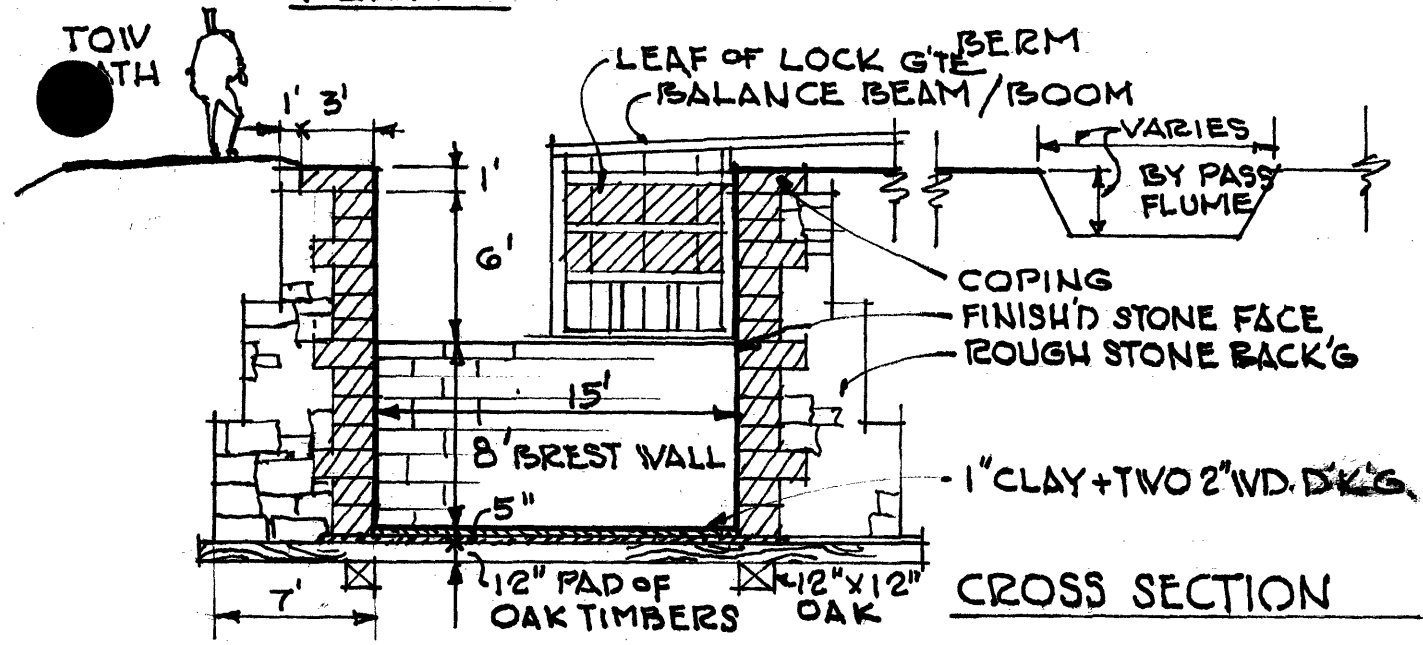
B. - Locks:

From the sea level elevation of zero feet for the Potomac at Georgetown, the river rises to the inland elevation of 605' at Cumberland. This change of elevation of 605' was divided up into 74 increments of change, thus giving the majority of locks an 8' vertical movement of water to be accomplished and accommodated. The use of the canal was totally dependent on the proper functioning of the locks. A standard plan was

developed and the written specifications required a wood foundation of oak timbers, stone of high quality, carefully cut and finished and properly laid in cement mortar. The workmanship was of high standards to be accepted. Minor variations in the locks were made at specific locations to suit existing local conditions, but the plans, and the specifications of 1829 and 1830 (which move the brest wall from the down edge to the up edge of the upper lock gate pocket thereby requiring two tall lock gates), held until the 1848-1850 period when restricted time and finances forced the Canal Company into many changes in the locks. The lock trench was dug or prepared to an exact surveyed depth. Unless solid rock was found at the proper depth, a bed was laid of 12" x 12" oak timbers, approximately 30' long, placed perpendicular to the run of the lock, and with their sides butted. This wood pad was underlaid by 12" x 12" timbers with their ends butted to give a continuous length of timber under the face of the two parallel lock walls. Three-inch thick plank sheet piling from the top of the pad to 5' below was placed at the up and down canal lock ends of the pad plus at two intermediate locations. Two-inch wood decking was placed over the timber pad and butt-laid perpendicular to it. The decking was laid to continue under the lock wall face stones. The lock walls were 15' apart and built of cut and finished stone with minimum dimensions of 2½' long, 1' high, and 18" thick, carefully set in cement mortar in regular courses. The walls were topped off with a coping stone of 12" height and 3' top exposed thickness with a minimum of 3' length. The top lock side edge of the coping stone was rounded with a 1" radius. Under the coping stone the face wall was backed up by a rough cut stone wall laid to give a total wall thickness of 4' at the top, increasing to 7' at the bottom in two equal steps. The height of the lock wall was dependent on the change of level of water to be accomplished in the lock, but a typical height of 15'-3" would include 2" finished decking butt laid crossways of the lock, 1" clay, 6' water level, 8' change of water level, plus 1' coping. The main body of the lock was approximately 92' long. At each end, each side of the main body walls a 10' long, 16" increase of width was laid to become a lock gate pocket. Typically the down canal edge of the upper lock gate pockets was the location of the 8' high stone, cross lock wall, known as the brest wall. It was here that the bottom of the lock moved up to the top of the brest wall for the remainder of the upper lock. It was the height of this brest wall that gave the lock the ability to change the water level more or less than 8'. Above the upper lock gate pockets the lock walls moved back to the 15' clear width and continued in straight run (known as extension wall) for approximately 7', at the end of which they curved out in a quarter of a circle to run about 12' perpendicular to the lock walls. (known as wingwalls) to either bank of the above canal. Immediately below the lower lock gate pockets the lower extension walls run for about 14', with a clear width of 15', curve out in a quarter circle and run for 12' plus as wingwalls perpendicular to the lock. Water ducts were placed at the bottom level of the walls in the upper pockets and main body of the lock. Water was controlled by iron wicket gates in the pocket wall that could be adjusted by iron stems that emerged through the coping stones. To fill the lock, when the top lock gates were in their normal closed position, the lower gates were closed, the upper water wickets opened, and the lock filled, then the upper gates could be opened, a
