**Cultural Landscape Assessment
for the Ferris Property
Colonial National Historical Park
Yorktown, VA**

Cheryl A. Sams

Cultural Landscape Program, Philadelphia Support Office

2001

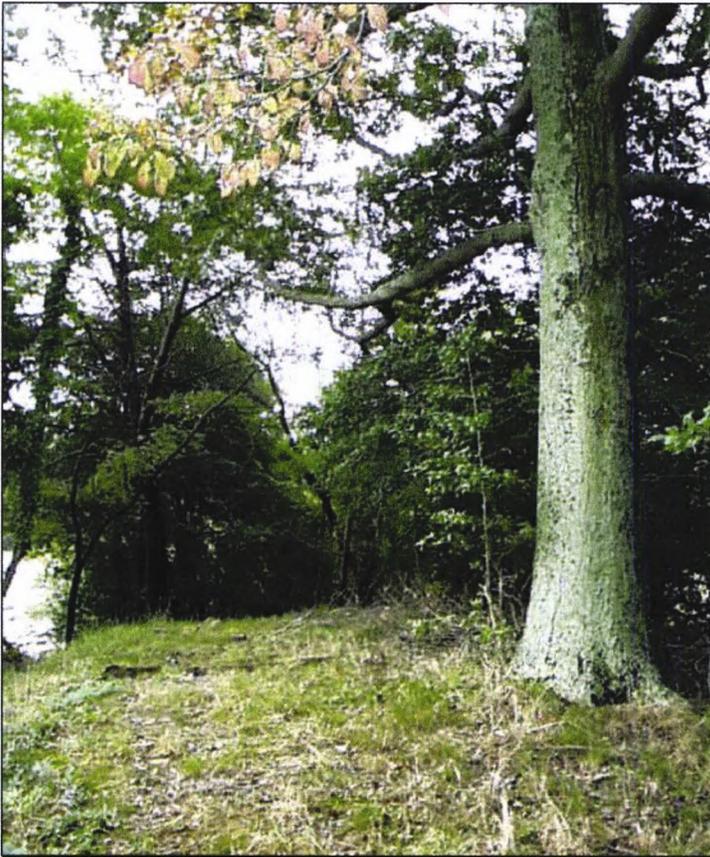
Hangman's Point has several mature trees located on its crest. Specifically, there is one large, healthy southern red oak centered on the point. (Figure 5) There are also several mature holly trees on the point. However, there is much new scrub growth on both slopes of the point. Some of this growth should be removed to open views to the river and to Yorktown. This would also reduce the competition with the larger, mature trees. Caution should be taken removing vegetation from the south slope of the point, however. The vegetation located on this slope is important in stabilizing the slope.

Figure 5: Large oak tree on Hangman's Point (COLO 2001).

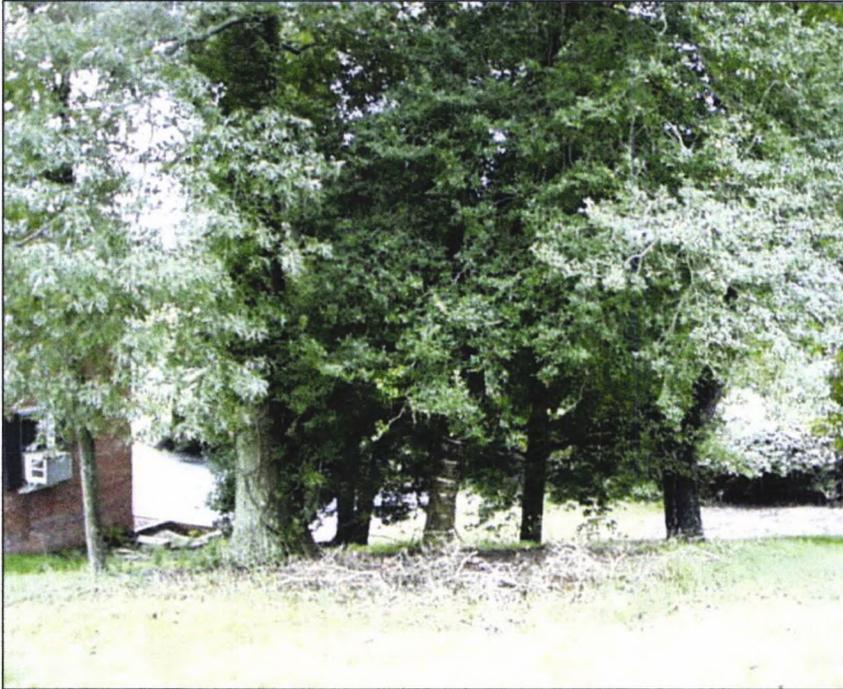
There is a series of decorative plants planted in the immediate vicinity of the house. The types of vegetation located here include several azaleas and a large camellia shrub. The west yard of the house has several mature cherry trees, an oak and a mature holly. (Figure 6) The vegetation near the driveway includes a large southern magnolia and some crepe myrtle. The severely invasive kudzu vine has established itself along the northwest corner of the house.

Figure 6: Vegetation located in the west yard of the house (COLO 2001).

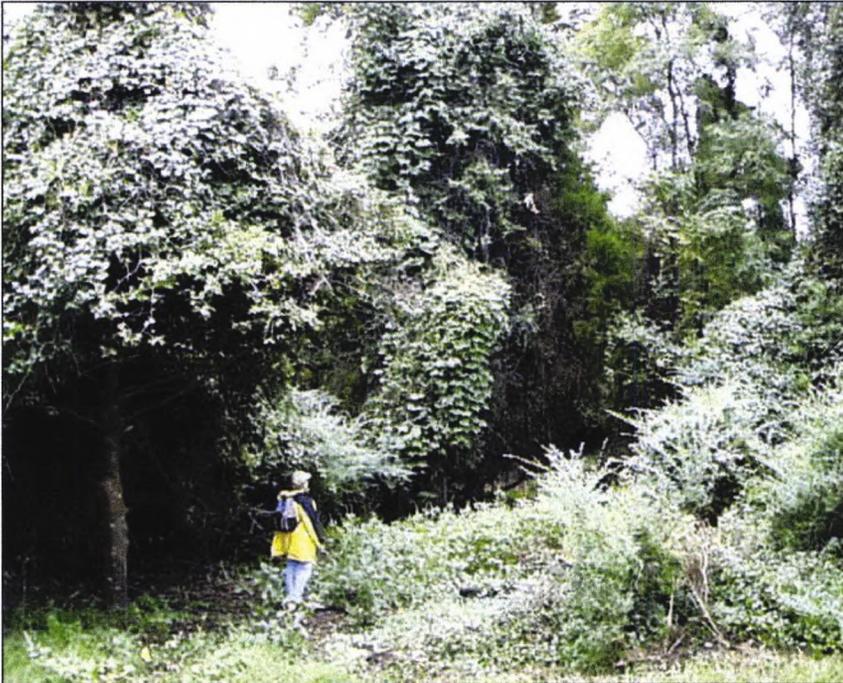
There is a large mass of vegetation located west of the lawn and north of the historic road trace. Analyzing the historic aerials and by studying the type of plants located in this area, these plants were most likely planted for the purpose of providing a border between the two houses located here in the 1930s. (Figure 7) Invasive vines like kudzu have seriously affected the plants in this area, but there are several mature specimens buried in the vines. They include holly and invasive privet shrubs and several mature cedar trees. Several small boxwoods and some privet hedges also indicate the edge of the historic road trace.

Figure 7: Former property border vegetation covered with invasive vines (COLO 2001).

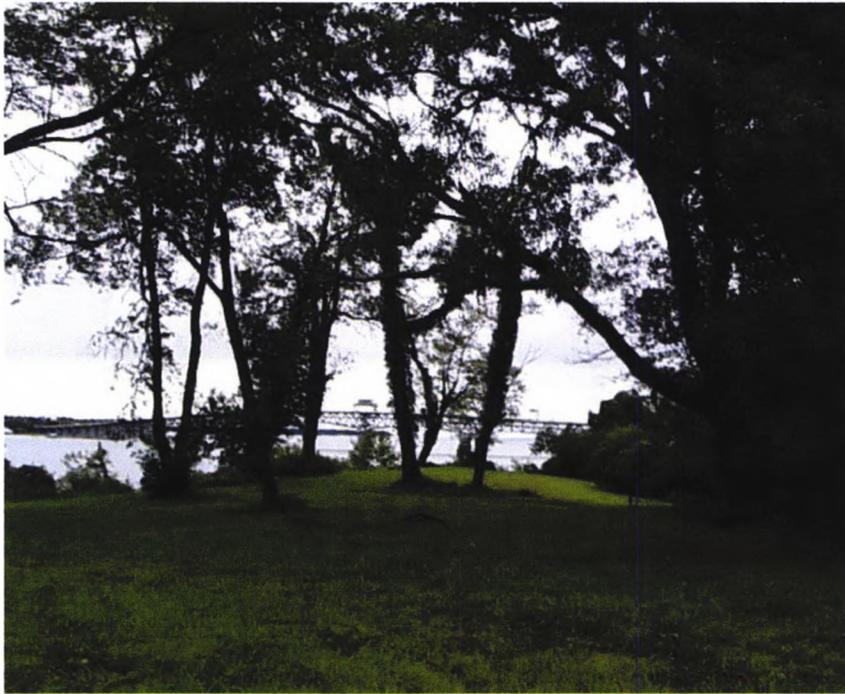
The northern ridge of the Ferris Property is an open grassy area with a grove of younger trees in the clearing. This is most likely the site of the Pitts house located on this property in the 1920s. There are some mature trees planted along the edge of the bluff and younger grove of trees on the ridge. (Figure 8) Care should be taken to retain as many of these trees as possible when laying out the river walk.

Figure 8: Grove of trees located on northern ridge (COLO 2001).

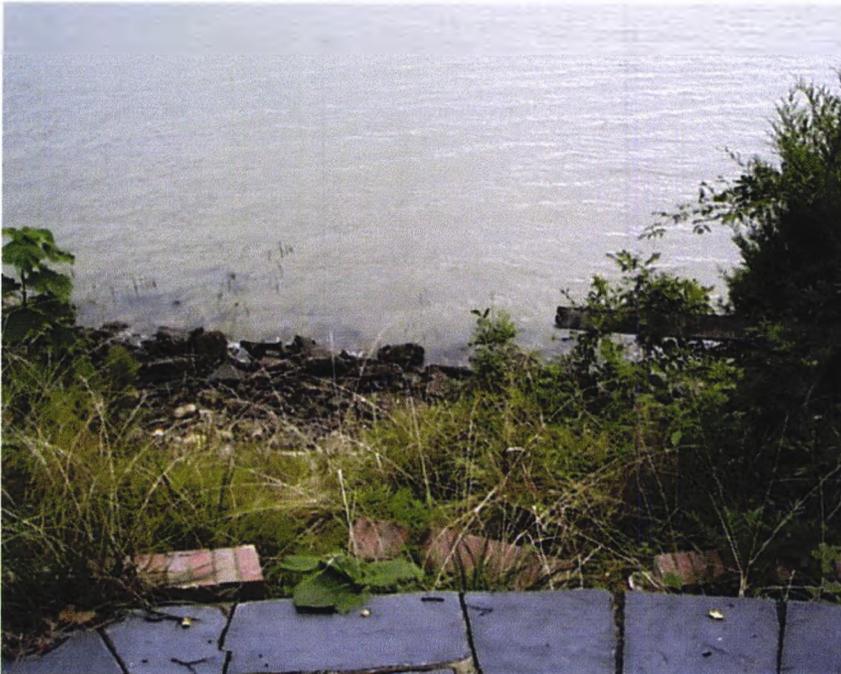
The Ferris Property is located on a bluff overlooking the York River. The bluff face to the river is very steep and has been cutback by severe erosion. Some riverbank stabilization methods have been attempted in the past, such as a seawall and concrete riprap, but the bank has eroded to the point that the slate and concrete patio located behind the Ferris House has begun to fail.

Figure 11: Bluff erosion causing the collapse of the slate terrace (COLO 2001).

As the bluff location and the topography of the site is the most historic feature of the Ferris House site, care should be taken in the river walk development to stabilize the bluff. However, the grading changes made to the site should be minimized to retain as much of the historic character of the bluff as possible.

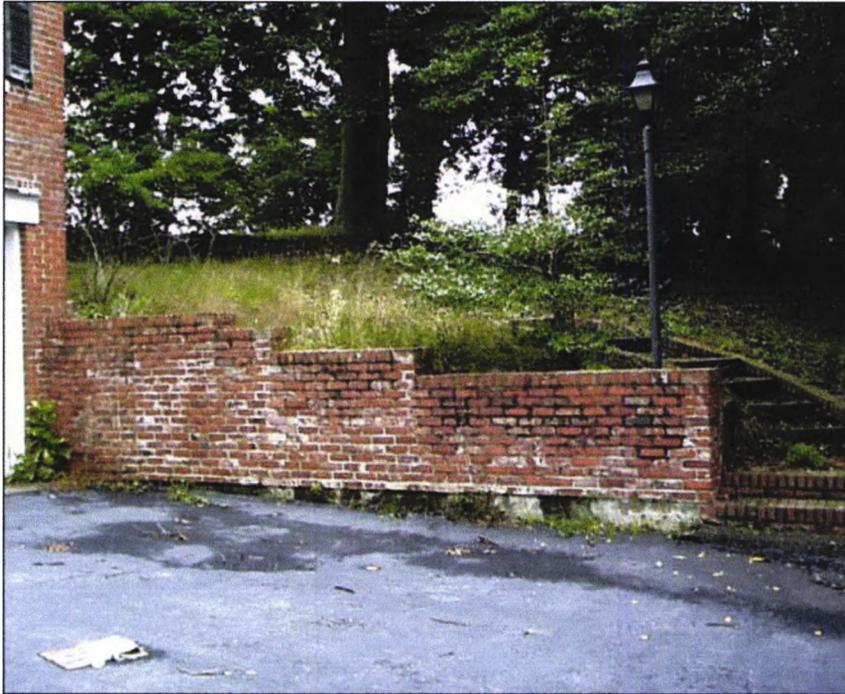
concrete wall. (Figure 12) The brick retaining walls on the southwest side of the house are mortared brick only.

Figure 12: Brick retaining wall at edge of driveway (COLO 2001).

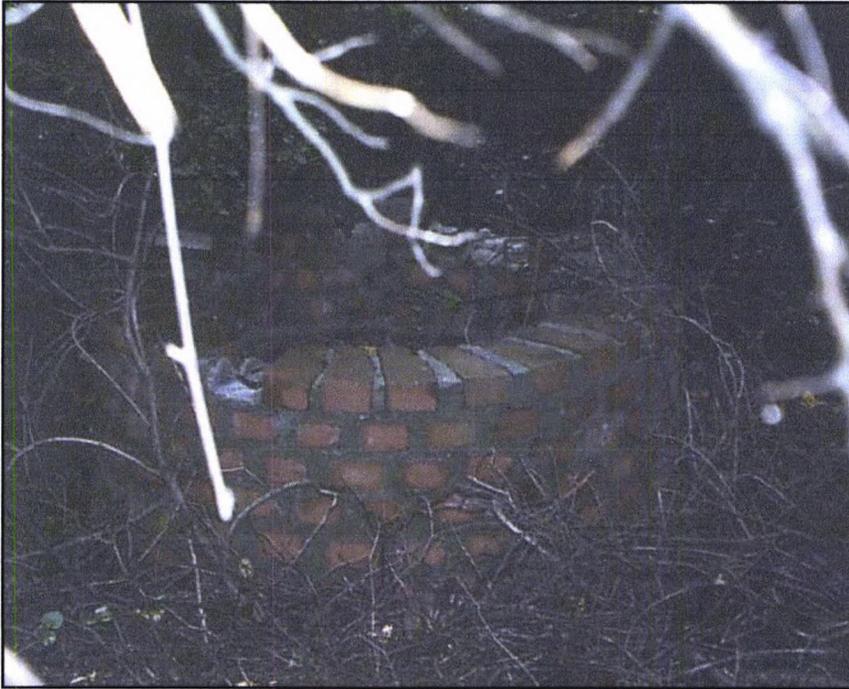
A brick-faced well is located in the woods north of the historic road trace. The well is approximately 2-3 feet tall and has an opening that measures approximately 4 feet in diameter. It is unknown if this well served any purpose other than decoration, but the style of the brick seems to match the brick style of the house. (Figure 15)

Figure 15: Brick well located north of the historic road trace (COLO 2001).
