HISTORIC STRUCTURES REPORT

HASTER ARMORER'S QUARTERS

BUILDING NO. 36

Harpers Ferry National Historical Park

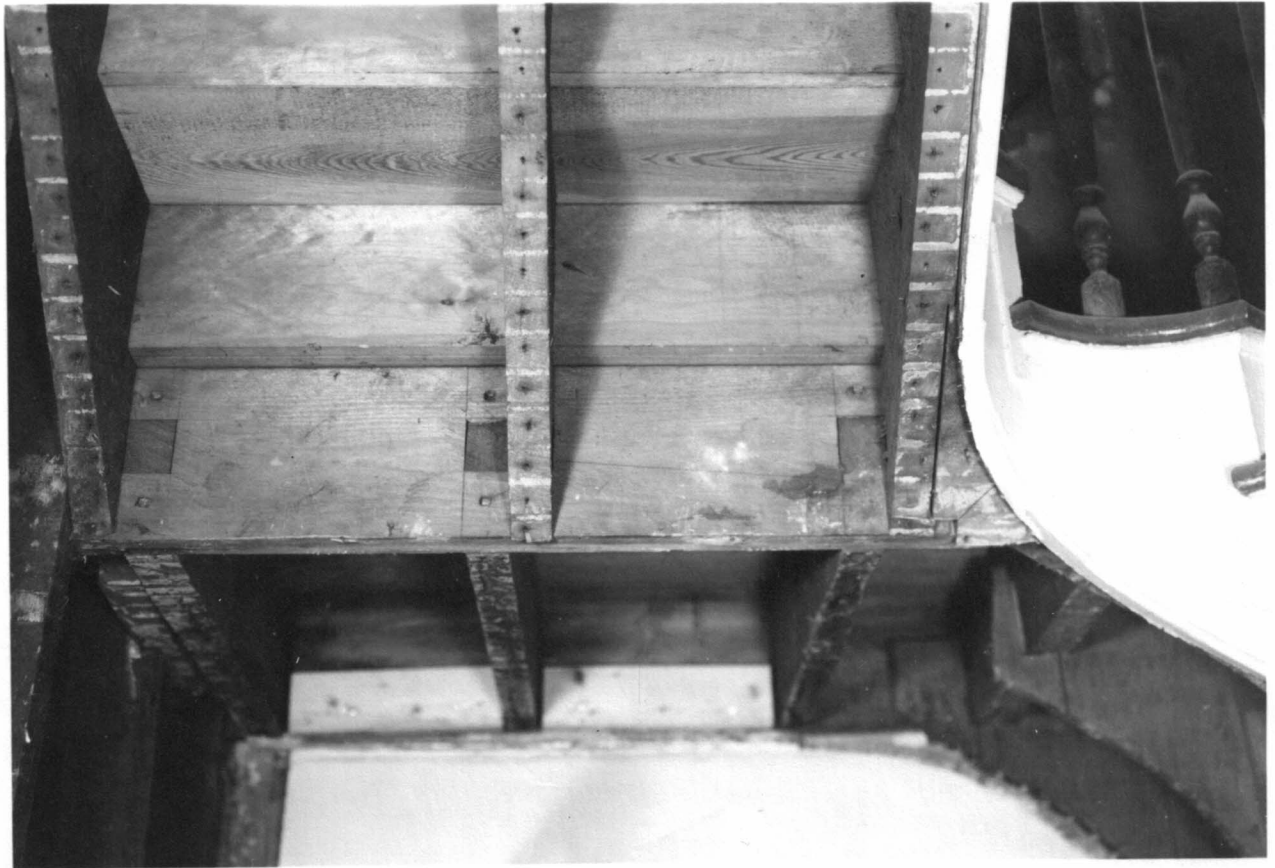
ILLUSTRATION NO. 1

STAIR LANDING FRAMING

Here the plaster has been removed from the soffit of the stair and the intermediate landing to the second floor. Most structural members in the building, such as the landing joists and stair carriages, were mortised and tenoned together. Lighter components were nailed where less stress was anticipated.

Where plaster surfaces were to be warped, scabs were cut to the desired profile as in the case shown here.

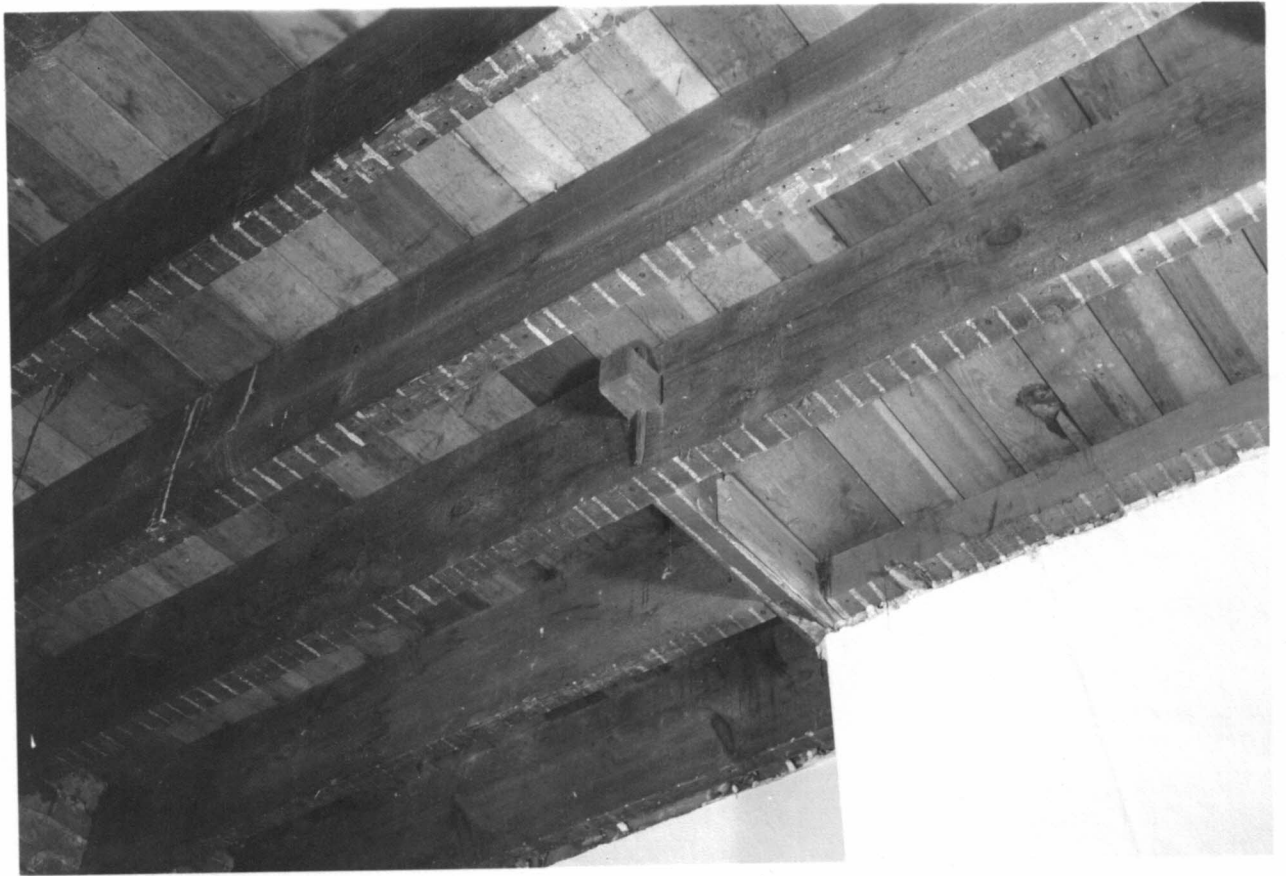
ILLUSTRATION NO. 2

FIREPLACE HEARTH FRAMING

From this angle, looking toward the underside of the second floor, can be seen the framing and boards supporting a second floor fireplace hearth. Here again a mortise and tenon was used with a wood pin through the tenon only and driven tight against the joist. This practice is better than that found in many of the other building in the Park where the pin is driven both through the joist mortise and the tenon. The latter method cuts down the capacity it would otherwise have.

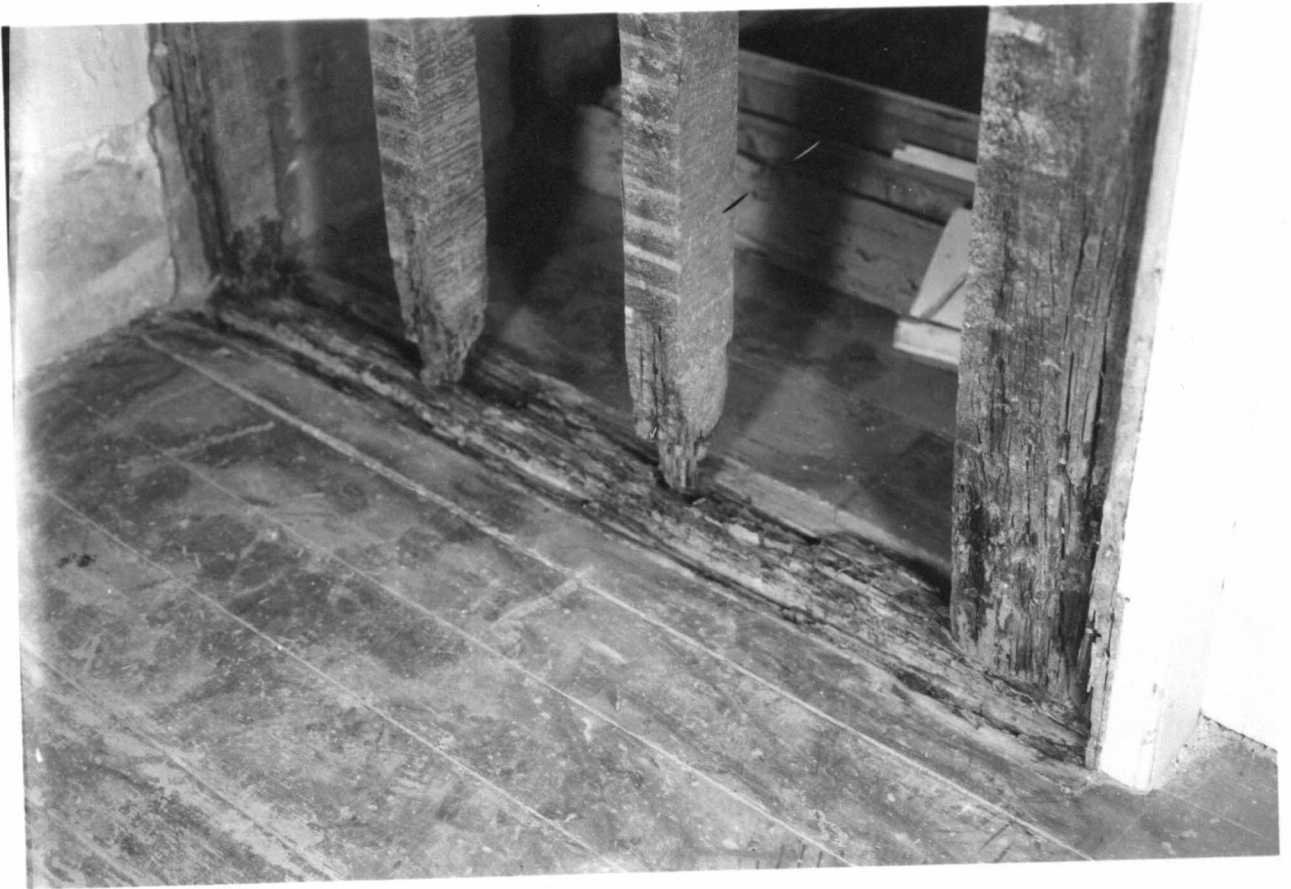
ILLUSTRATION NO. 4

FIRST FLOOR BEARING PARTITION STUDS

Shown in this photograph is damage resulting from floods. This partition separates Rooms # 4 and # 5. It is a bearing partition and supports the floor joists of the floor above. The lower ends of the studs were tenoned and fir into corresponding mortises in a continuous plate. The plate is nailed to the single thickness flooring of the first floor, and was used only under bearing partitions and not under dividing partitions. The upper ends of the studs were cut to form a half-lap at the bottom of the joist above and were nailed to the side of the joist.

Plaster droppings between studs absorbed and retained moisture from flood waters, causing the stud ends to rot. Sawn lath were used and nailed to the studs with cut nails.

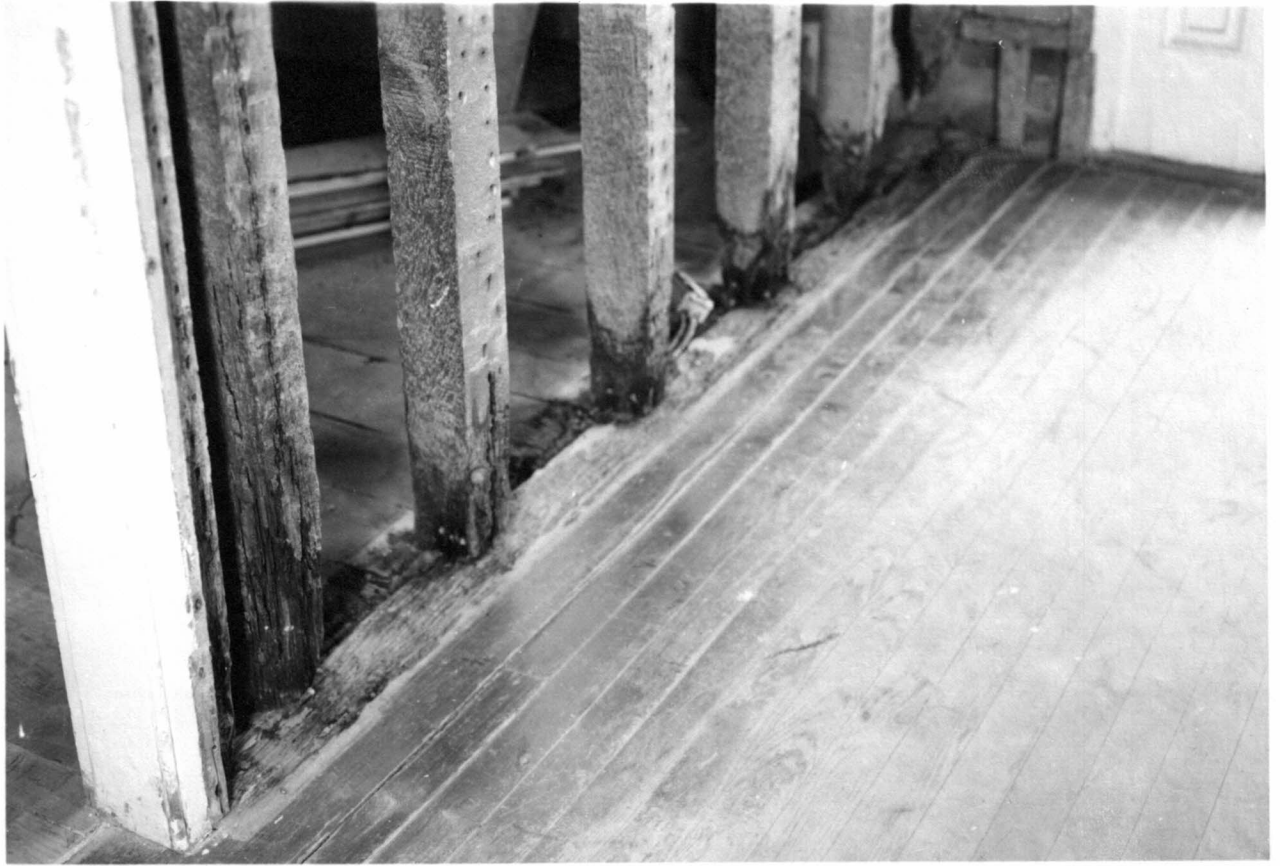
ILLUSTRATION NO. 5

FIRST FLOOR DIVIDING PARTITION STUDS

In the case of a non-bearing partition the bottom ends of the studs rest directly on the single thickness flooring of the first floor. This partition separates the central hallway from Room # 6. A beam runs under the flooring directly under the partition line. The upper ends of the studs are half-lapped on to the second floor joists. A corner of the main entrance door can be seen and the flooring inside the door has been renewed with modern flooring. The trim portion of the window and door casings have been removed.

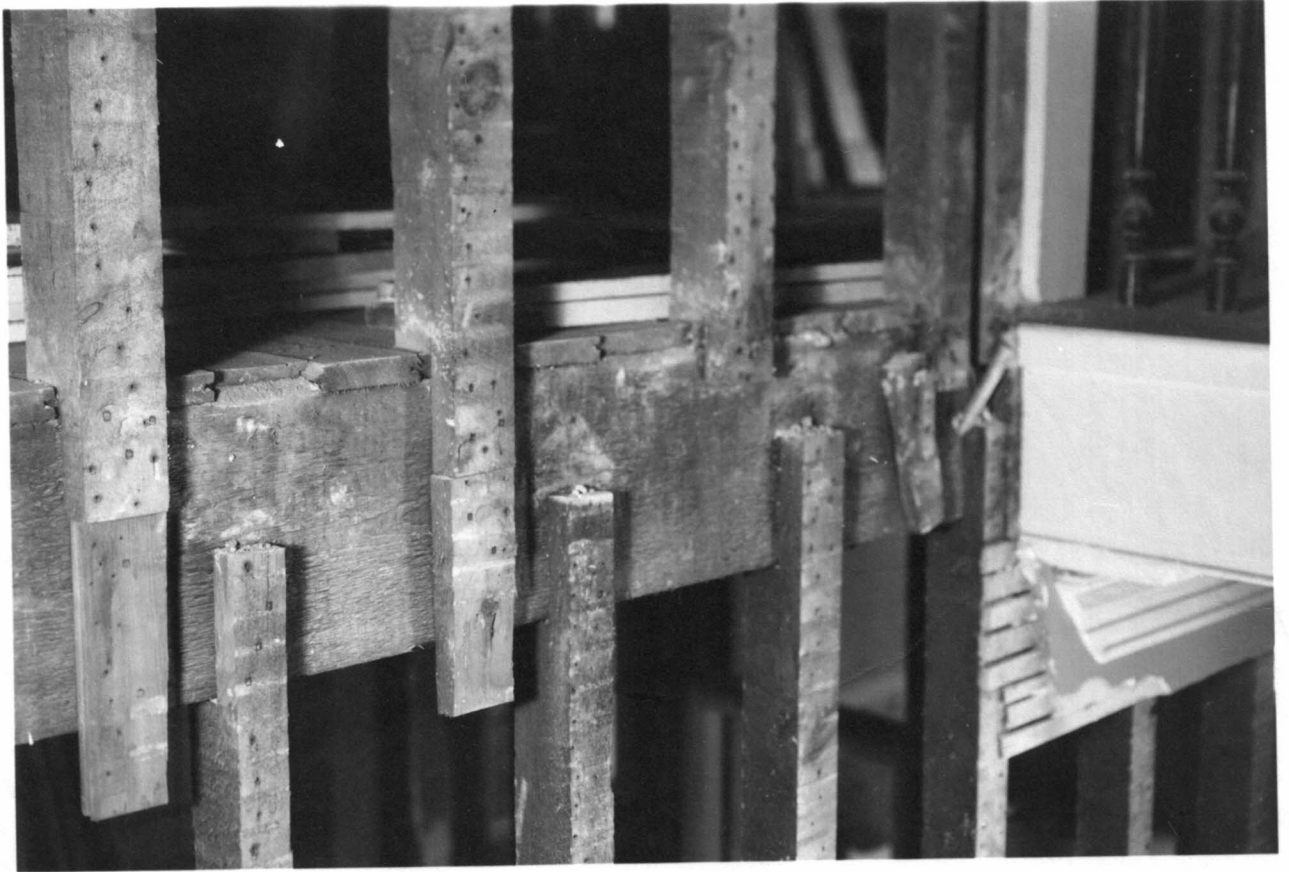
ILLUSTRATION NO. 6

SIDEWALL STUDS OF MAIN STAIRWELL

The first and second floor studs overlap the second floor joists at the stairwell employing dutchmen to give continuity to the plaster wall surface.

A portion of the plaster cornice of the first floor main hall can be seen terminating below the skirt of the stairwell.

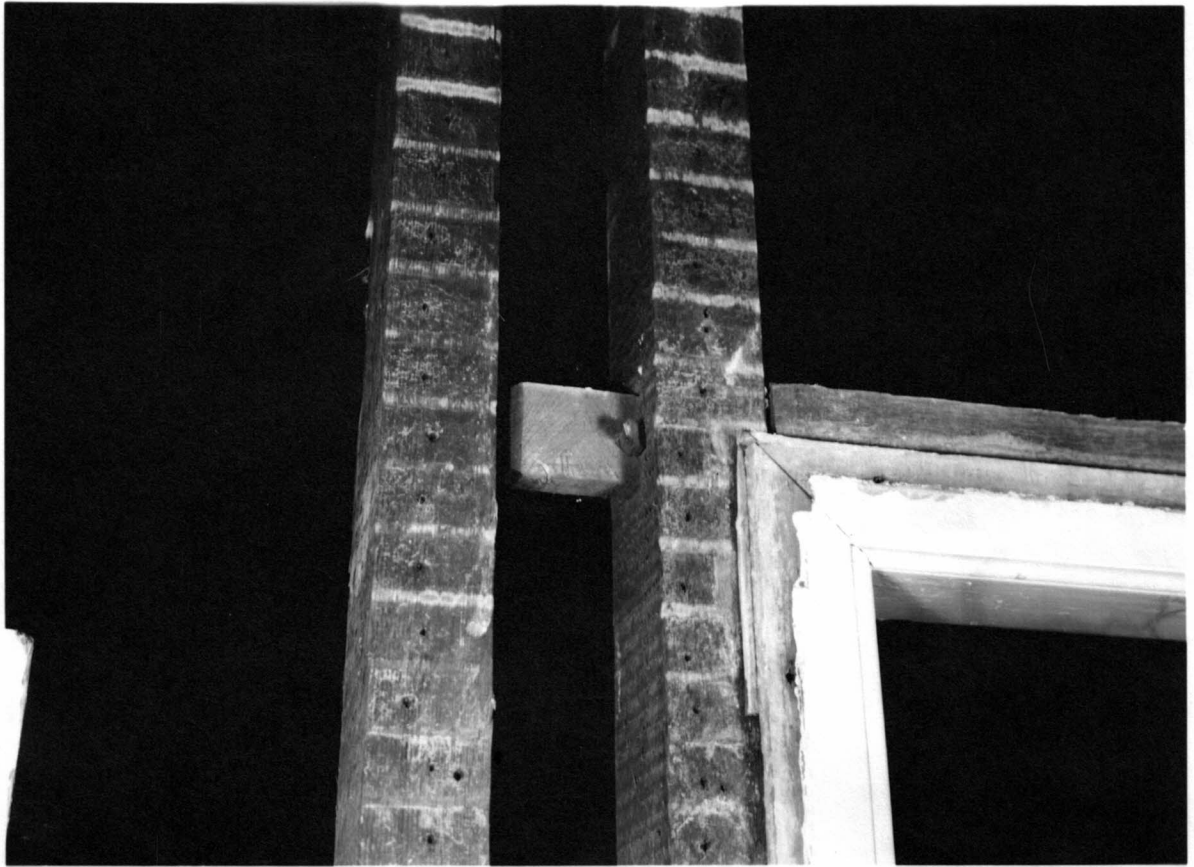
ILLUSTRATION NO. 7

INTERIOR DOOR FRAMING DETAIL

The rough framing of a typical interior door opening is shown here where it can be seen that the lintel was fastened by a mortise and tenon joint to the studs and further secured with a wood pin. The pin was driven through the tenon only and hard against the side of the stud to lock it in place. Using a drifted hole, this method made it possible to make the connection very tight.

The cover trim board of the casing has been removed leaving only the jamb lining. The plasterer depended on these boards for his ground.

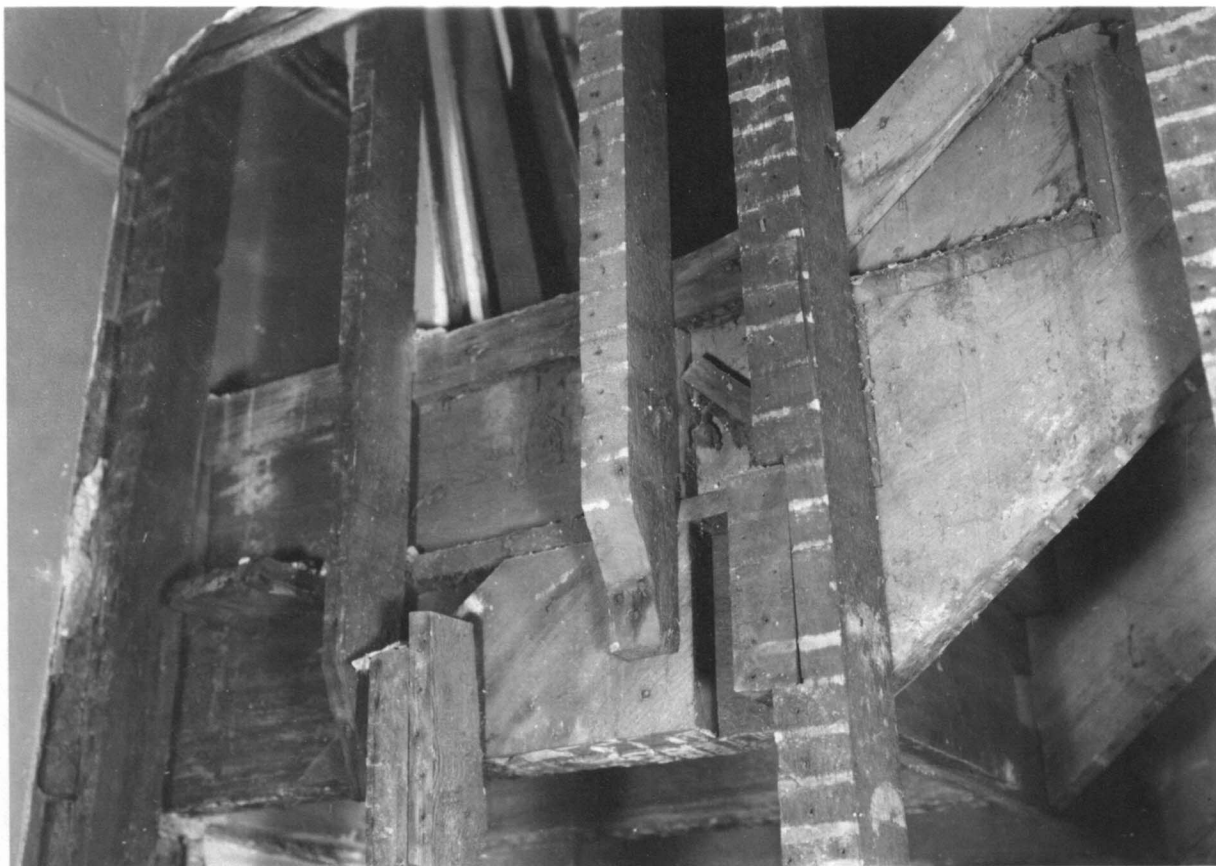
ILLUSTRATION NO. 8

DETAIL OF STAIR CARRIAGE

The treads and risers appear here in end view showing how they fit together. The plaster ground of the rake shows just above the nosings serving also as a nailing strip for the stringer trim. The stud next to the wall is considerably rotted out as several similarly placed studs are at other locations. They apparently gathered moisture from the masonry walls following floods.
