Technical Preservation Services National Center for Cultural Resources

I I SInterpretingNUMBER 16The Secretary of the Interior's Standards for Rehabilitation

Subject: New Infill for Historic Loading Door Openings

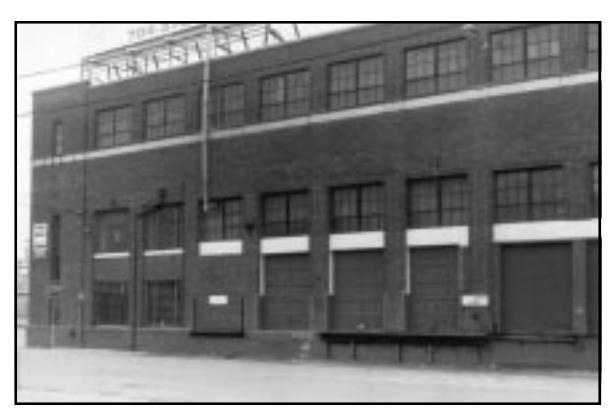
Cargo bay doors are incorporated within the fenestration rhythm. Some of the existing openings have been enlarged and later metal roll-up doors installed.

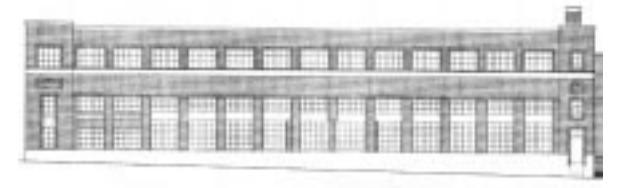
With the proposed glazing system all evidence of the former cargo bay doors is obscured. Modifications to the proposed design such as altering the light pattern to resemble the original door panels as well as adding some solid panels need to be made in order to bring the project into conformance with the Standards.

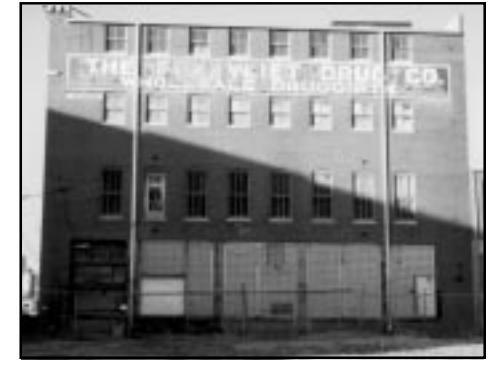
A series of cargo bay doors across the first floor is a prominent element of this facade.

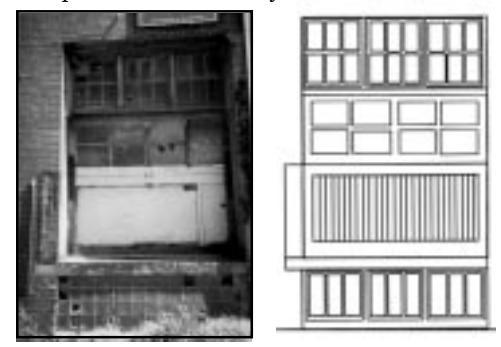
The image on the left shows the only remaining door. On the right, a drawing illustrates the design of the new infill. The visual character of the original doors is maintained by using the major elements of the original door and transom in the new design.

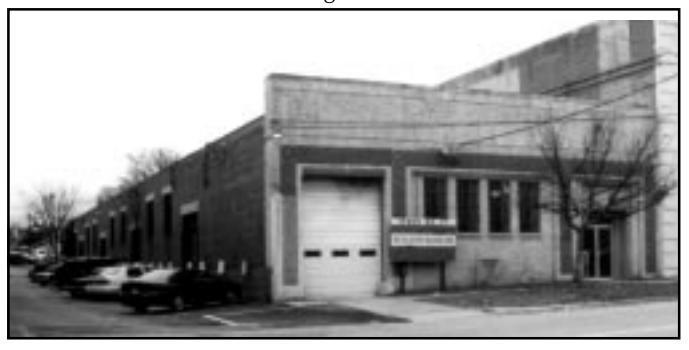
View of the building before rehabilitation.

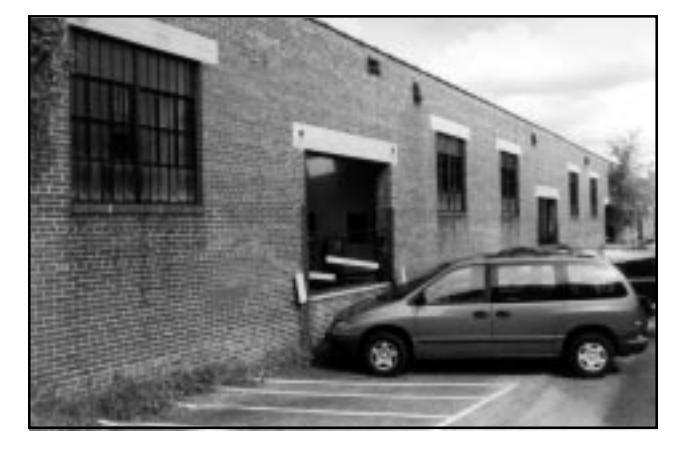
Loading door elevation after rehabilitation.

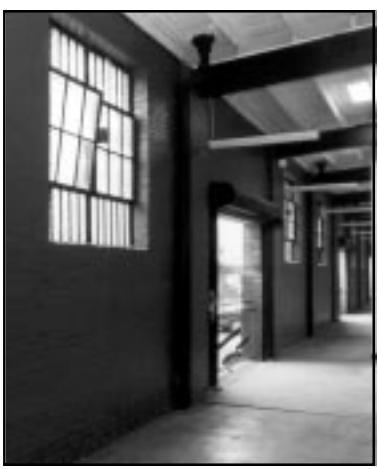
Interior view after rehabilitation. Existing roll-up doors were retained. Exposed roof structure and concrete floors are still visible.
