Subject: Adding Awnings to Historic Storefronts and Entrances

- Applicable Standards:**
2. Retention of Historic Character
 6. Repair/Replacement of Deteriorated or Missing Features Based on Evidence
 9. Compatible New Additions / Alterations
 10. Reversibility of New Additions/Alterations

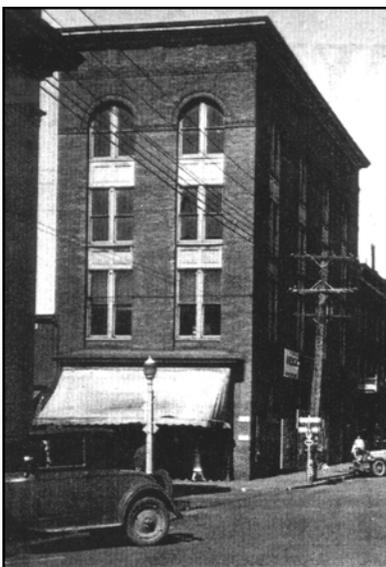
Historic photo showing retractable canvas awning.

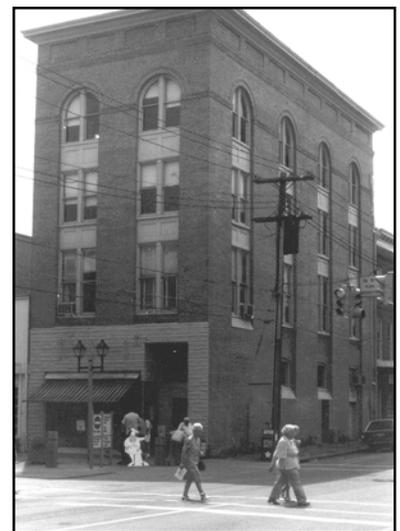
Application 1 (*Incompatible treatment later corrected to meet the Standards*): This relatively modest, four-story commercial structure was built in the 1890s on a corner in a small-town business district. A decorative cornice, arched window openings and wood windows and spandrel panels on the upper stories survived to the period of rehabilitation, but the main entrance and display area had been replaced with a permastone storefront. Historic photographs indicated that the storefront was originally topped by a narrow projecting roof with a large shed-shaped canvas awning below.

Building with permastone storefront prior to rehabilitation.

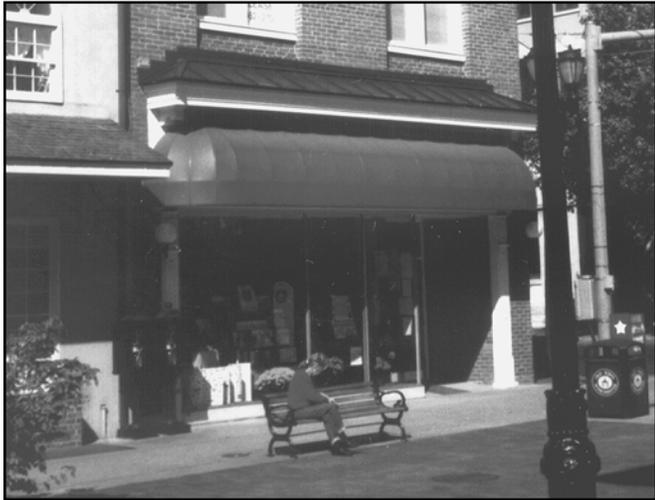
As part of the rehabilitation, a compatible storefront was installed consisting of a simple glass display window with a standing-seam metal shed roof above it. The replacement awning, however, was a contemporary "long dome" awning with a glossy vinyl covering.

Original "long-dome" treatment for replacement awning.

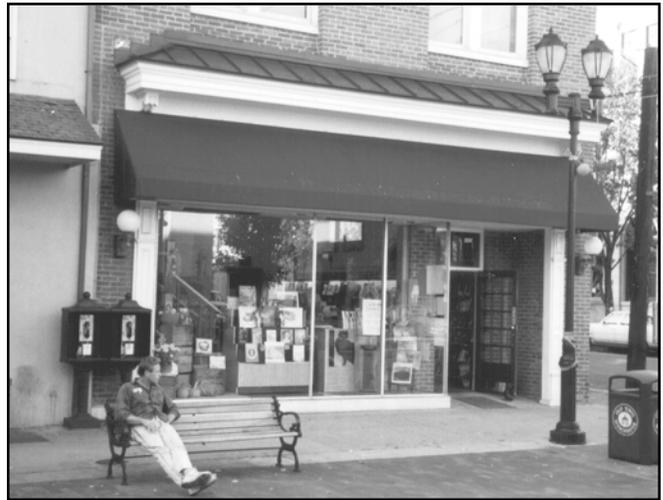
Revised solution matches historic awning shape and material.

To conform with the **Secretary of the Interior's Standards for Rehabilitation**, the inappropriate awning was replaced with a type that more accurately resembled the shape and material shown in the historic documentation and known to be common among turn-of-the-century storefronts. The replacement awning is a standard, shed shape that is sold by many companies as a stock product. Although a functioning, retractable awning would have been the most appropriate solution, the fixed, shed awning was an acceptable compromise.

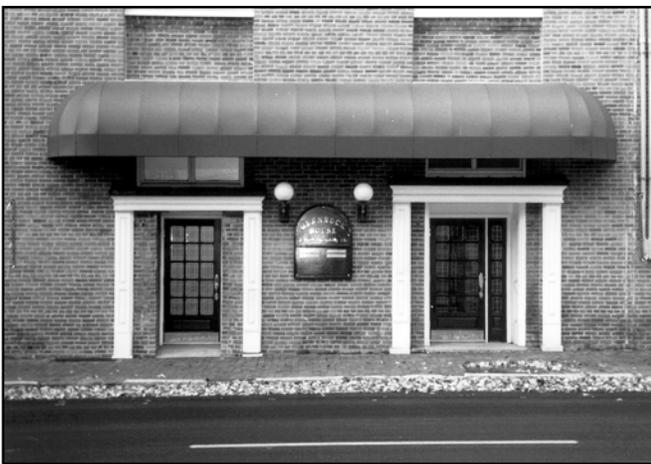
Application 2 (*Incompatible treatment corrected to meet the Standards*): The same rehabilitation project converted two doors on the side of the building to main entrances for upper floor tenant space. A long dome awning, like that used on the front of the building, was installed over the two doors and decorative wood surrounds were applied on the sides of both entrances. The awning was not a traditional style that would have been used historically, nor would a single awning have been placed over two separate entrances. The new surrounds were also not based upon historic documentation. These two treatments were incompatible with the historic character of the building. Together they gave this secondary facade a prominence it never had.

Side entrances with single continuous awning.

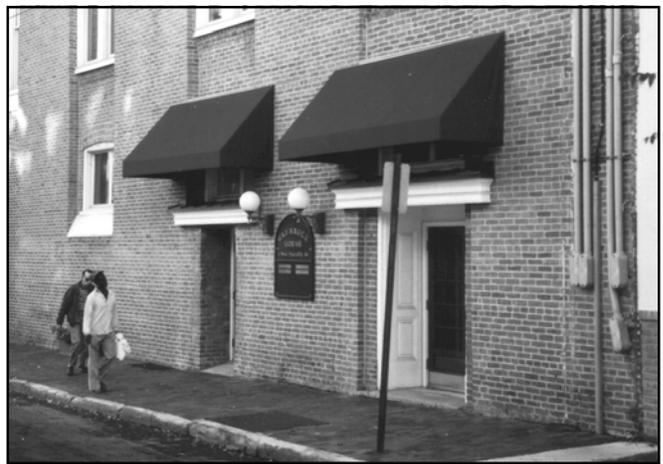
Revised treatment with a shed awning over each entrance.

In order to meet the **Secretary's Standards**, the surrounds were removed and the long dome awning was replaced by two individual awnings. The revised treatment was more in keeping with traditional awning arrangement, shape and material. This approach identified the entrances but did not group them into a single arrangement that was contrary to the building's historic design and appearance.
