Subject: Installing New Systems in Historic Buildings

January 2008, ITS Number 51

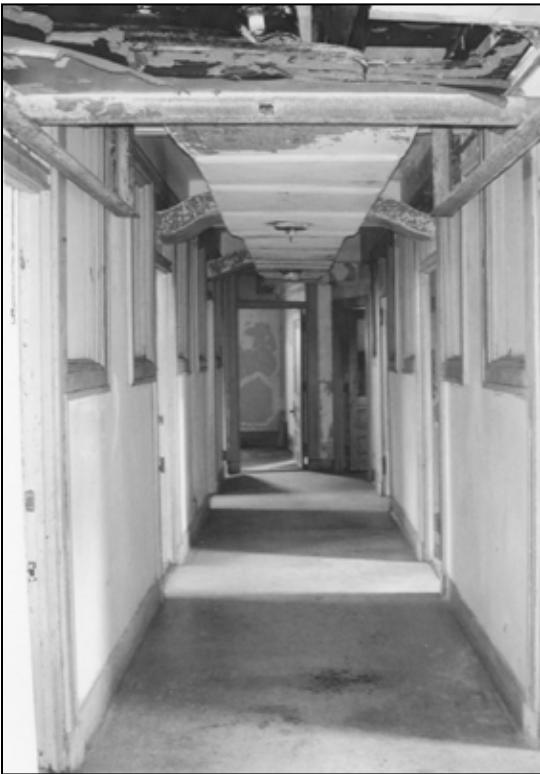
Above: The dropped ceiling has been partially removed, revealing the old ductwork running through the center of the hallway and branching into each office. The ceiling had been lowered from its historic height of 10 feet to just 7 feet.

A dropped ceiling can change the appearance of a historic space. It might obscure a decorative ceiling or cornice, change the proportions of a room, cover door transoms, and/or cut across windows. Such changes can alter a building's historic character and do not meet the Secretary of the Interior's Standards for Rehabilitation.

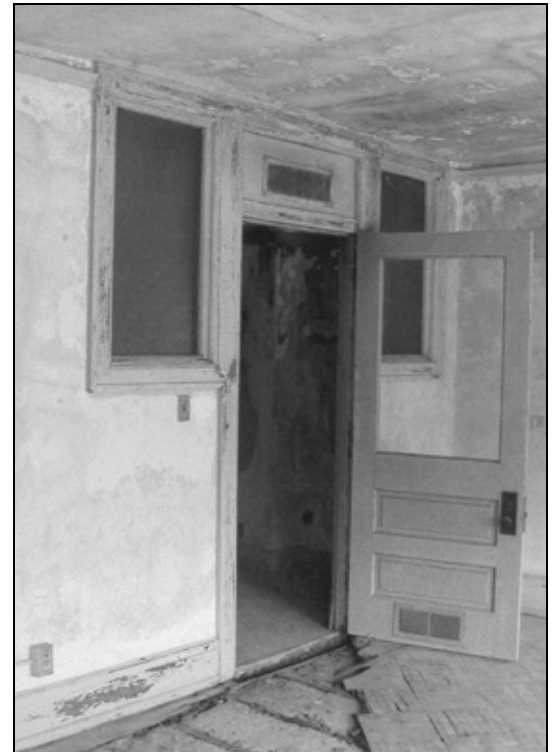
network of ceiling distribution ducts. As a cost-cutting measure, the main distribution ducts were run along the corridors, below the existing ceiling, and branched off into the individual offices. Rather than cutting through the walls to add the necessary room vents, the vents were installed through the transoms above the office doors. The very low suspended ceiling that was added to conceal the ductwork also obscured the transoms and cut across the windows in the corridors. This dropped ceiling dramatically and negatively impacted the historic appearance of the corridors.

Above: Prior to rehabilitation the offices had air supplied through vents installed in the original door transoms.

In the current rehabilitation, the design team took an alternative and very sensitive approach to provide climate control in the office spaces. The new HVAC ductwork was routed along the building's perimeter walls at floor level

and concealed in a new built-in feature that contained not only the air supply and return, but also included new electrical service and voice and data lines. The design for the new interior built-in feature drew on the appearance of the old window seat-styled radiator covers that were common in buildings of the era and even incorporated the original, historic baseboards in its design. This design provided for an unobtrusive and aesthetically pleasing appearance for the new built-in feature.
