FLORIDA STATE CAPITOL

Tech Notes

NUMBER 7

Window Awnings

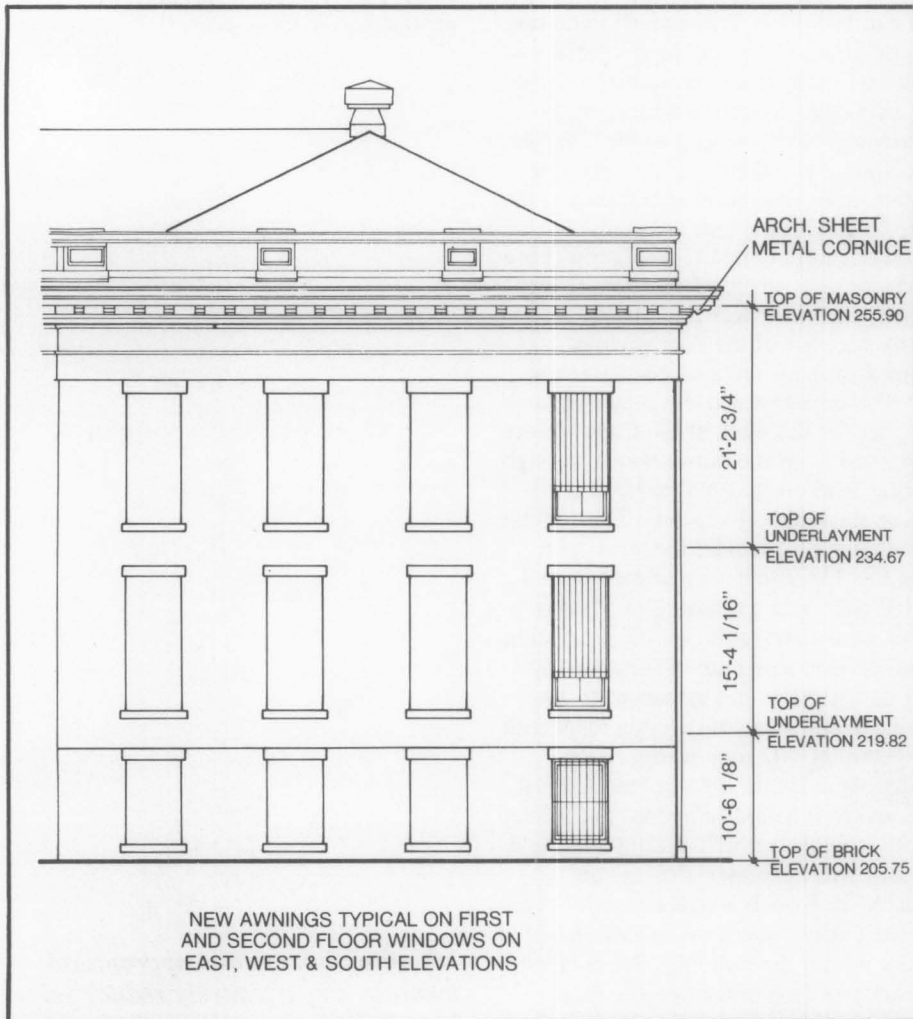
Figure 1. Large awnings were specified for all but the north elevation in order to reduce solar gain. Drawing: Courtesy, Shepard Associates, Architects and Planners, Inc.

Since the primary facades of the Capitol faced east and west, awnings were needed on the two main floors on all but the north side (see figure 1). Solar heat gain, which originally would have consumed 54% of the required cooling load, was now estimated to be 31.5% of the equipment load, and allowed a downsizing of the HVAC system by 25 tons. In typical first floor offices, the exposed glass surface would now only account for 46% of the required cooling load down from 72%. On the second floor, there was a similar change from 56% down to 30%.

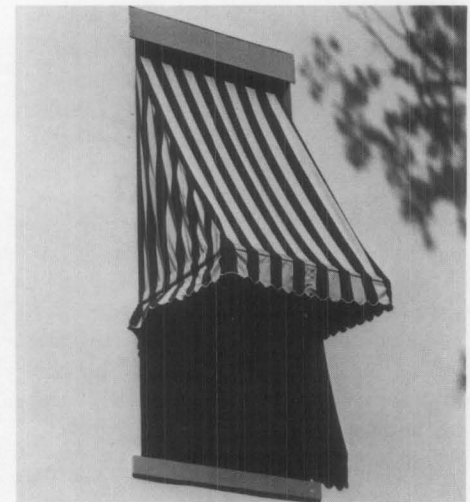
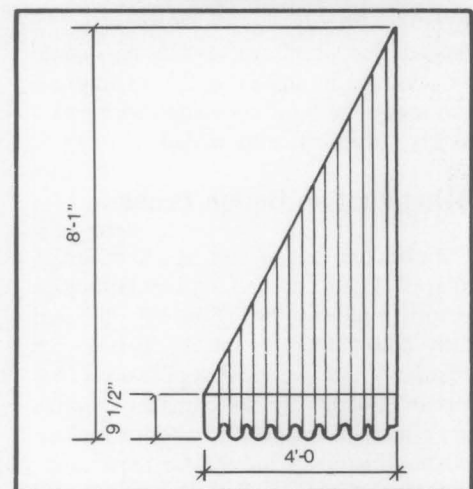
The awnings were fabricated to the architect's design of 4' wide by 4' deep with a height of 8'-1" and a 9 1/2" scalloped valance (see figure 2). The 100% acrylic fabric has vertical stripes four inches apart. Regrettably the production of the acrylic weave did not allow for pure color separation, and as a result the striping is in reality red and a very light pink; still the impression of red and white is maintained.

Figure 2. Early photographs were used in determining the appropriate design and size of the new awnings shown in the photograph. Drawing: Courtesy, Shepard Associates, Architects and Planners, Inc.; Photo: Courtesy, Florida Bureau of Historic Preservation.

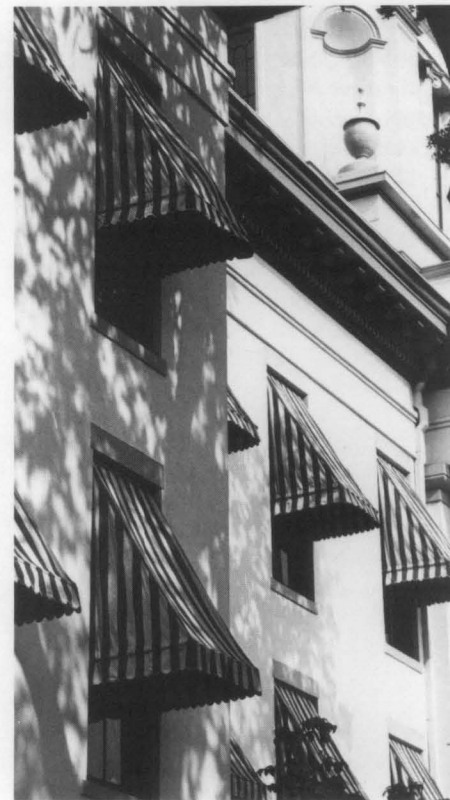
Figure 3. By reducing the glare and solar gain, the awnings have eliminated the need to purchase and maintain interior shades and draperies in various offices. Photo: Courtesy, Florida Bureau of Historic Preservation.

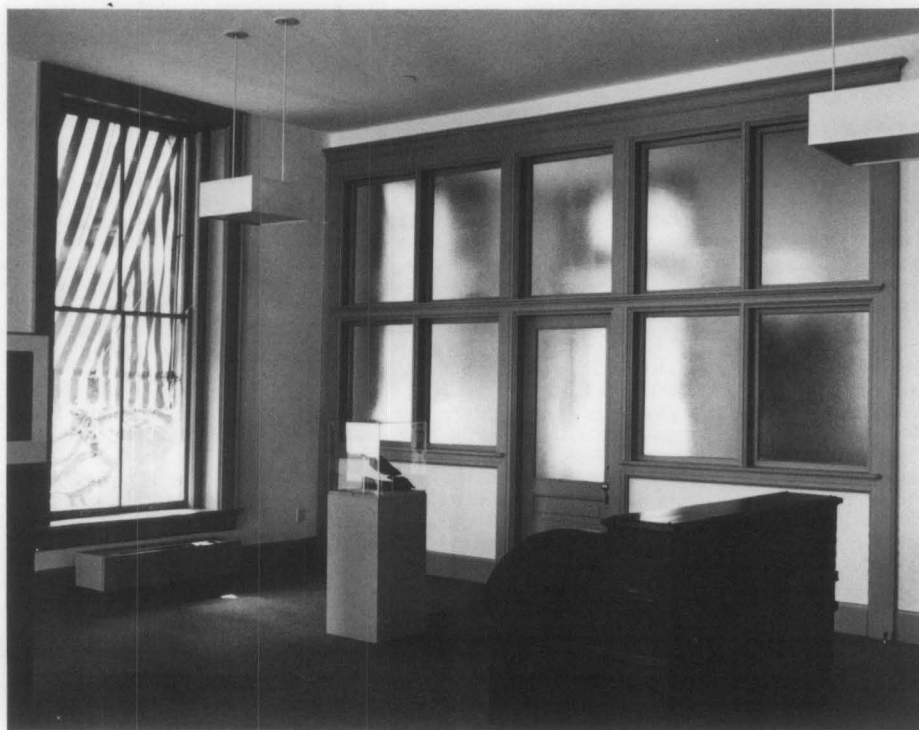
The decision to make the frames rigid to prevent retraction of the awnings on the Florida State Capitol did prove to be unwise, since seasonal high winds, exacerbated by large adjacent new construction, caused greater damage than had been anticipated. To correct this condition, the windows, which had been screwed shut and sealed, were easily reopened; the awnings were rigged so that they can be drawn back in high winds; and various sleeves and pins were removed from the frames, returning them to their original operable condition. Now whenever inclement weather is anticipated or more sunlight is required in certain rooms, maintenance personnel can

Figure 4. While the awnings were installed in order to save on energy costs, the restoration of this highly decorative and colorful feature enhances the historic appearance of the building. Photo: Courtesy, Florida Bureau of Historic Preservation.

easily retract the awnings. The awnings now are performing admirably and this highly distinctive historic feature has generated considerable local interest (see figure 4).
