APPENDIX B
MORE HILL HISTORIC DISTRICT

Appendix B,
Historic District

STRUCTURE NAME Warehouse, More Hill STRUCTURE NO. H-38.3

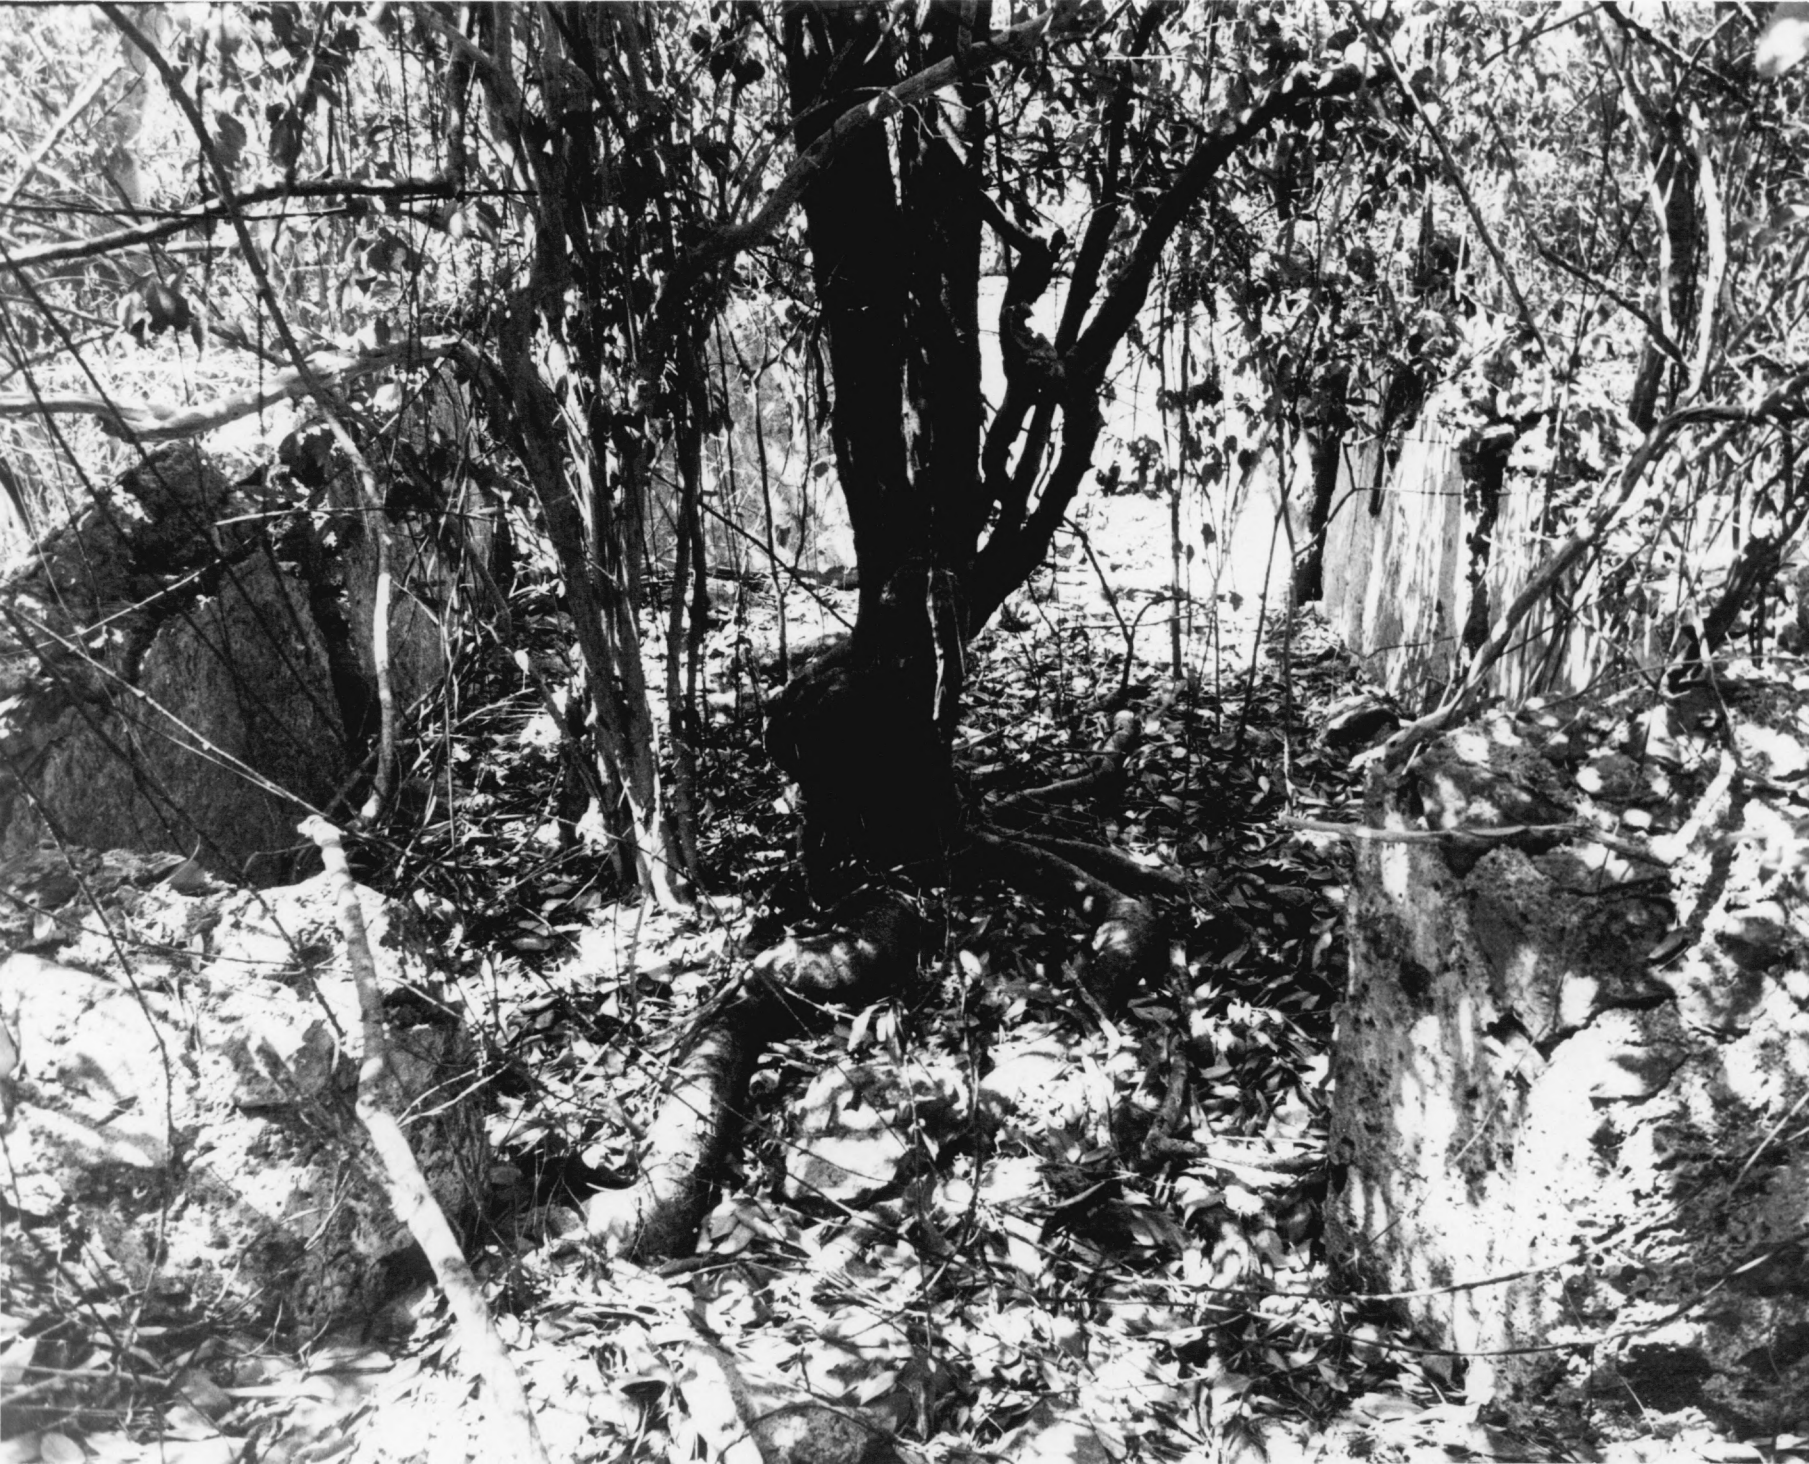
Servants Quarters

Interior of servants quarters H-38,2 viewed from
entrance (south) note impressions of posts in wall.

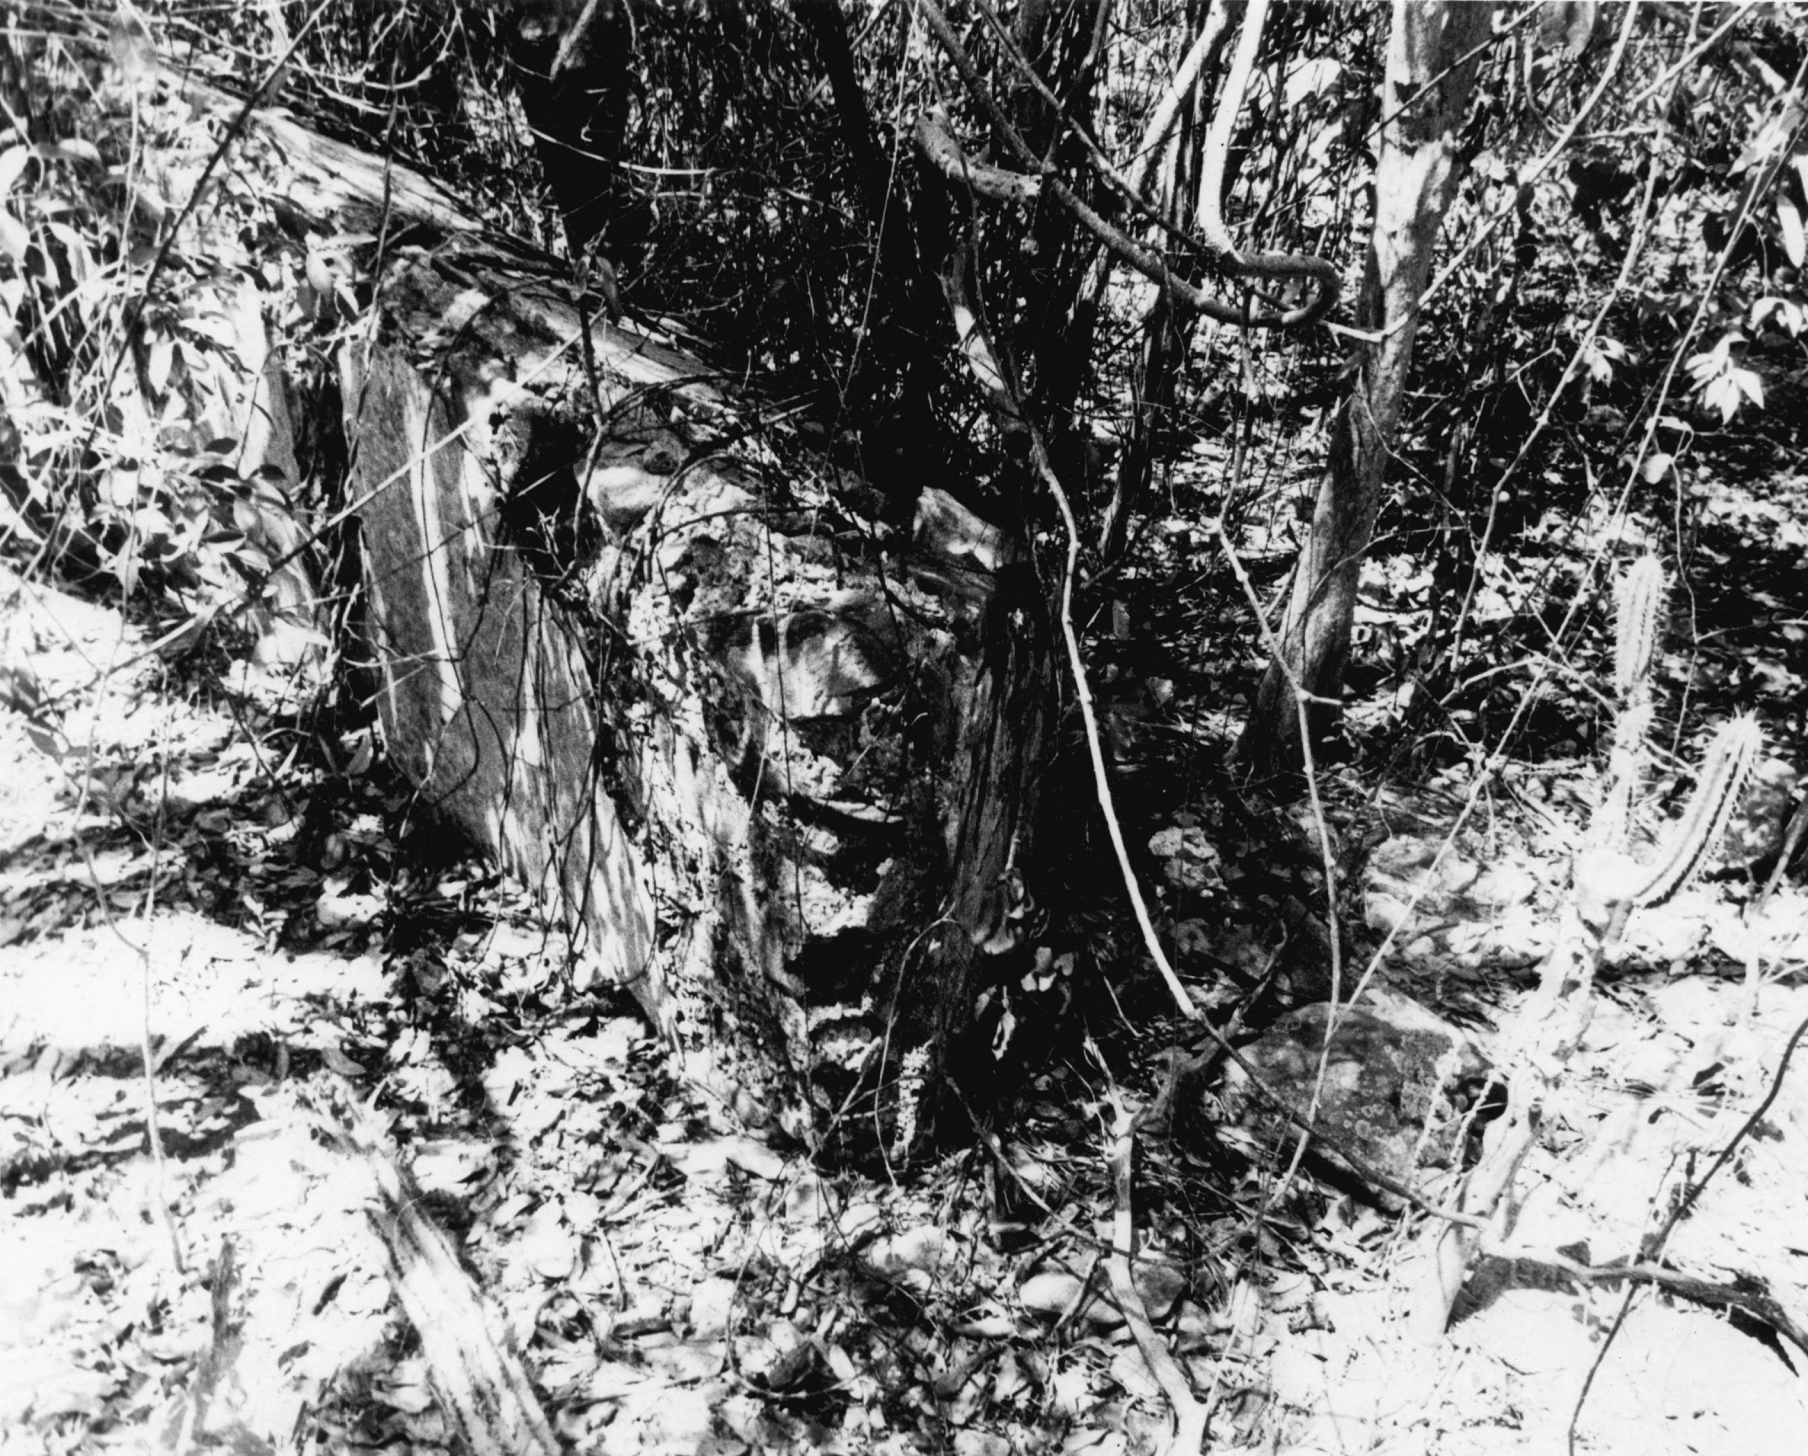
Warehouse

Physical Description: The lower rubble masonry walls of a rectangular building 24'x48' is located on slightly lower ground 75' southeast of the residence. The building is oriented due north and south and has 4 doorways 2 in each of the long sides placed approximately 4' from the corners. The walls stand from 2 to 4' out of surrounding grade and like the other 2 buildings of the site supported wood walls on posts set in the lower masonry walls. Fragments of a red clay tile indicate that the floor of the building was paved. Approximately 80% of the masonry walls remain standing.

Northwest entrance to warehouse H-38,3 viewed from
the north.
