ARCHEOLOGICAL EXCAVATIONS  
AT THE MANITOU FISH CAMP,  
APOSTLE ISLANDS NATIONAL LAKESHORE, 1983

by  
Jeffrey J. Richner

Midwest Archeological Center  
Technical Report No. 4

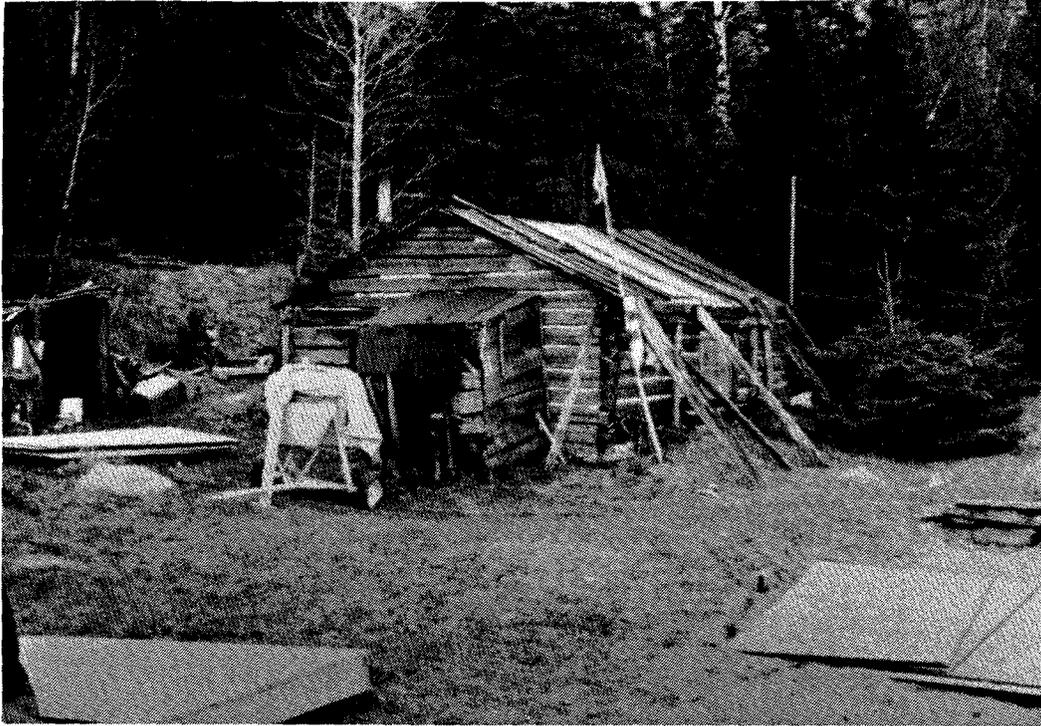
Figure 3. Historic Structure 1.

The construction and occupational history of the camp began in the 1890s when four Swedish loggers constructed a 14-x-18-foot cedar log cabin (Structure 1). The cabin is typical of traditional northern European log construction and contains hewn cedar log walls joined at the corners with full dovetail notches which provided closely fit logs and a stable exterior for the structure. At least three types of chinking were used on the structure, with moss being the earliest chinking material. Lime and sand mortar, and finally, concrete, were subsequently used to seal the small spaces between the logs. Window and door openings were cut out of the walls and framed

with wood. The tarpaper covered roof consists of boards nailed to a ridge pole and purlins. Door latches, hinges, and handles are a combination of hand-carved wood, hand-forged iron, and leather. Prior to National Park Service restoration efforts the cabin remained intact, but wooden elements had deteriorated extensively (Figure 3). In addition, the structure had settled appreciably. This settling process was coupled with extensive deterioration of the lowest course of logs.

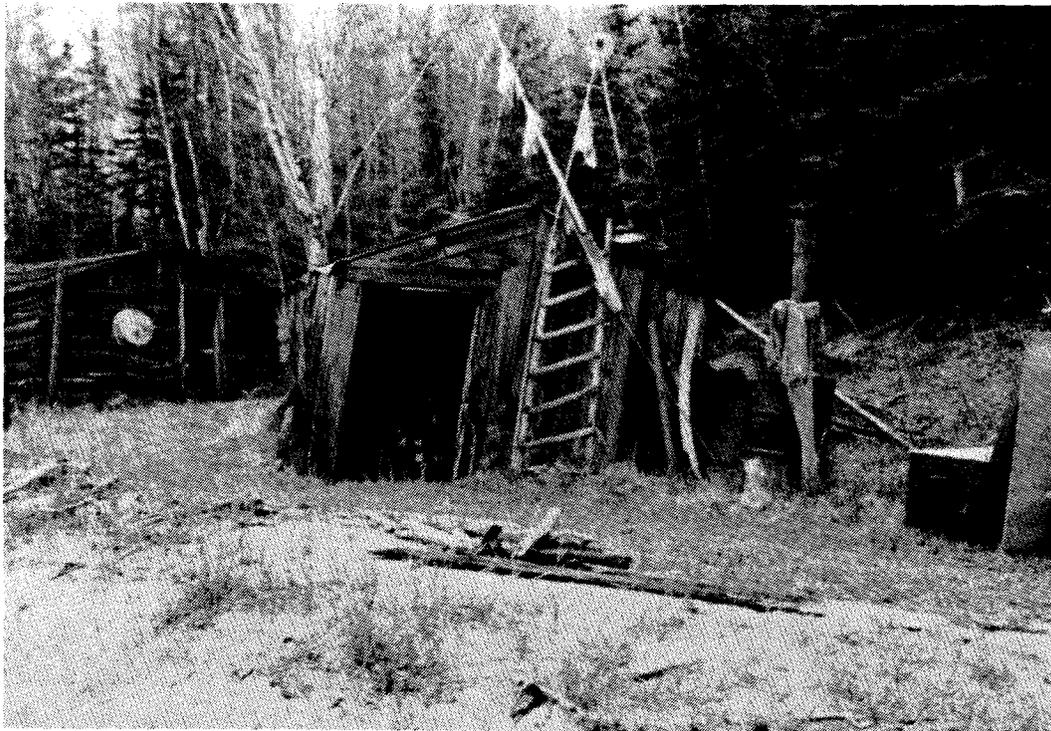
Figure 4. Historic Structure 2.

Structure 2, a twine shed, was built in the early 1900s by John Hanson, a Swedish logger who remained on Manitou Island to fish after the initial logging efforts were completed (Figure 4). The structure is of simple frame construction with wide vertical plank siding. The structure is 17 x 11 feet in extent and apparently served numerous functions including a stable for Hanson's horse and storage space for nets and fishing equipment. Prior to National Park Service restoration, the structure had suffered deterioration of wooden elements at ground contact, and considerable settling was also apparent.

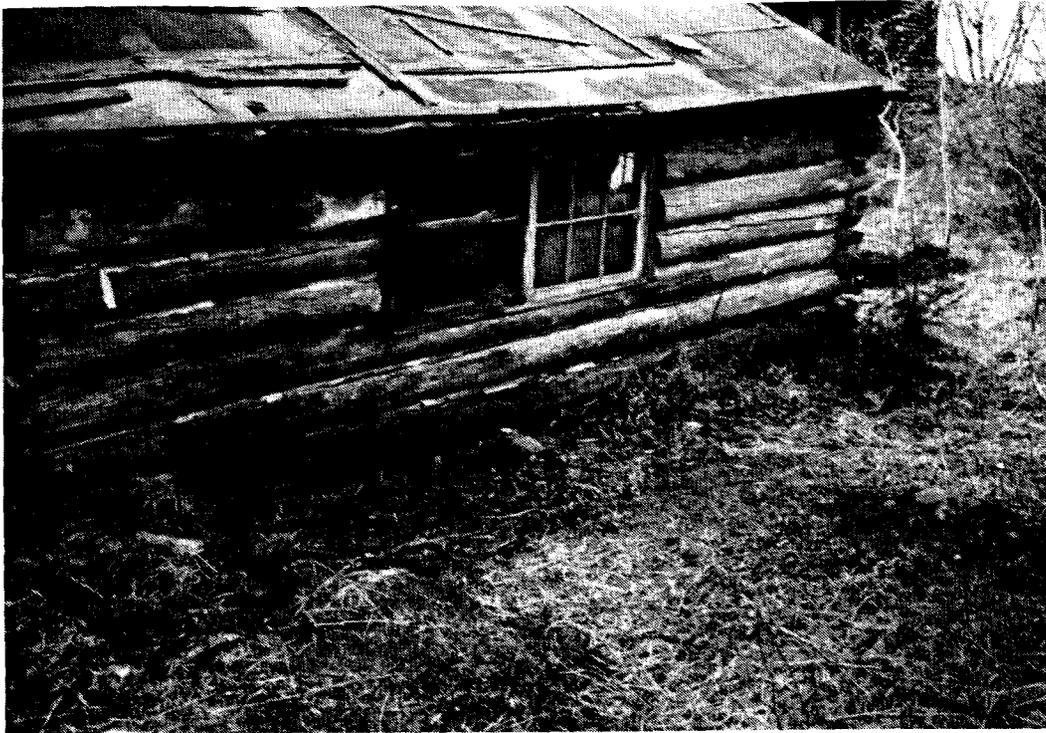
Figure 5. Historic Structure 3.

Structure 3, a bunkhouse, was built in the early 1930s by Theodore Olson, one of two brothers who utilized the Manitou Fish Camp continuously since the 1930s. This 14-x-18-foot, one room, single gable, log building was initially constructed on Ironwood Island, but was dismantled and reassembled at the Manitou Fish Camp. The balsam fir logs were left in-the-round and simple saddle notches were used at the corners. By 1983 the cabin was seriously deteriorated, with the fir logs extensively rotted (Figure 5).

This log structure, formerly used as a bunkhouse, was in a seriously deteriorated condition when the Midwest Archeological Center team worked at the site in May, 1983. The balsam fir logs were extensively rotted, and it appeared that the structure had settled extensively. Since it was evident that extensive replacement of fabric and major restoration would be required at Structure 3, the field crew attempted to excavate a large portion of the perimeter of the building. This goal was accomplished with considerable difficulty due to high water levels encountered around the building. The water problem was most acute along the north and west walls. Standing water was present over some of the area, including the interior of the building immediately under the floor boards. During and immediately after archeological fieldwork, the drainage problems noted at Structures 2 and 3 were thoroughly discussed with APIS staff, and plans were developed to mitigate the

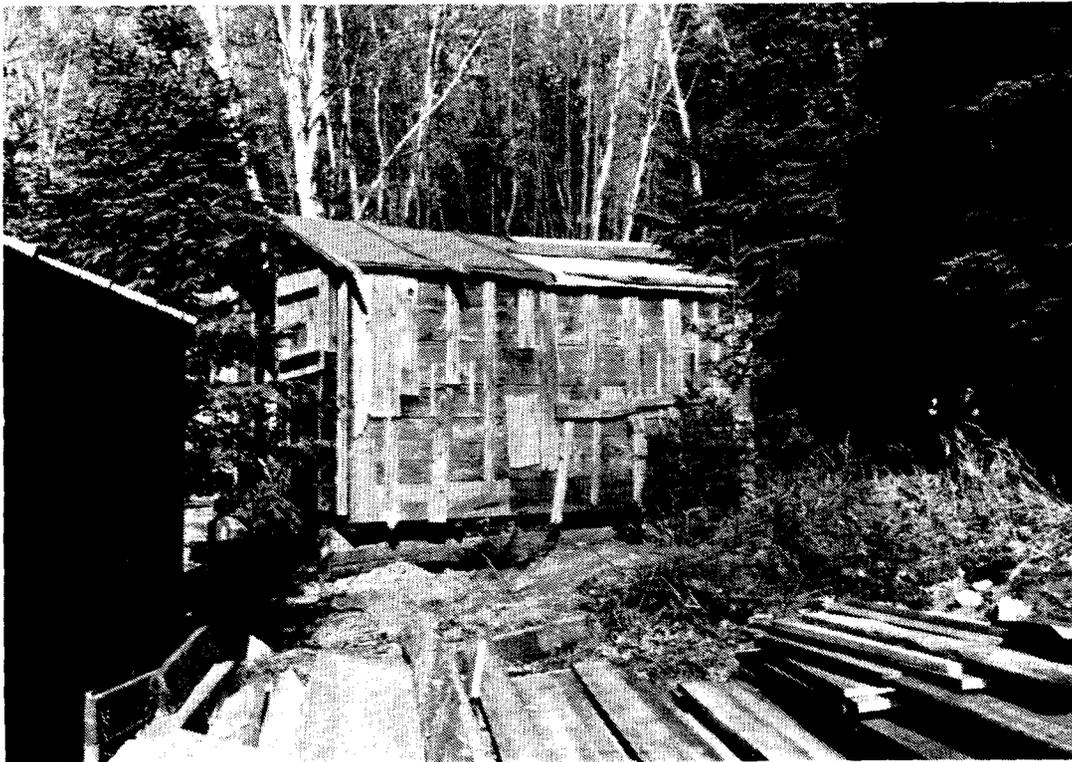
Figure 6. Historic Structure 4.

Structure 4 is a second twine shed, built in the mid 1930s by Theodore Olson. This 9.5-x-12.5-foot frame building is faced with wide horizontal plank siding (Figure 6). The structure was used for hanging nets and for storage of a wide variety of fishing equipment. Since the structure is in a well-drained setting and is raised from the ground surface by large log footings, deterioration of the wooden fabric has been minimal.

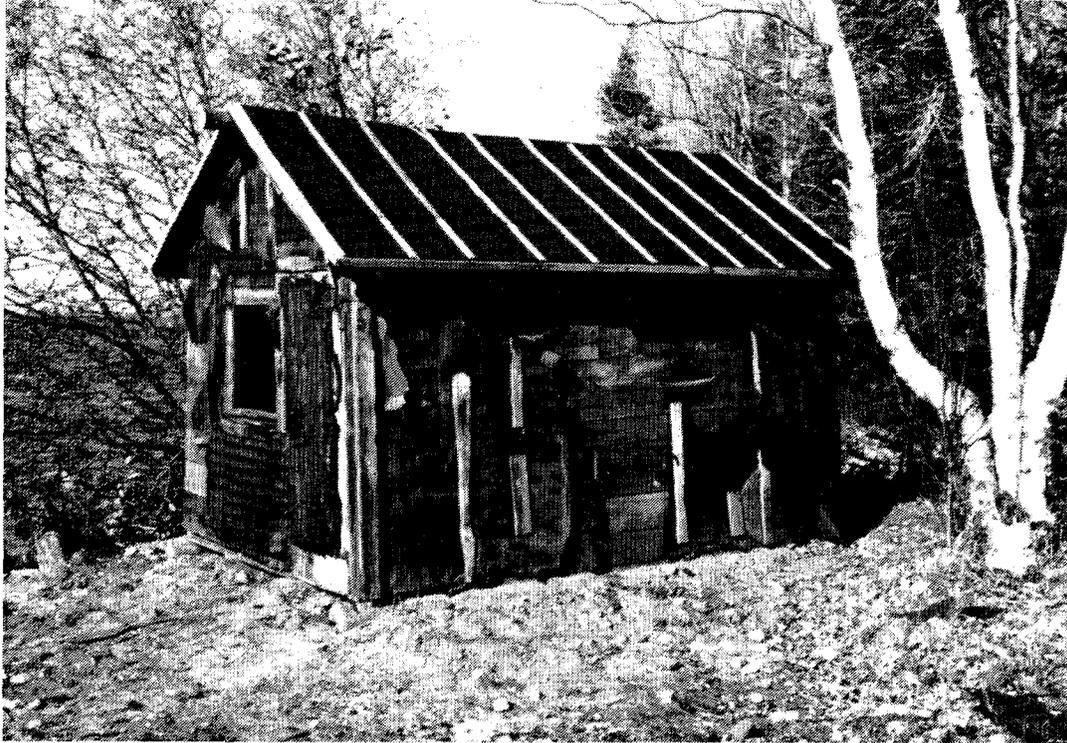
Figure 7. Historic Structure 5.

Structure 5 is a small cabin built by Frank Childs in the late 1920s or early 1930s (Figure 7). The one-room frame structure was moved several feet from its original location by ice action. Prior to National Park Service restoration efforts in 1983, this structure was in a serious state of disrepair.

This small structure was in jeopardy of destruction from the action of ice along the shoreline. APIS staff believed that the structure had been moved by the ice to the location it occupied in 1983. The southwestern corner of the building was wedged against a huge boulder at the edge of the beach (Figure 12). The structure had no foundation and rested on coarse beach sand. A surface examination of the area northeast of the building revealed two low linear mounds and a depression. It appeared very likely that the mounds were sand embankments which formerly served as a platform for the walls of the structure, or alternately, insulating embankments similar to those commonly found at logging camps (Richner 1986).

Excavation of one square meter in Units 27 and 28 revealed little about the structure, since nails were the most common artifact recovered, and other diagnostic materials were not discovered. The immediate area is strewn with boulders covered by coarse beach sand, making excavation difficult. Since the linear "mounds" and depression were the only available evidence for an original structural location, it was recommended that the structure be moved to that nearby location.

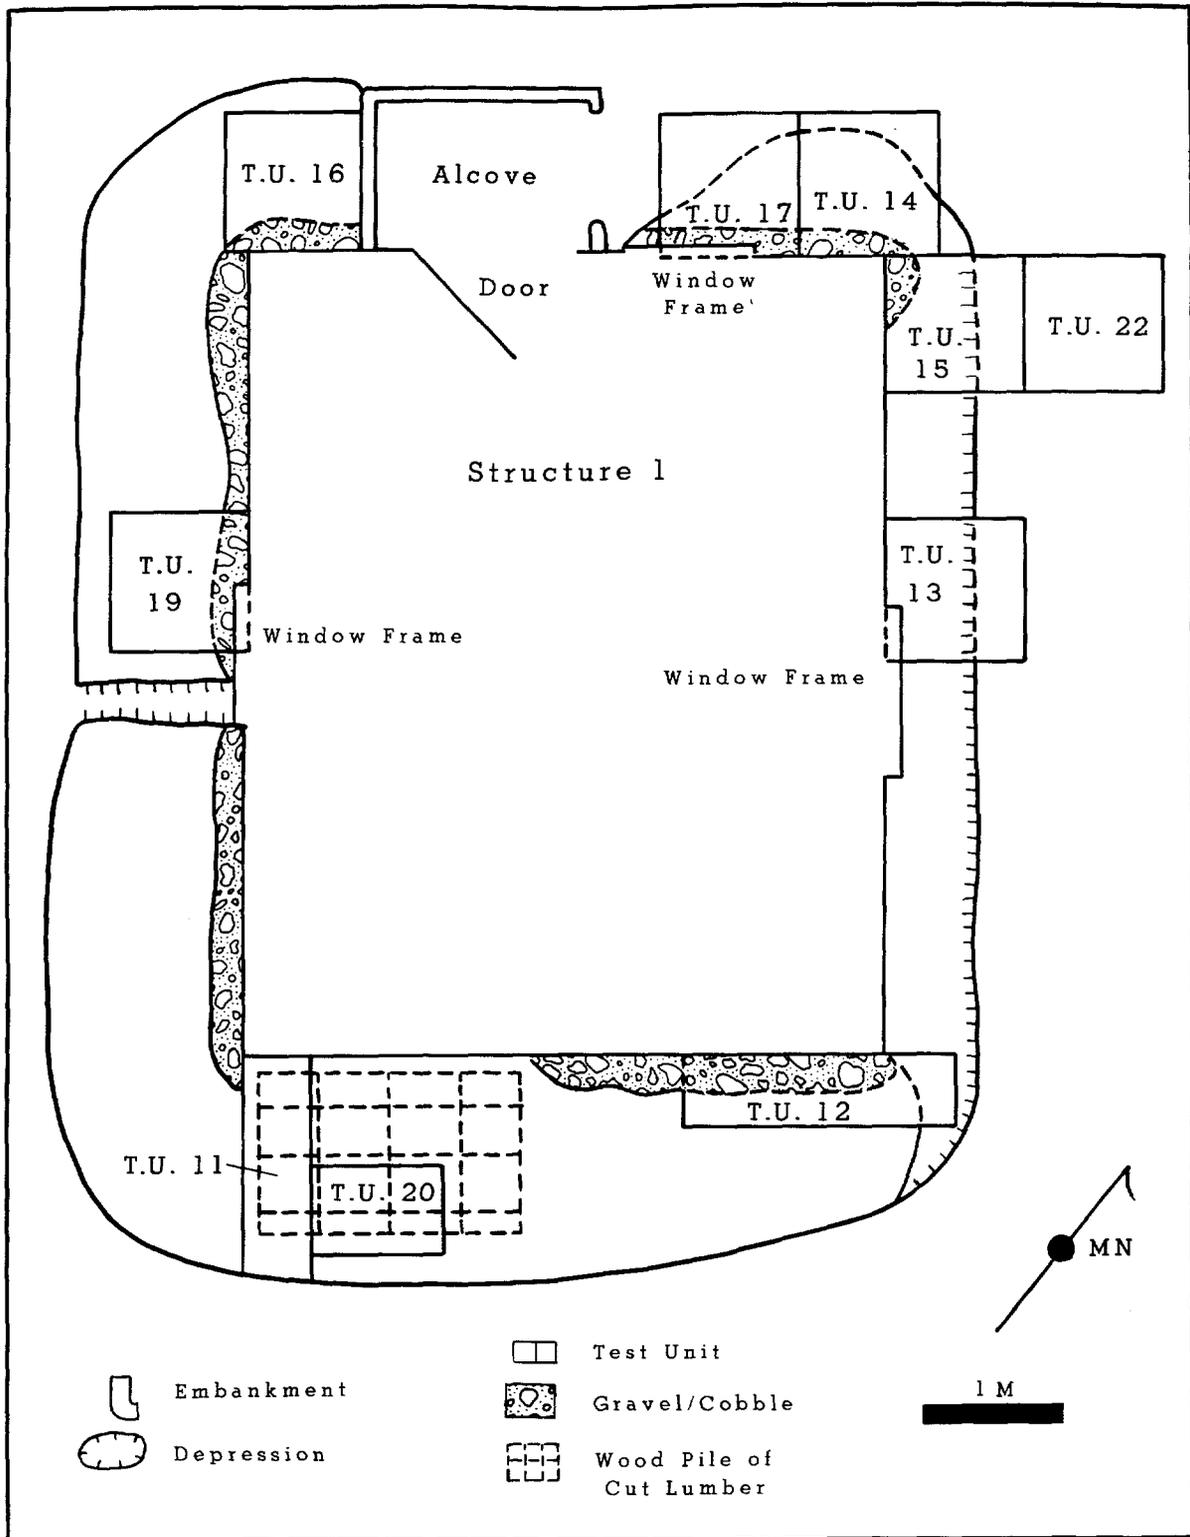
Figure 8. Excavation plan, Structure 1.

Ten excavation units covering about 10 sq m were excavated immediately adjacent to the walls of the cabin (Figure 8). Unit 19 along the west wall and Units 11, 12, and 20 on the south wall yielded few artifacts. However, these units exposed clear stratigraphic profiles which yielded useful information on the configuration of the earthen pad upon which the cabin was built. Unit 12 was excavated nearly 70 cm into the pad, and the profile revealed that extensive amounts of sand and rock fill from the nearby beach had been added to cover the boulder-strewn surface prior to construction of the cabin.

Units 11 and 12 were placed at the southeast and southwest corners of the cabin in order to examine possible foundation elements. No foundation was located. Instead, the cabin was found to have been built with the base course of logs lying within the sandy soil and rock of the prepared pad. The cabin had settled into this loose soil somewhat, but not to a great degree. Other than architectural elements (nails, mortar), few artifacts were found within these units. In Unit 11, the recovered materials include: three wood stove burners (one of which is fragmentary), nails, a red brick fragment, 3 bottle glass fragments, tarpaper fragments, and 11 pieces of mortar/chinking. Diversity was minimal in Unit 12, with a recent D cell battery, a small copper wire fragment, three nails, 10 pieces of tarpaper, and 12 fragments of mortar/chinking constituting all recovered materials. Samples of mortar found in the lower levels of these units showed clear impressions of wood, and are interpreted as chinking which has fallen from its original position between the cedar log walls of the cabin. This mortar is made from lime and coarse sand and is distinctly different from the concrete which was present as chinking in 1983. Samples of the mortar, which along with sphagnum moss appear to be from the early years of use of the structure, were provided to the restoration team so that the mix and color could be duplicated when the cabin was restored.

Unit 19 was excavated under a window mid-way along the northwest wall of the cabin (Figure 8). Smooth beach pebbles and cobbles were present on the ground surface touching the lower course of logs here and elsewhere around the cabin. These smooth rocks appear to have been used to partially protect (or mask) the rotting base course log and insulate the cabin. Artifact yield from Unit 19 was very limited. Mortar (20 fragments), three stoneware fragments, one fragment of recent plastic, two window glass sherds, and three fragments from a colorless glass oil lamp chimney are the only artifacts from Unit 19.

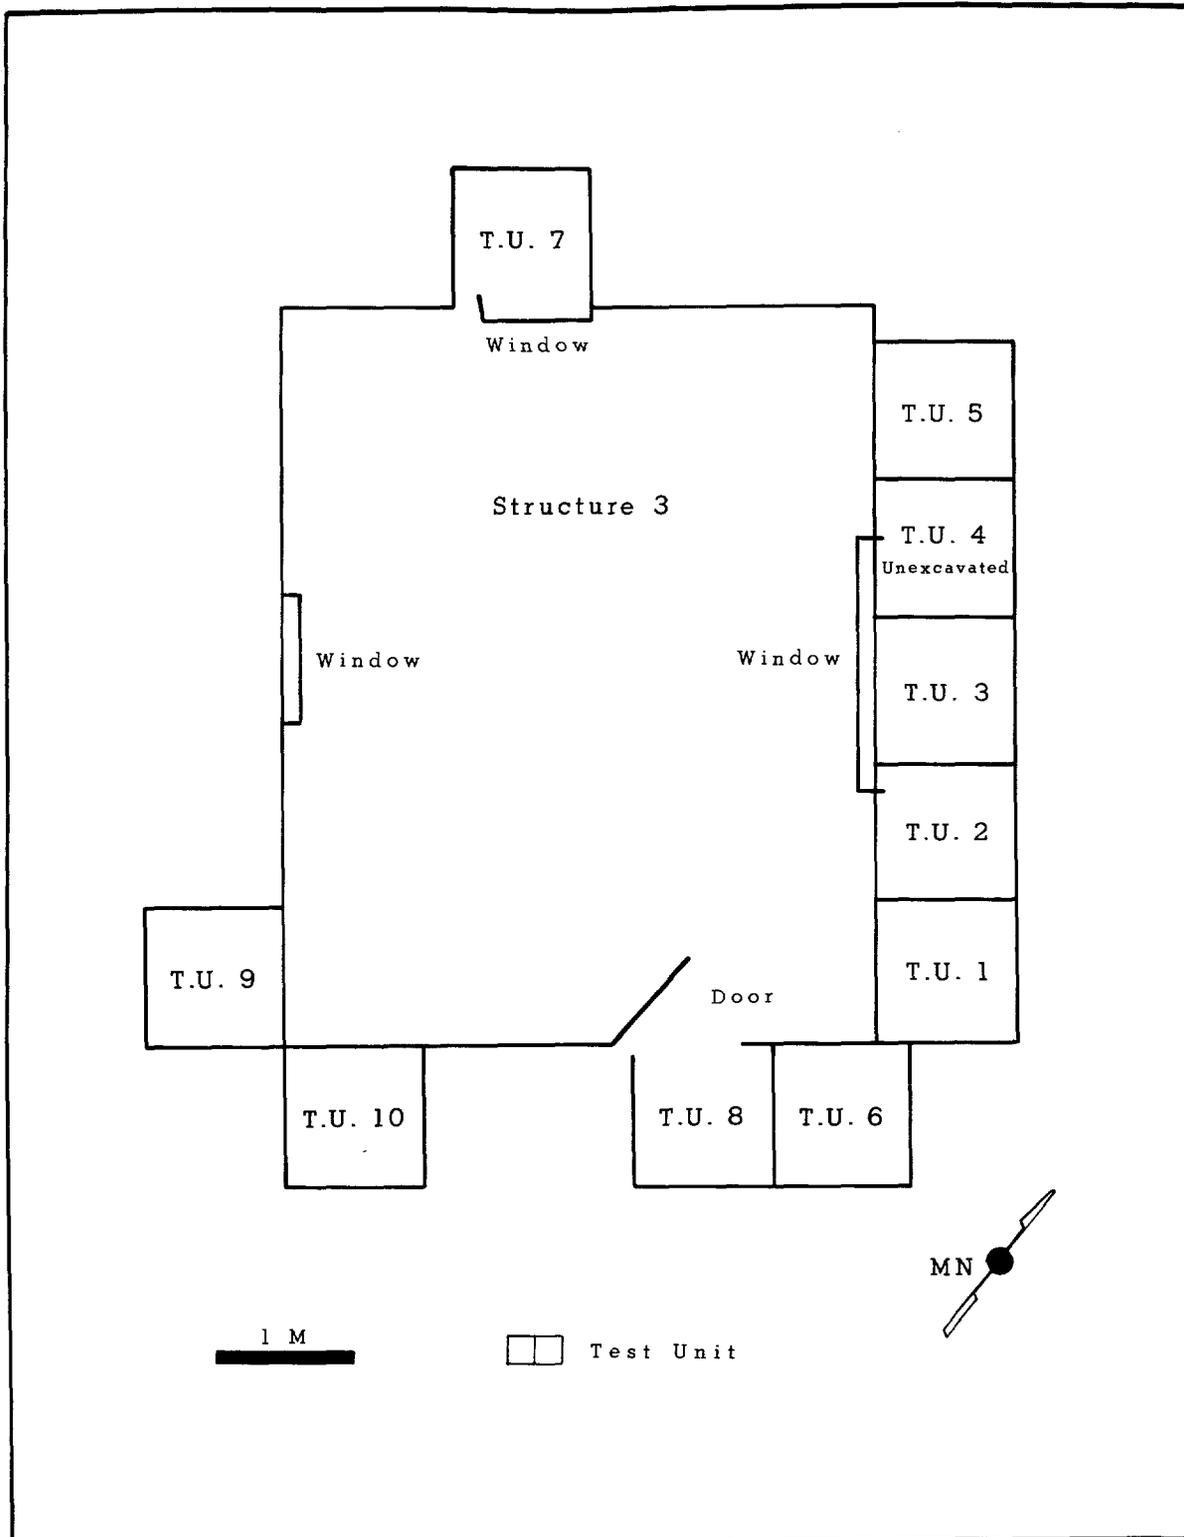
Figure 10. Excavation plan, Structure 3.

Despite the wet ground conditions, nine excavation units covering nine square meters were placed at Structure 2. After excavation, ground water filled all of the open units. Figure 10 shows that excavation coverage was very thorough along the east and south walls, but minimal along the north and west walls due to the distribution of saturated soils. Approximately 50 percent of the perimeter of the structure was investigated through these excavation units. The recovered archaeological data are thought to be a representative sample of materials distributed around the perimeter of the building. During restoration of Structure 3, no areas outside the immediate perimeter of the structure were disturbed.

Excavation Units 1-5 were placed along the east wall of the structure (Figure 10). The artifacts from these units showed little diversity and were limited mainly to nails and window glass (Tables 1, 2, 3, and 4). Window glass is very numerous, and reflects breakage and repair of the large, multipane window located near the midpoint of the east wall.

No foundation was discovered under the base course of logs at Structure 3. That course was in a state of advanced deterioration and no logs were noted under it. However, the very short height of the structure suggests that other courses of logs were initially present and have completely disintegrated as the structure settled into the wet sand. When the structure was restored, the log walls had to be completely replaced and, despite a lack of direct evidence for the presence of additional courses of logs below the lowest course present in 1983, courses were added to bring front door height to approximately six feet.
