CRATER LAKE NATIONAL PARK

Lady of the Woods Loop

TRAIL GUIDE

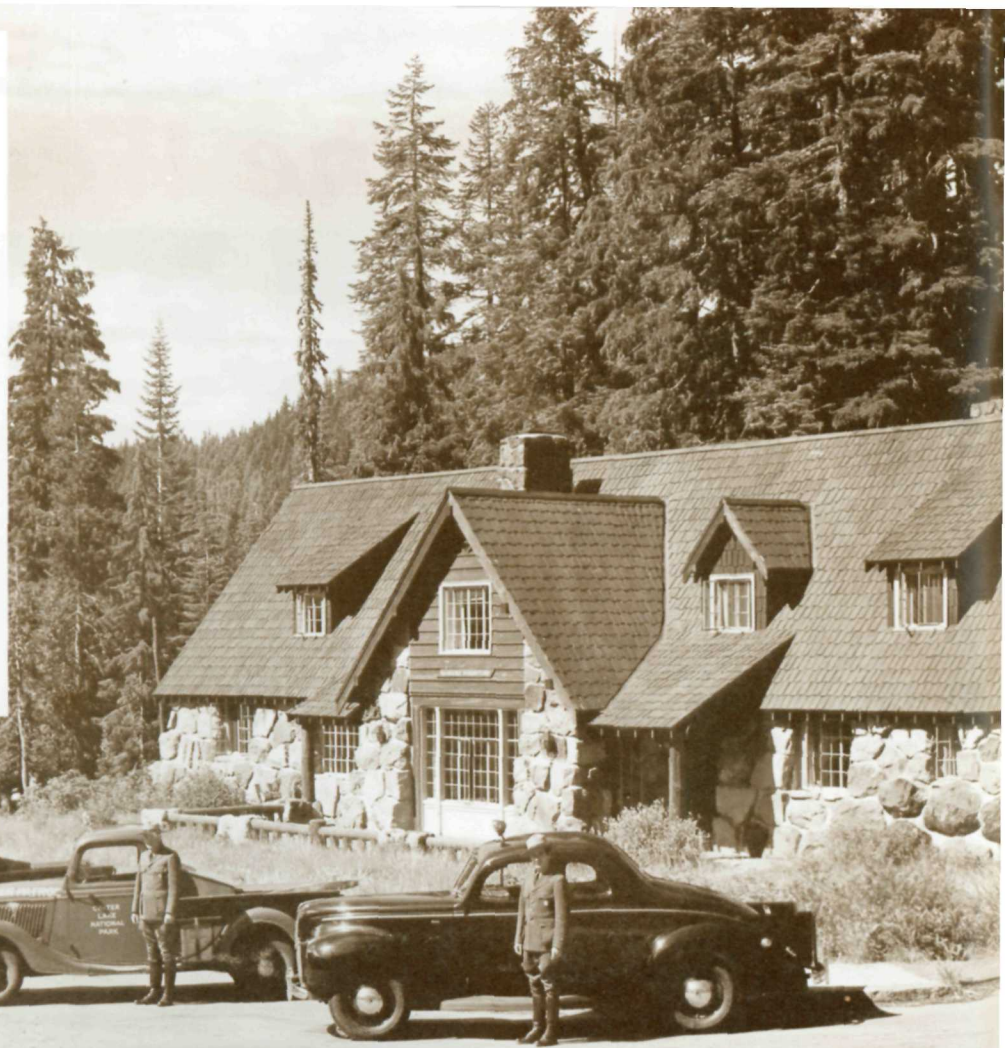
Rangers and their patrol vehicles at Park Headquarters, 1941.

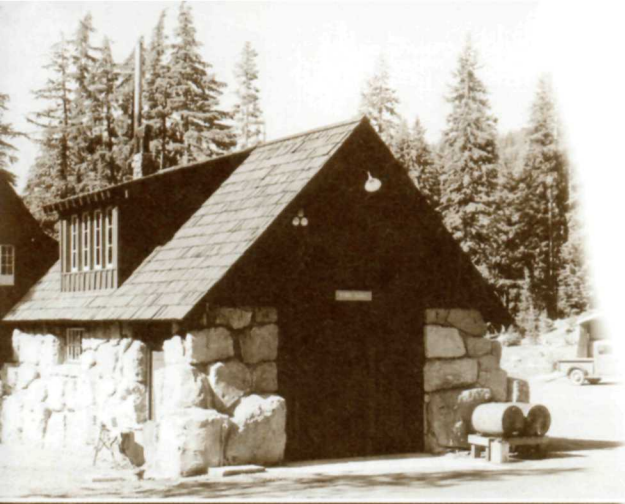
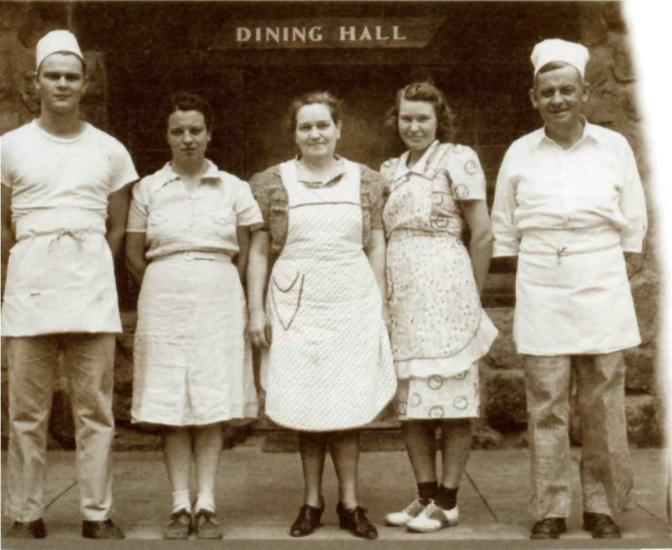
Stop #2

Top: The Fire Hall (1931), one of several buildings that once stood near the Machine Shop. Bottom: Employees at front of Mess Hall in 1941.

In front of you are several structures in the maintenance area. The **Mess Hall** (1929, additions 1934) at left was intended as a dining hall and dormitory for single employees, whereas the **Meat House** (1929) allowed cooks to store food in a shaded place protected from bears. Further right are **Lumber Sheds** (1934), and the **Warehouse** (1926, additions 1934). A portion of the **Machine Shop** (1932) can be seen in the distance.

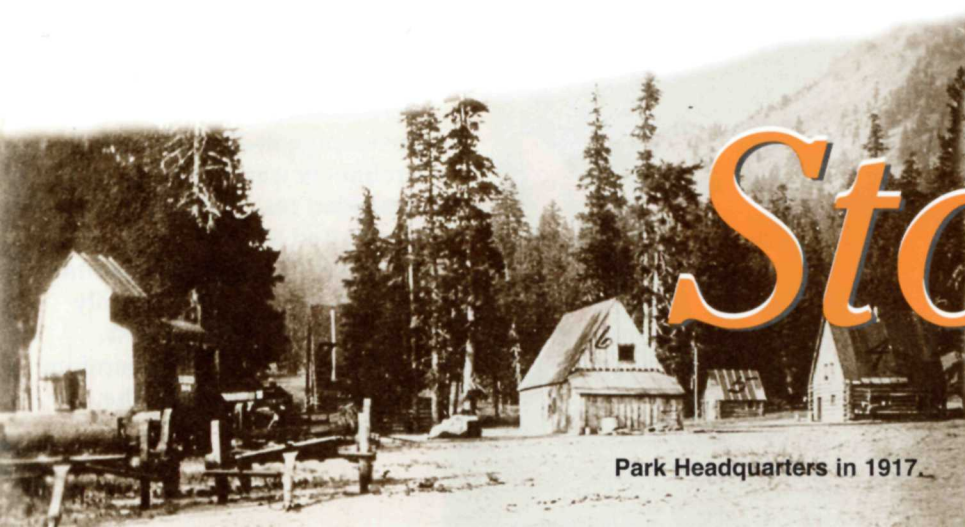
Park Headquarters in 1917.

Promoters soon made the Lady of the Woods into a visitor attraction, so the National Park Service responded by building a trail to the sculpture in 1924. Two years later, the NPS formulated a plan to transform the log structures and unpaved roads Bush had known into a development better integrated with its surroundings. The area had undergone a complete metamorphosis by 1940, with the stone figure being virtually the only survivor from an earlier era.

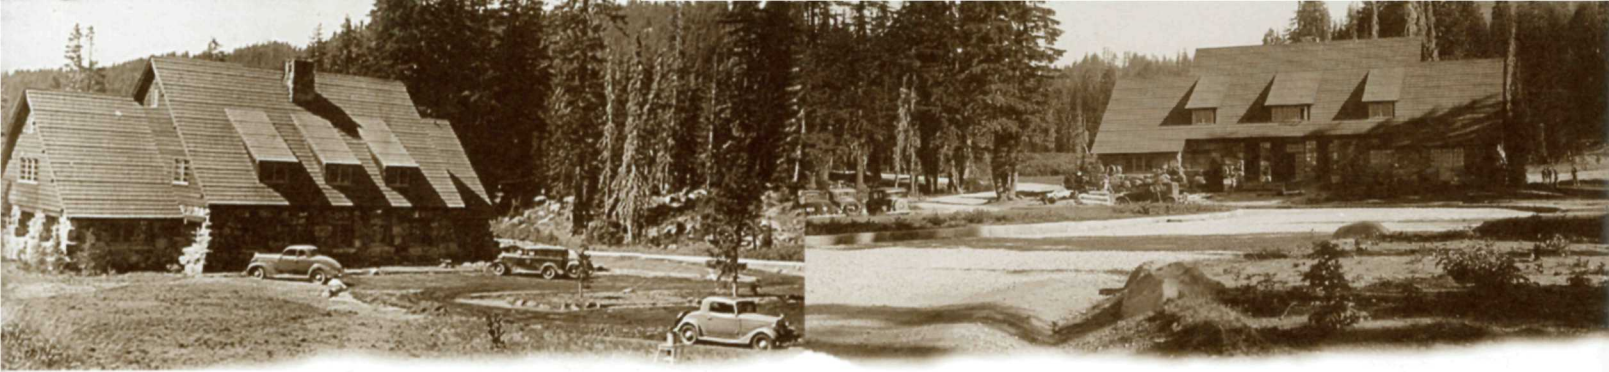
Stop #9

Planners designed Park Headquarters for summer occupancy. Winter conditions change the landscape.

The three **Employee Residences** on the terrace were built in consecutive years (1927, 1928, and 1929) and form a line, one seemingly broken by the **Garage** and **Woodshed** (1933) being placed at a slight angle. Details in each structure are symmetrical and complement the linear pattern. The irregular cluster, by contrast, features the two houses seen from stop #4 (center and right), along with an **Employee Residence** (1930) to the left of them. Their placement and details are asymmetrical, but designers still achieved a balanced appearance.

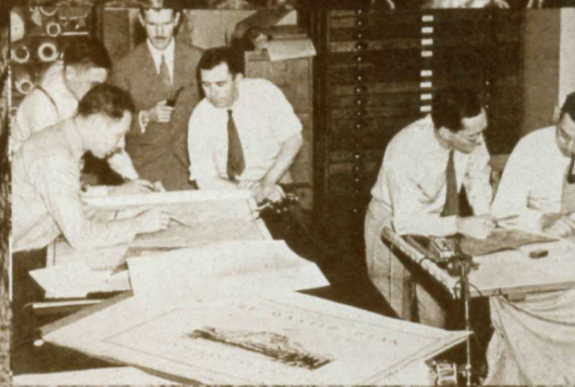
National Park Service landscape architects also designed small scale features like this foot-bridge built at Park Headquarters in 1939.

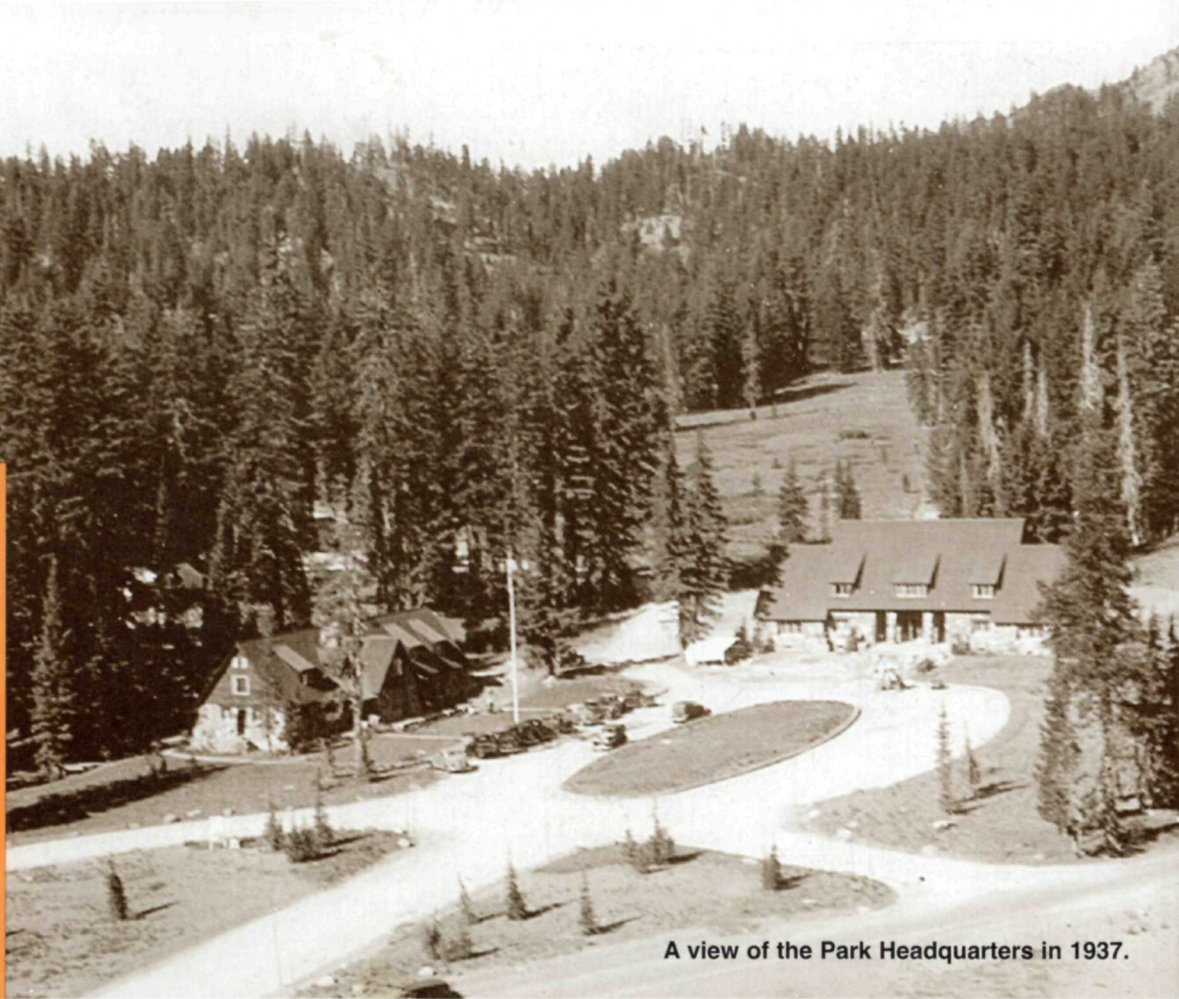
A view of the Park Headquarters in 1937.
