## Gleeson House Rehabilitation Project

### Preserving a Rural Landscape

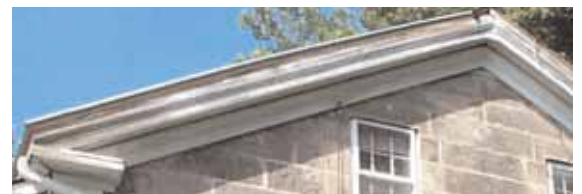
Greek Revival heavy moldings and cornice return. NPS Photo.

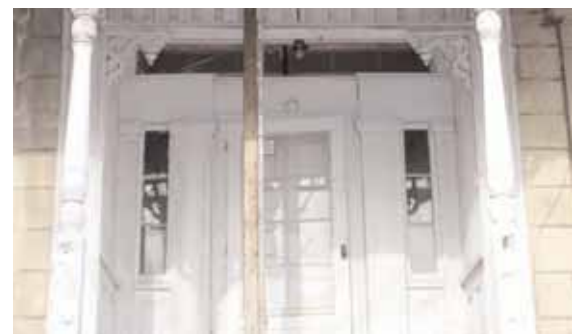
Grand entrance of the modest Gleeson House. NPS Photo.

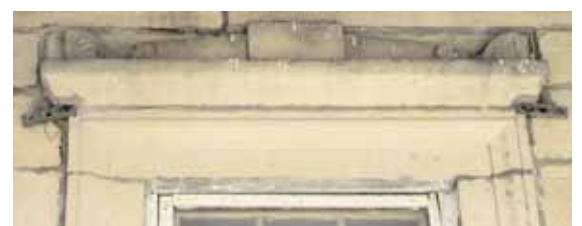
Decorative stonework surrounds the windows. NPS Photo.

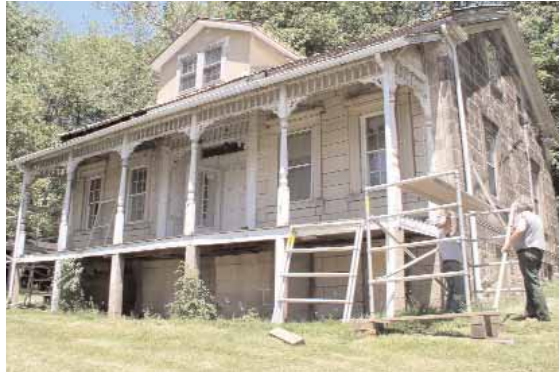
Workers begin to set up scaffolding at the front of the house to begin dismantling the front porch in early June 2005. NPS Photo.

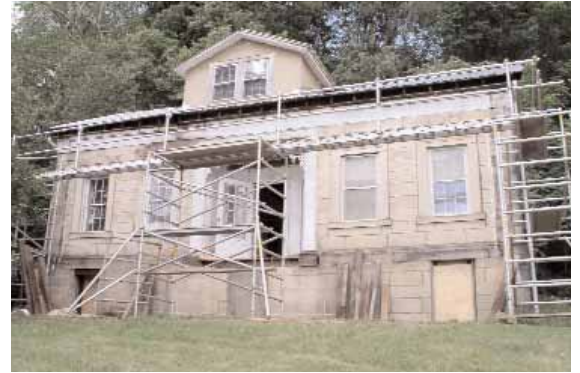
Front porch removed from the front of the house. June, 2005. NPS Photo.

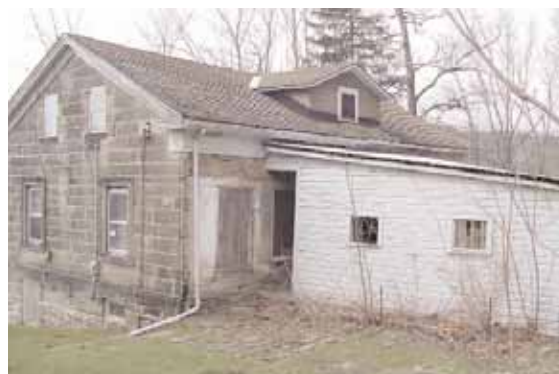
The back of the Gleeson home and carport addition, before rehabilitation. Spring 2001. NPS Photo.

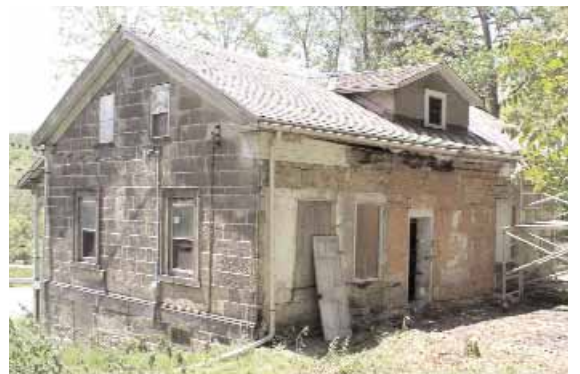
The carport addition was removed in early June, 2005. NPS Photo.

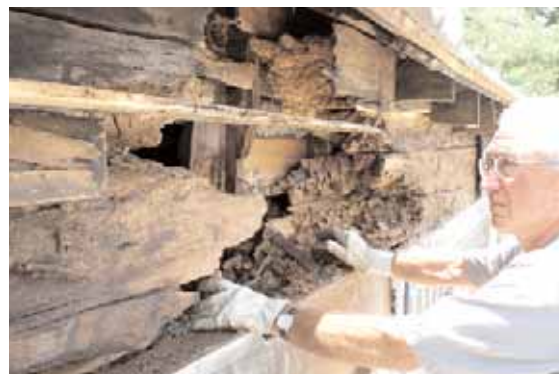
Extensive water damage to two large roof beams on top of the front wall. June 2005. NPS Photo.

Three elements will be balanced in the rehabilitation of the Gleeson House: historic preservation, health and safety for the occupants, and principles of adaptive use. Architecturally, stone and woodwork will be restored or replaced to ensure that the Greek Revival style is maintained. A new foundation, rebuilt front wall, and new supporting roof beams are necessary to stabilize the building. Lead paint

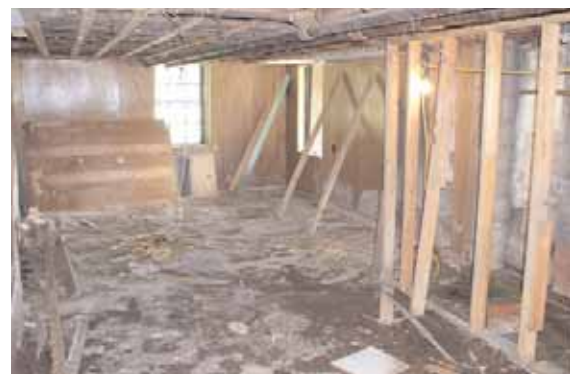
Demolition work has started in the basement. June 2005. NPS Photo.
