Fort Barrancas

As military technology and American values evolved, the mission for Fort Barrancas remained the same – protect the bay and the laws, principles, and lives of American citizens.

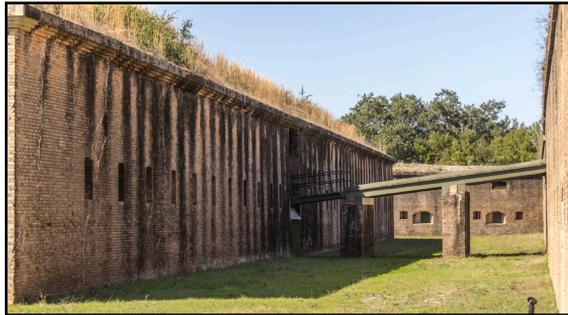
1. Glacis: This gentle earthen slope protected the fort from land-based artillery while exposing attacking infantrymen.

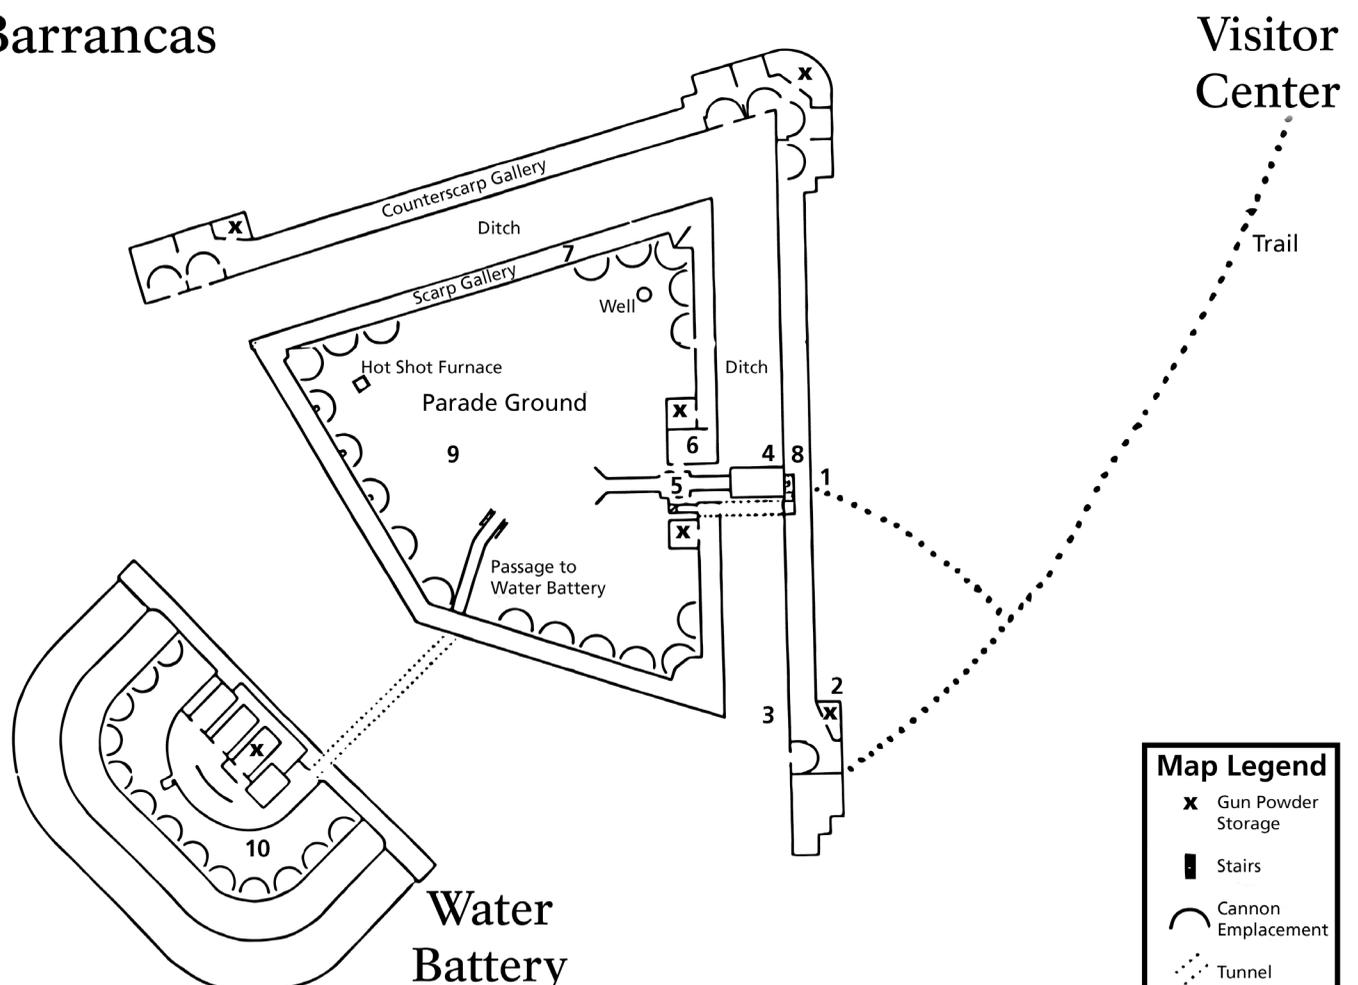
Guide to Fort Barrancas

3. Ditch: A dry ditch covered two sides of the fort. Assaulting infantrymen who entered the ditch would suffer heavy casualties from musket and cannon fire through openings in the walls.

4. Drawbridge: Operated by a counterweight and winch, it pivoted at the center. It could be raised to isolate the fort's scarp from a land-based attack.

5. Sally Port: The main entrance to the fort was guarded by heavy oak doors. A small wicket gate allowed entry without opening the main doors.

6. Guard Room: This room had four bunks and a six-man guard detail. Soldiers rotated with two men on guard duty (2-hours on, 4-hours off, for 24-hours) while four men rested. The main barracks were to the east of the fort.

7. Scarp Gallery: A series of arches supported the sand fill and allowed access to the loopholes for muskets. Vertical vents above the loopholes allowed smoke from the guns to escape.

8. Counterscarp Gallery: A tunnel under the ditch leads to this casemated area, containing loopholes for muskets, embrasures for cannon, and powder magazines to allow reverse fire into the ditch.

9. Parade: This open area is where troops were inspected or drilled. The foundation in the corner indicates where a hot shot furnace, in which round shot was heated before firing, once stood.
