Lincoln Home

National Park Service
U.S. Department of the Interior
National Historic Site

Interpretation of the 1860 Lincoln Home Photographs

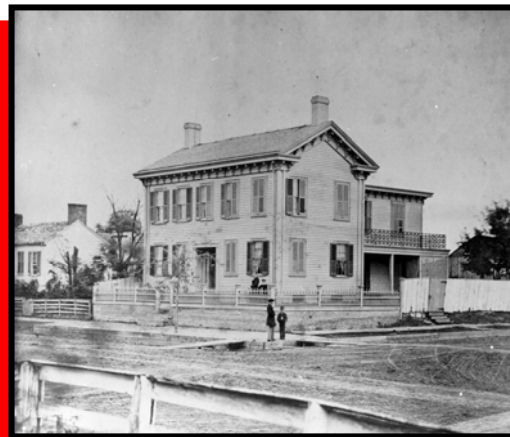
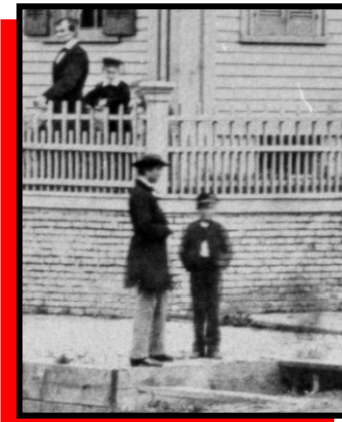
Photograph 1 (LIHO- 001) clearly shows Abraham Lincoln and his son Willie standing behind the fence. A close look reveals that the youngest son Tad is peaking from behind the corner post. The identity of the people in front on the walkway is not known.

Years later, three photographs that were produced during the summer of 1860 would become valuable tools for interpretation and restoration of the Lincoln home. One of the photographs, (LIHO- 001) is reproduced on the back of the Lincoln Home tour ticket which provides an opportunity for comparison of the historic image of the Lincoln Home with the Lincoln Home that we can visit today.

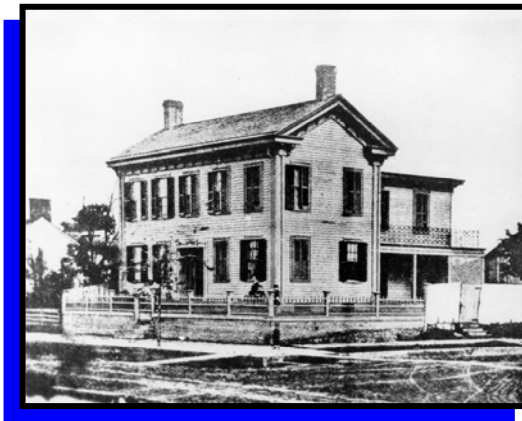
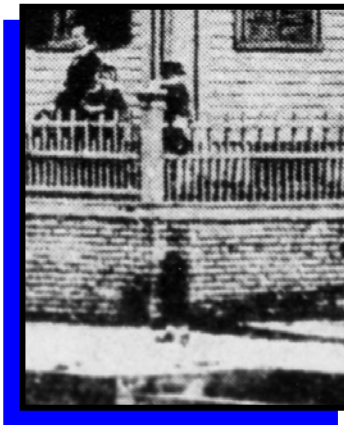
Photograph 2 (LIHO- 002) again shows Abraham Lincoln and his son Willie, but in this version Tad is more visibly seated next to the corner post. The blurry image in front, with only the feet clearly visible, is that of the Lincoln boys' playmate, Isaac Diller. Diller recalled that "I ran across the street from my aunt's house to get in a free picture with the Lincolns, but I turned my head at the wrong moment to look at a farm wagon. Only the stripes on my socks and my boots showed up." (From *Lincoln in Photographs: An Album of Every Known Pose*, by Charles Hamilton and Lloyd Ostendorf, 1985, pp. 56- 59)

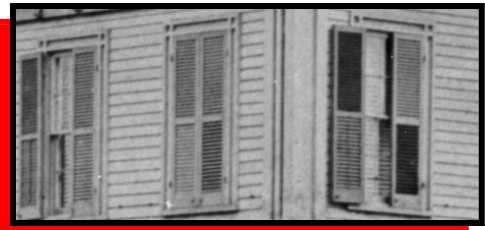
Whipple Photograph Interpretive Details

1. Use of the shutters; note that some are open and some are closed.
2. Venetian blinds are visible in the corner guest bedroom.
3. The small elm tree that appears in the photograph is one that Lincoln may have planted himself.
4. One of two backyard apple trees is visible.
8. The back porch latticework is visible.
9. It is apparent that a missing section of the decorative railing on the back porch roof was missing in 1860. That piece has never been replaced.
10. Mr. Lincoln was not known as “Mr. Fixit.”
11. A portion of the neighboring Carrigan House is visible.
12. The streets were made of dirt.
13. The streets were much deeper than they are today.
14. The walkways had ramps that extended over the street “gutters.”
