## Archeology and Fire

### Archeological Resources

## Archeology After the Chapin 5 Fire

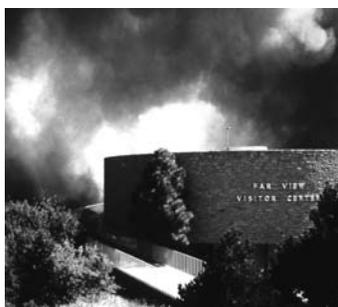
Massive smoke plume behind the Far View Visitor Center.

When the 1996 Chapin 5 Fire burned 4,781 acres near the Far View Visitor Center, it was the largest fire in recorded park history. Because of Mesa Verde's difficult terrain and topography, firefighters used aerial water drops and fire retardant, or slurry. The slurry, dyed bright red so aircraft pilots can see it, stains the landscape. While the color will fade, a stain persists, and the slurry can damage the sandstone. Such stains are particularly noticeable along the trail to Spruce Tree House.

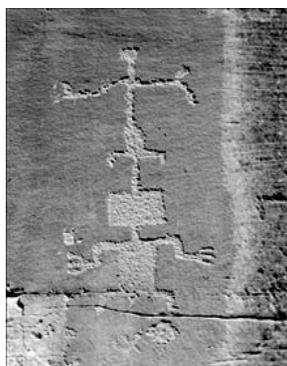
Portion of the Battleship Rock Panel

In addition, intense heat (700-800°C or 1292-1472°F) from fires leads to spalling, the peeling away of the rock face, as the water in the sandstone evaporates. Spalling does occur naturally but is accelerated by fire. This process is most devastating to “rock art” panels. Because petroglyphs (pecked in) and pictographs (painted on) are only on the sandstone surface, spalling can completely destroy a design. The Chapin 5 Fire destroyed a large panel known as the Battleship Rock Panel.

← Before spalling  
After spalling →

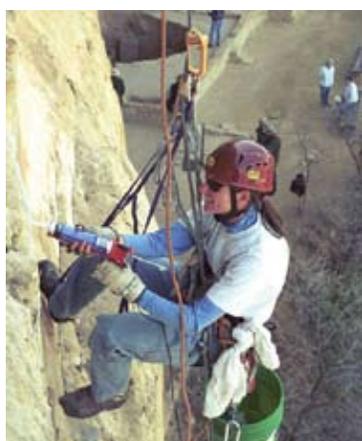
Applying silicon beading at Spruce Tree House.

After the Chapin 5 Fire, park archeologists began a post-fire assessment using modified procedures developed at Bandelier National Monument following their 1996 Dome Fire. The first step was a condition assessment of fire effects to known architecture and petroglyph and pictograph panels. Fires made mesa top sites and artifacts much more visible, allowing archeologists to easily walk through burned areas to assess the damage. Archeologists located and mapped sites using GPS technology, updated their site records, and made recommendations for post-fire treatments.

Treatment methods were used to preserve the sites after they were assessed. Erosion posed one of the greatest dangers, threatening to wash away site features and artifacts. Erosion-control matting and silt logs, made from aspen shavings and sometimes impregnated with native seeds, were put in drainages to slow water runoff and shade pioneering plants. Log diverters, burned logs angled on the slope above an alcove site, kept water from rushing down into cliff dwellings and eroding building stones and mortar. A bead of silicon applied to the cliff face redirected the natural drip lines. Archeologists realized that there was no way to restore the pre-fire appearance of spalled surfaces, but they could help to prevent future spalling by removing vegetation from around structures and in front of petroglyph and pictograph panels.
