MISSION CHURCH  
*and* GROUNDS

TUMACACORI NATIONAL MONUMENT  
19 Miles North of Nogales, Arizona

# Tumacacori National Monument, Arizona

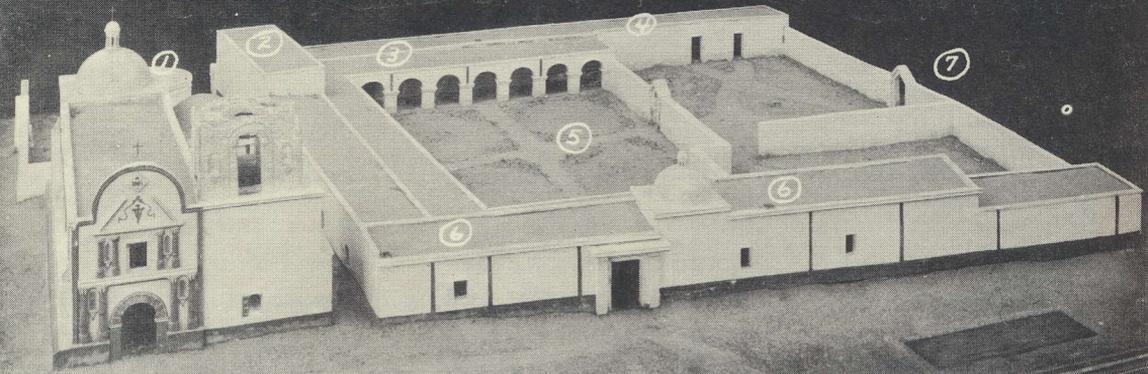
*Possible uses of buildings other than the church. (1) Mortuary chapel; (2) Granary; (3) Kitchens and living quarters; (4) Stables; (5) Gardens; (6) Indian School; (7) Orchards.*

**Station No. 2** This table model represents the church you see through the window, and shows it and its adjoining buildings as they probably were in the 1820's.

The model shows the mission church: to the north, a portion of its walled cemetery area (the round structure is the unfinished mortuary chapel); and to the east, the great walled patio, around which are shown arcades and the rooms. Some of the rooms were living quarters for the one or two resident priests, others were for community storage and the granary, still others were classrooms for the Indian school, and a workshop with perhaps a blacksmith forge, space for repairing leather goods, furniture, etc.

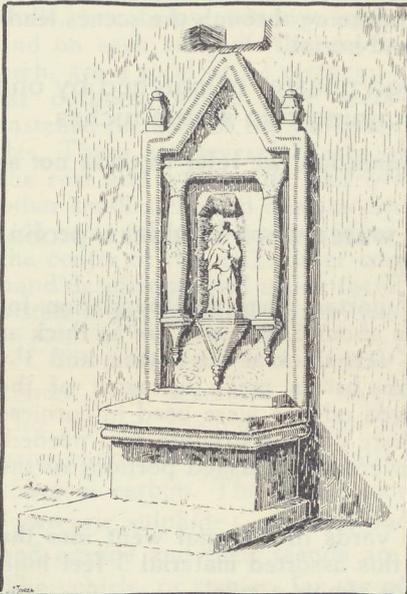
Artist's restoration of a side altar

**Station No. 9** Here is one of the four original side altars in the nave. It is composed of burned adobe bricks and lime mortar, having a base of the same material.

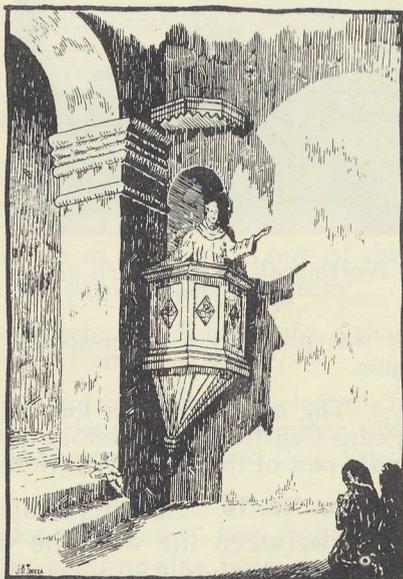
*How the pulpit may have looked*

#### Station No. 14 Restored pulpit base.

The original pulpit was destroyed or fell away from the wall, long ago, leaving only the outline where it had fitted, and a couple of timber sockets.

This partial restoration was done in the 1920's, following the old outline, and with the wood fitting the old sockets. Actually, we do not know the shape of the original pulpit, which may have had three instead of two sides.

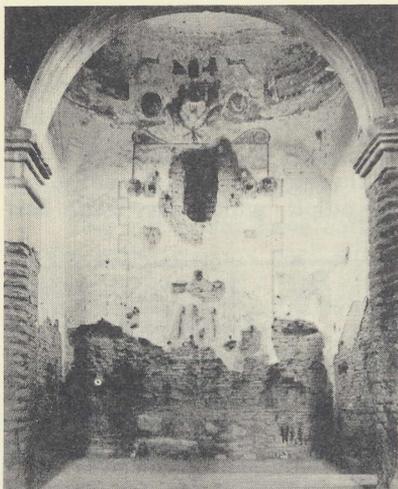
*North wall of sanctuary as it appears today*

**Station No. 15** You have entered the sanctuary, that part of a church immediately surrounding the main altar where the priest said the Mass. The original dome is overhead. The walls, plaster and painted decorations are original.

The highest part of the dome ceiling is 32 feet above the floor, and the room is 17' 4" across, both ways. The dome is about 12 inches thick, made of burned adobes and lime.

Along the east and west walls, just below window level, and on each side of the south arch, are a total of 12 rectangular outlines, where once were fastened pictures of the 12 Apostles.

There are several friezes of stencilled flower patterns across the east and west walls, and over the south arch, as well as many other small stencilled designs circling the base of the dome, and inside some compass-drawn circles in the extreme top of the dome. In the center of the arch, other compass-drawn circles have tiny free-hand designs painted inside them. Some free-hand scroll work is also visible in horizontal bands on either side of the arch.

The sanctuary is by far the most highly decorated part of the church, with remnants, in several colors, of a number of designs. One pigment, the blue, is made from indigo, a plant not native to this hemisphere, but introduced into Mexico in Spanish times; black is charcoal carbon. The other colors are all mineral: red is cinnabar (mercuric sulphide), green is one of the copper compounds, yellow and orange and their blends are ochreous hematites (iron oxides). The vehicle, or carrier, for the pigments, has long ago disappeared.

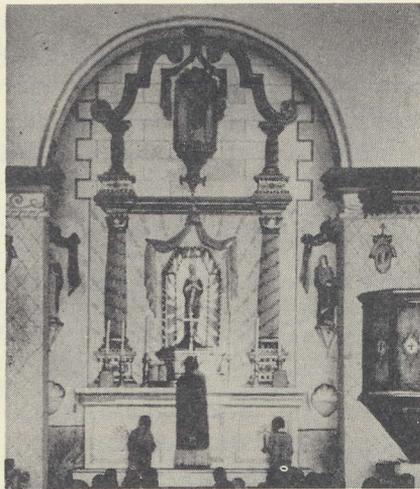
*Reconstruction of how it may have looked in 1820*

**Station No. 16** Let this trailside display show you the contrast between the way the wall looks now and the way it probably looked 130 years ago.

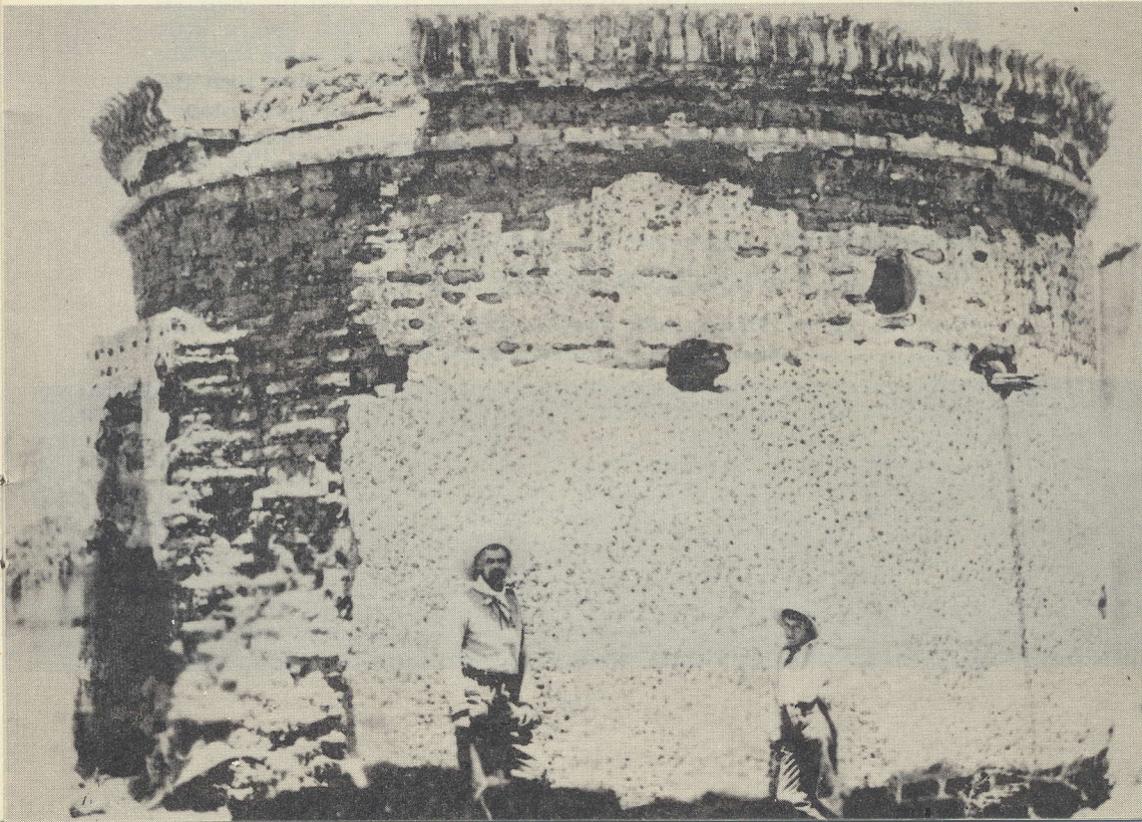
*The unfinished mortuary chapel, in 1889.  
Photo by—George Roskruge, Tucson, Arizona*

**Station No. 24** This building was intended, we believe, to serve as a mortuary chapel, or laying-out place for the dead, and possibly the location of the religious burial services.

The chapel was never completed. Doubtless, a dome was intended, but was never built; the plastering was incomplete, with only the base coat applied to the walls. Although there are brick fragments worked into this plaster, there is no pattern to them. The fragments were undoubtedly to provide a good bond for the proposed finish plaster coat.

original burned adobe cornice bricks. Below the cornice is the original moulding. The two holes through the walls were too high for defensive loopholes, and must have been simply to provide light and ventilation.

A great deal of re-surfacing has been necessary on this building. Much bare adobe of the walls had been exposed.

Around the outside of the building you can see a line of holes which *do not* go through the wall. From one of these projects part of an original timber. These holes are scaffolding holes, and were used to seat the poles which supported cat-walks or planks. On the planks stood the Indian workmen while they were building upper portions of the wall. The fact that the scaffolding poles were left projecting from the wall is evidence the builders were expecting, at least until very shortly before abandonment, to complete the structure.

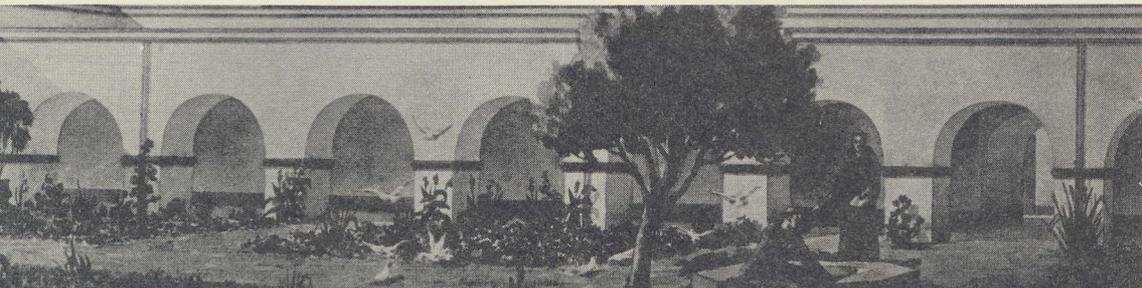
*Part of a typical mission patio garden of the period, with the arcades (loggia) which separated it from the rooms.*

The patio was a completely surrounded space, capable of defense against Apache invasion. Rooms around the north, west, and south sides were separated from the interior of the court by a loggia (series of arches supporting a roof).
