CRM BULLETIN

A National Park Service
Technical Bulletin

Vol.4, No.1
March 1981

Twenty-Eight Coats of White House History

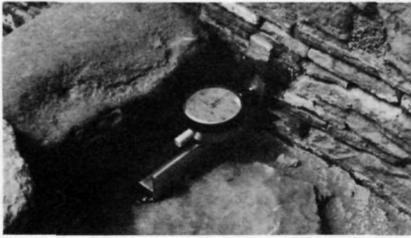
This dial gauge installation produced the data in the line chart. The gauge is mounted on top of a wall on one side of the crack. A metal plate is attached to the taller back wall. The spring-loaded spindle of the gauge rests on the metal plate, but is not attached to it. As crack width changes, the spindle moves and changes the position of the gauge hands.

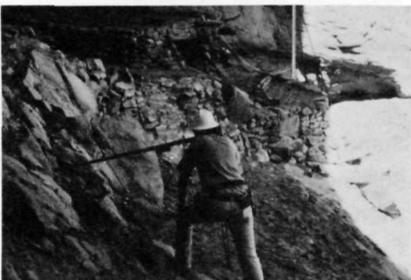
Precise leveling equipment being used to measure settlement of ruins. While similar to conventional surveying in technique, specialized equipment allows direct readings of 1/10 mm with estimates to 1/100 mm.
