# BULLETIN

Cultural Resources Management • A National Park Service Technical Bulletin

July 1984

## Management Issues in the Field of Cultural Resources

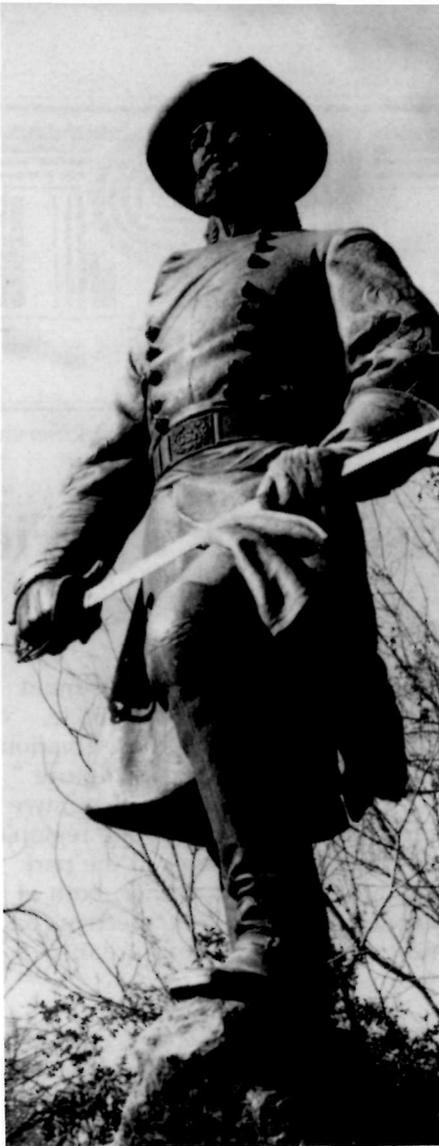
*General Stephen Dill Lee, Vicksburg National Military Park, by Henry Hudson Kitson, 1909.*

*General Stephen Dill Lee* is evoked by his upright carriage and his confident grip on his drawn sword, as much as by facial details. In the cavalry group of the Wisconsin State Monument at Vicksburg, the sculptor shows the courage and composure of a typical cavalryman by contrasting his steady aim with the agonized expression on the reared head of his wounded horse. This dynamic composition with its agitated outline forms a statement much different from the static sentinels, who stand with quiet dignity. The closed contour or silhouette of the statue and the simplified folds of the heavy cloak enhance the sorrowful attitude of memorial statues of this type.

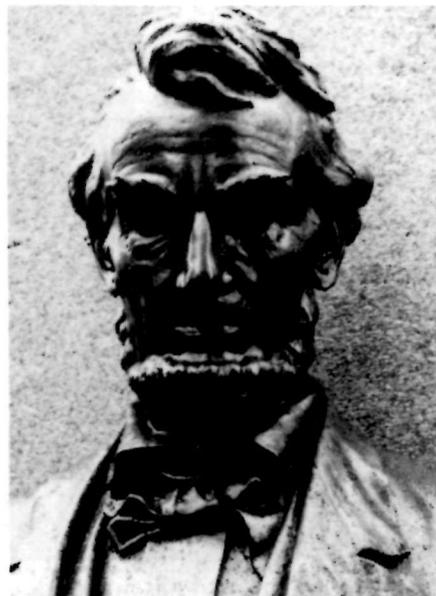
*Bust of Abraham Lincoln, Gettysburg Address Memorial, Gettysburg National Cemetery, by Henry Kirke Bush-Brown, modeled and cast 1904, dedicated 1912.*

and jacket. The surface is a deep rich brown—and it beads water.

The potential gains of conscientious preservation are illuminated by comparing monumental bronze sculpture with the recently cleaned and waxed bust of Lincoln on the Gettysburg Address Memorial. Thorough cleaning, waxing, and polishing produced results dramatic enough to stop the heart of an outdoor sculpture connoisseur! No stains or streaks disfigure the face. Minute detailing can be seen around the eyes and furrowed brow and in the curly beard. Light plays across the folds and broad planes of the shirt

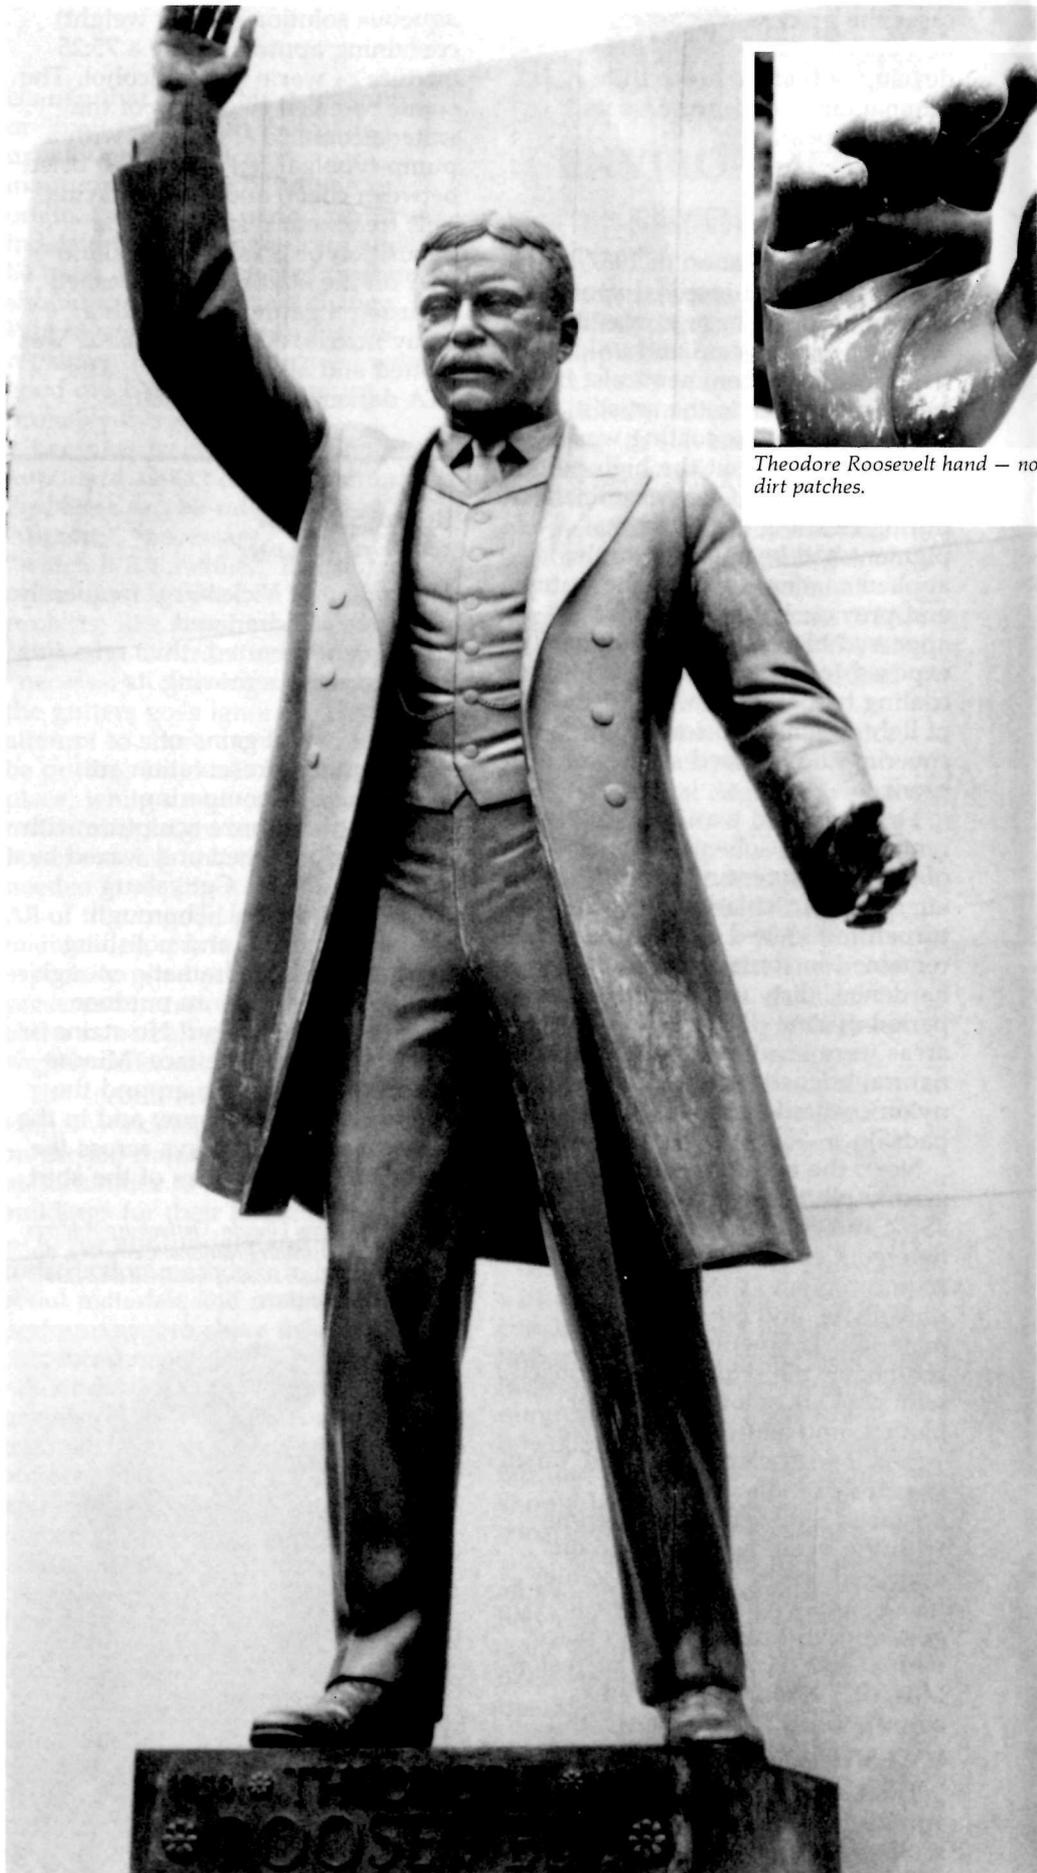
Theodore Roosevelt hand — no dirt patches.

Statue of Roosevelt after cleaning.

For a number of reasons, *Theodore Roosevelt* remained untreated until the early summer of 1983. At that time, areas such as the coat skirt, shoulders, head, and upraised arm exhibited large patches of moderately green corrosion, minus the four year old wax coating. Waxed areas were removed with Varsol, followed by washing with a solution of Igepal CO-630 in water.

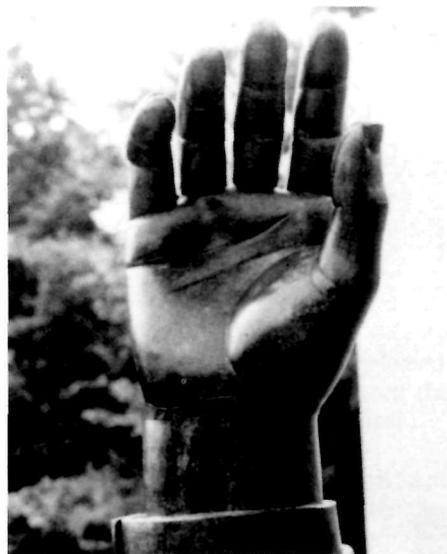
Hand one year after treatment. Note lustrous tones.

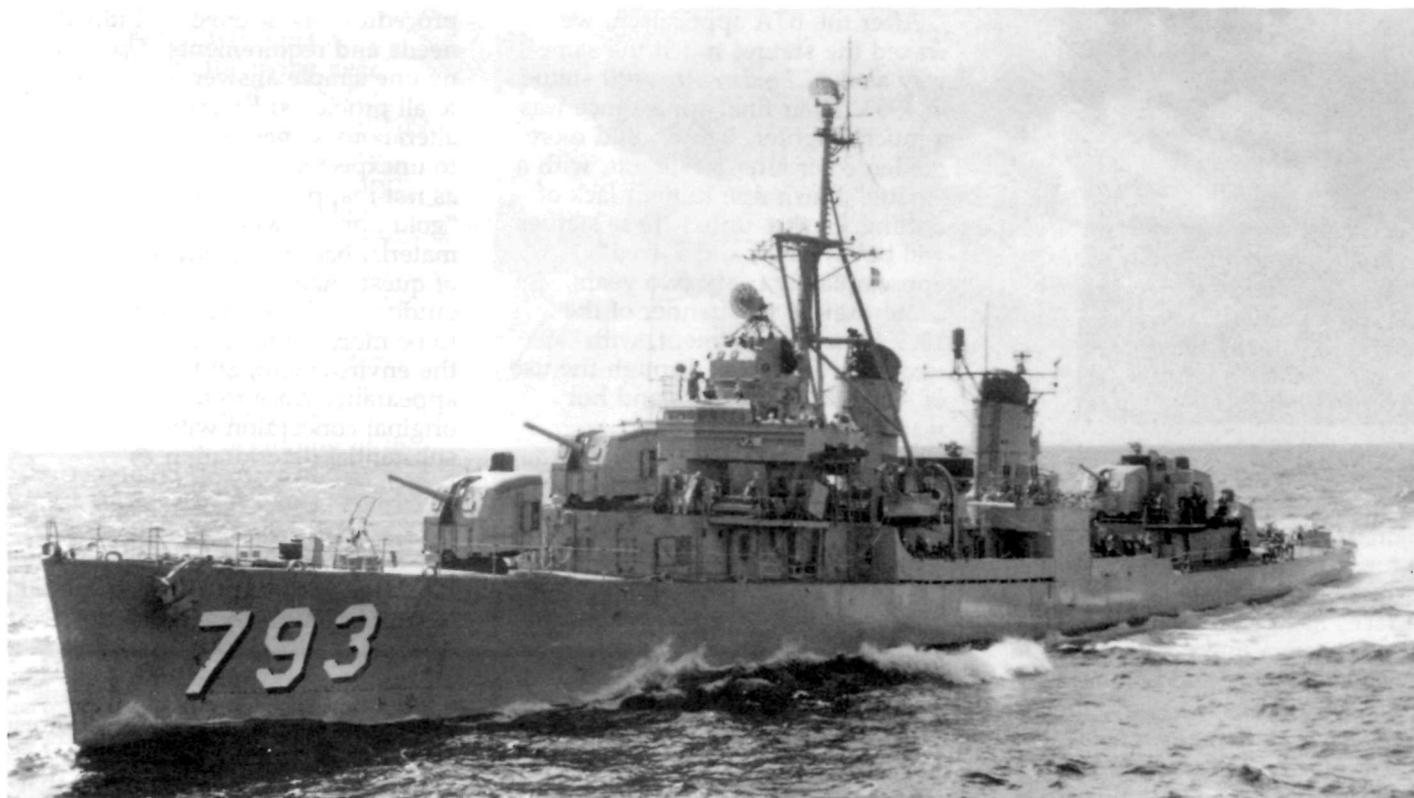
*USS CASSIN YOUNG, 1958 (U.S. Navy photo).*

The National Park Service acquired the destroyer USS CASSIN YOUNG from the U.S. Navy in 1978. The ship opened to the public in 1981, as part of the Charlestown Navy Yard exhibit at Boston National Historical Park. CASSIN YOUNG is the first warship afloat under National Park Service management. The experience of rehabilitating it provides a relatively new application of preservation practice and may be of interest to cultural resource managers.

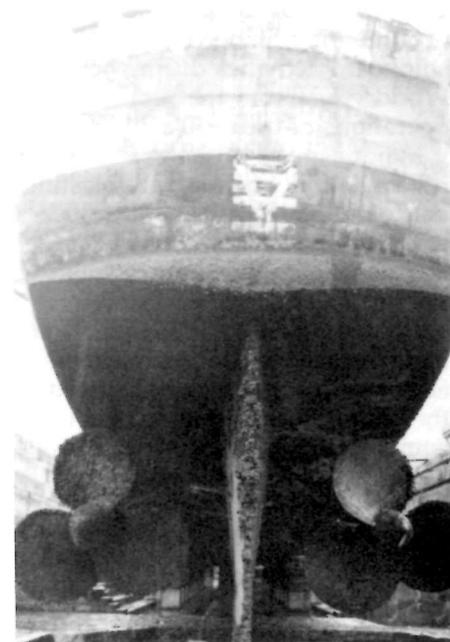
*CASSIN YOUNG in dry dock, Charlestown Navy Yard, prior to rehabilitation.*

Corrosion can kill any metal ship. Prior to rehabilitation, CASSIN YOUNG looked very sick, marred with extensive and severe rust, missing parts, and "mothball" equipment. The last Navy diver inspection of the underwater hull, in 1965, reported marine fouling, paint failure, and corrosion of metal over 30% of the underwater surface. The surface experienced 15 years of continuous corrosion since that time. Boston National Historical Park was fortunate to have a dry dock (one of the nation's oldest) and a maintenance crew with the skill and dedication to successfully dry-dock a warship. With the ship in dry dock, we inspected, tested, and prepared the hull for many more years of service with minimum loss of fabric.

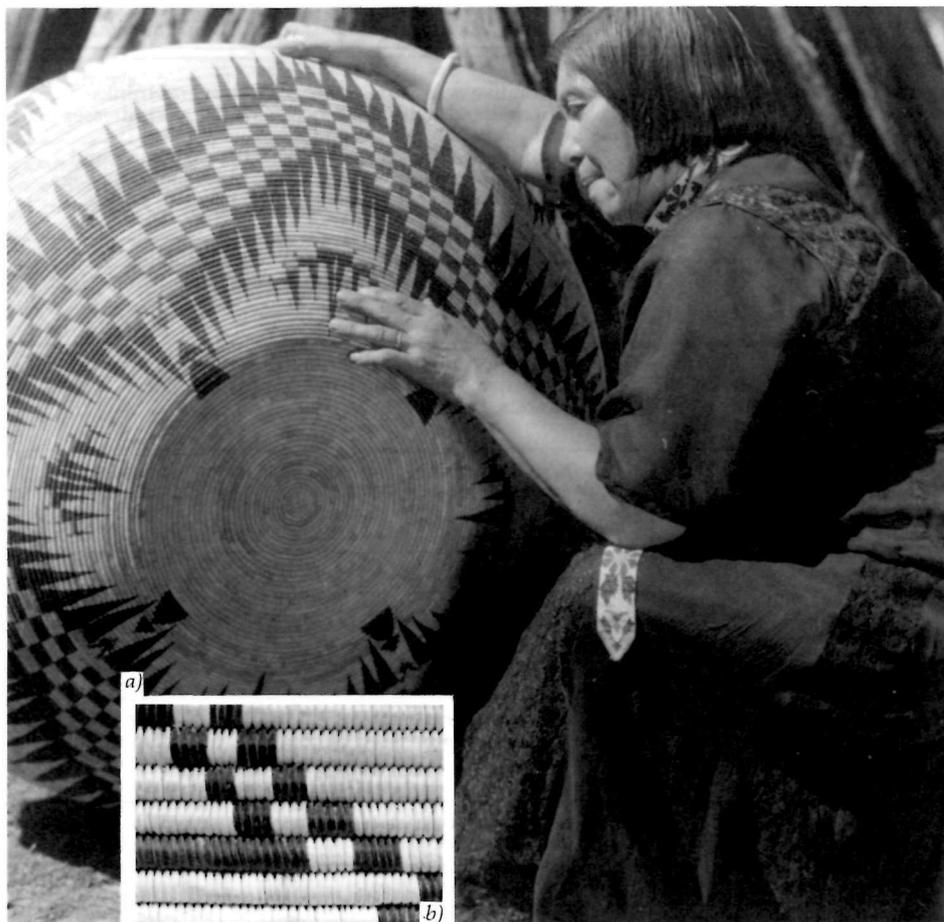
a) Photo of Lucy Telles, Miwok-Paiute, 1933; b) Closeup of stitching of basket.

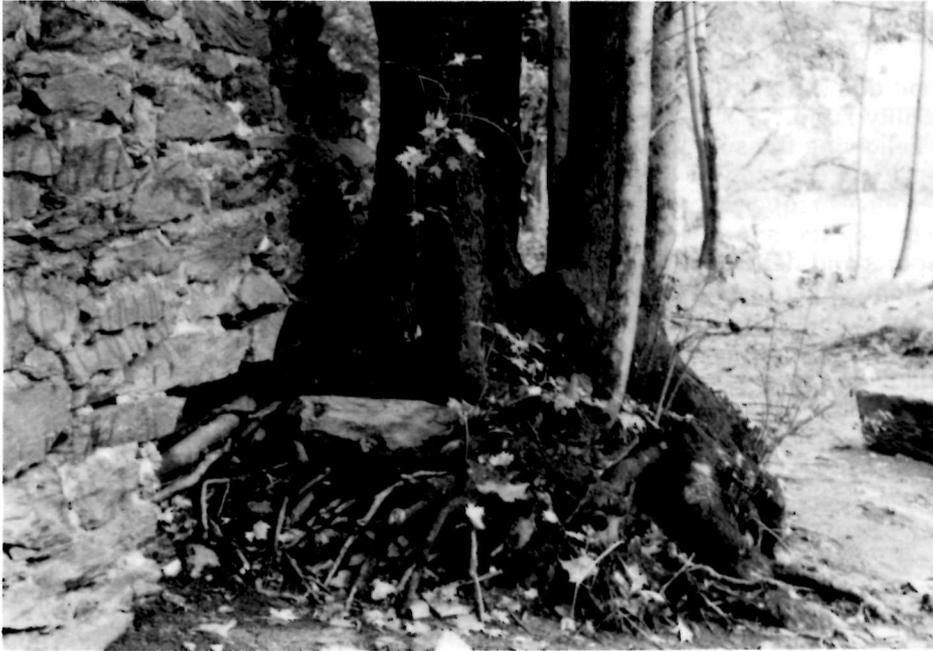
*Tree invasion, Virginius Island, Harpers Ferry NHP.*

Trees which gain great heights and have extensive root systems may pose a severe threat in proximity to an historic landscape. Management options for well established invasive trees are relatively few, generally requiring a decision to remove the tree or face continued damage to a structure.

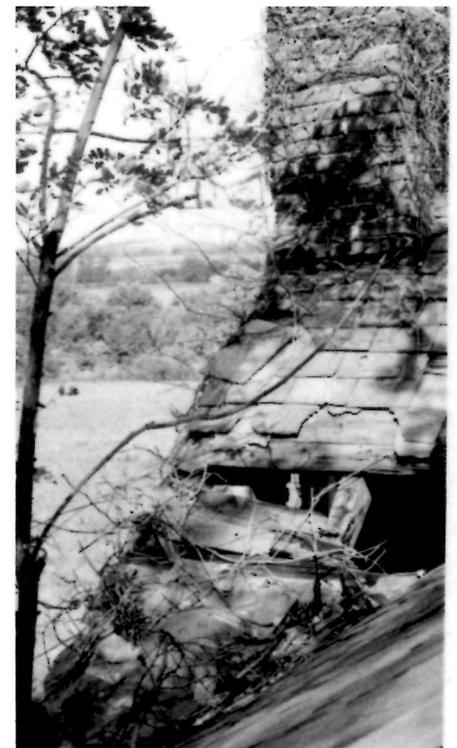
*Worthington House, Monocacy NB. Note vine and tree invasion.*

Vines cause severe damage since they create a damp area between their leaves and the walls of a building, while sending out invasive root systems. Vines growing directly on a wall may strangle a wooden or masonry structure, forcing apart its components (i.e., wisteria lifting off a wooden porch roof or the balusters from a limestone balcony). They may insert tendrils or aerial roots in the mortar or brick, weakening the mortar and masonry by increased exposure to freeze-thaw actions, or enlarging the openings and dislodging stone or brick from a moisture damaged wall (poison ivy, English ivy, Boston ivy, honeysuckle). A root enzyme which attacks the stability of lime may disintegrate the mortar until only the sand remains (all

vines). Dense vine growth prevents the sun from drying the wall: as moisture builds up, dry rot can occur in wood, and decay in mortar and masonry (primarily poison ivy, English ivy, Boston ivy, Virginia creeper, and honeysuckle).

Vines may be controlled by girdling or by cutting at the base (left to dry, they should be carefully removed from the structure within a few weeks). Great care must be taken in removing vines so as not to disturb mortar and masonry. Digging up roots will discourage further growth, but elimination of habitat will be required to eliminate all growth. Organic debris should then be cleared from around a structure allowing the surface to be exposed to sunlight and free air circulation. In some cases, a systemic herbicide may be recommended when a vine is severely damaging to a structure, and should be applied to roots and stems. Where a vine is to be used as a part of the historical interpretation of a site, a strict grooming design and schedule should be followed. In such a case, intensive maintenance is the only acceptable solution.

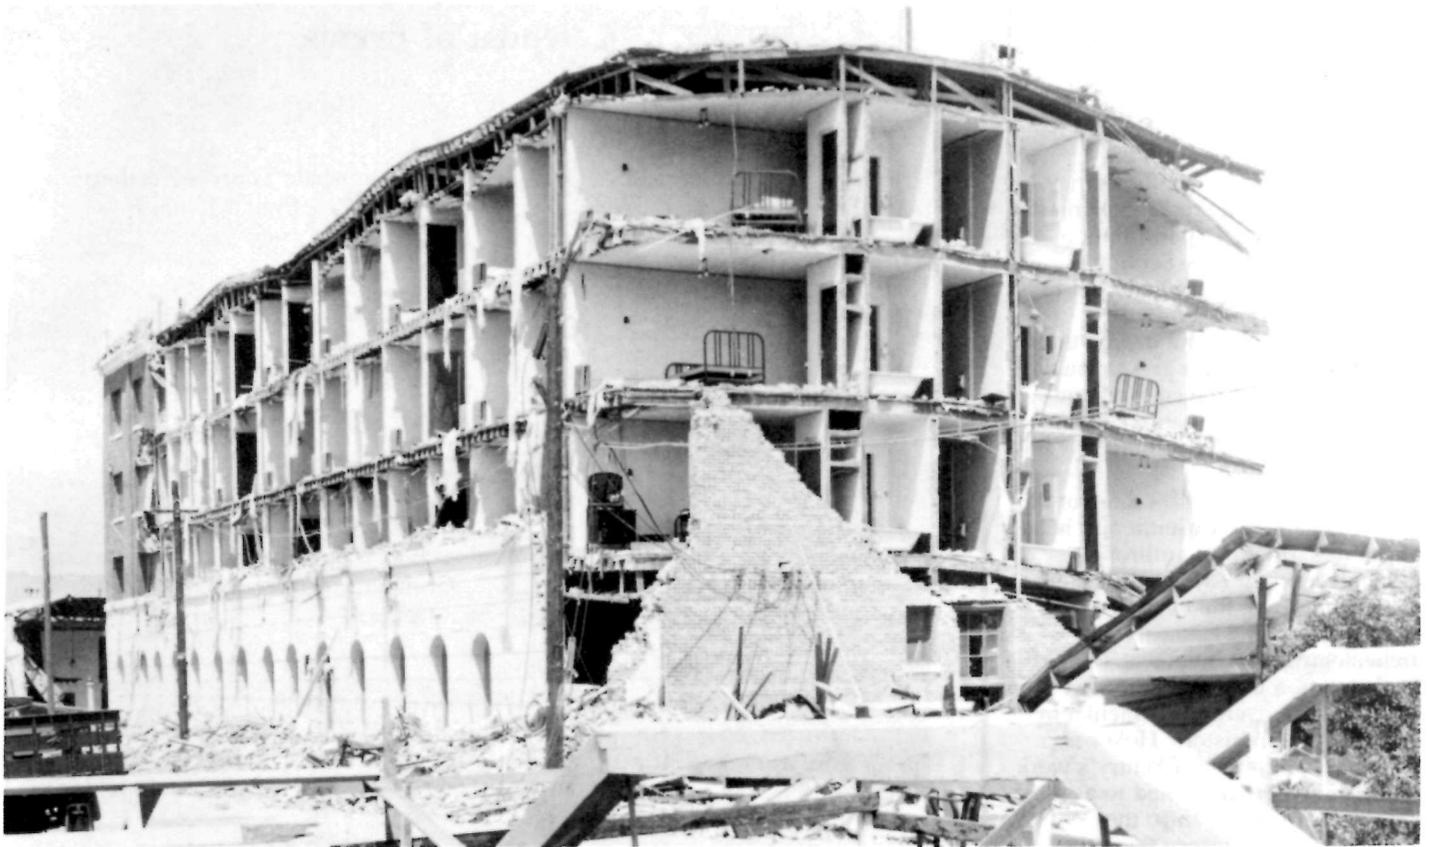
*Hotel California after 1925 Santa Barbara Earthquake.*
