Disaster Management

Information for parks, federal agencies, Indian tribes, states, local governments, and the private sector that promotes and maintains high standards for preserving and managing cultural resources

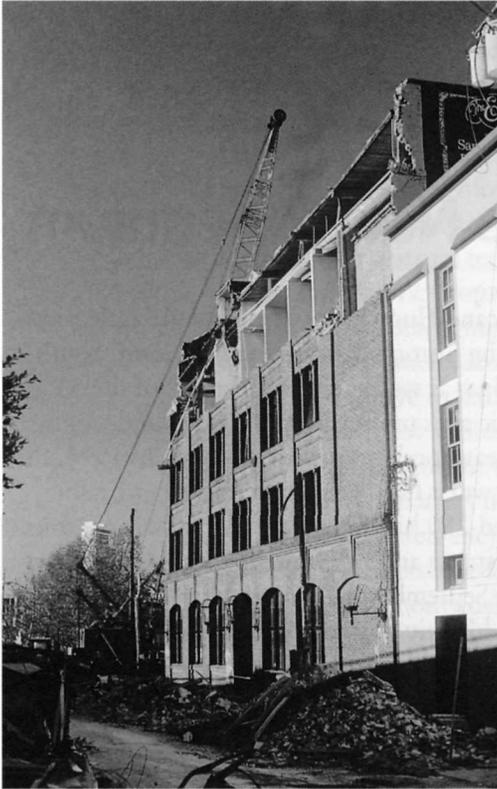
By progressive failure the unreinforced-brick parapet and fourth-floor façade of this building on Bluxome Street collapsed onto the sidewalk and street during the Loma Prieta earthquake killing six people in a car pool.

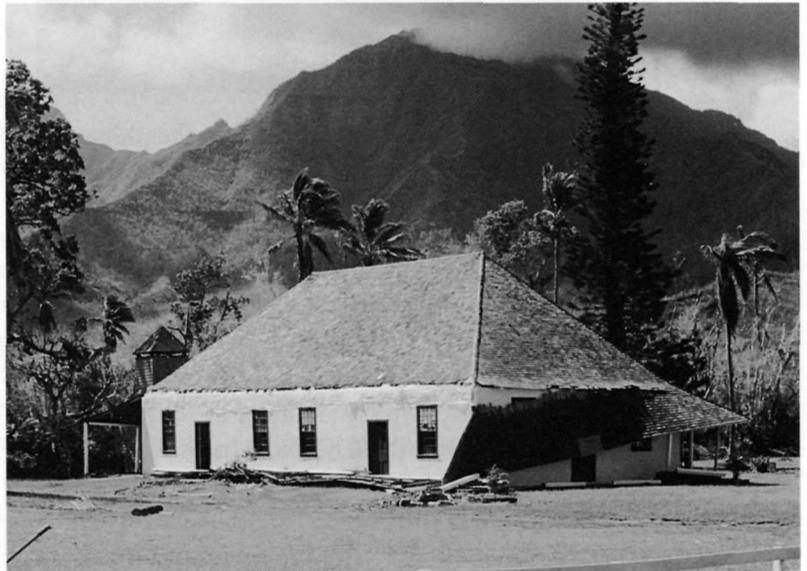
Waioli Mission Hall (c. 1830), Hanalei, Island of Kauai, Hawaii. Damage from Hurricane Iniki in 1992 destroyed the lanai (covered porch) that ran completely around the building. The building was restored and structurally strengthened using FEMA funding. Photo by Randolph Langenbach, FEMA.

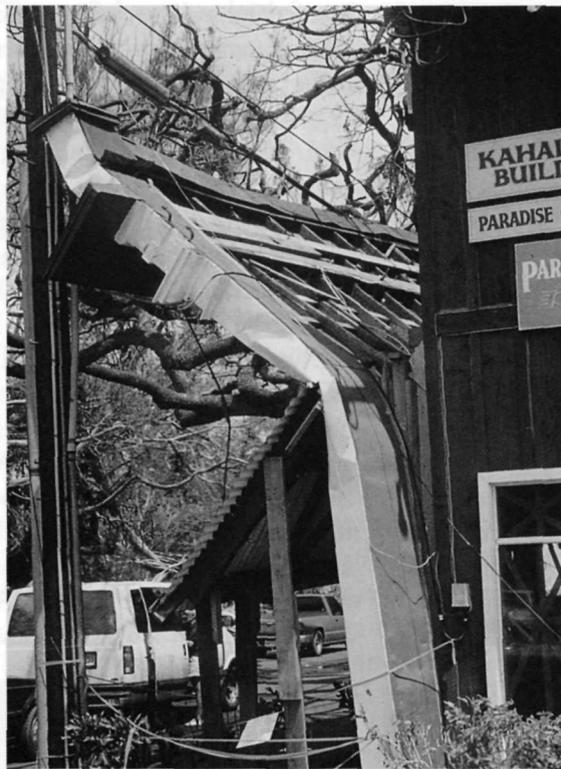
Hurricane Iniki in 1992 ripped the façade from this one-story vernacular store building on Kauia, Hawaii. The utility pole prevented the façade from falling onto the sidewalk and road. Photo courtesy David W. Look.

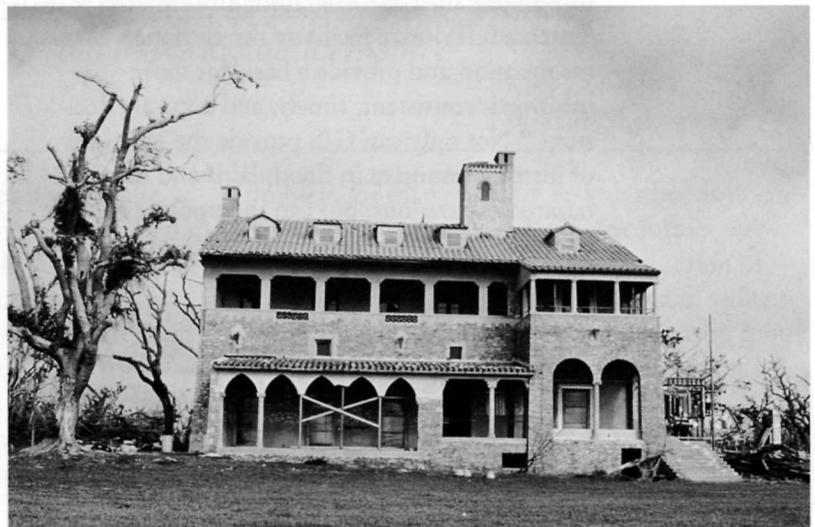
Richmond Inn, Miami, Florida. This building suffered extensive damage from Hurricane Andrew in 1992. Photo courtesy FEMA.

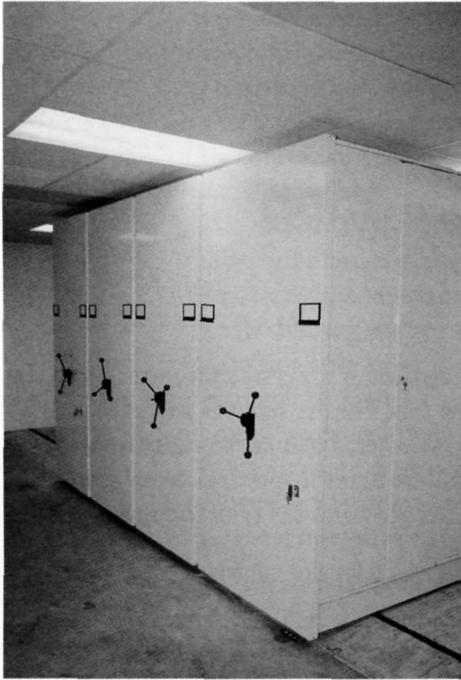
Fox Theatre collections room now.

The new collections space measures roughly 28 by 14 feet, with a 12-by-6-foot corridor on one side (slightly smaller than the old space, but designed with an eye toward efficiency). The safety features of the new space include a sprinkler system, two perimeter walls of four-hour masonry construction with one-hour rated gypsum wall board on metal-stud furring, and two perimeter walls of two-hour rated metal stud and gypsum wall board.

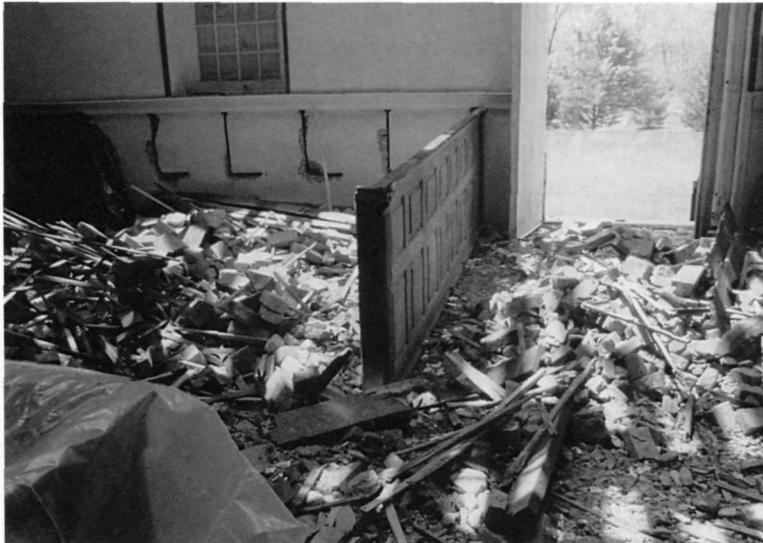
Twenty-two tons of brick, mortar, plaster, lath, and framing fell to the sanctuary floor crushing four box pews and two original deacon benches. The debris was carefully sifted for all salvageable materials. Photo taken May 23, 1996.

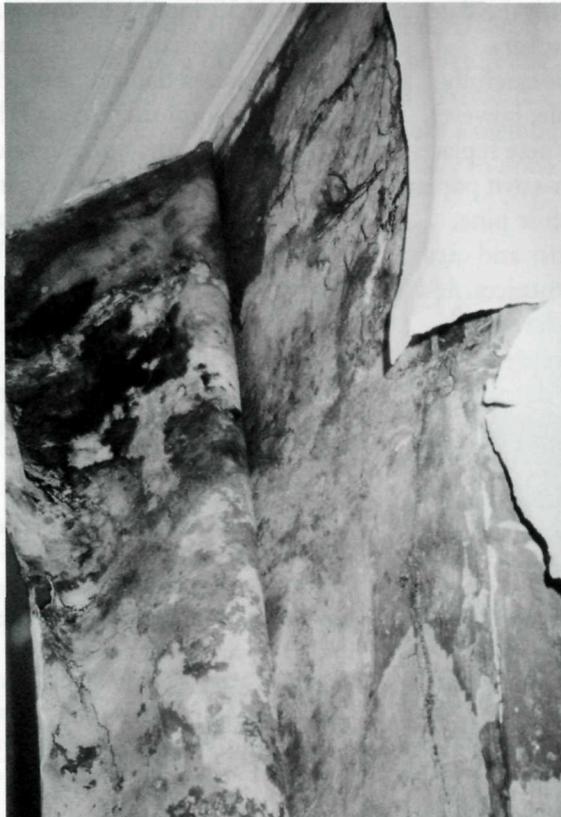
Inside the house in the central corridor immediately beneath the cracked and leaking gutter (see next photo) the wallpaper over a doorway was found to be peeling off the wall, with a massive fungal attack growing on the soaking wet wall paper paste and animal protein glues of early distemper paints.

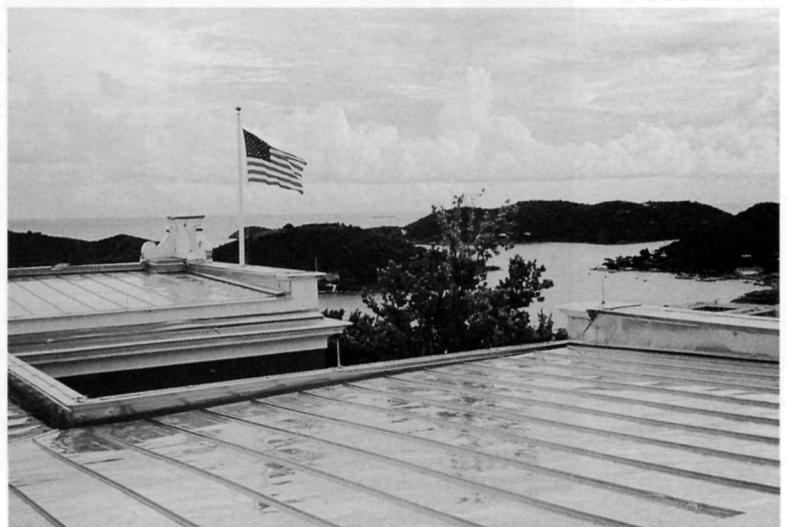
New stainless steel sheet roofing with complete cap flashings on all parapets and roof ornaments. Note new lighting protection system. All rainwater drains have been doubled in size.

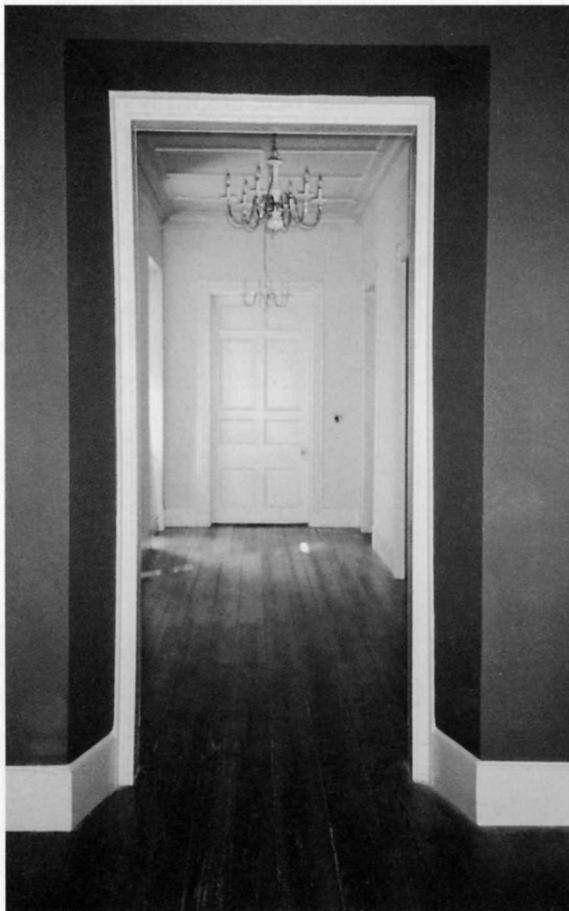
Less than a year later, after the installation of new roofing, the interior is fully restored. The fine timber beams and flooring were restored using the same pitch pine that was originally used. The colors and distemper paint finishes are precise reproductions of the originals from the 1830s.

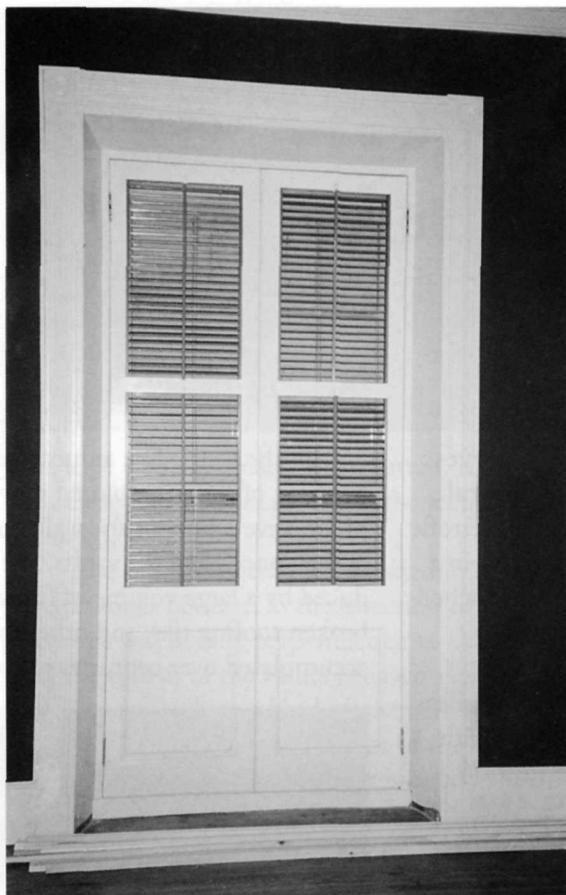
Typical, accurately restored historic jalousie doors that provide natural cross ventilation.

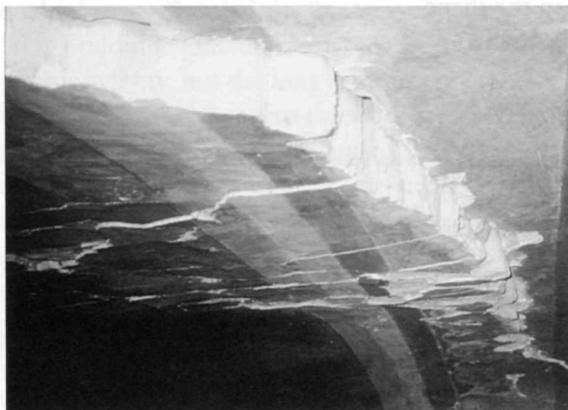
Large cracks in the vaults with relative movements of around 25 cm.

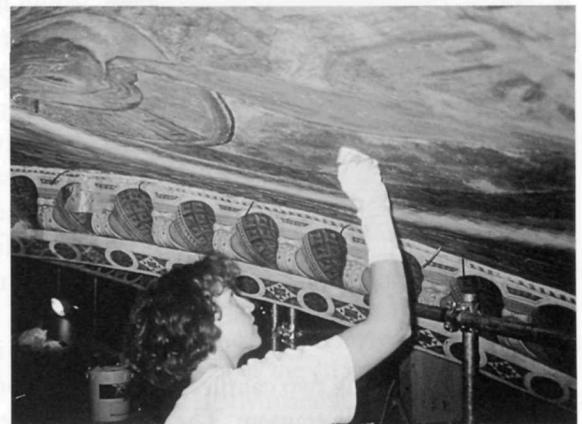
Suspension of the deformed kerbs (restraining straps) to the roof.

- Removing the huge load of the fill in the springer zones of the vaults;
- Filling the cracks with a salt-free mortar to limit possible damage to the frescoes, first taking the precaution of inserting a strip of polyurethane in the larger cracks to prevent the mortar from flowing out;

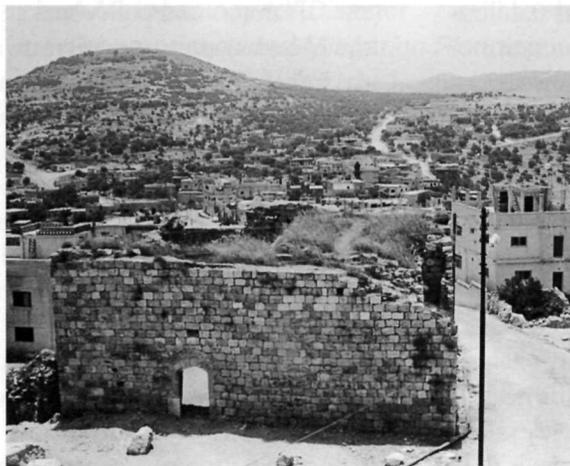
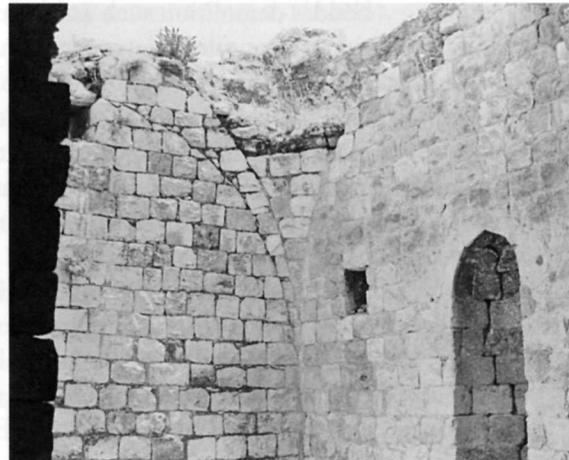
Exterior and interior views of the Zaidani Mosque of Tibneh in northern Jordan. The roof of the mosque has been severely damaged after the 1927 earthquake. The mosque, stands deserted, still waiting funding for its rehabilitation.
