Blue Duck Ships Store
Islesford
Little Cranberry Island
Hancock County
Maine

HABS No. ME-170

ADDENDUM TO:
BLUE DUCK SHIPS STORE
(Hadlock Store)
(Islesford Market)
Acadia National Park
Harborside on Hadlock Cove, Little Cranberry Island
Islesford vicinity
Hancock County
Maine

BLUE DUCK SHIPS STORE (Hadlock Store) (Islesford Market)

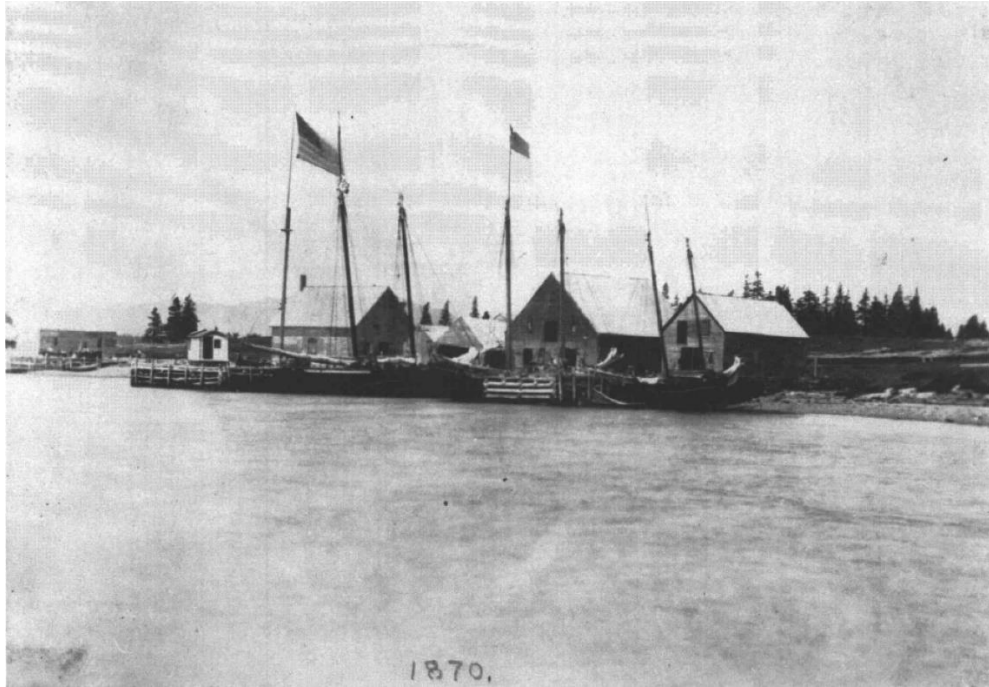
Figure 2: Waterfront view of The Blue Duck from the south, July 4, 1870.

The west façade, facing the water, originally had no windows and only the double doors. This is confirmed by the earliest known photograph of the building dated 1870 which shows the south and west facades fairly clearly. By 1893 a window had been added to the north of the door on the west facade. The doors and frames on the west, south, and east facades are apparently all original, with peaked casings over the doors (although hidden on the south end by the overlapping shingles). The single door in the northeast corner was most likely an original feature as well.

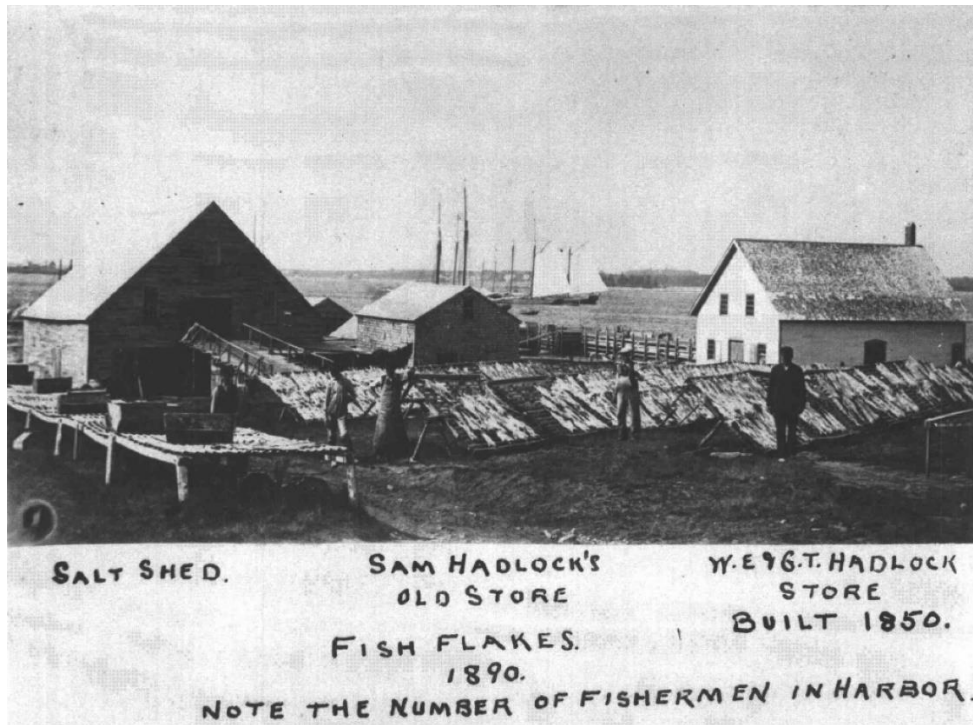
Figure 3: View of The Blue Duck from the southwest, showing south and east elevations, when it operated as W.E. & G.T. Hadlock Store; B. T. Williston, ca. 1880s.

Williston, B.T. "View from the Northwest," photograph of the Blue Duck, view of the south and east, showing original windows on the south gable and no windows on the east wall, ca. 1880s; copy negative, Acadia National Park Archives.

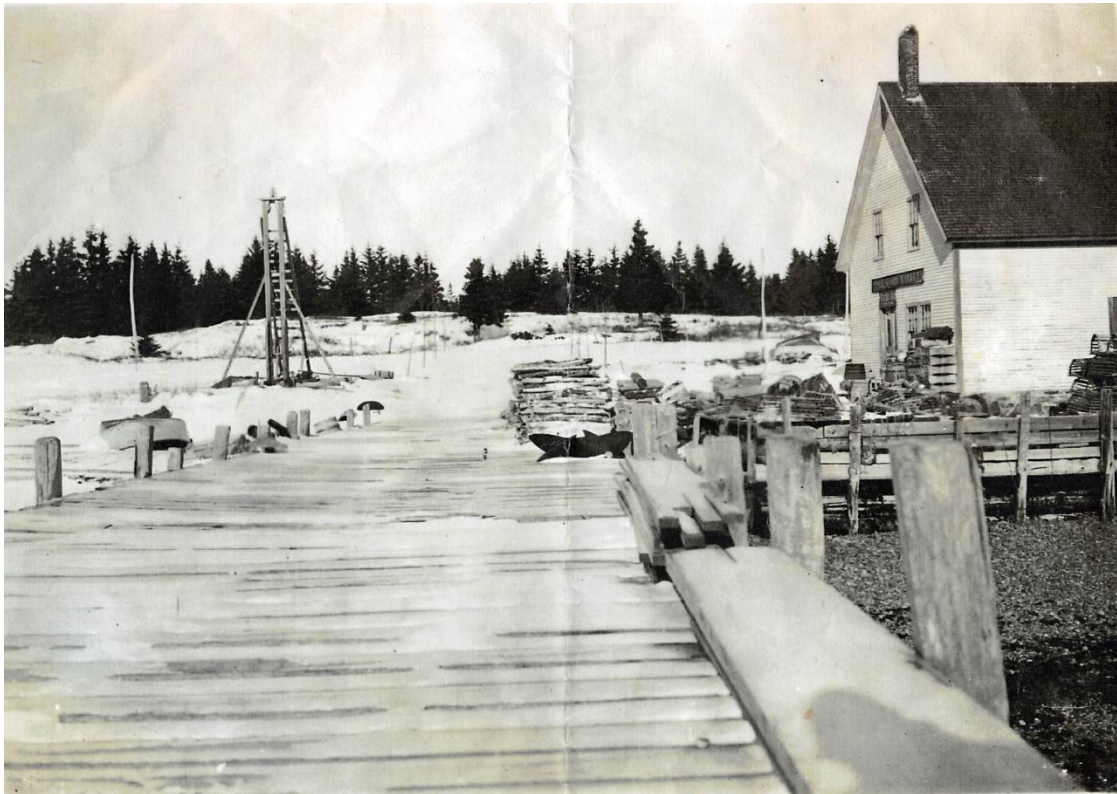
Figure 4: View of the former pier and the north gable end of The Blue Duck, ca. 1895.

Ibid., "View of Southwest End of Building," photograph of the Blue Duck, looking south, showing original 6-over-6 lights and chimney cap. Also showing pier associated with the Blue Duck no longer extant, ca. 1895; copy negative, Acadia National Park Archives.

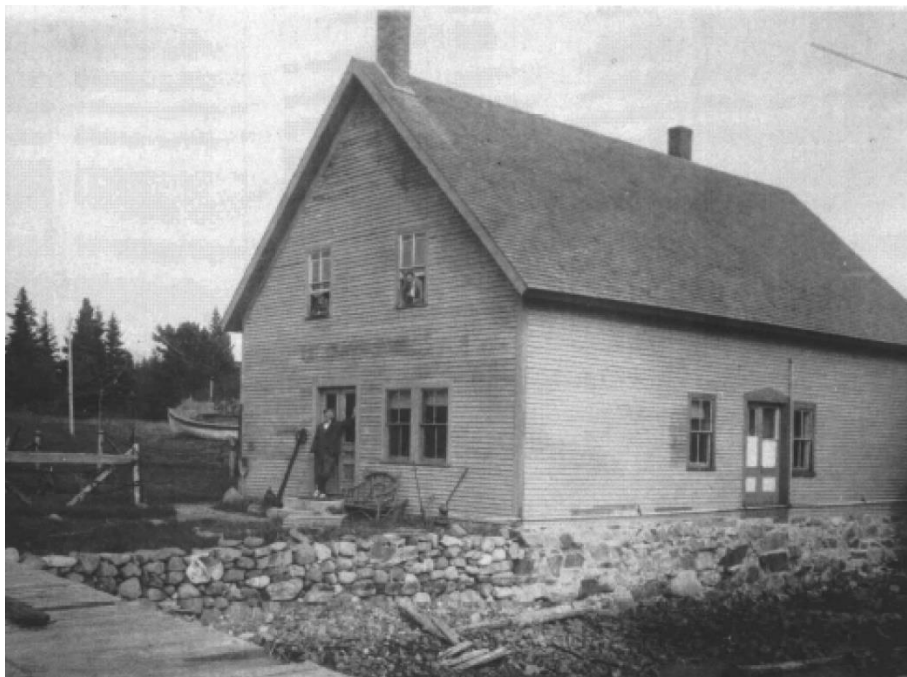
Figure 5: View of William Sawtell standing in north doorway of The Blue Duck in 1916.

Ibid., "William Sawtell Standing in West Doorway of The Blue Duck," photograph of the Blue Duck looking south showing changed fenestration on the north gable-end, added chimney to the south and current configuration of windows and doors, ca. 1916; copy negative, Acadia National Park Archives.

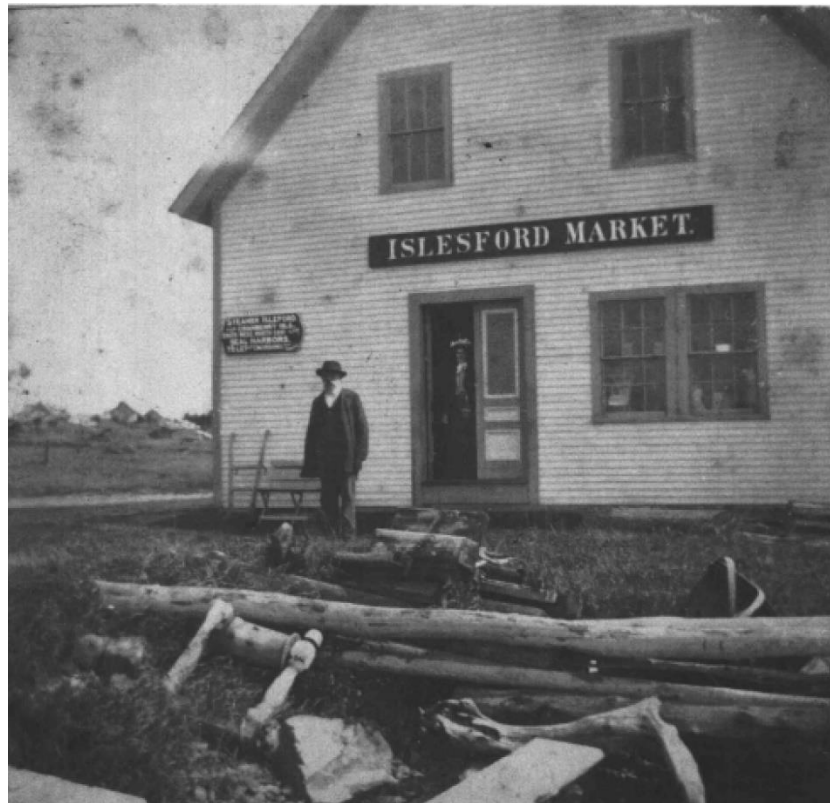
Figure 6: View of the north gable front of The Blue Duck as Islesford Market in 1900.

There is a patched area to the east of the north gable-end exterior doors (visible from both the inside and outside) which shows where these double doors replaced earlier windows. The windows were then placed together on the west side of the door in their current configuration. This patch corresponds in height to an original window frame, and is directly

below the second-floor windows (which have been replaced by taller windows but have not been moved).

- b. Windows and shutters: Originally, there were no windows on the east and west sides. Earlier six-over-six double-hung sashes were replaced between 1908 and 1910 by the current two-over-two double-hung sashes with plain wood frames. Two sets of two-over-two double-hung sashes were added to flank the original double doors on the east façade around 1910. The double door on the west side, facing the water, had the window to the north added by 1893. The south gable-end is the only façade that retains its original door and window placement. Windows on the second floor are in their original location but the ones on the north gable-end were lengthened by 1919.

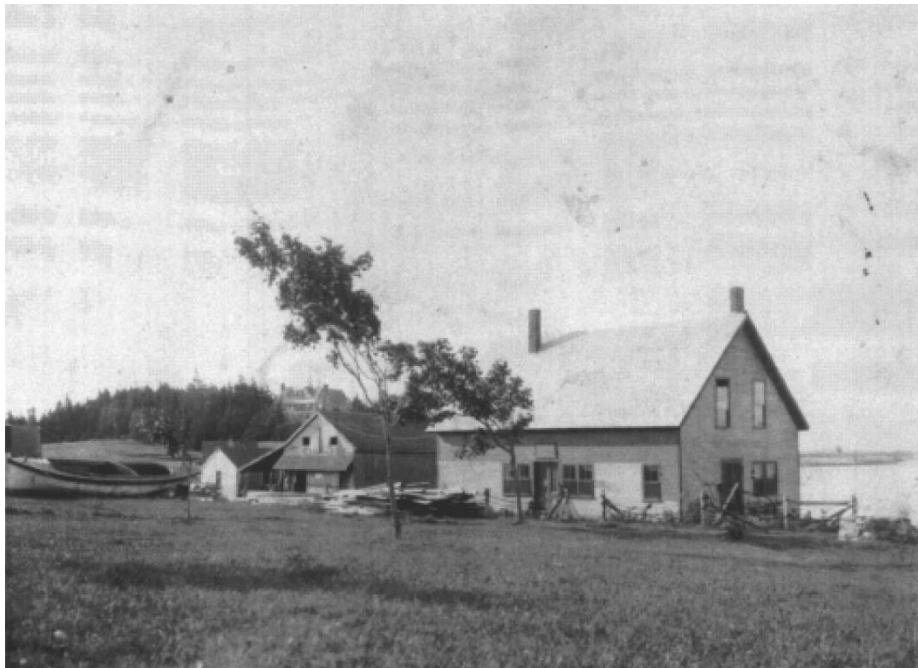
Figure 7: View of the north and east elevations of The Blue Duck in 1919.

Ibid., "View of Blue Duck from Northwest," photograph of the Blue Duck looking south and east, showing current windows and door on the east wall, ca. 1919; copy negative, Acadia National Park Archives.

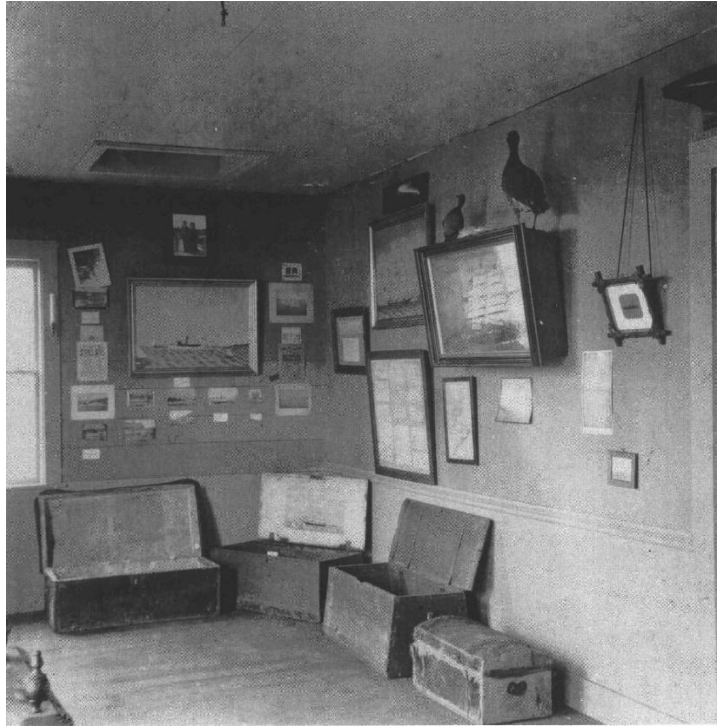
Figure 8: Interior view of The Blue Duck, North Room, looking east, 1919.

Ibid., "Interior View of North Room," photograph of the interior, north room looking east showing partition, wall and ceiling boards, ca. 1919; copy negative, Acadia National Park Archives.

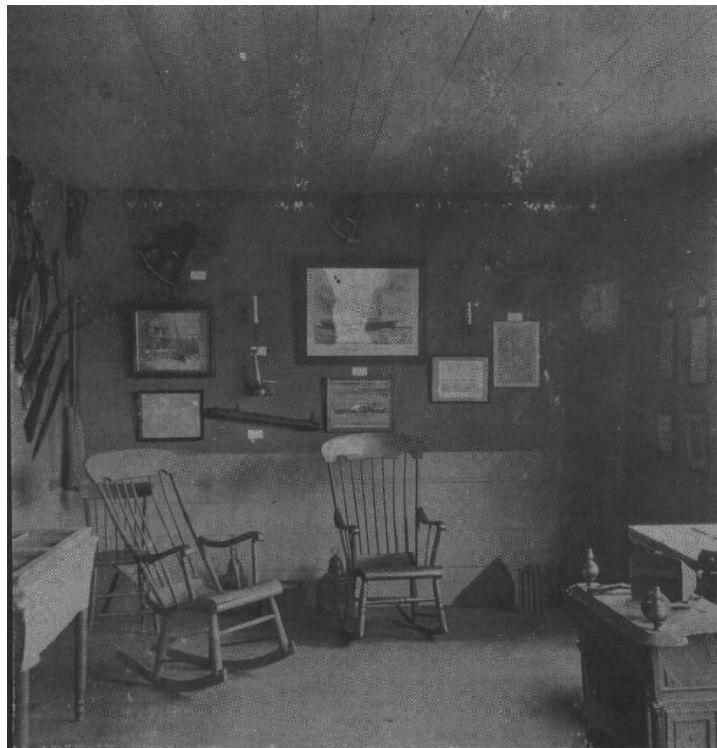
Figure 9: Interior view of The Blue Duck, North Room, looking west, 1919.

Ibid, "Interior View of North," photograph of the interior, north room looking west showing partition, wall and ceiling boards, and stove, ca. 1919; negative, Acadia National Park Archives.

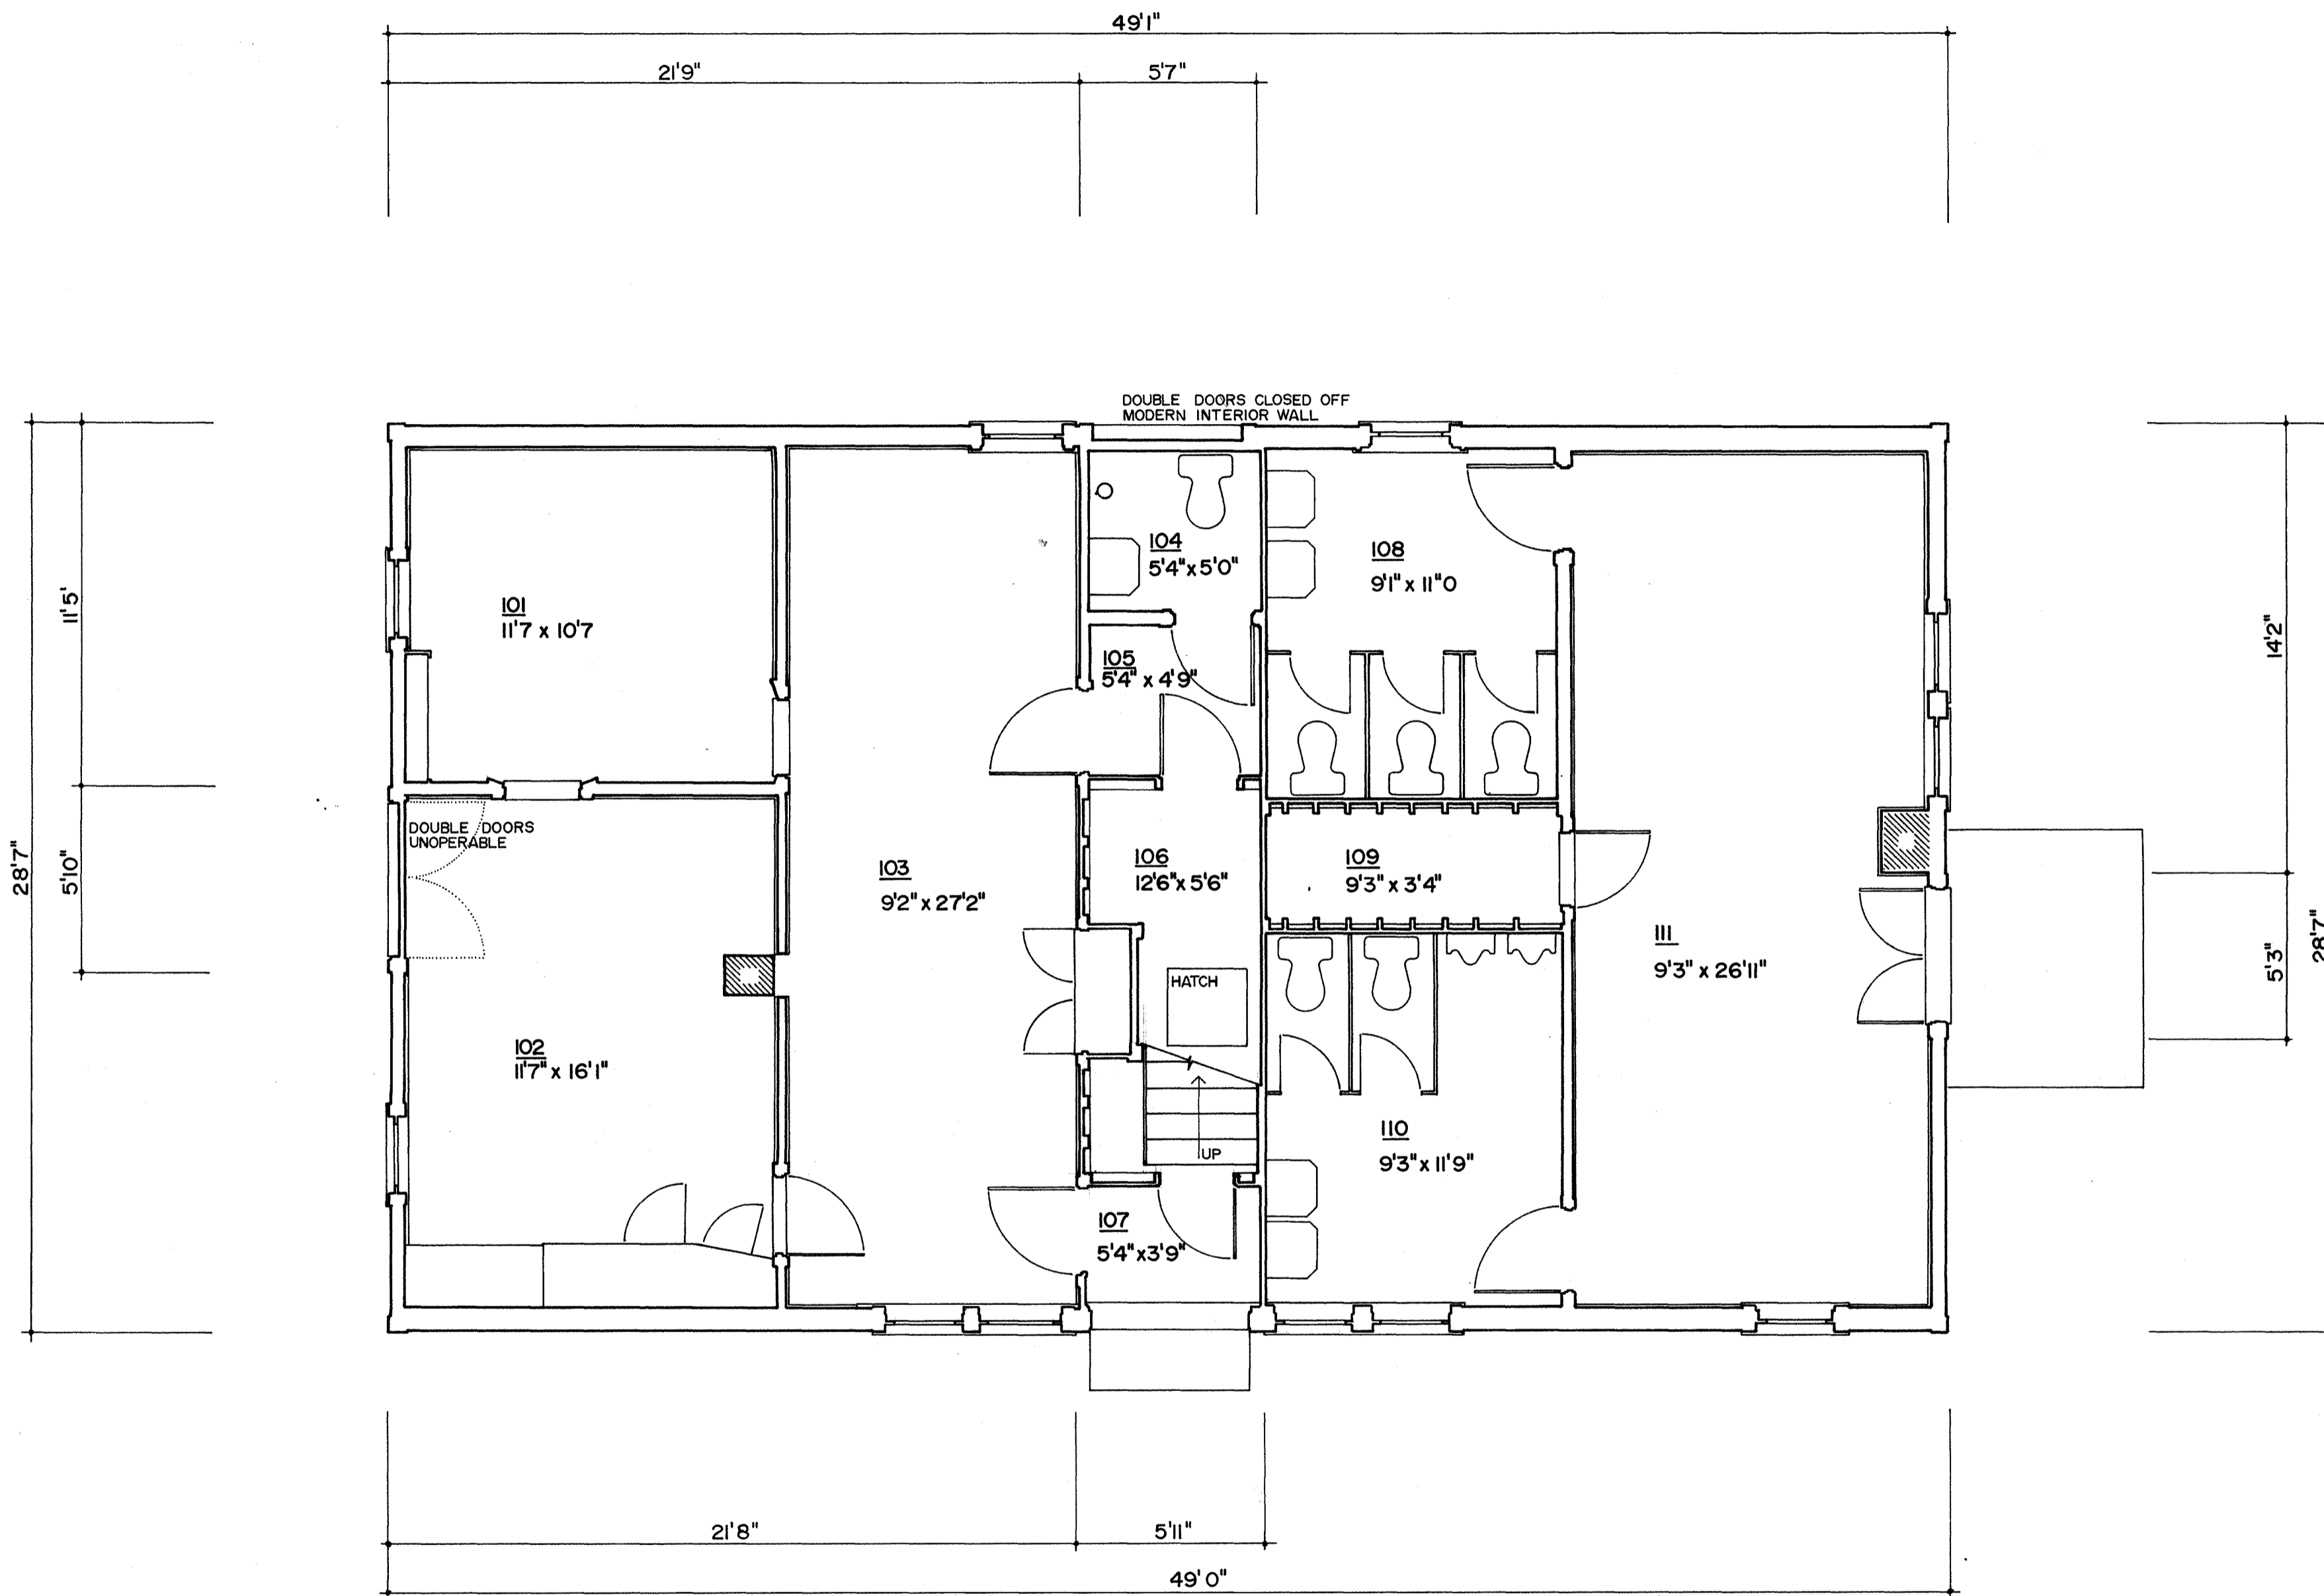
FIRST FLOOR PLAN

NOTE:
 ALL THRESHOLDS AS SHOWN.
 MODERN FIXTURES AND PARTITIONING IN
 ROOMS 108, 109, 110.
 MODERN INTERIOR WALL SHEATHING IN
 ROOMS 101, 108, 110, III.
