Apostle Islands National Lakeshore
Wisconsin

Hadland Fish Camp

Cultural Landscapes Inventory

June 2014

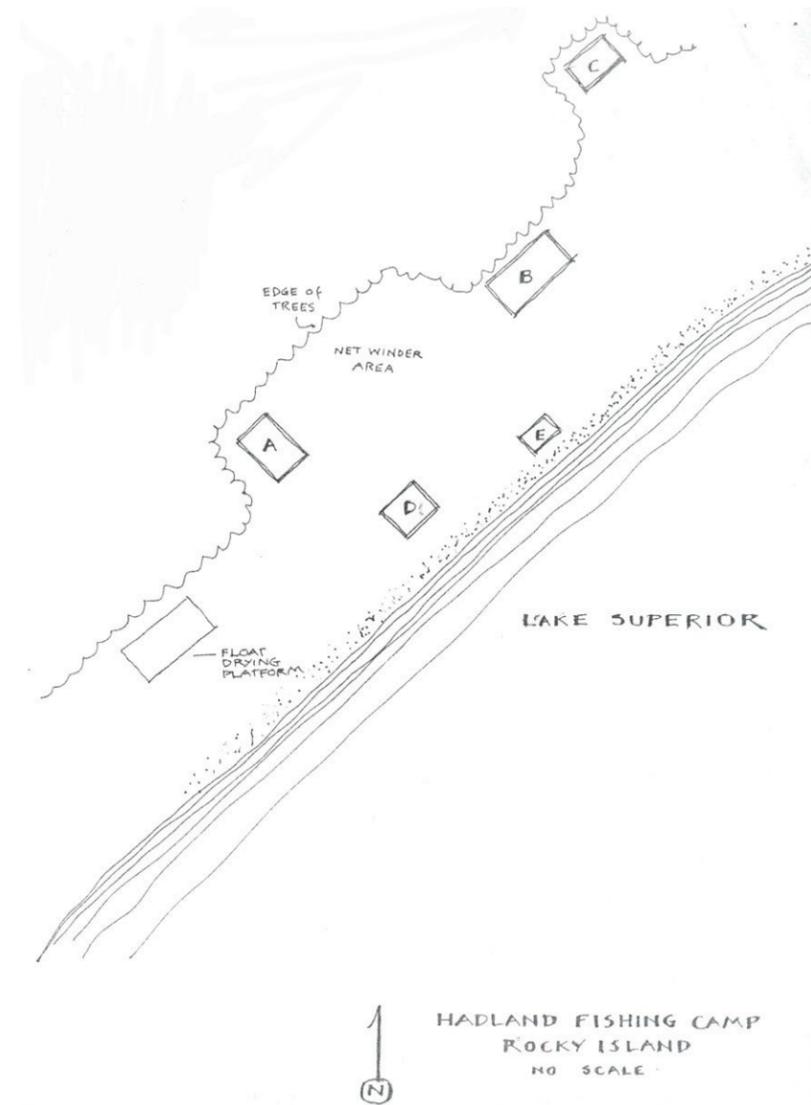
Site plan provided in National Register nomination; 'A' is the Fried Cabin, 'B' is the Hadland Family Cabin, 'C' is the Hired Man's Quarters, 'D' is the Storage Shed, 'E' is the Ice House. Buildings B-E are either collapsed or gone.

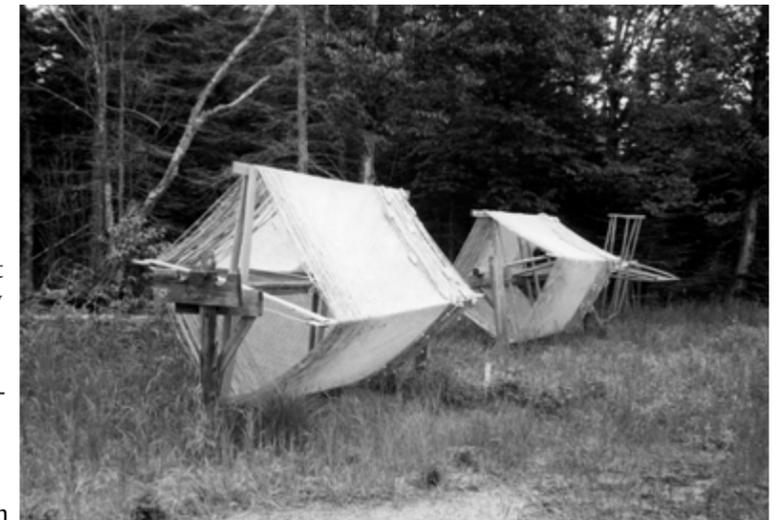
Gill net winders, view from the south, from Rocky Island Historic District nomination. (Parnes 1975)

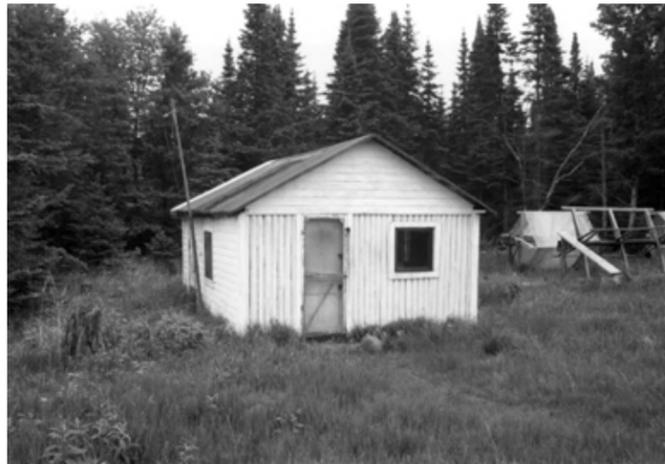
John Fried Cabin, with vertical log front and back, view from the southeast, from Rocky Island Historic District nomination. (Parnes 1975)

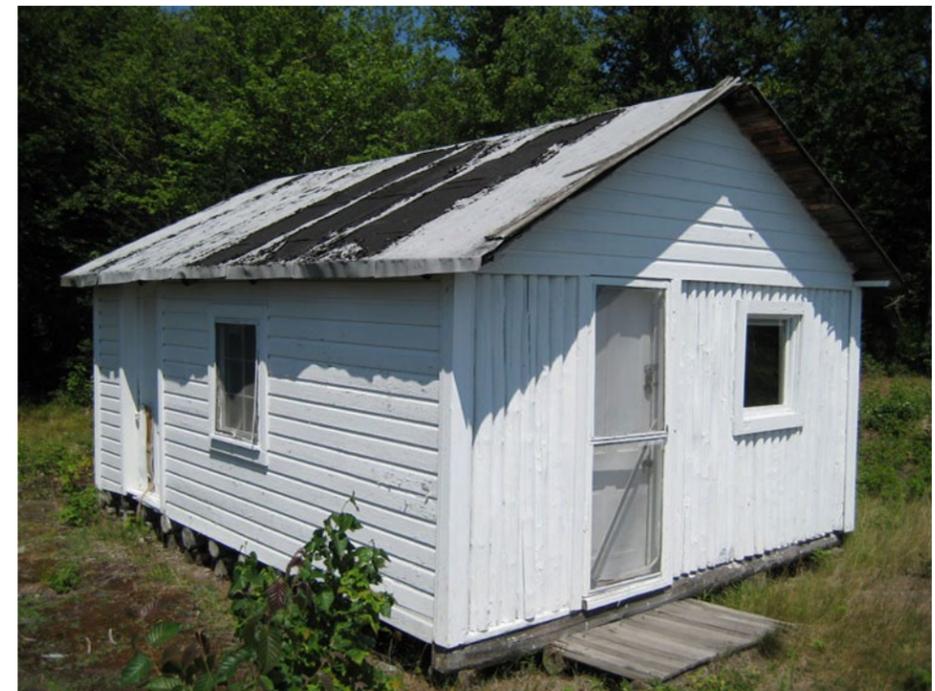
Associated Image Page Numbers in CLI: Page 28

The John Fried Cabin (Building A on NR nomination), constructed in 1932, is a single-story, one-room, gable-front structure resting on a horizontal log foundation. The gabled ends of the cabin are unique in that hand-trimmed logs are placed vertically, side by side, rather than horizontally. The side walls are frame construction with horizontal tongue-and-groove wooden siding. A smokehouse and storage shed have been added to the rear gable end. All the walls are whitewashed and the roof is covered with rolled asphalt. There is lap siding in the gable ends and panel doors on the south and west facades.

Feature:	John Fried Cabin	
Contributing?	Yes	
LCS Structure Name:	Rocky Island: John Fried Cabin (Hadland Fish Camp)	
LCS ID Number	6399	
LCS Historic Structure Number:	16103C	
Locational Data:		
Source: GPS- Uncorrected		
Point Type: Point		
Datum: WGS84		
Zone: 15	Easting: 677249	Northing: 45212647
Longitude: -90.666618	Latitude: 47.0435666

John Fried Cabin. (NPS 2010)

Although the site has been stabilized, significant deficiencies to landscape features such as the John Fried Cabin remain unresolved.

In September 2010, maintenance work on the Fried Cabin included the replacement of rotted sections of sheathing and re-roofing with with rolled asphalt. The new materials cost a total of \$1,200.

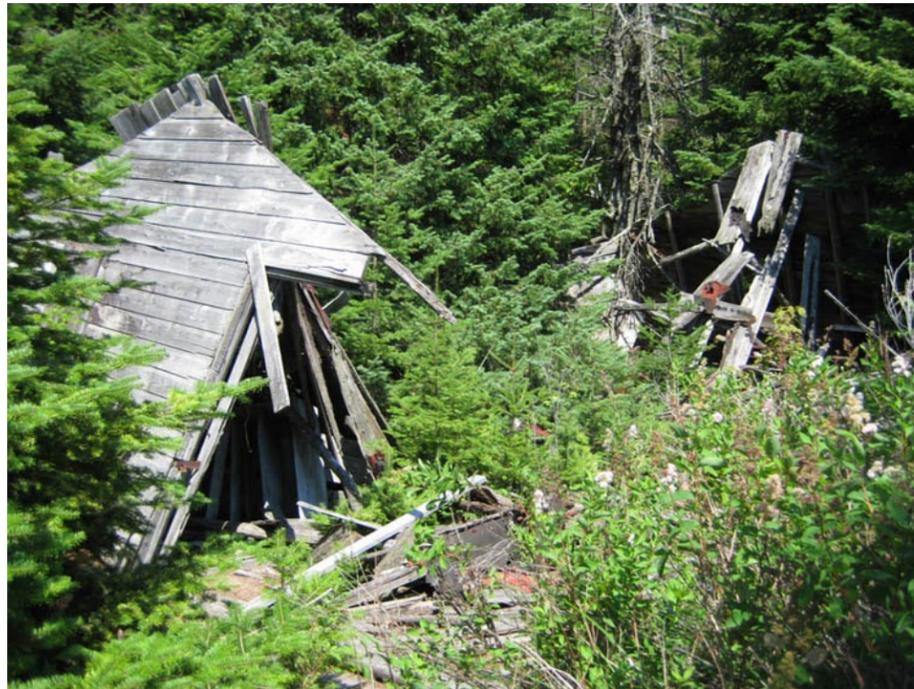
Associated Image Page Numbers in CLI: Page 29

The main family cabin (Building B on NR nomination) is in ruins. It was constructed in 1938 by Christian Hadland as the main residential cabin of the camp. It collapsed in the early 1980s and its remains are overgrown by vegetation.

Feature: Main Cabin Ruin
Contributing? Yes
LCS Structure Name: Rocky Island Hadland Fishing Camp Family Camp Ruin
LCS ID Number 6398
LCS Historic Structure Number: 16103B

Remains of Hadland Family Cabin. (NPS 2010)

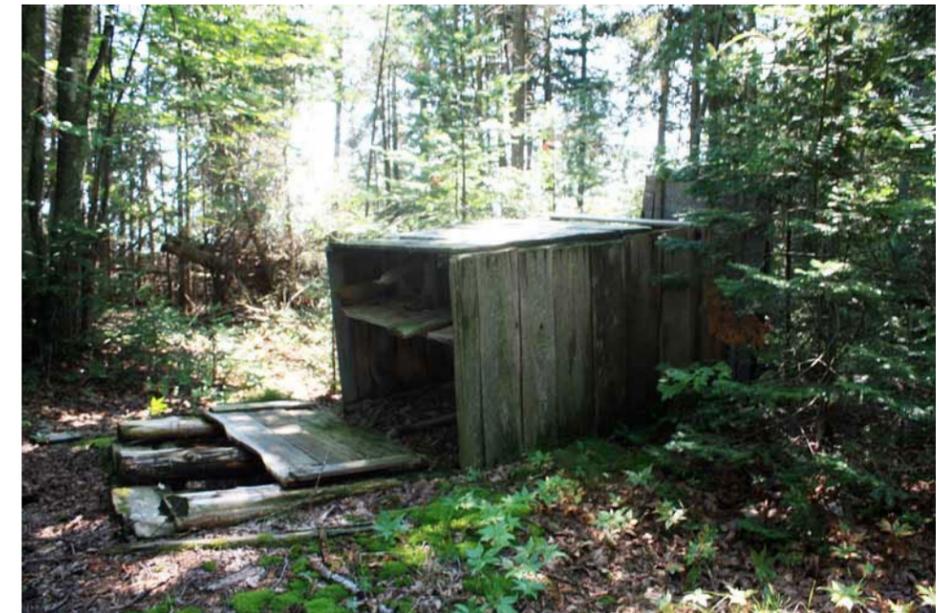
Associated Image Page Numbers in CLI: Page 29

The privy (non-contributing) is no longer standing and is lying on the ground. The two-hole privy has no door, but an opening that is the width of one door on the southwestern side. It has a shed roof covered in tarpaper. There walls consist of unpainted wood boards.

Feature: Privy
Contributing? No
LCS Structure Name: Not Currently Listed
LCS ID Number
LCS Historic Structure Number:

Topped over Privy. (NPS 2010)

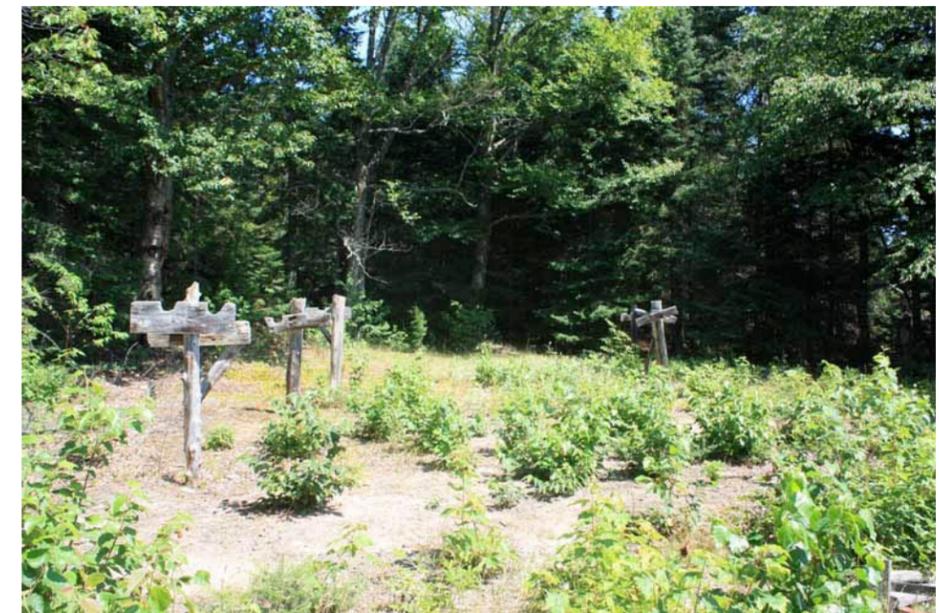
Associated Image Page Numbers in CLI: Page 33

Feature:	Net Reels	
Contributing?	Yes	
LCS Structure Name:	Rocky Island: Hadland Fishing Camp Net Reels	
LCS ID Number	6402	
LCS Historic Structure Number:	16103F	
Locational Data:		
Source: GPS- Uncorrected		
Point Type: Area		
Datum: WGS84		
Zone: 15	Easting: 677256	Northing: 5212661
Longitude: -90.666510		Latitude: 47.043687

Remains of Net Reels. (NPS 2010)

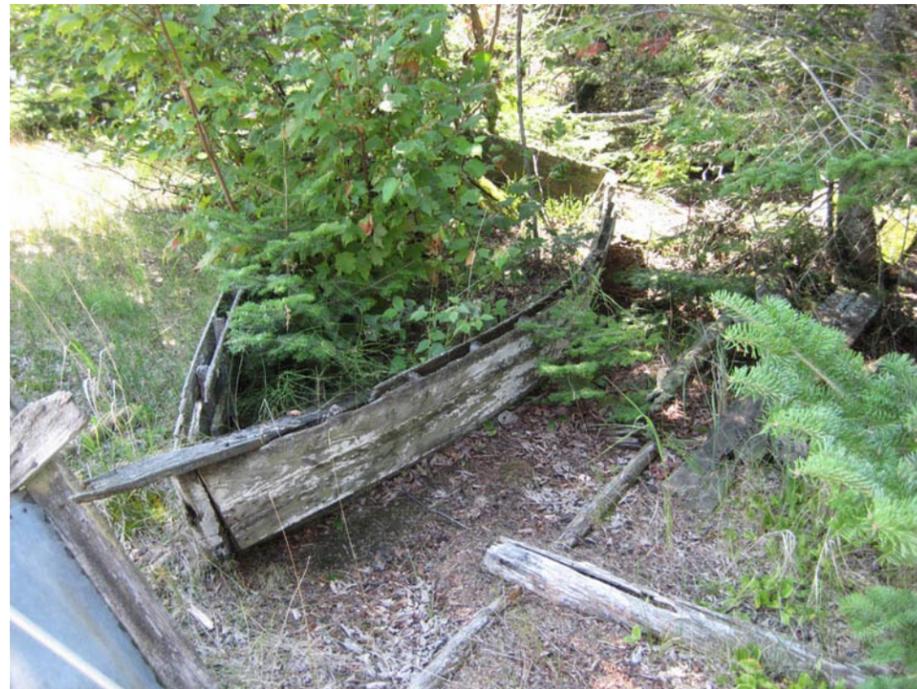
Associated Image Page Numbers in CLI: Page 34

Feature: Floating Drying Platform
Contributing? Yes
LCS Structure Name: Not Currently Listed
LCS ID Number
LCS Historic Structure Number:
Locational Data:
Source: GPS- Uncorrected
Point Type: Point
Datum: WGS84
Zone: 15 Easting: Northing:
Longitude: Latitude:

Skiff and remains of Float Drying Platform. (NPS 2010)

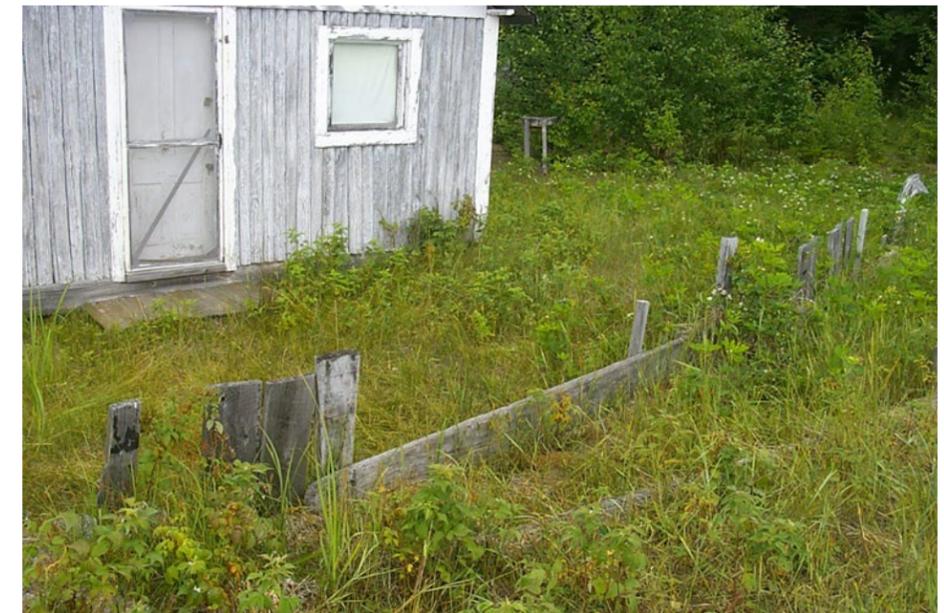
Associated Image Page Numbers in CLI: Page 34

Feature: Breakwater
Contributing? No
LCS Structure Name: Not Currently Listed
LCS ID Number
LCS Historic Structure Number:
Locational Data:
Source: GPS- Uncorrected
Point Type: Point
Datum: WGS84
Zone: 15 Easting: Northing:
Longitude: Latitude:

Breakwater in front of Fried Cabin. (NPS 2010)

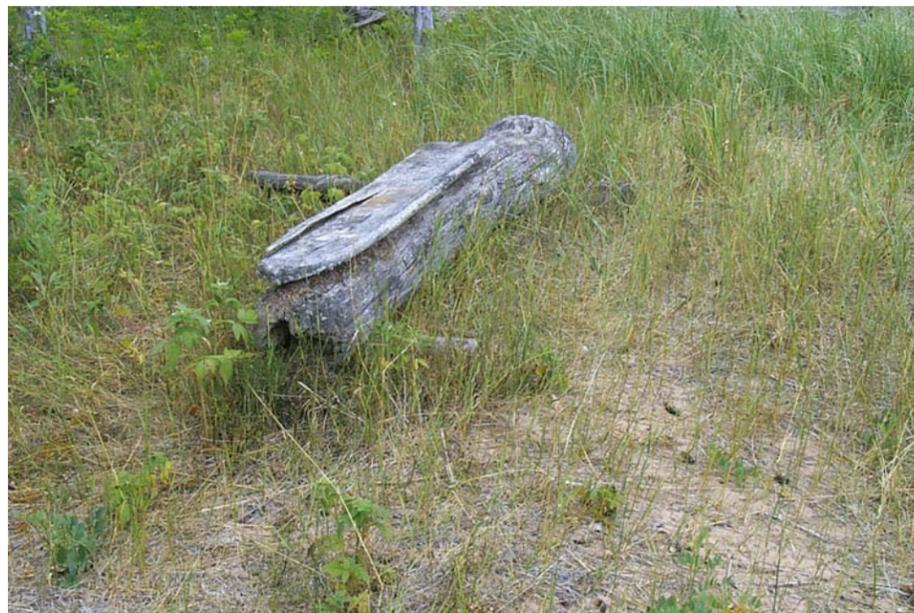
Associated Image Page Numbers in CLI: Page 34

Feature: Rustic Wooden Bench
Contributing? No
LCS Structure Name: Not Currently Listed
LCS ID Number
LCS Historic Structure Number:
Locational Data:
Source: GPS- Uncorrected
Point Type: Point
Datum: WGS84
Zone: 15 Easting: 677251 Northing: 5212638
Longitude: -90.666590 Latitude: 47.043481

Rustic Wooden Bench. (NPS 2010)
