National Park Service
U.S. Department of the Interior

Of Adobe, Lime, and Cement: The Preservation History of the San José de Tumacácori Mission Church (Part I - The Fabric)

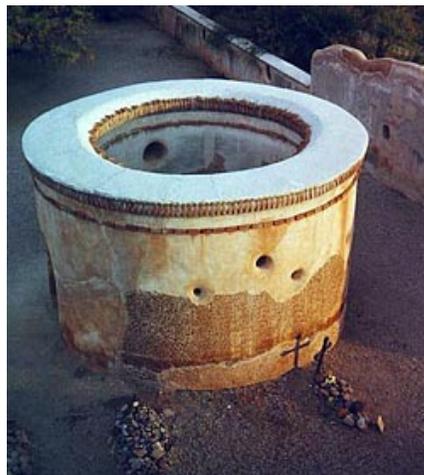
Tumacacori mortuary chapel, seen from above.

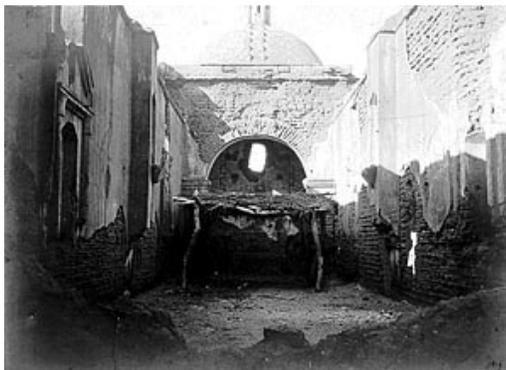
Ramada at the altar ca. 1905. Church is roofless. Rubble in foreground is the remains of the choir loft.

Following abandonment, the roof was probably the first part of the church to be destroyed, primarily due to neglect, but also from the stripping of roof beams by local ranchers. The earliest account of a roofless church comes from Mr. Hayes who visited Tumacacori in December of 1849; however this account is questionable.⁴ The church was not fully abandoned until 1848, but the roof may have started to collapse around 1848-1850. Thomas Davies, Superintendent of the Aztec Syndicate Mines, wrote that when he passed by in 1849, the church roof was *nearly* intact and "much of the interior in a good state of preservation."⁵ Samuel P. Heintzelman's journal of 1858 noted the church "now without a roof."⁶ Pinkley talked with two men who saw beams in place in the 1880's.⁷ One man saw a beam in place in 1882, the other in 1886, both said the beams were pine. By the time the 1889 Roskrige photos were taken there were no beams. If Pinkley's informants are correct, the last roof beams fell between 1886 and 1889. Most of the beams may have been taken from the roof by Joseph King and William Lowe, sometime in the 1860s-1870s.⁸ A photo from circa 1905 shows reuse of the roofless nave.

The 1887 earthquake was, at an estimated 7.4 magnitude, the largest historical earthquake of the southern geological Basin and Range Province. The epi-center was in the Teras Mountains of Sonora, near Bavispe, Mexico. The trembler caused destruction from Guayas, Mexico, to Tucson, Arizona, and as far east as El Paso, Texas. At towns as distant as Albuquerque, New Mexico, water in tanks spilled over, buildings cracked, chimneys were toppled, and railroad cars were set in motion. An observer in Tombstone reported sounds like prolonged artillery fire.⁹ A large crack in the interior west wall of San José de Tumacacori Mission Church was most likely initiated by the earthquake. It also damaged the base of the façade columns, and weakened the pediment and the choir loft.

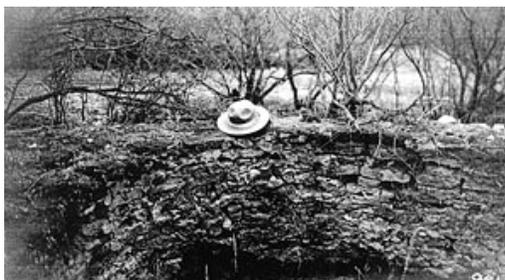
C. E. Peterson's photo of the lime kiln in 1930.

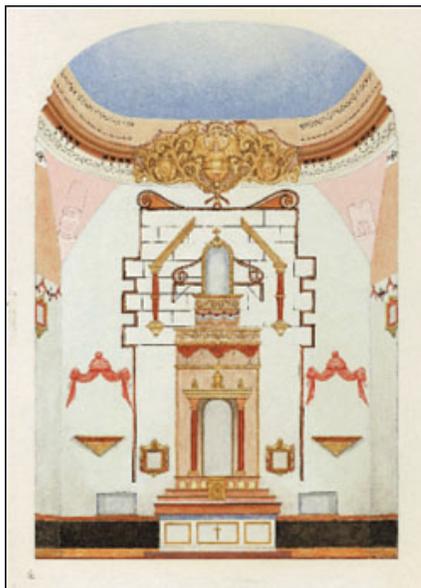
Trujillo's reconstruction of the sanctuary's north wall and the location of the hole repaired by Pinkley in 1921. (Drawing by Jimmie Trujillo, 1952)
