<h1 style="text-align: center;">Archeology Program</h1>	<p style="text-align: right;">National Park Service U.S. Department of the Interior</p> <p style="text-align: right;"> <a href="#">SITEMAP</a> <a href="#">HOME</a> </p>
	<p style="text-align: center;"> <a href="#">▶ QUICK MENU</a> <span style="float: right;"><a href="#">◀ FEATURES</a></span> </p>

## Of Adobe, Lime, and Cement: The Preservation History of the San José de Tumacácori Mission Church (Part III – Garden and Orchard)

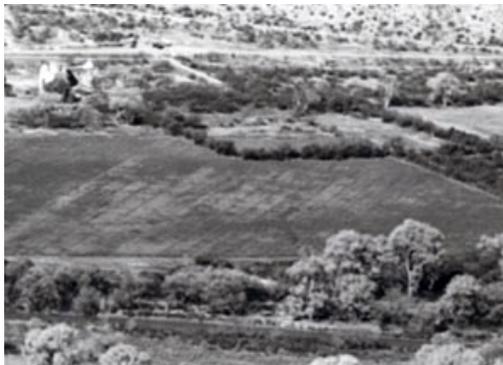
**Aerial photograph showing tree lines defining the garden walls in the upper right. Photo taken in 1936.**

Aerial photographs from 1936 show the original configuration of the garden walls. The square tree line marked the extent of the garden; today, these trees are some of the tallest and oldest on the mission grounds. The north wall of the garden was destroyed sometime after 1949, but the southeast corner was avoided during plowing of the surrounding agricultural fields.

Remnants of the garden walls, described in travelers' accounts and surveyed by archeologist Paul Beaubien in 1934, formed a rough orthogonal shape on three sides. The fourth side (west) connected to the north wall by a diagonally-indented fifth wall, which eliminated the northwest corner. The south and west sides incorporated walls of other buildings in places, resulting in double walls.<sup>11</sup> This diagonal wall is a perplexing aspect of the garden. Why was the northwest corner diagonal rather than squared? Did this wall reduce construction costs, or does it represent a purposeful design choice related to planting or some other function?

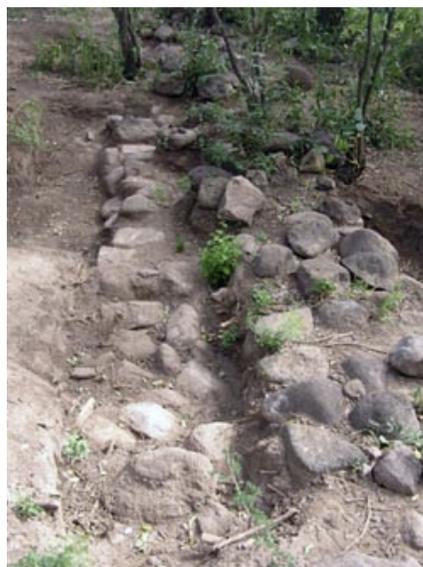
**Photo of the foundation for the south garden wall showing lower ledge or footing along the interior. Adobes were probably stacked on the portion of the foundation showing at the surface in the right.**

Archeological investigation of the garden wall began in 2004 with assistance from the NPS Western Archeological and Conservation Center. Work began on the south garden wall where river-cobble foundation stones are exposed at the surface. Two 3' x 3' units were excavated adjacent to the foundation stones; one along the interior and another along the exterior. No cobbles were found in the unit along the exterior of the wall, but the excavation of the interior unit revealed cobbles 20 cm below the ground surface. The cobbles along the interior appear to be a ledge or step in the lower sub-surface portion of the foundation.

It is unclear why the cobble foundation for the south wall was constructed with a ledge. The ledge may have supported buttresses to help strengthen the wall. An example of the use of buttresses to strengthen a garden wall was discovered in the 2004 excavations at San Agustine, in Tucson. Buttresses were placed at regular intervals along the interior of the wall.<sup>13</sup> As more units were excavated along the interior of the Tumacácori south garden wall, however, the rock ledge was found to continue along the full extent of the exposed 60 feet of foundation.

If the cobble ledge isn't a buttress, could it be the edge of the foundation for an earlier wall? The cobble foundation showing at the surface appears to be tied into the lower cobble ledge however. If all of the cobbles are part of one foundation, the south wall foundation is 4.5 feet wide, which is an extremely wide foundation for a simple garden wall.

The south and east walls may have been repaired multiple times. Although the garden area does not flood today, high intensity floods were frequent in the past. It is probable that the ledge of the south wall foundation represents an attempt to strengthen the south wall by providing a footing or toe for the foundation on which the adobe wall was built. Perhaps, at some time in the past, the south wall was perpendicular to the flow of rushing water, causing increased adobe erosion and subsidence of the wall, requiring it to be rebuilt. Subsequent flooding and wind erosion destroyed the adobes of the south wall after it was rebuilt. The east wall remained intact longer because it was parallel to the flow of rushing water during floods.

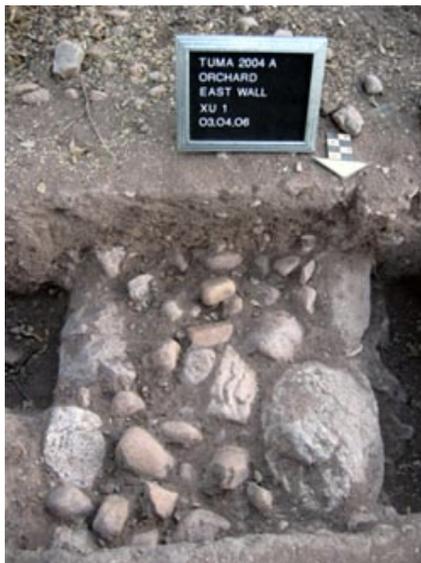
East wall foundation after excavation.

The construction method for the foundation of the east garden wall significantly differs from the south wall. The east wall foundation is only about 2 feet wide, and was constructed using the core and veneer technique of placing large river cobbles on the sides and filling the space between with smaller cobbles and mud. In contrast, the foundation stones for the south wall are size-sorted and the core and veneer technique was not used. The east wall foundation stones are not exposed at the surface, instead they are covered by a mound of adobe melt.

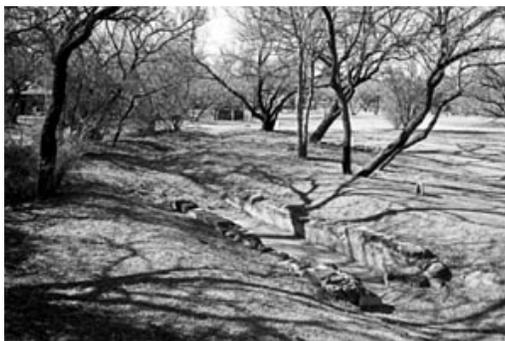
The *compuerta* or *lavandaria* just inside the south garden wall.

Wrightson noted that "the *acequia* [sic] passes through this [the garden wall], and here is the remains of a washing vat and bathing place."<sup>17</sup> The washing vat is the diversion box or *compuerta* located 14' inside the south orchard wall. This feature was first identified by Beaubien in 1934. The structure measures 4'1" wide by 13'10" long, with a 3" dip in the ends of the north and south floor. It is constructed of fired adobe bricks and hydraulic lime plaster with a crushed brick (*cacho pesto*) finish. Although its function is unknown, the feature probably served to impound water by constricting and slowing ditch flow in order to create sufficient head for lateral ditches that feed gardens and orchard trees.

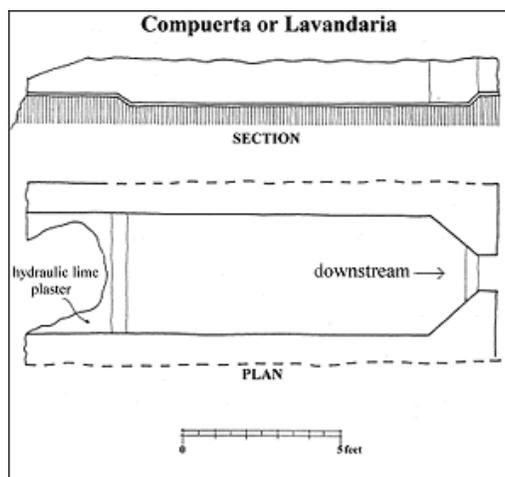
Plan and section of *compuerta* attached to *acequia*.

The *compuerta* may have also served as a *lavandaria*, or laundry tank. The *lavandaria* was a common element of mission gardens in the Pimeria Alta and Alta California.<sup>18</sup> In 1849, Forsyth described the feature as one of the "beautiful baths," suggesting there was more than one *compuerta*.<sup>19</sup> Although only one has been found, it is probable that numerous diversion boxes were needed along the *acequia madre* to feed lateral ditches for wheat and corn fields.
