# Archeology Program

National Park Service  
U.S. Department of the Interior

## The History of the Spring Enclosure, Fort Davis National Historic Site

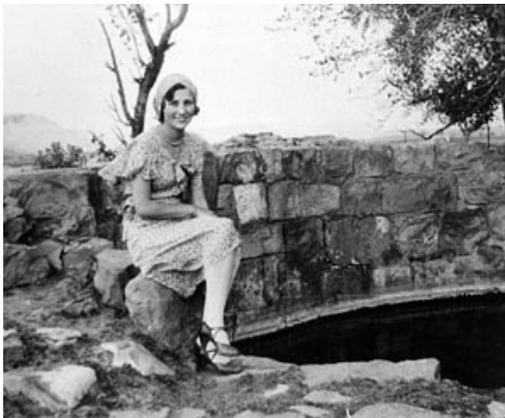
The spring enclosure ca. 1930. Photograph probably by Frank Higgins, courtesy of Fort Davis National Historic Site.

Following the abandonment of the fort, many buildings fell into disrepair. A 1916 photograph of the spring enclosure shows only the western portion of the wall still standing. The interior is full of dirt and there is no evidence of water. In contrast, a photograph taken sometime around 1930 shows the interior of the spring cleaned of debris and full of water, though the wall had not been repaired. It seems highly likely that the clean-up efforts were conducted by Jack Hoxie, a movie man from Hollywood who saw Fort Davis as a business opportunity. Various articles in the local newspaper, the *Alpine Avalanche*, between 1929 and 1932 outline his plans to restore sections of the fort and build, in various combinations and to various specifications, a rodeo ground, a tennis court, a golf course, and other resort amenities.

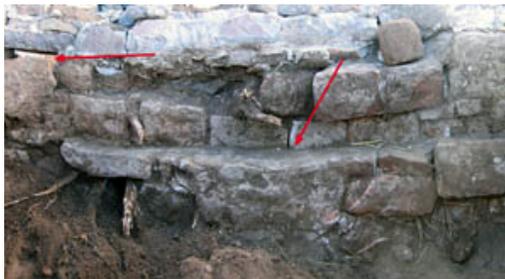
The south wall of the spring enclosure after excavation. The left arrow points to the outlet in the improved spring enclosure, the right arrow to the top of the old spring enclosure. Photograph courtesy of Emily J. Brown.

The water table in this part of Texas has been falling and the spring stopped flowing several years ago; we were able to dig down into the spring enclosure without encountering ground water. Although we did not dig down to the very bottom of the masonry wall enclosing the spring, we did reveal two separate episodes of construction. Below the wall that extends above the ground surface today was an older enclosure made from much smaller, generally unshaped stones. There was an outlet on the north side, and the top of the stones was capped with a thin layer of concrete.

The stonework that was added to this was made of much larger, shaped stone blocks laid in a mortar heavy in lime. It appears that this later construction was built around and above the older one, completely enclosing and significantly enlarging the overall structure. There is an outlet in the southeast side, complete with a stone slab paving the bottom of it, which allowed the water to flow swiftly out at a steep angle.

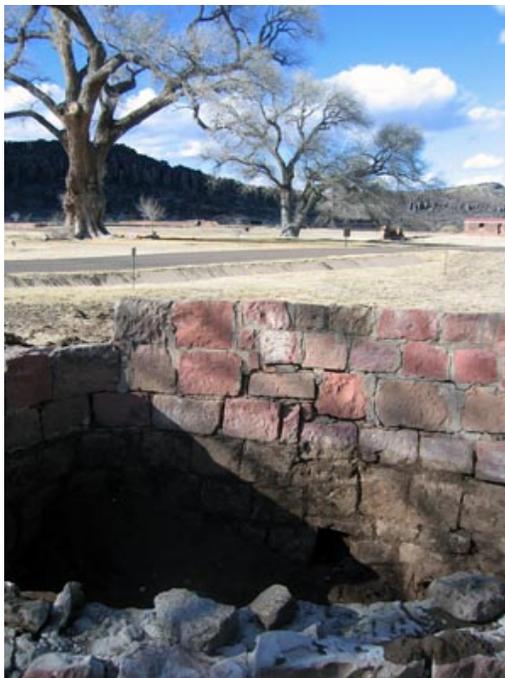
Overview of the spring enclosure after excavation. Photograph courtesy of Emily J. Brown.

If we look at the changes evident in the later additions to the original spring enclosure, they follow the Post Surgeon's recommendations exactly. The new spring enclosure essentially encased the other in a large, impermeable wall. The lime-based mortar would have sealed it better, the height certainly would have restricted access by animals and even people, and the outlet was high in the wall and steep so that water could not flow back in. In this case, the archeological record verified the evidence in the historical records and provided the details on the construction that the historical records were lacking. The problems of obtaining water in sufficient quality and quantity was a reoccurring theme over the course of occupation of the fort. The story of the spring enclosure provides a window into one aspect of daily life at the fort and highlights the importance the army placed on a clean, reliable source of water in the challenging desert environment of western Texas.
