ARCHEOLOGICAL ASSISTANCE PROGRAM
Technical Brief No. 1

FILTER FABRIC:
A Technique for Short-term Site Stabilization

By Robert M. Thorne
Center for Archaeological Research, University of Mississippi

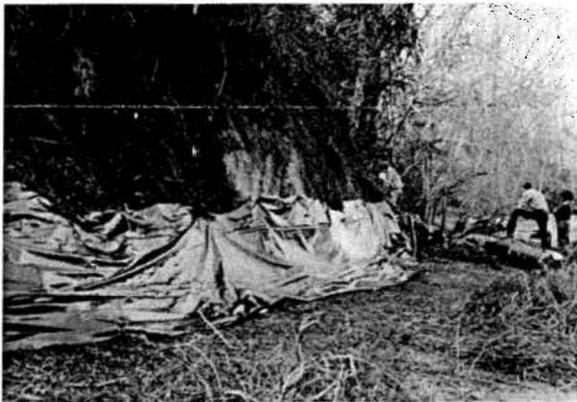
Figure 2. Installation of underliner

underliner would be to protect the portion of the fabric that would be submerged by the lake water. It was considered possible that the submerged fill material in the mound would be melted during the period of submersion and the silt sized particles would then be trapped in the pores of the fabric. Filling of the pores would not only retard the passage of rainwater during low water periods, but the accumulated soil would add weight to the fabric. This added weight would then in turn put additional stress on the pins that hold the fabric in place. To prevent this situation from developing, an underliner of black polyethylene (6 mils) was installed along the face of the mound to a height of 4 ft, well above the high water line on the face of the mound.

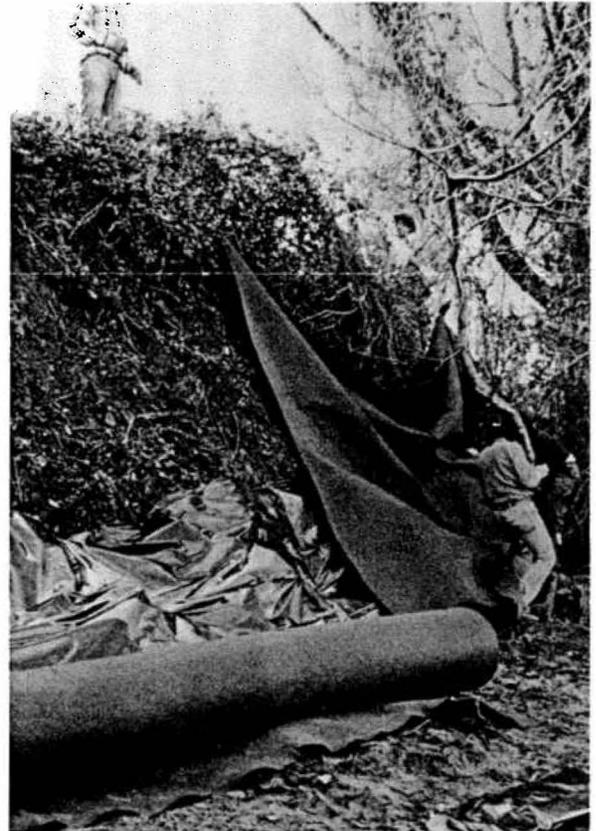
Figure 3. Installing filter fabric

Installation of the filter fabric was accomplished by cutting appropriate lengths of material off the roll and draping each piece down the cutbank like a curtain. The fabric measures 14.5 ft wide and can be cut to appropriate lengths with a sharp knife. Scissors are not recommended because the fabric will compress and pinch between the scissor jaws. In addition, the cloth will quickly dull the cutting edge of any implement, making frequent resharpening necessary.

The first piece of the material was installed on the downstream end of the bank and pinned into place using 18 inch steel pins that have a 1 1/2 inch washer affixed to the top. This washer keeps the pins from pulling through the fabric. Additional pieces of the fabric were added with a 6 to 8 inch overlap at the joints. Once all of the pieces had been properly located and temporarily pinned, additional pins were added at strategic points to insure that the fabric

conformed to the undulations of the cutbank. Obviously, the specific installation progression that was employed at Huffine Island will likely have to be adjusted to particular resources being treated in other places.

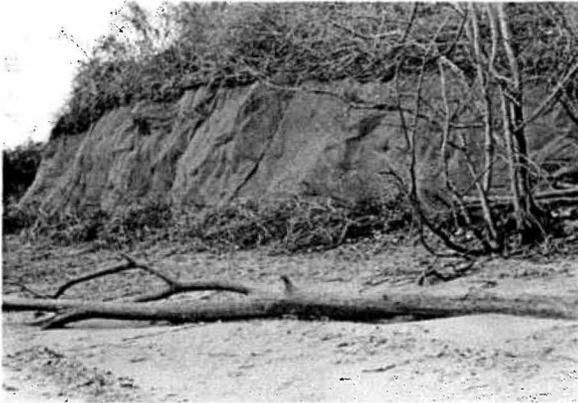
Figure 4. Present appearance of site

At Huffine Island, monitoring is completed on a quarterly basis. Responsibility for completion of the inspection process is shared by both the Center and TVA. On the basis of these regular inspections it will be possible to determine if the predicted five year life of the fabric will be reached. If and/or when failure of the material becomes evident, a new effort to further protect the site will be initiated. The material at Huffine Island has been in place for a year at this writing and is functioning in an excellent fashion.
