Subject: Roof Replacement on Bunkhouse at Serpentine Hot Springs, Bering Land Bridge National Preserve

Historic name: Serpentine Hot Springs Bunkhouse

This document is to ascertain the stand-alone significance of the Serpentine Hot Springs Bunkhouse outside of previously being determined non-contributing to the Iyat Traditional Cultural Property (BEN-00168). This document in no way impacts the already determined boundaries or significance of the Iyat TCP.

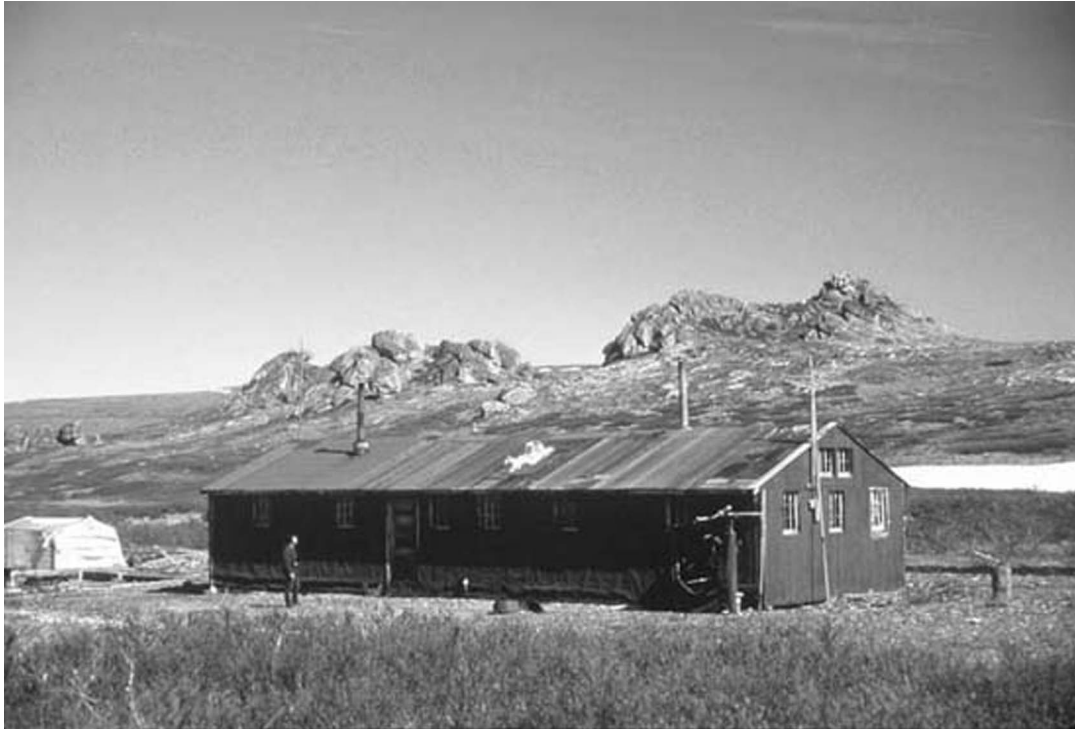
Figure 1: Article, The Nome Nugget, Wednesday, February 20, 1946, Page 6

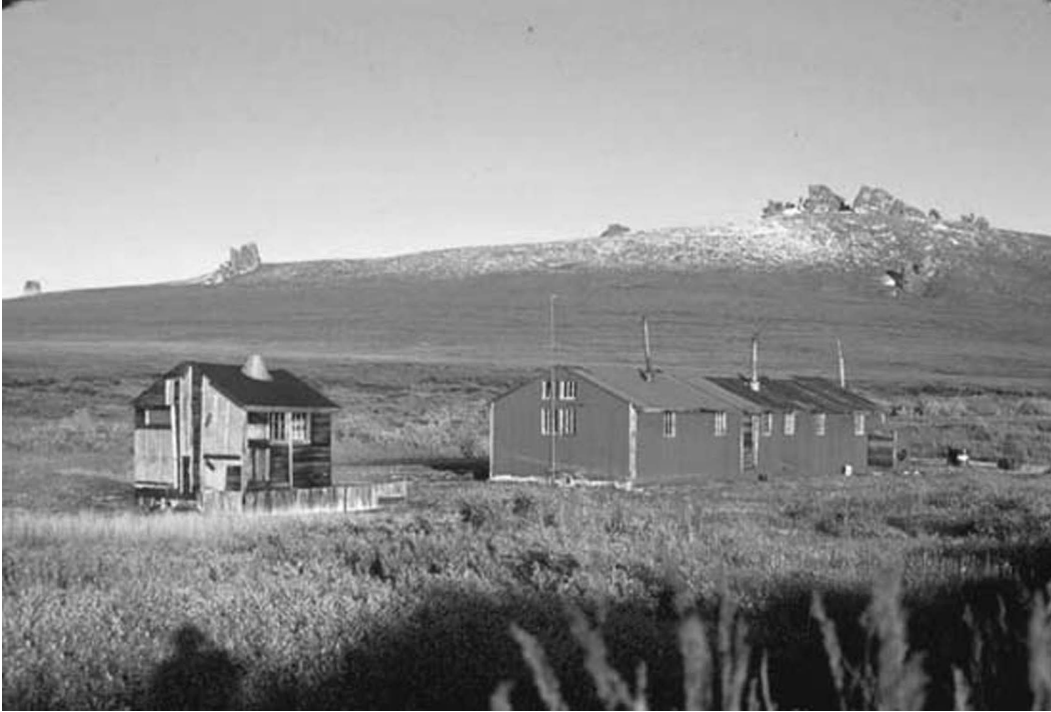
Figure 2: Bunkhouse, pre-1976, note tent over hot springs area, CLI Program Files

Figure 2: Bunkhouse, pre-1976, note tent over hot springs area, CLI Program Files

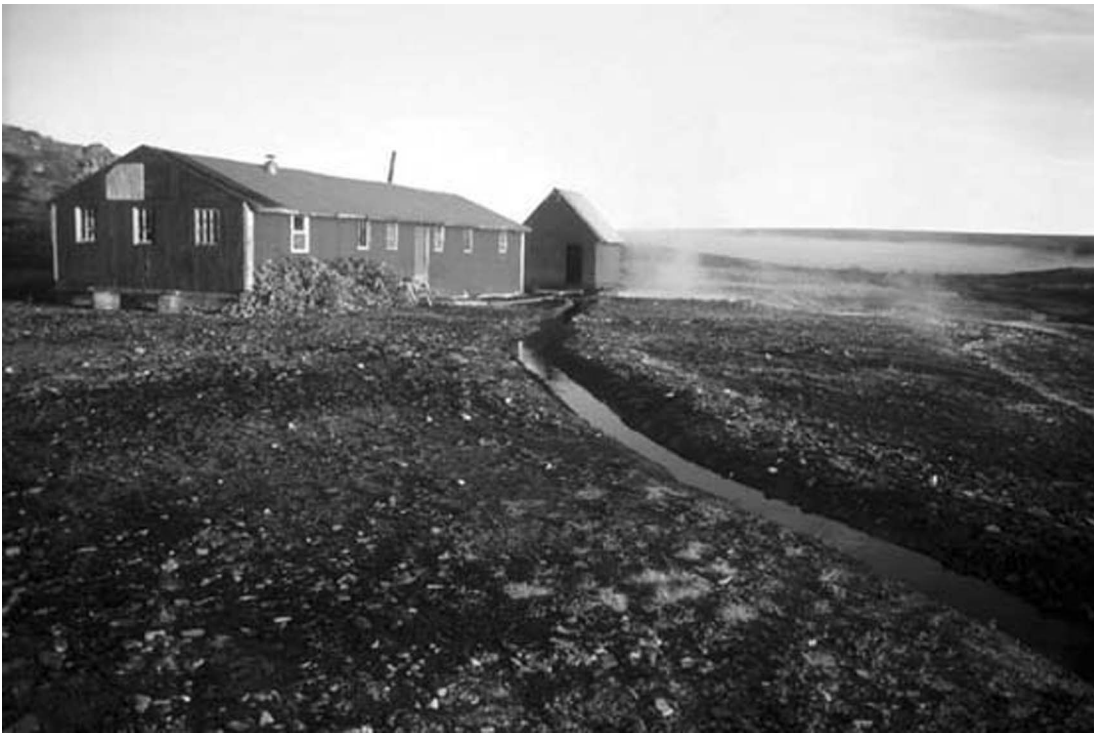
Figure 3: Bathhouse and Bunkhouse, pre-1976 due to old bathhouse in photograph, CLI Program Files

Figure 3: Bathhouse and Bunkhouse, pre-1976 due to old bathhouse in photograph, CLI Program Files

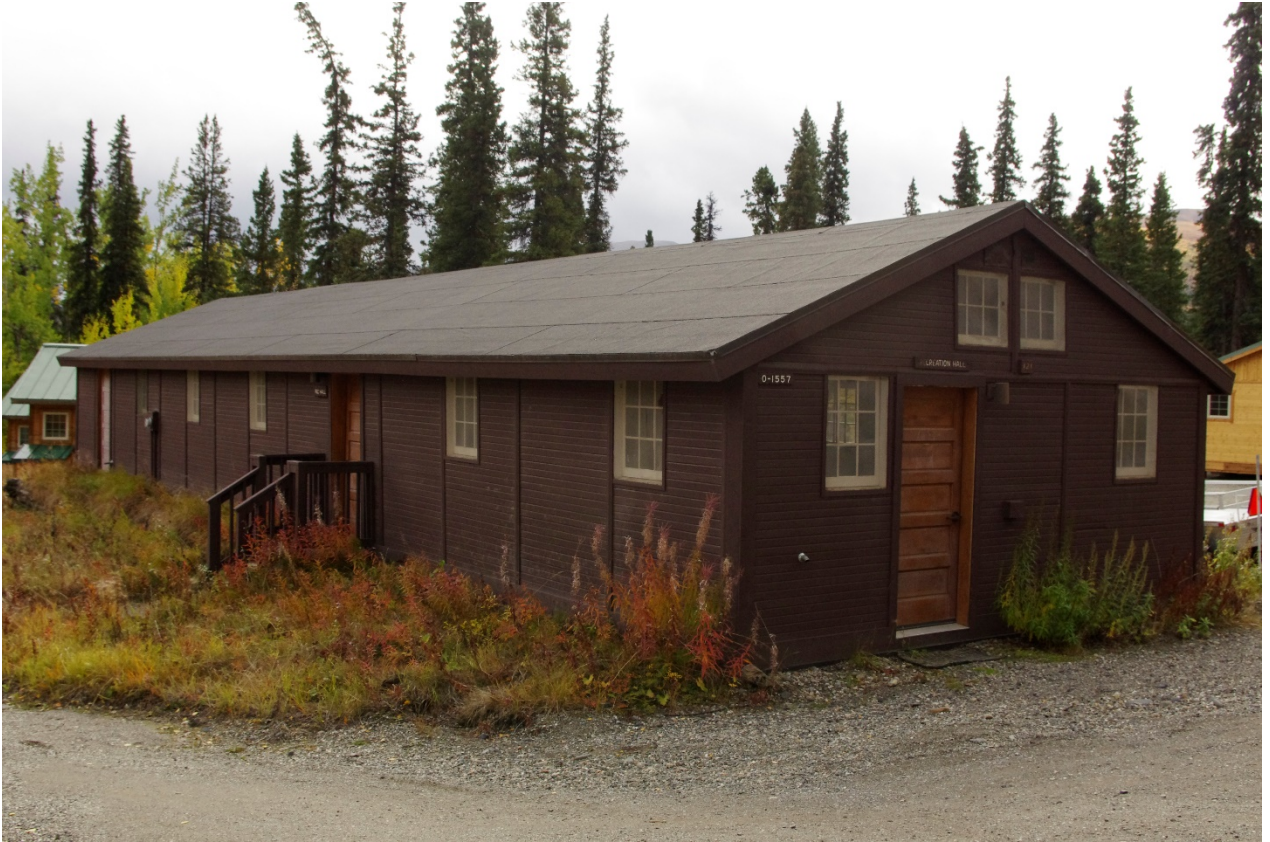
Figure 6: C-Camp Mess Hall, Denali National Park and Preserve, Similarities in Modular Construction, 2013

From the basic shape, fenestration pattern, and materials the bunkhouse appears to be a “CCC type building” which was a prefabricated sectional wood panels with tarpaper roofs and drop siding, known for being knockdown and portable. (Klein et al, 1987, 2-44, 2-25, 4-26). It is very similar to other CCC era structures in the State of Alaska, like the C-Camp Mess Hall at Denali National Park and Preserve (Figure 6). It is likely that the original siding was a drop siding and that the roof was covered in tarpaper. No photographs are known to exist currently of the structure shortly after its reconstruction at the Serpentine Hot Springs. This knowledge can change with future research. If these were the original finishes, the harsh arctic environment quickly took its toll. At least two layers of asphalt rolled roofing currently exist on the exterior of the structure. Recent bear damage reveals that drop cove siding is intact in the areas revealed.

Figure 7: C-Camp Mess Hall, Denali National Park and Preserve, Similarities in Modular Construction, 2013

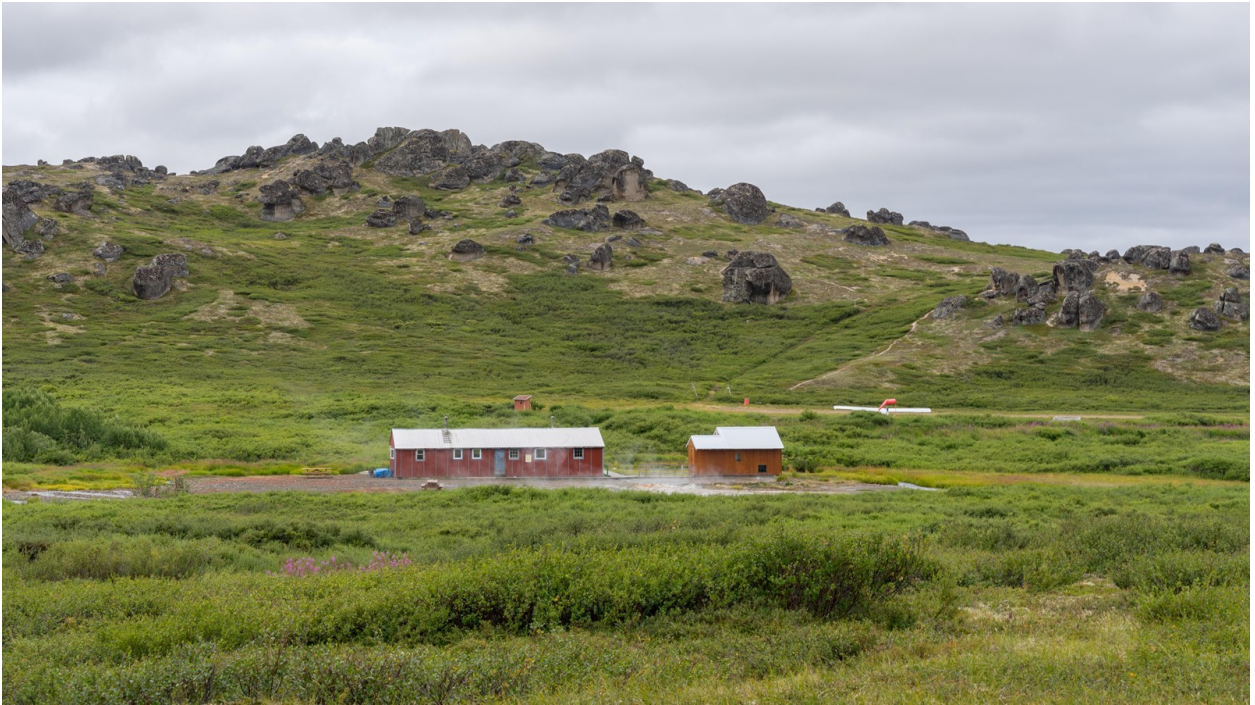
Photo 1: Overview of facilities at Serpentine Hot Springs, Bunkhouse, Bathhouse, Privy, Airstrip, Toward Southeast, BELA Files, 2017

Photo 1: Overview of facilities at Serpentine Hot Springs, Bunkhouse, Bathhouse, Privy, Airstrip, Toward Southeast, BELA Files, 2017

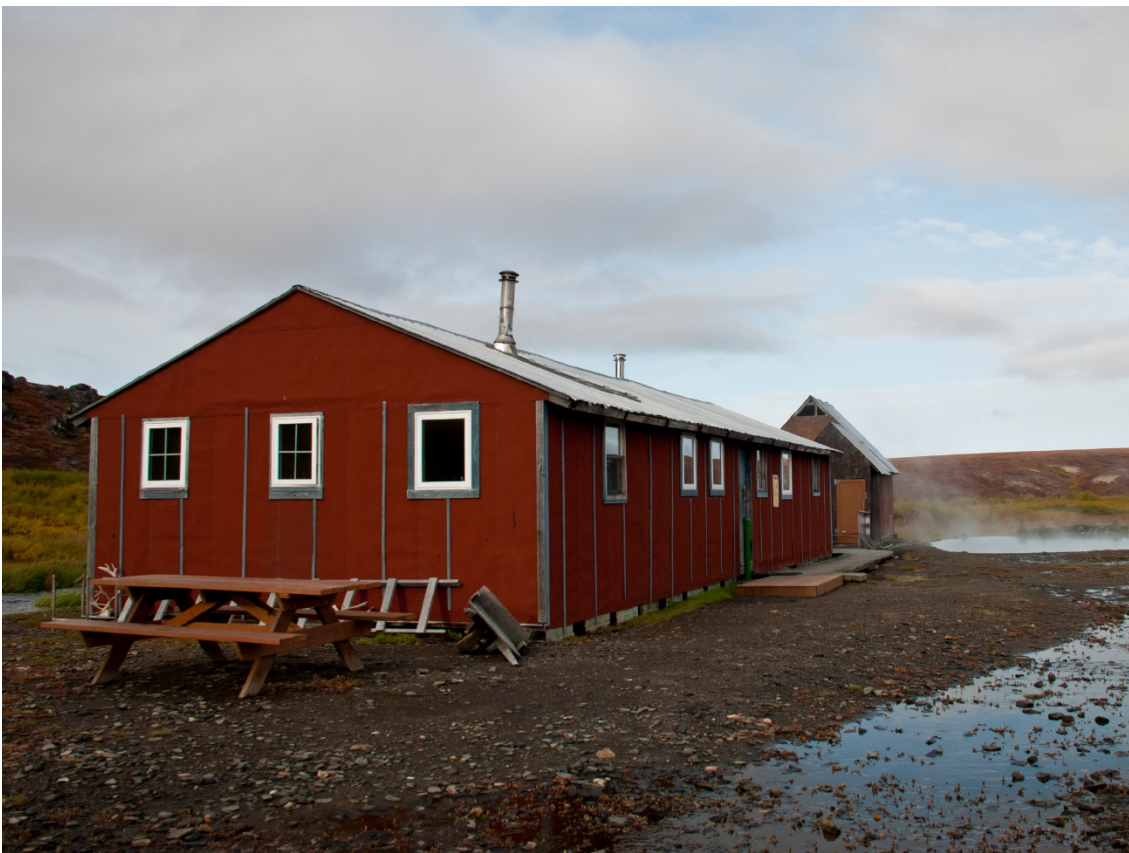
Photo 2: Serpentine Hot Springs Bunkhouse, Toward North-Northwest, BELA Files, 2015

The northeast elevation features the entrance to the building, a board door with a metal handle. To the northwest (right) the elevation features two modern vinyl sliding sash windows and one modern vinyl casement windows. To the southeast (left) the elevation features three windows, two modern casement windows and then a modern sliding sash window. The southeast elevation of the bunkhouse features three casement windows, the two to the southwest are single light modern vinyl casement windows with "four-light" 2/2 false muntions while the one to the northwest is a single light modern vinyl casement window. The southwest elevation features six windows and a no longer operational panel door, slightly

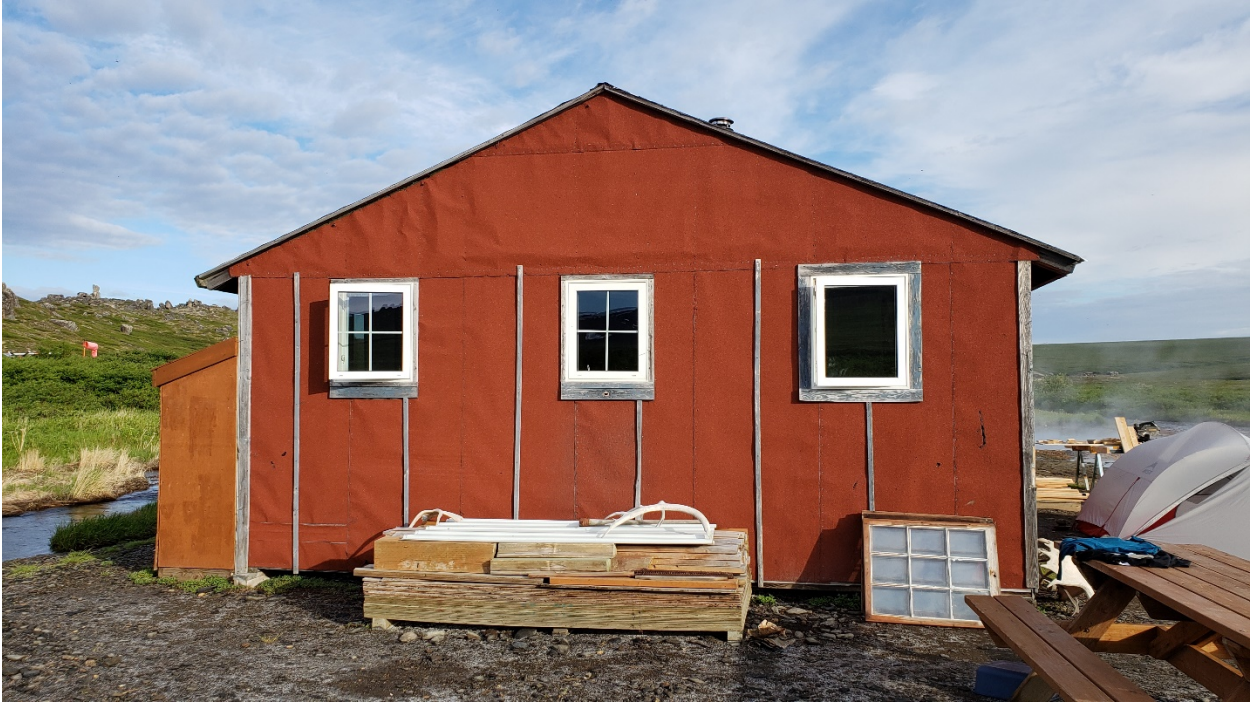
Photo 3: Serpentine Hot Springs Bunkhouse, Gable End, Toward Northwest, BELA Files, 2018

northwest of the center. From northwest to southeast, the first four windows are modern vinyl sliding sash windows, the following two are modern vinyl casement windows. The southwest elevation of the roof features a metallic chimney aligned between the two windows to the northwest of the in operational exit. The northwest elevation features four windows. Two modern vinyl sliding sash windows are centered in the wall with two additional two-by-three wood windows sit just underneath the gable.

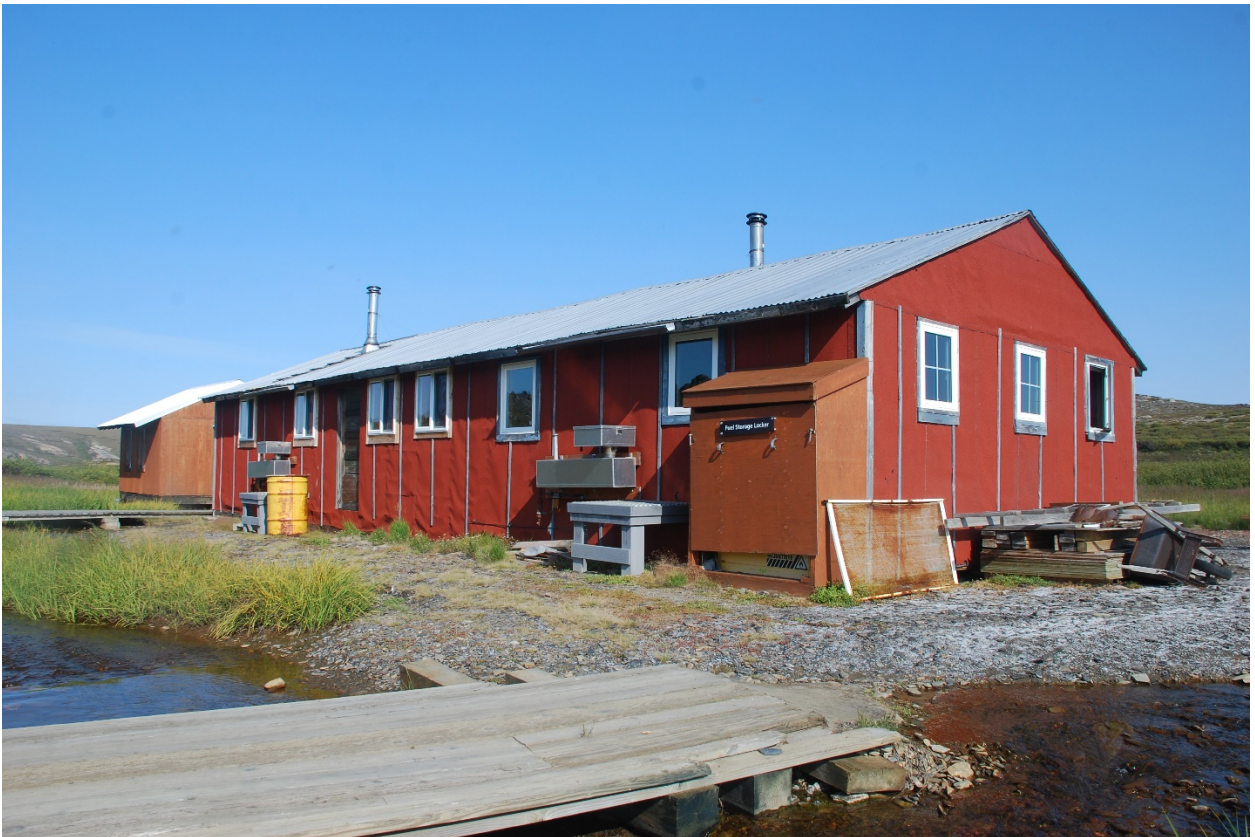
Photo 4: Serpentine Hot Springs Bunkhouse, Toward Northeast, BELA Files, 2020

Photo 4: Serpentine Hot Springs Bunkhouse, Toward Northeast, BELA Files, 2020

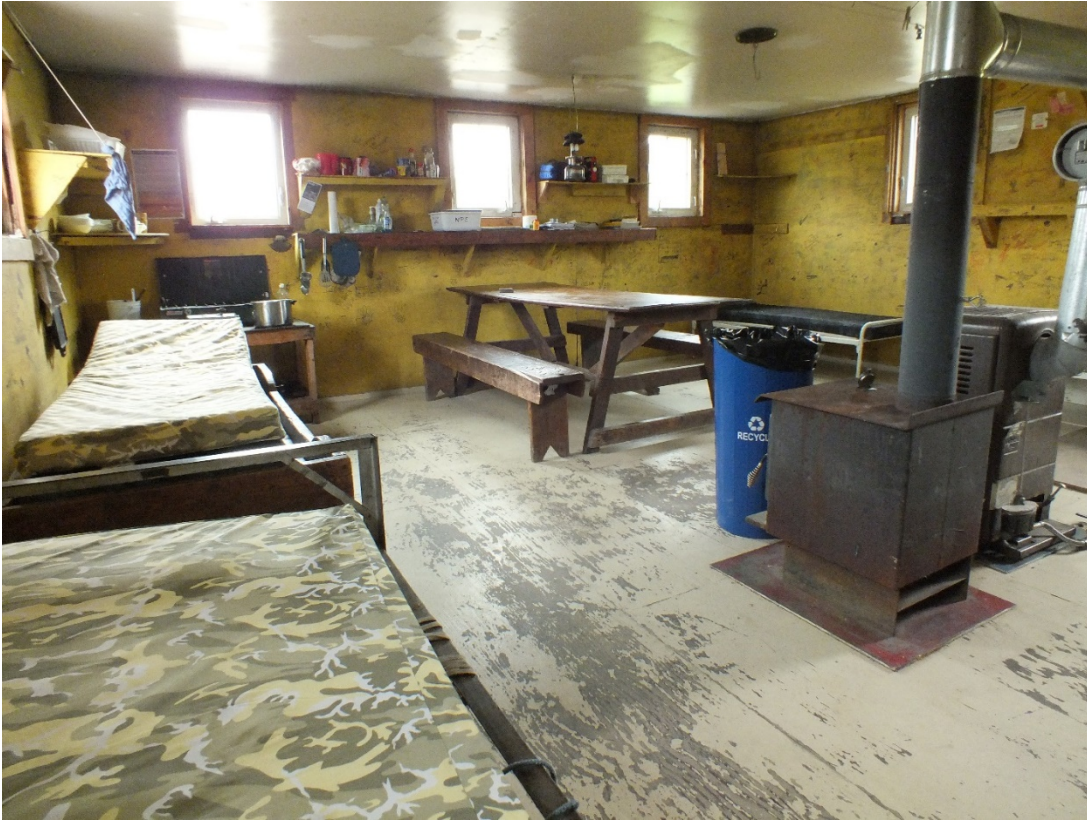
Photo 5: Serpentine Hot Springs Bunkhouse, Interior, Southern Room, BELA Files, 2018

The southeast room also features a heating stove in the center of the room and is approximately 20'x20'. A preparation and cooking table sits in the eastern corner along the southeast elevation underneath a pair of triangular shelves, also in the corner. A large table and two searching benches are aligned against the southeast elevation underneath two levels of shelves. Six cots surround the remaining perimeter of the room which also contains clothes lines as well.

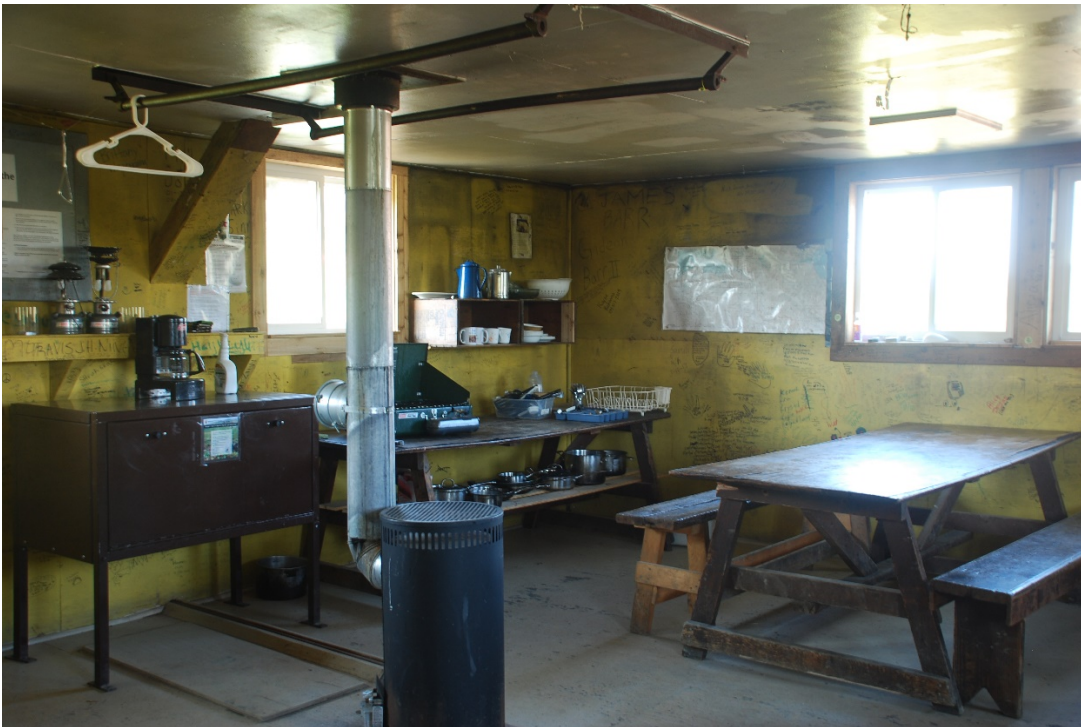
Photo 6: Serpentine Hot Springs Bunkhouse, Interior, Northern Room, BELA Files, 2020

The northwest room features a heating stove in the center, three tables and five cots and is approximately 20'x20'. A preparation table sits along the southwest elevation in the western corner of the room and a small table for a camp stove is situated adjacently and on the northwest elevation. A large table with two seating benches completes a "U" shaped setup of the dining area. The cots are organized along the remaining perimeter and clotheslines are strung along the ceilings.
